# LAND-1 ROAD CONDITION ASSESSMENT TECHNICAL MEMORANDUM

**KERN RIVER No. 3 HYDROELECTRIC PROJECT**  
***FERC PROJECT No. 2290***

July 2024

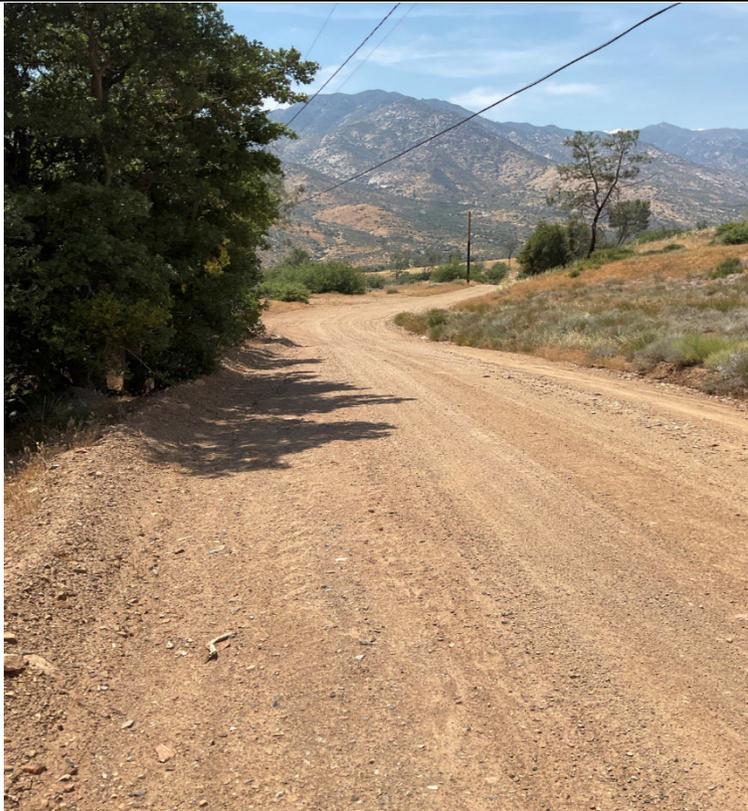
**Photograph: 1**

Example of Project Access Road in “Good Condition”; no ruts or potholes, no vegetation in the road, drainage features were in good condition. Cannel Brush Creek Access Road, facing south.

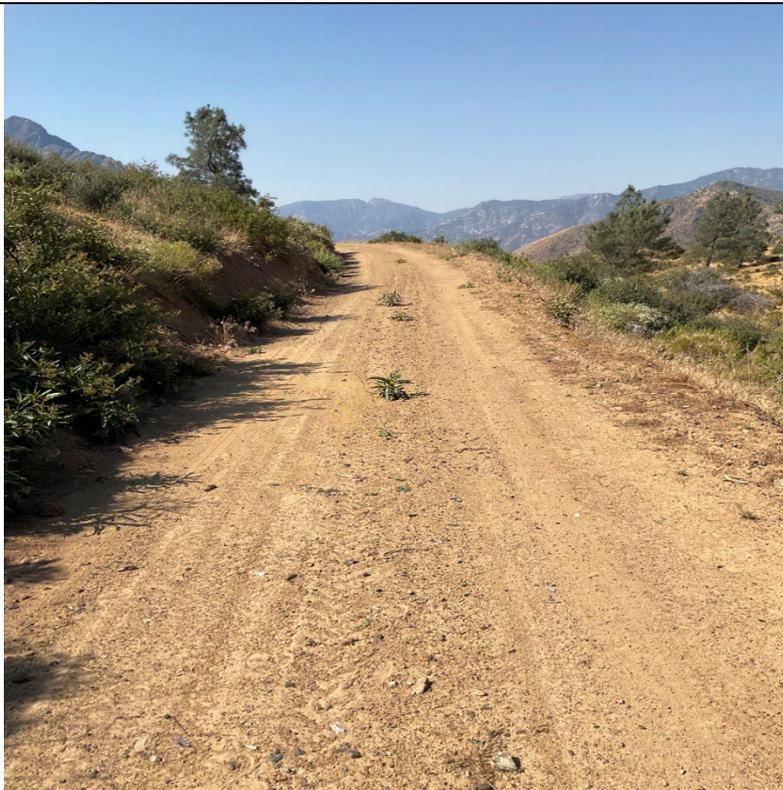
**Photograph: 2**

Example of Project Access Road in “Good Condition”, with very minor vegetation concern. Tunnel 16/17 Access Road, facing south.

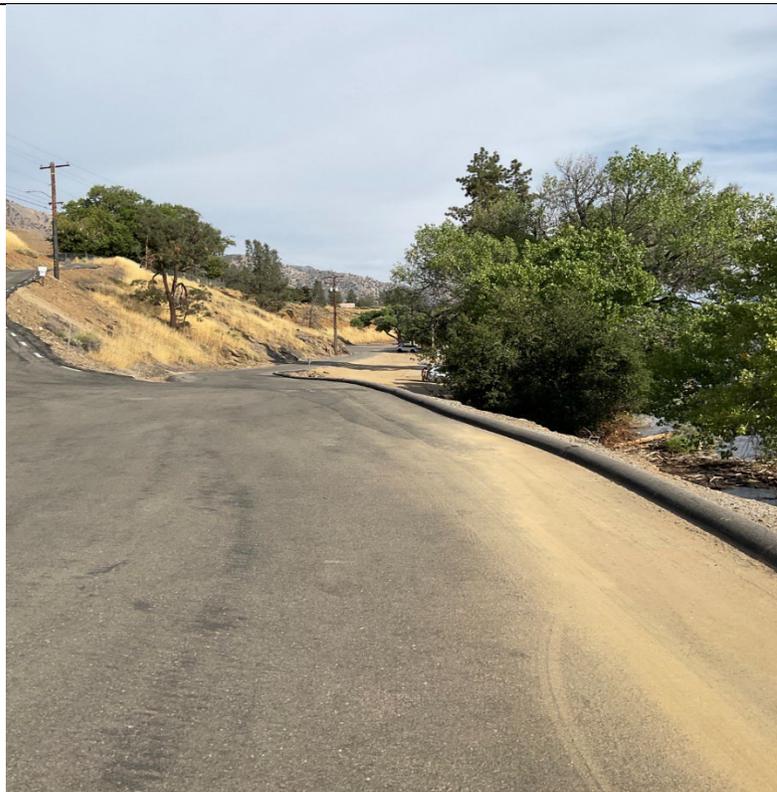
**Photograph: 3** Example of Project Access Road in “Good Condition”. Kern River No. 3 Powerhouse Access Road, facing east.

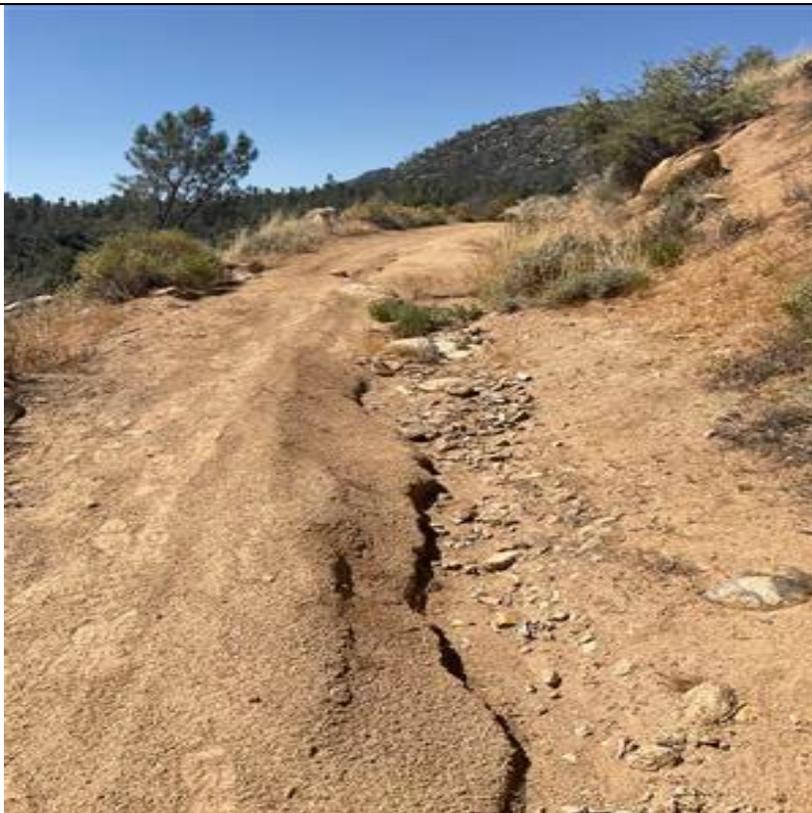
**Photograph: 4** Example of road in “poor condition”; erosion gullies, vegetation growing in road, multiple rills. West side of Rincon Trail Access Road, facing west.

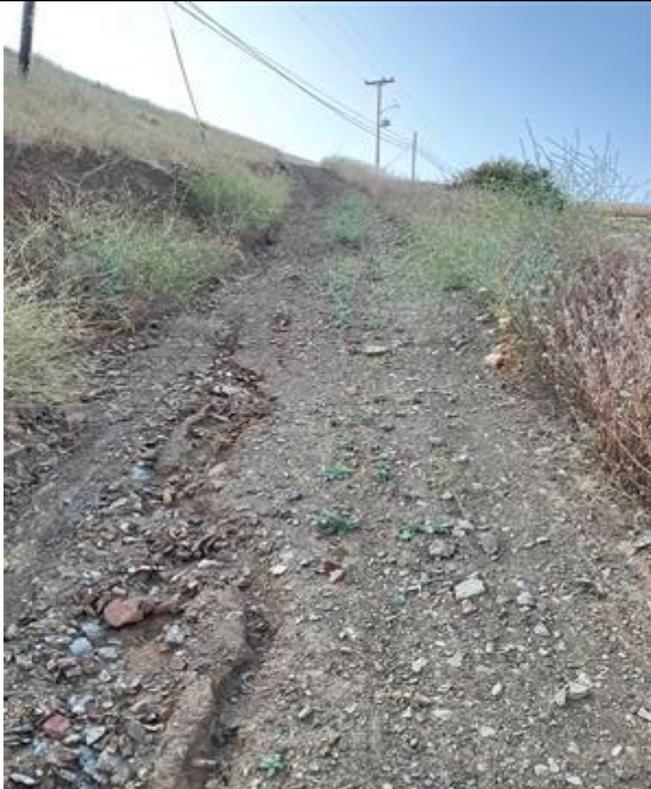
**Photograph: 5** Example of road in “Fair Condition. Note the rills and some overgrown vegetation. North Penstocks Access Road, facing east.

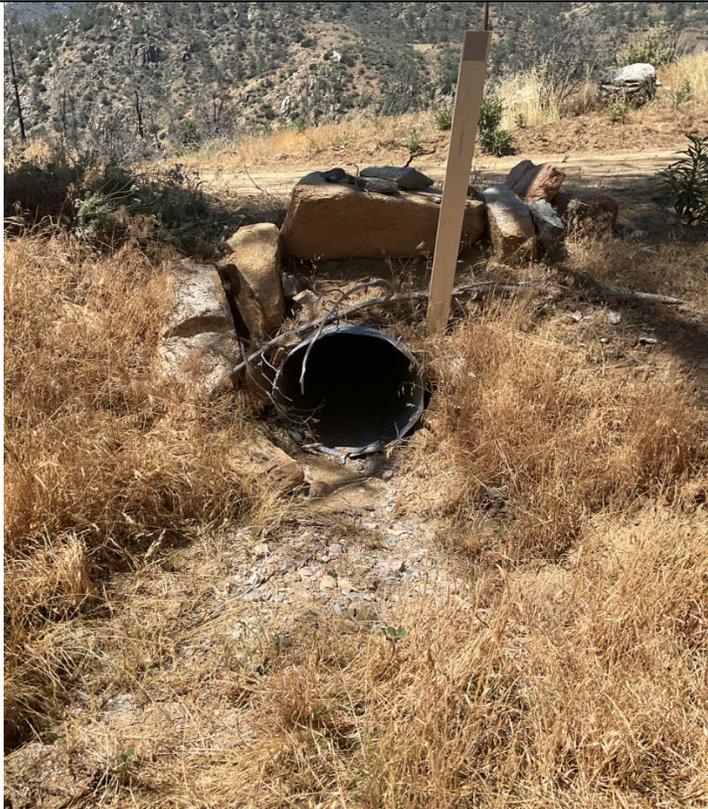
**Photograph: 6** Example of culvert categorized as “No Apparent Concern”, inlet side, facing west.

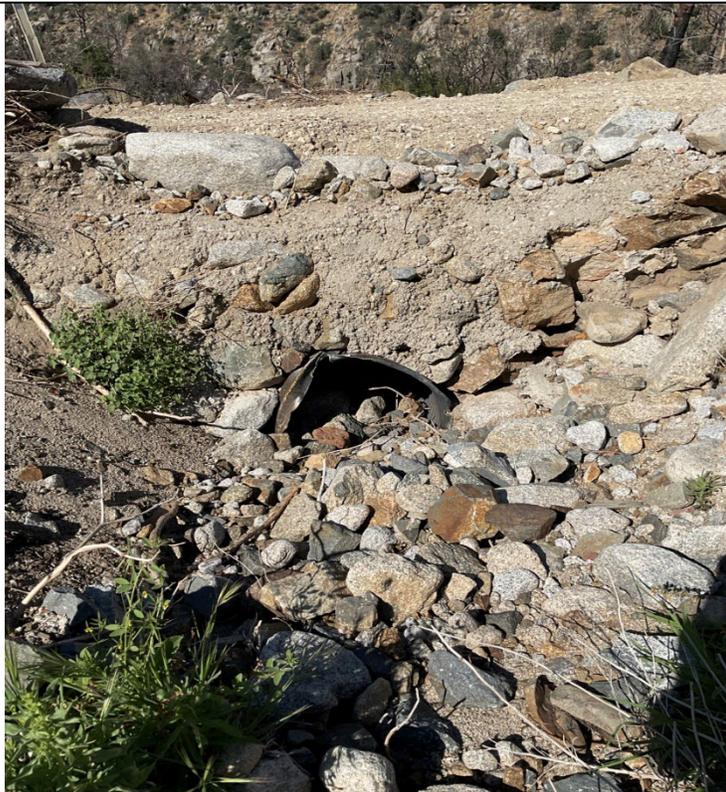
**Photograph: 7** Example of culvert categorized as “Potential Concern”, due to blockage inlet side, facing north.

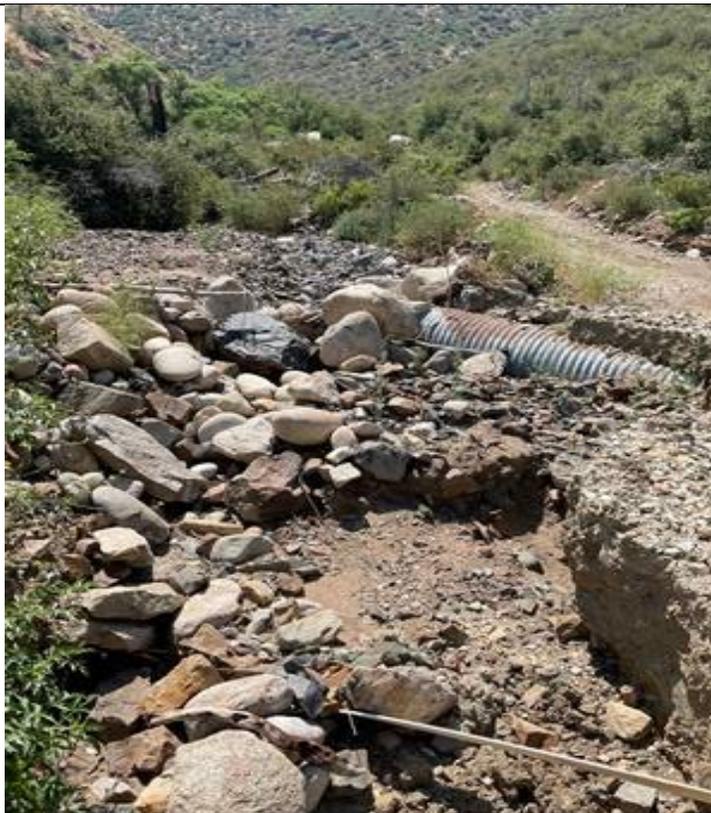
**Photograph: 8** Example of culvert categorized as “Concern Likely”, inlet side, facing northeast.

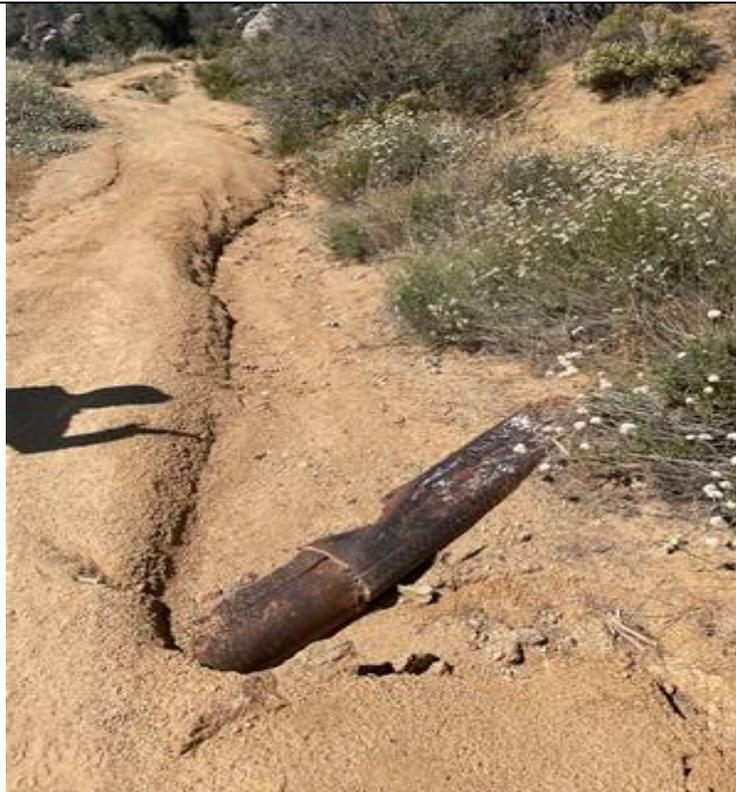
**Photograph: 9** Example of unmarked, non-functioning culvert. Rincon Trail Access Road, facing west.

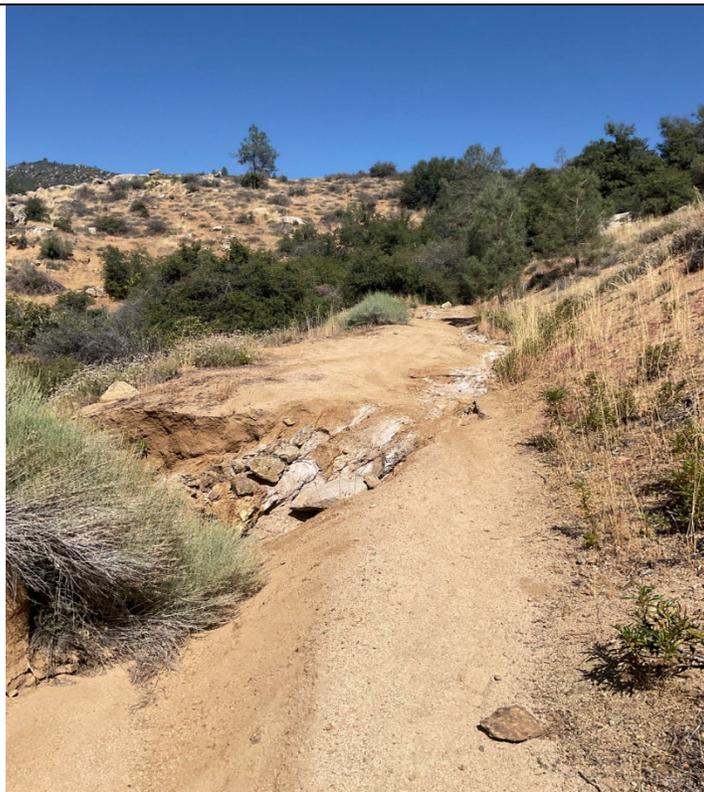
- Approximately 100 feet of the road over the stream crossing was not passable due to a bridge washout.
  - Based on historical imagery, a large storm event between 2010 and 2013 caused the road crossing to wash out.
  - Currently, the streambank is not stabilized by vegetation or boulders, making it susceptible to streambank erosion (see Attachment E, photographs 12 and 13). Also refer to Table 5.1-1 of the *GEO-1 Erosion and Sedimentation Technical Memorandum* (Appendix E.2 of this Draft License Application).
- Rincon Trail Access Road (#11)
    - The southeastern portion of Rincon Trail Access Road did not appear to be maintained and was not passable for a vehicle due to erosion gullies and soil sloughing (see Attachment E, photograph 10).

**Photograph: 10** Section of Rincon Access Trail Road that is not passable due to erosion concerns. On the east side of Rincon Access Trail road, facing west.

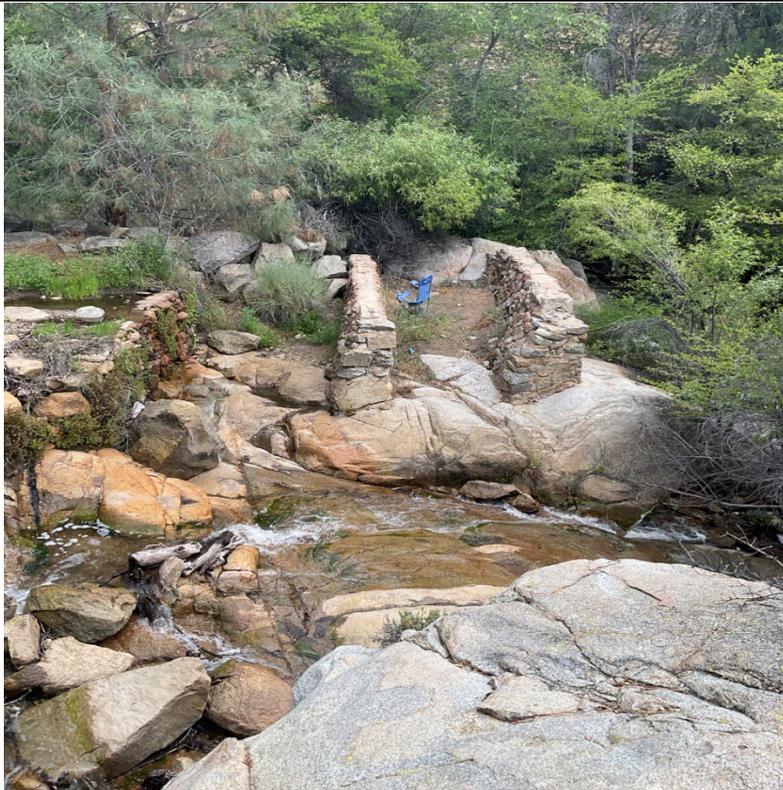
- Tunnel 8A/8B Flume Access Road (#4)
  - Approximately 30 feet off the south end of the road, immediately north of Rincon Access Road, was not passable due to a bridge washout. The rest of the Tunnel 8A/8B road is in good condition.
  - There are no apparent erosion concerns at the bridge washout location as the surviving bridge foundation, and boulders are protecting the stream banks from stream flow (see Attachment E, photograph 11).
- Tunnels 10–12 Access Road (#9)

**Photograph: 11** Where bridge used to be, Tunnel 8A/8B Flume Access Road, facing south. There are little erosion concerns as stream banks are protected by boulders and vegetation, dissipating the water's energy.

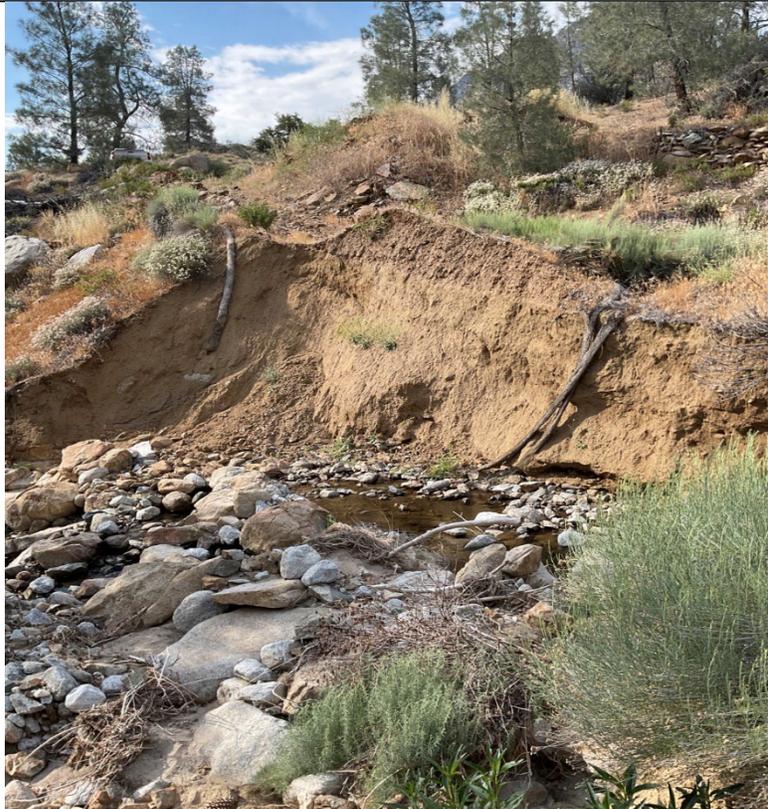
**Photograph: 12** Erosion concern, where bridge used to be at Tunnels 10-12 Access Road. Facing northwest.

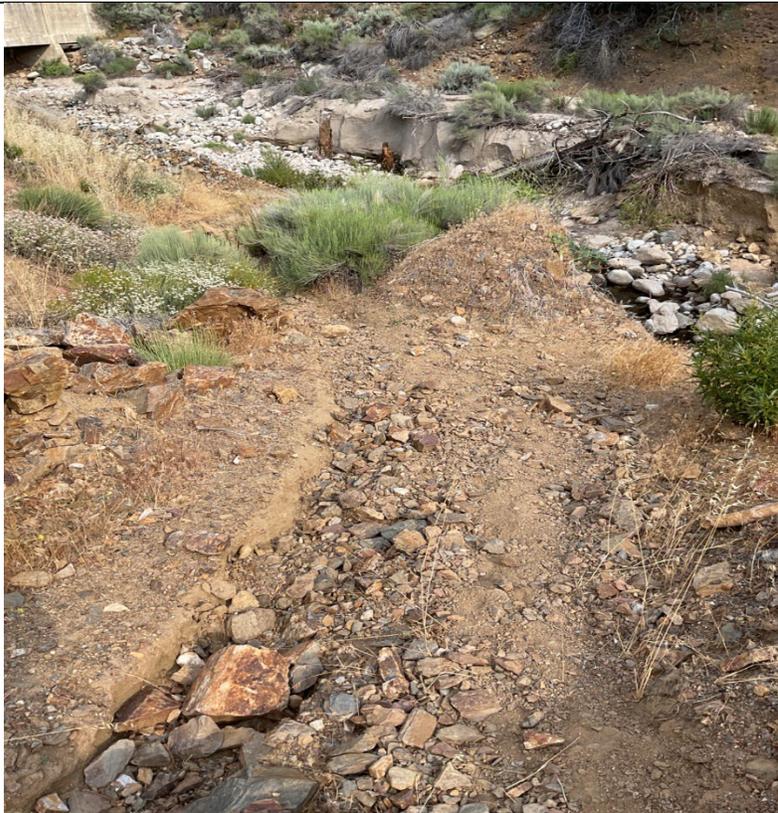
**Photograph: 13** Where bridge used to be at Tunnels 10-12 Access Road. Facing southeast.

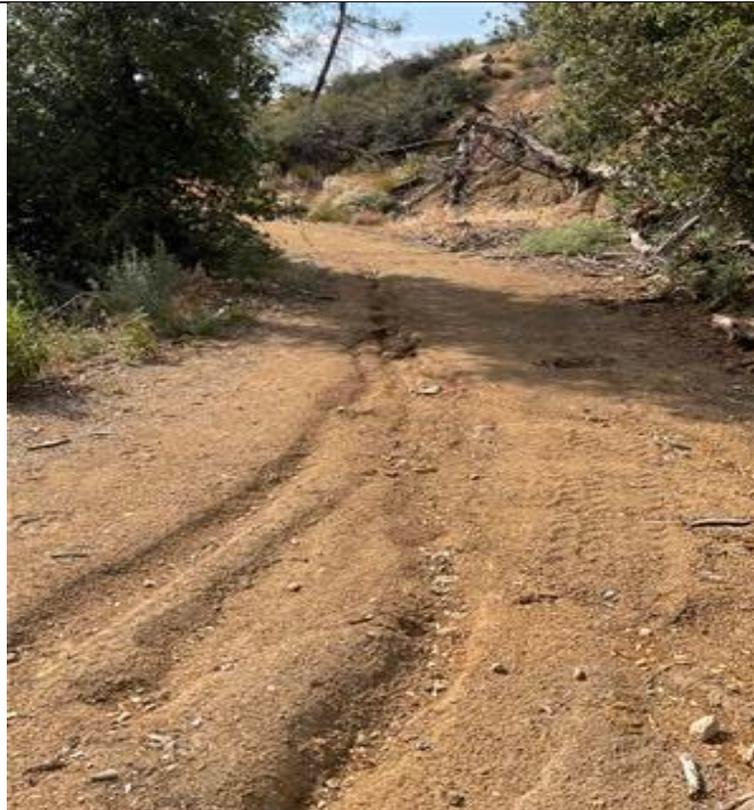
**Photograph: 14** Example of erosion rill, the most common erosion feature observed in the field.

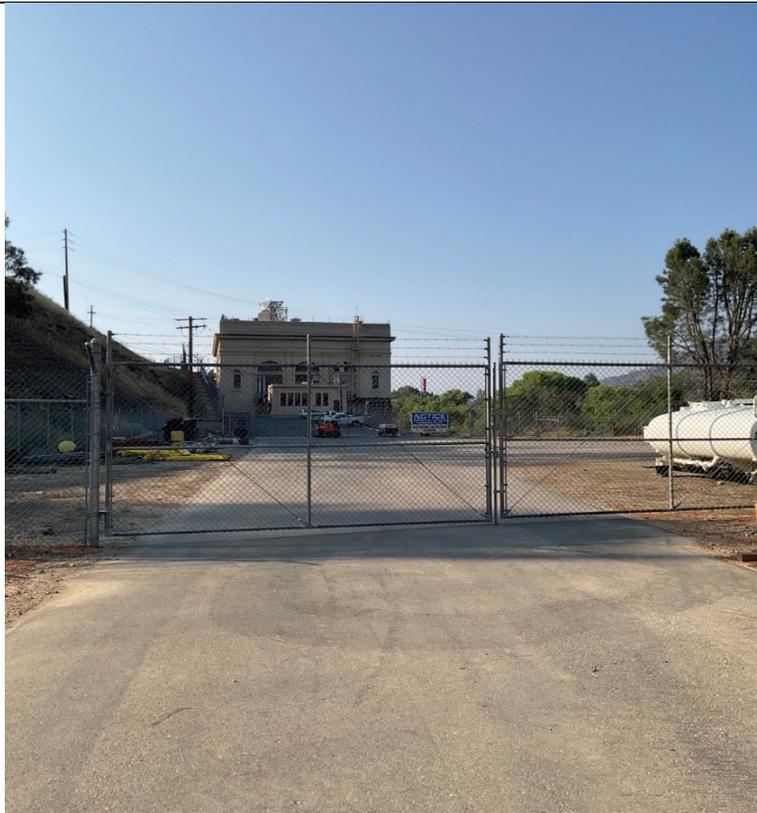
**Photograph: 15** Example of gated SCE Project Road, restricting public access. All SCE gates were locked and in good working condition.

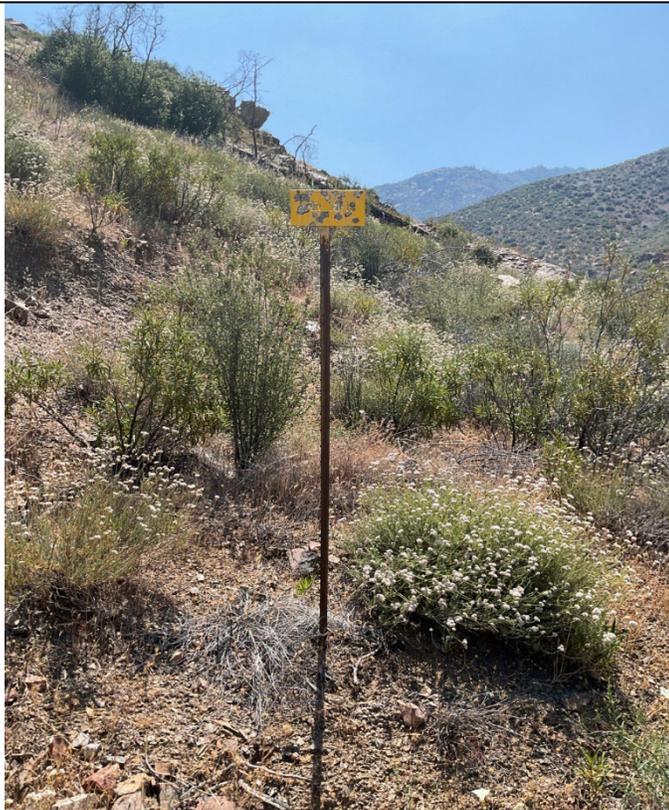
**Photograph: 16** Example of SCE sign that will need to be replaced.

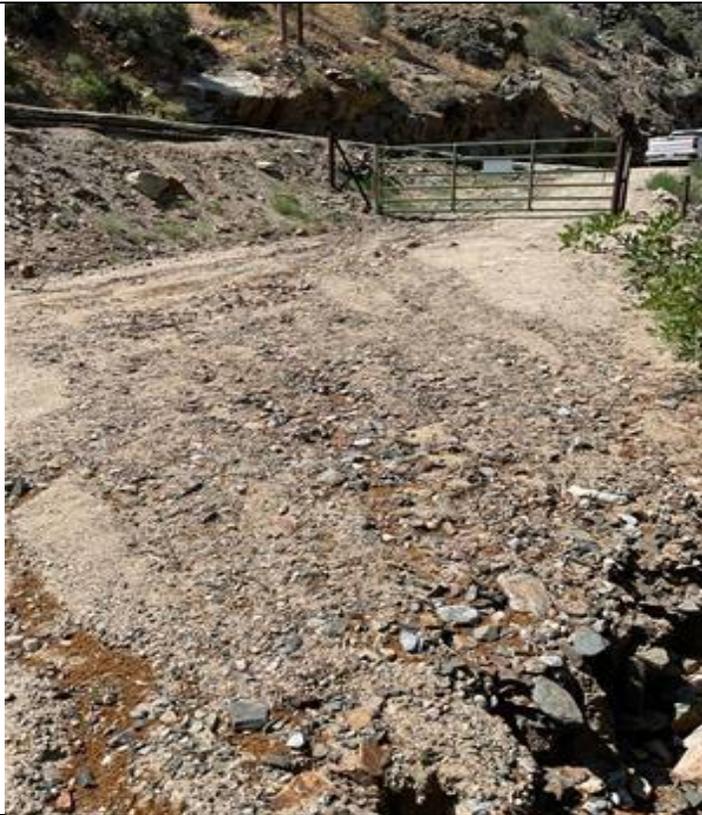
**Photograph: 17**

Example of sheet erosion due to run-off from Sierra Highway. Sandbox Access Road, facing southwest.
