LAND 1 – ROAD AND TRAIL CONDITION ASSESSMENT TECHNICAL MEMORANDUM

**KERN RIVER NO. 1 HYDROELECTRIC PROJECT
*FERC PROJECT No. 1930***

December 2025

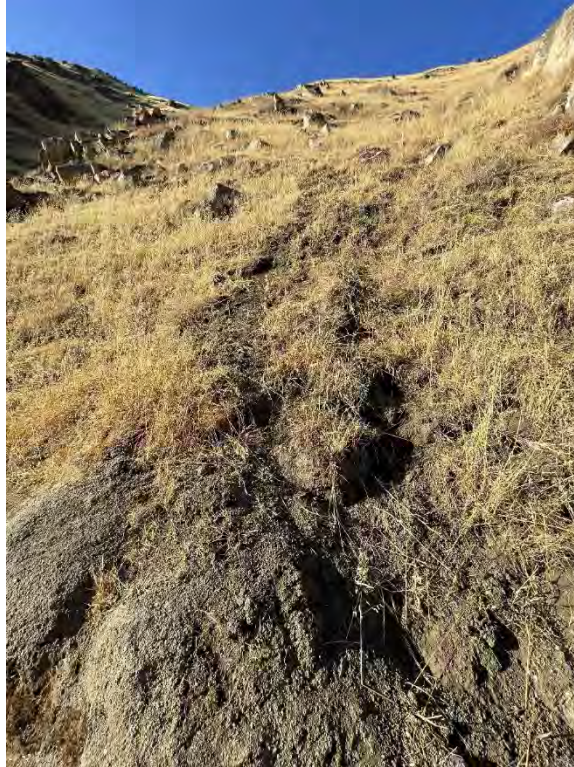
Photo D-1. August 27, 2024. Adit 17 & 18 Trail. Example of hillslope erosion present within steep, grassy trails.

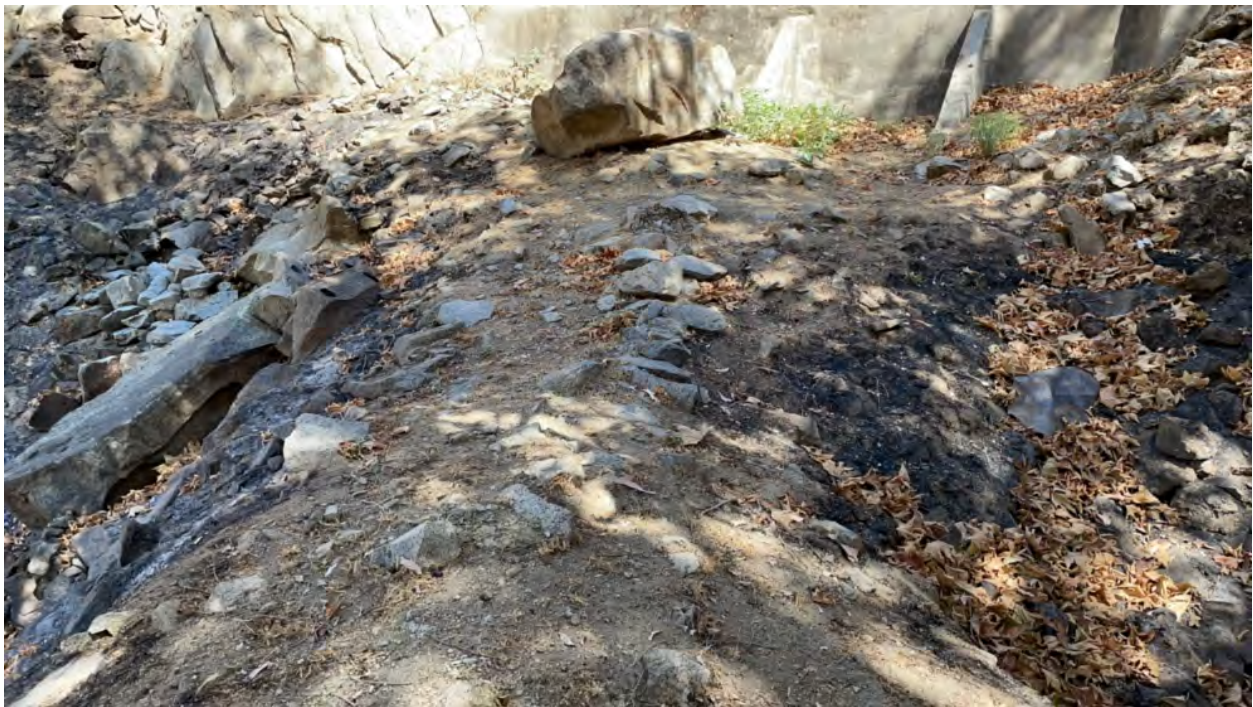
Photo D-2. August 25, 2024. Conduit No. 3 Trail. Burned soil following the July 2024 Borel Fire.

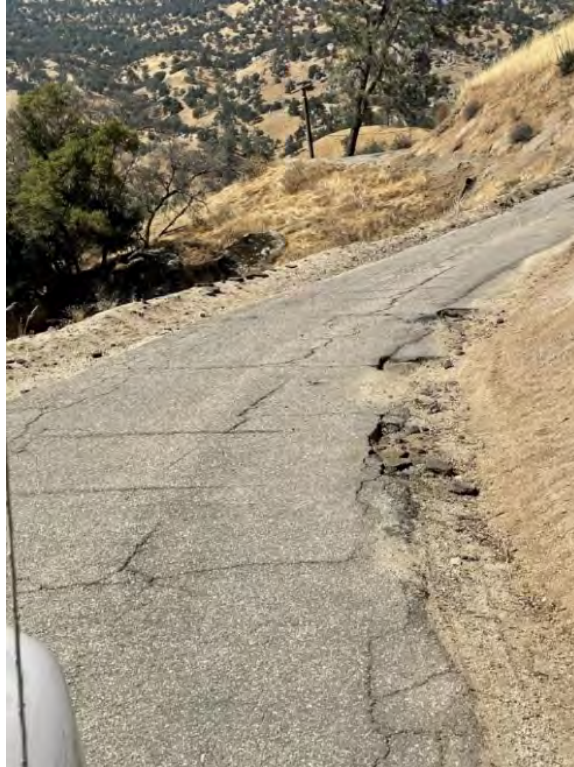
Photo D-3. August 26, 2024. Democrat Dam Road. Example of road surface erosion present throughout this road.

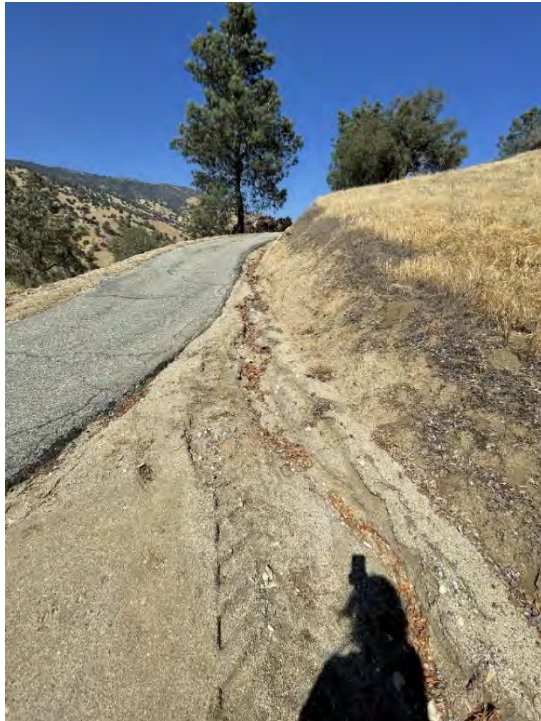
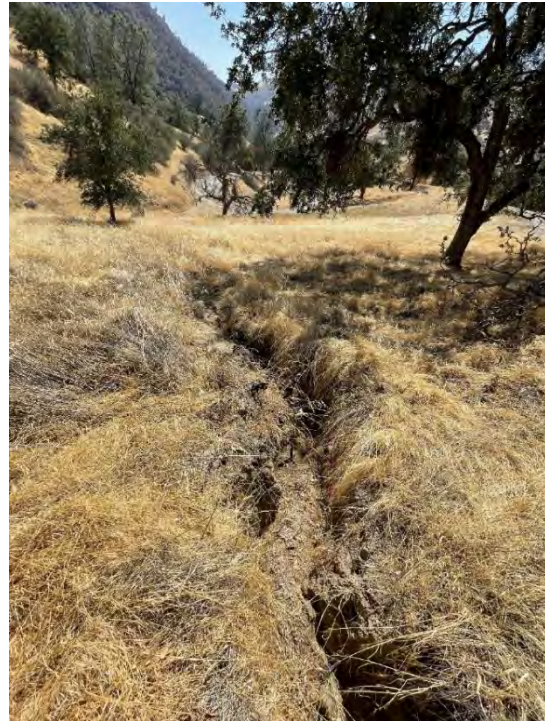
Photo D-5. August 26, 2024. Democrat Dam Road. Gully along shoulder extending into vegetated hillslope.

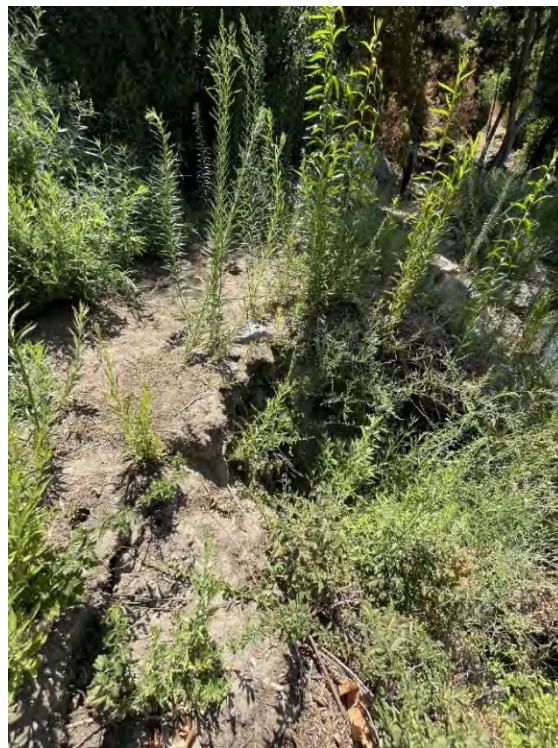
Photo D-6. August 26, 2024. Democrat Gage Trail. Bank failure along trail and overgrown vegetation.

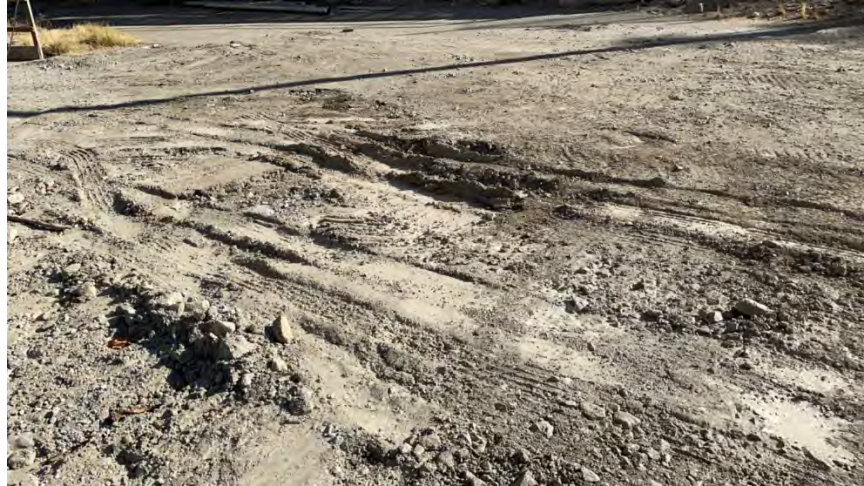
Photo D-9. August 26, 2024. Lower Powerhouse Road. Tire ruts within the lower turnout area.

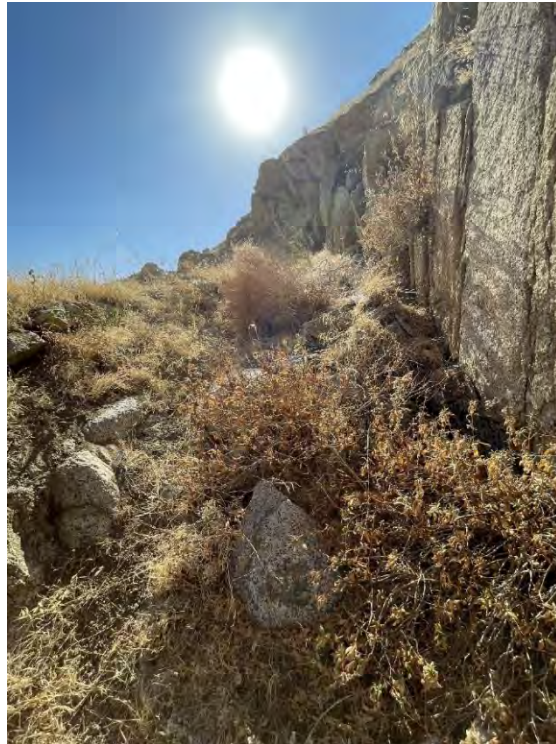
Photo D-10. August 27, 2024. Overflow Spillway Trail. Example of overgrown vegetation that is typical of this trail.

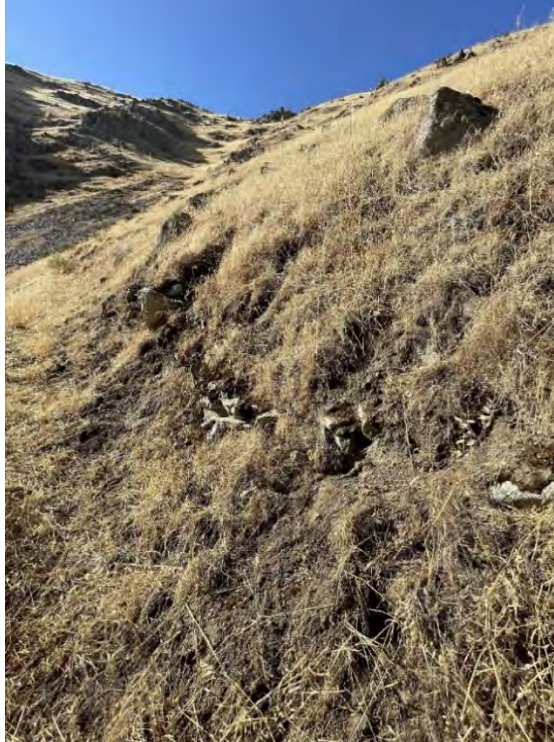
Photo D-11. August 27, 2024. Overflow Spillway Trail. Trail is poorly defined and unmaintained.

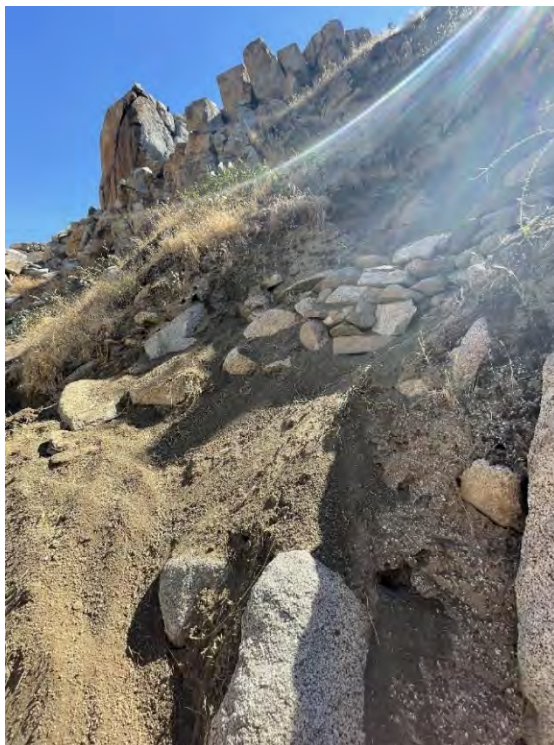
Photo D-12. August 27, 2024. Skip Hoist/Forebay Trail. Example of soil erosion characteristic of this trail.

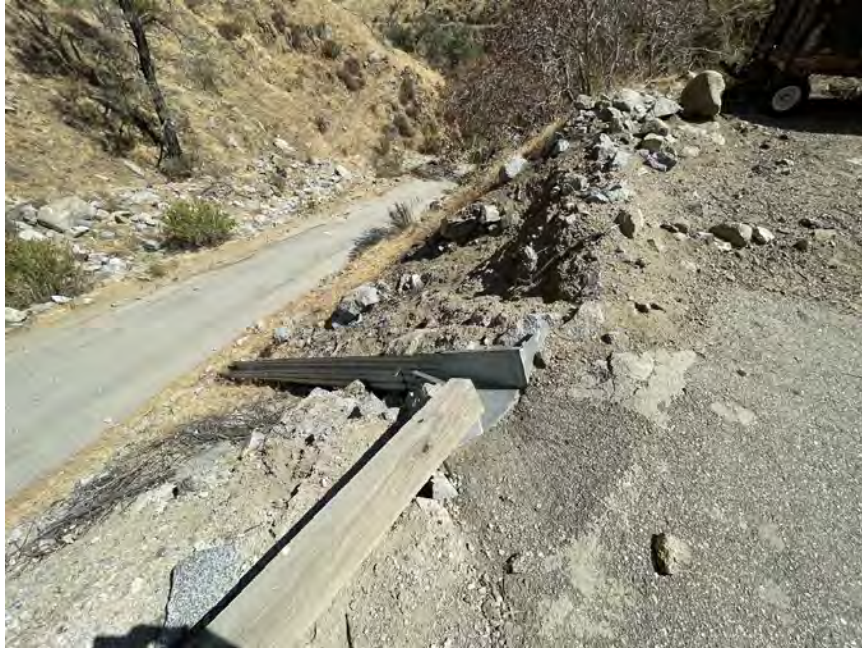
Photo D-15. August 26, 2024. Stark Creek Road. Example of steel slope drain in good condition, which are present throughout Stark Creek Road.
