MISSION CREEK RESTORATION PROJECT – PHASE 1 POST CONSTRUCTION

Mission Creek/Tunnel Trail Road, Santa Barbara County, California

April 10, 2020

LOCATION: TUNNEL TRAIL AREA	SHEET NO. 1
MISSION CREEK AS-BUILT K-RAIL EXHIBIT	SCALE: AS SHOWN
	1 OF 4 SHTS.

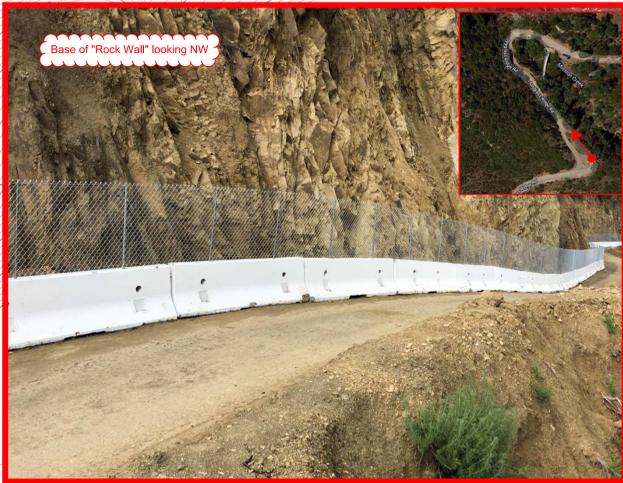
Photo #1 - After chainlink fence installation

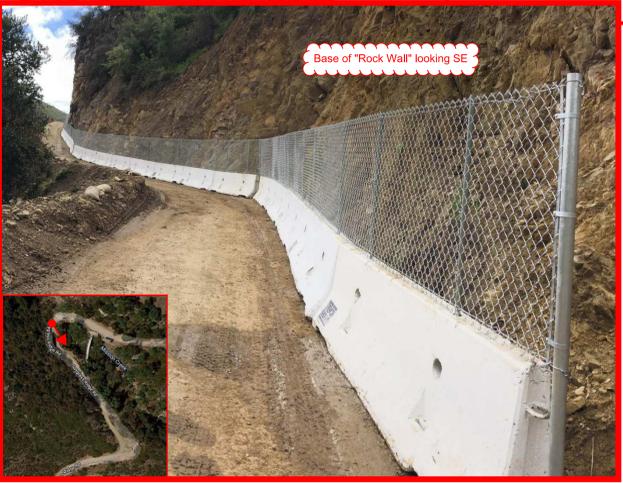
Photo #2 - After chainlink fence installation

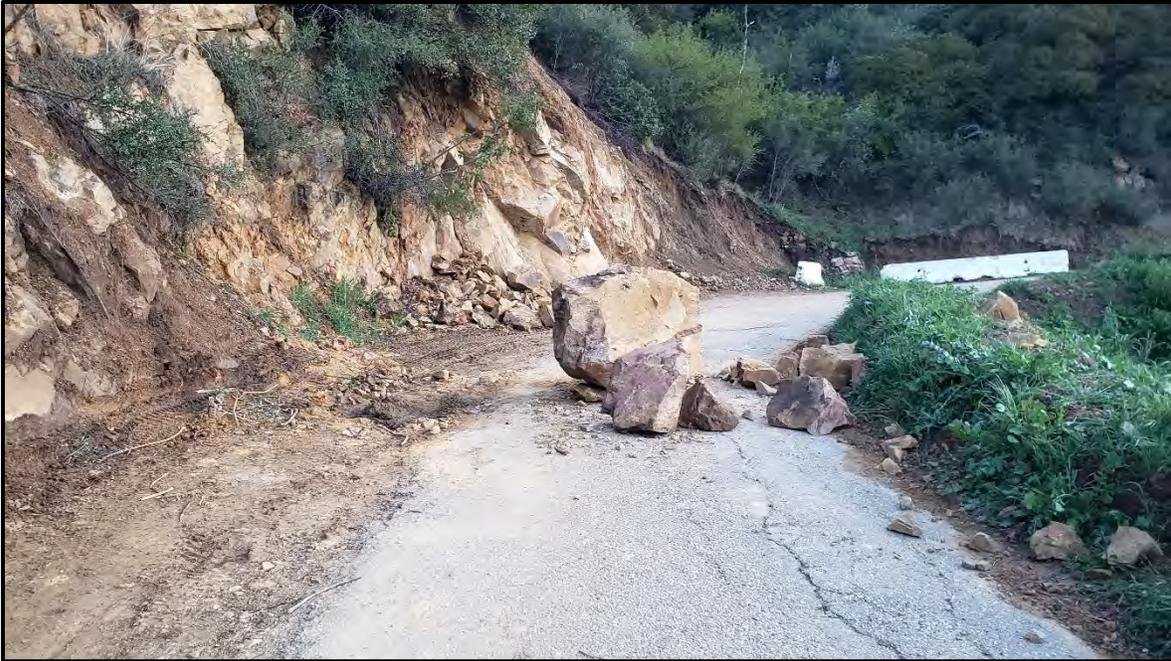
Photograph 1. Looking northeast, March 18, Spyglass Ridge Road rock fall debris from a storm just days prior, preventing access.

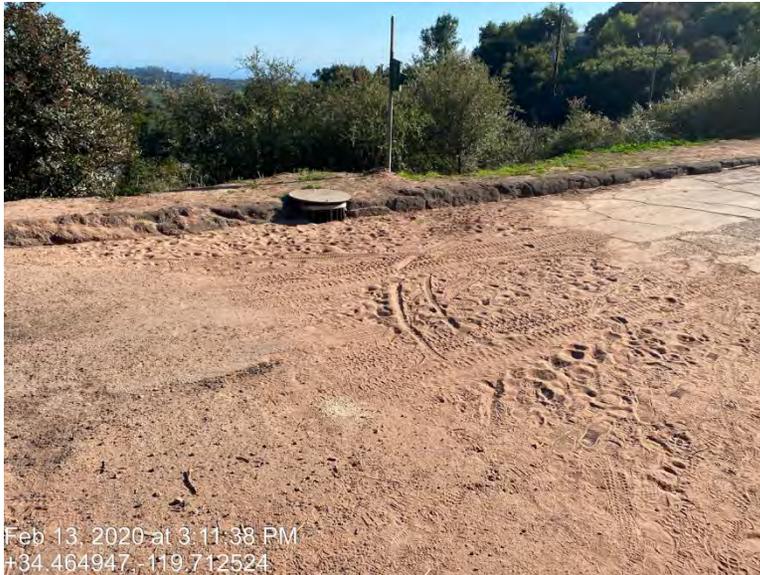
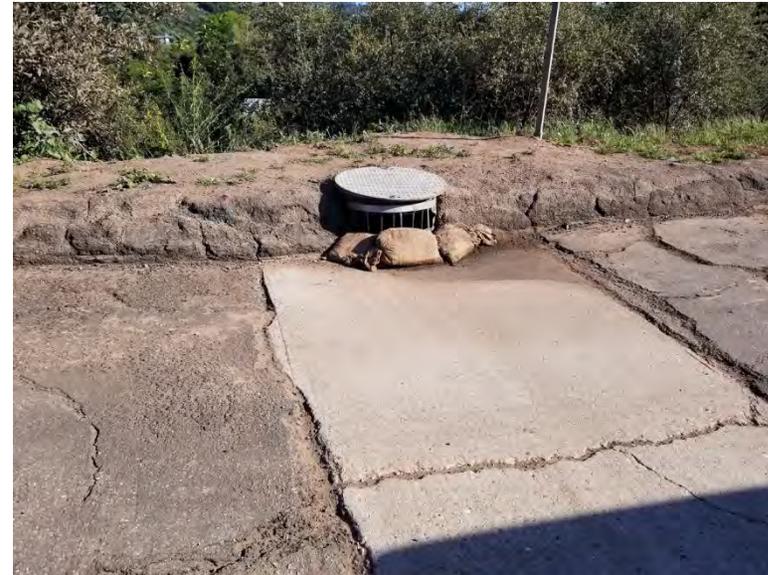
The storm drain at the gate was cleared of sediment, and a gravel bag check dam was added.

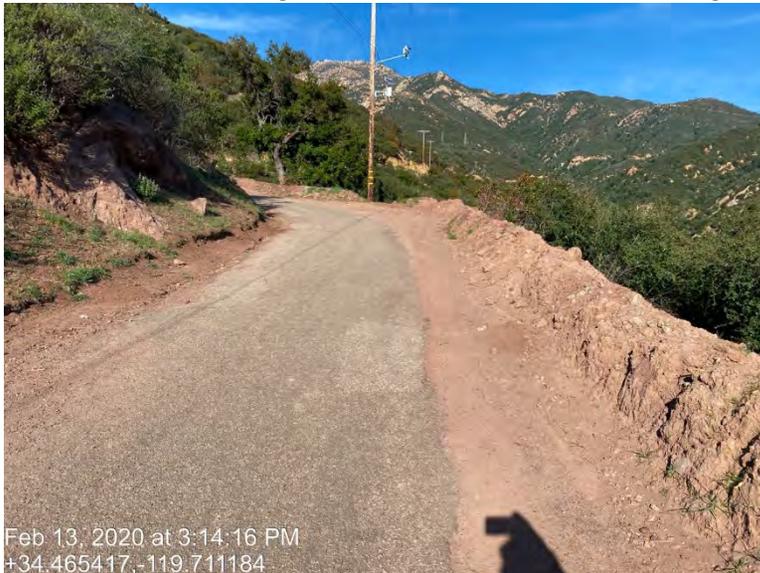
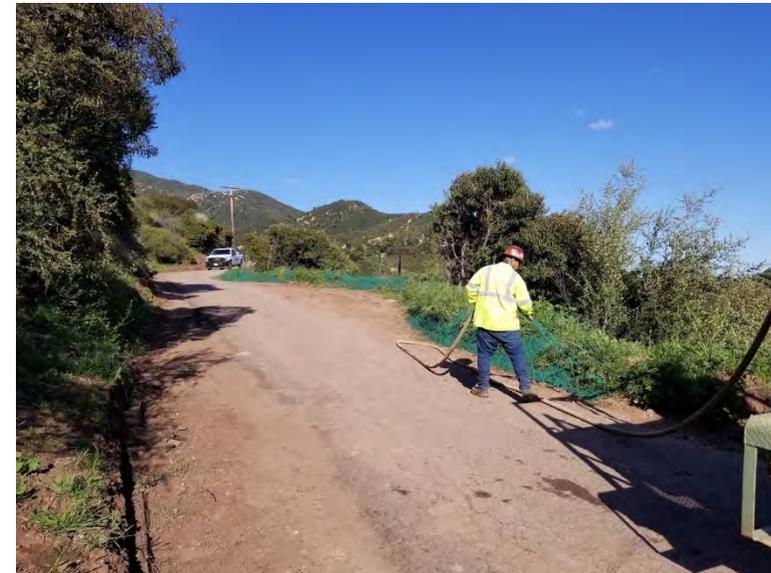
All loose berm areas were sprayed with hydromulch from the entry gate to Road Area 10, and up the left fork to the towers. Portions of the steep section on the left fork were protected using erosion control blankets because the hydromulch vehicle was not able to climb the steep slope.

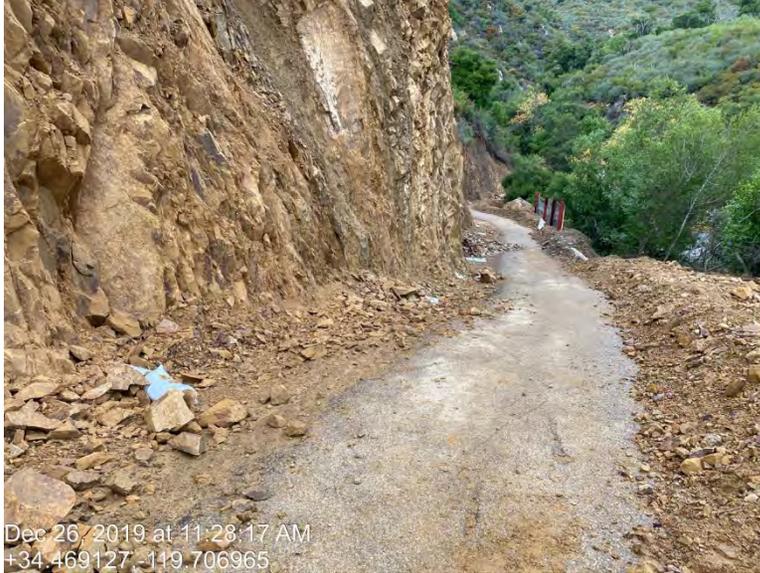
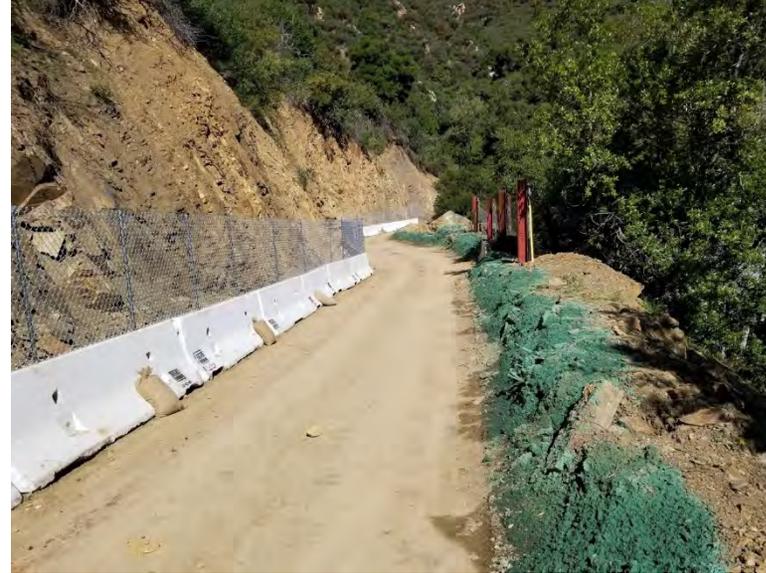
The rock wall area is protected with k-rail, chain link fence, gravel bag check dams, and hydromulch.

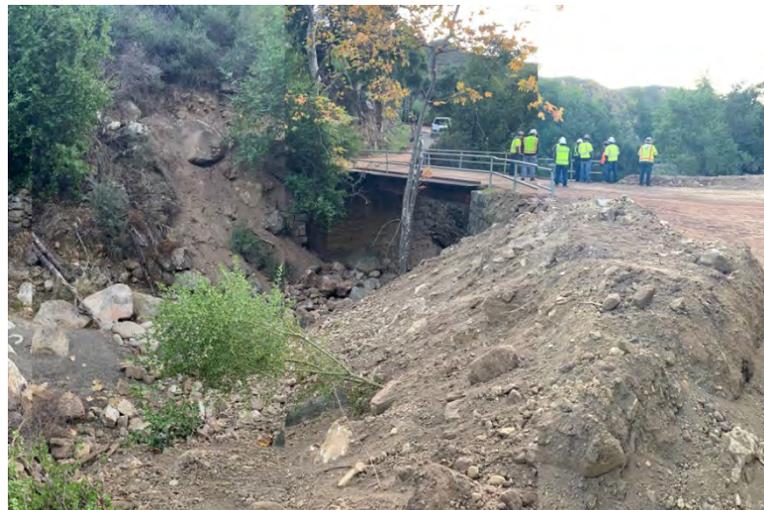
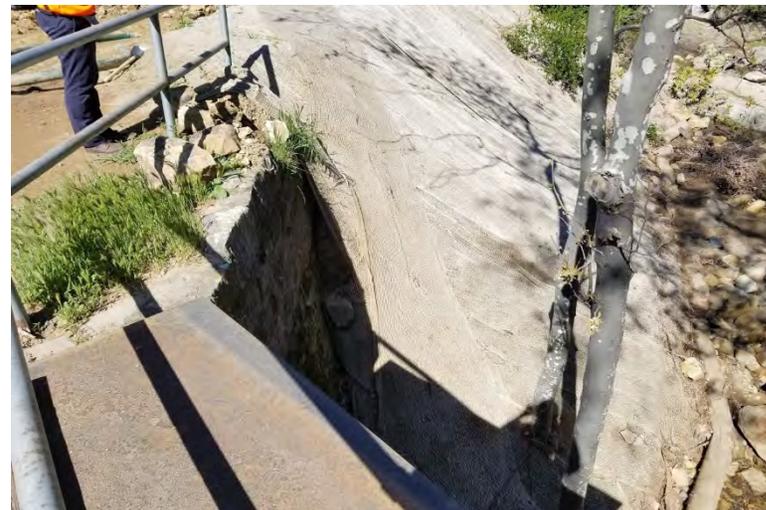
Creek areas 1a and 1b are protected with erosion control blanket. This was completed prior to Phase 1 commencement.

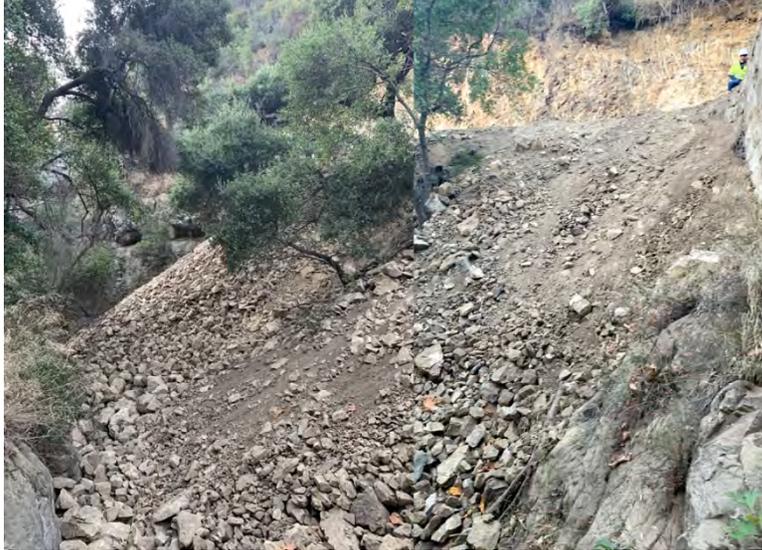
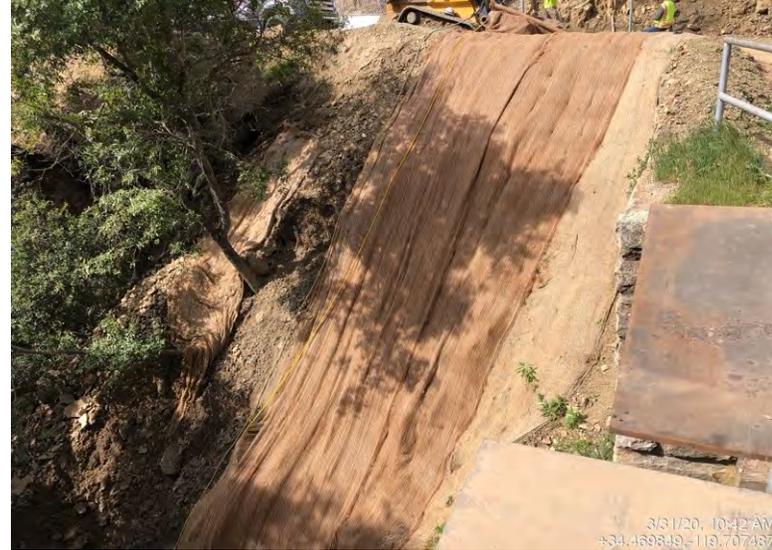
Creek Area 2 was protected with erosion control blanket prior to Phase 1 commencement.

- ii. Hydraulic mulch had no plastic and was weed free. No seeding was done during the effort.
 - c. Erosion control blankets at Creek Site 2 were replaced on March 31, 2020, immediately following completion of Phase 1.

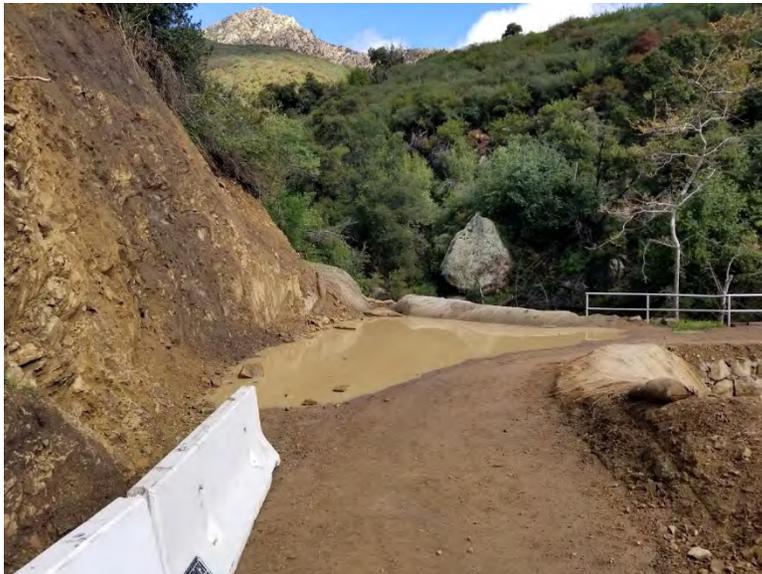
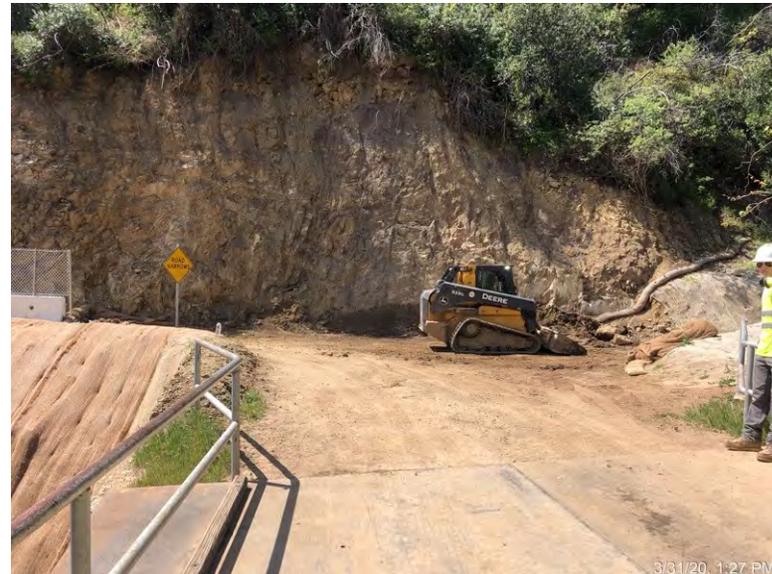
Accumulated water and mud were removed from the low area near the bridge. Also, a Narrow Road sign was placed at top and bottom of the rock wall, as seen in the right photo.
