1.0 EXECUTIVE SUMMARY

During 2003, Southern California Edison's (SCE) Raptor Protection Program was reviewed. A review of the designs of the Big Creek ALP transmission and Project powerlines under 33 kV was performed to determine if they meet the guidelines set forth in *Suggested Practices for Raptor Protection on Power Lines: The State of the Art in 1996* (APLIC 1996). Overall, SCE's Raptor Protection Program is consistent with the recommendations made in APLIC (1996). SCE has a system of reporting raptor mortalities, and the information is used to determine which power line structures pose a risk to raptors. SCE attempts to modify power line structures that pose a risk to raptors within 30 business days. SCE's Raptor Protection Program also includes annual training that educates SCE employees on the topics of raptor identification, pertinent environmental regulations, protocol for reporting raptor mortalities, protocol for working in areas with raptor nests, and modifications that can be used to decrease the risk of raptor electrocutions. SCE has worked well with resource agencies, including the California Department of Fish and Game (CDFG), the U.S. Forest Service (USFS), and

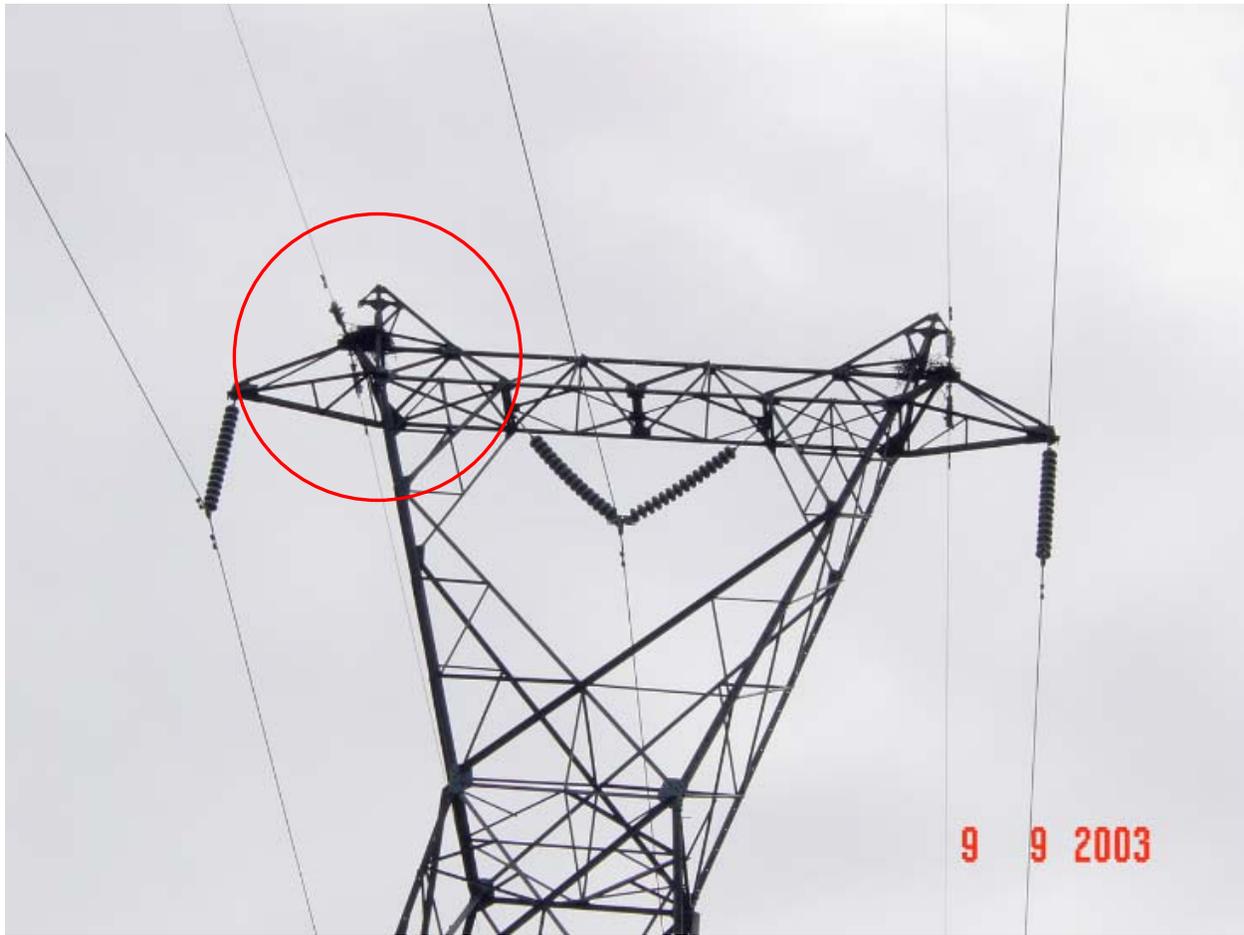
Figure TERR 8-3. Raptor Nest on Big Creek 1 to Eastwood Powerhouse Transmission Line.

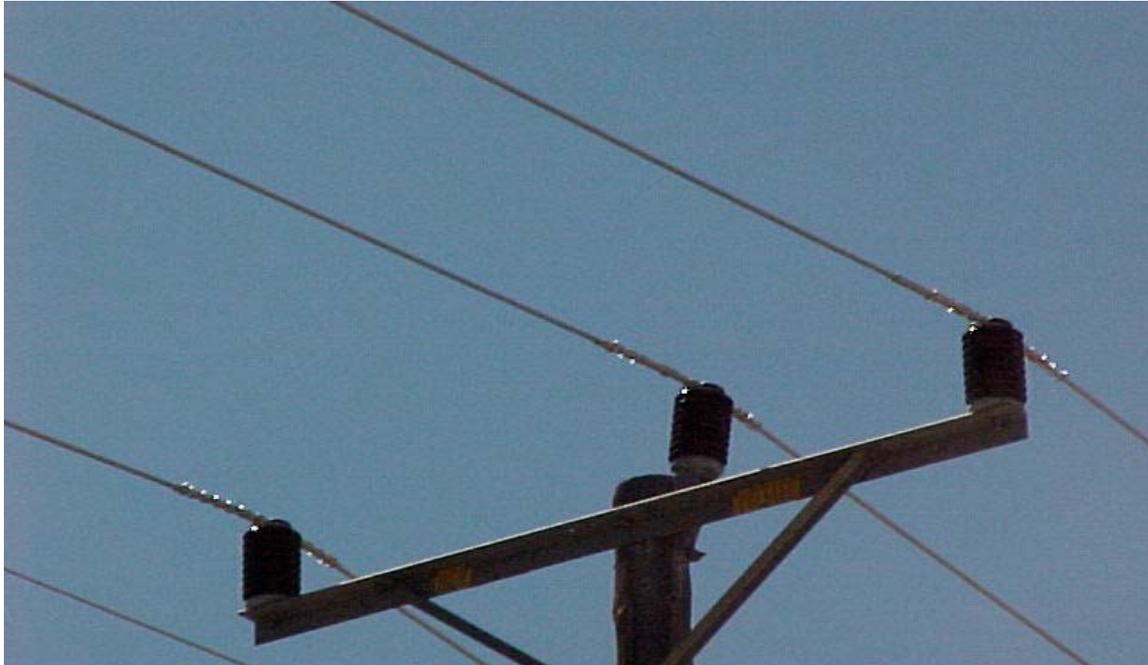
Figure TERR 8-4. Big Creek Transmission Line Without Raptor Hoods and With Raptor Hoods

The Portal Powerhouse Grid Interconnect Sub-transmission line is a 33 kV three-phase design and is comprised of two poles, with less than 125 feet of line. The majority of raptor electrocutions occur on power line structures with 1 to 69 kV. This line is also a three-phase design, which poses greater risk to raptors than other pole designs (e.g., two-phase pole designs). Phase-to-phase distances on some of the pole structures are 54 inches, which is less than the 60-inch minimum suggested by APLIC (1996). Phase-to-ground distances are 24 inches for all structures, which is less than the 43-inch minimum suggested by APLIC (1996). This line is connected to the Big Creek Portal Transmission Line. The Portal Powerhouse Grid Interconnect Sub-Transmission line borders Huntington Lake, an area known to be inhabited by bald eagles. There have been no recorded electrocutions in the Huntington Lake area, except for one bald eagle. An SCE biologist subsequently visited the area where this electrocution occurred and modifications to poles which the biologist considered hazardous were made at that time. SCE installed raptor hoods on two of the power line structures of the Big Creek Portal Transmission Line that were determined to be hazardous to raptors (Figure TERR 8-4). The SCE biologist did not find the Portal Powerhouse Grid Interconnect poles to pose a risk of electrocution to raptors, due to location. The Portal Powerhouse Grid Interconnect consists of only two poles, neither of which have a history of raptor electrocutions, and is located across Kaiser Pass Road about 1,000 feet from Huntington Lake without a vantage view of the lake for raptors foraging on the water (e.g., osprey and bald eagle).

Portal Powerhouse Grid Interconnect sub-transmission line without raptor hoods.

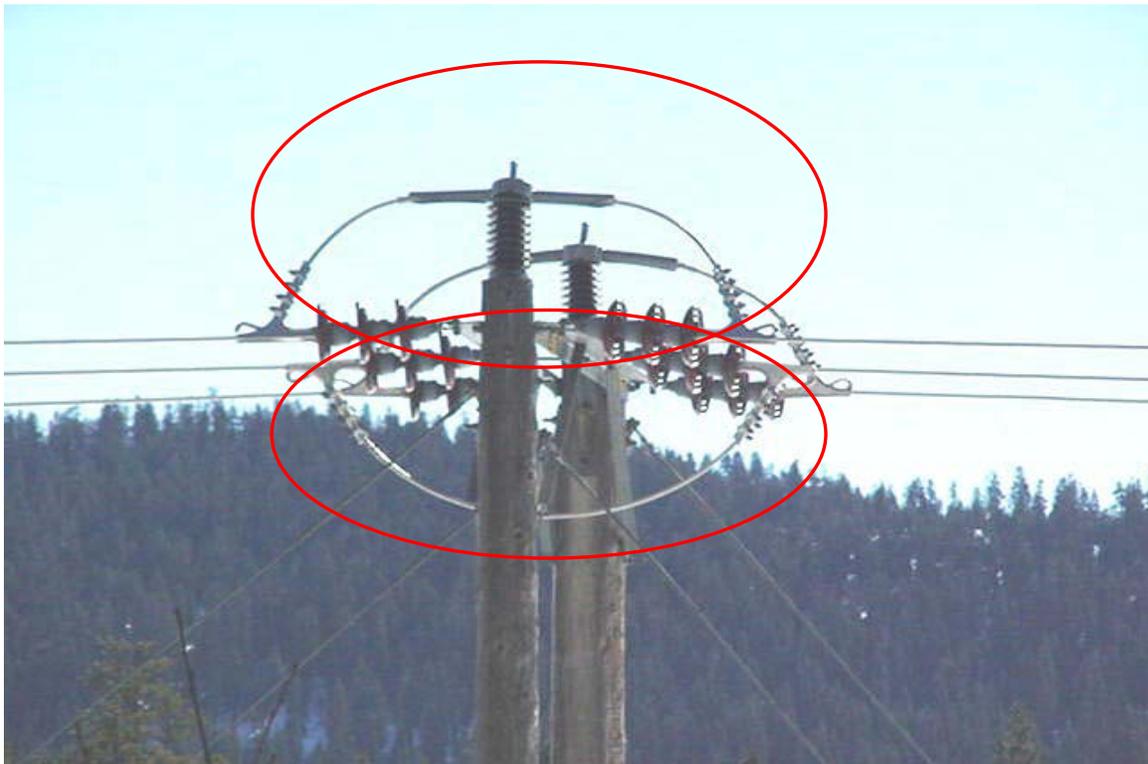
Raptor Hoods installed on the Big Creek Portal Transmission Line
