**Subject: Updated Study Report  
Bishop Creek Hydroelectric Project, FERC Project No. 1394**

**UPDATED STUDY REPORT**  
**ATTACHMENT 5**  
**REC 2 – RECREATION FACILITIES CONDITION AND PUBLIC ACCESSIBILITY**

### **RECREATION FACILITIES CONDITION**

#### **RECREATION FACILITIES CONDITION AND PUBLIC ACCESSIBILITY STUDY**

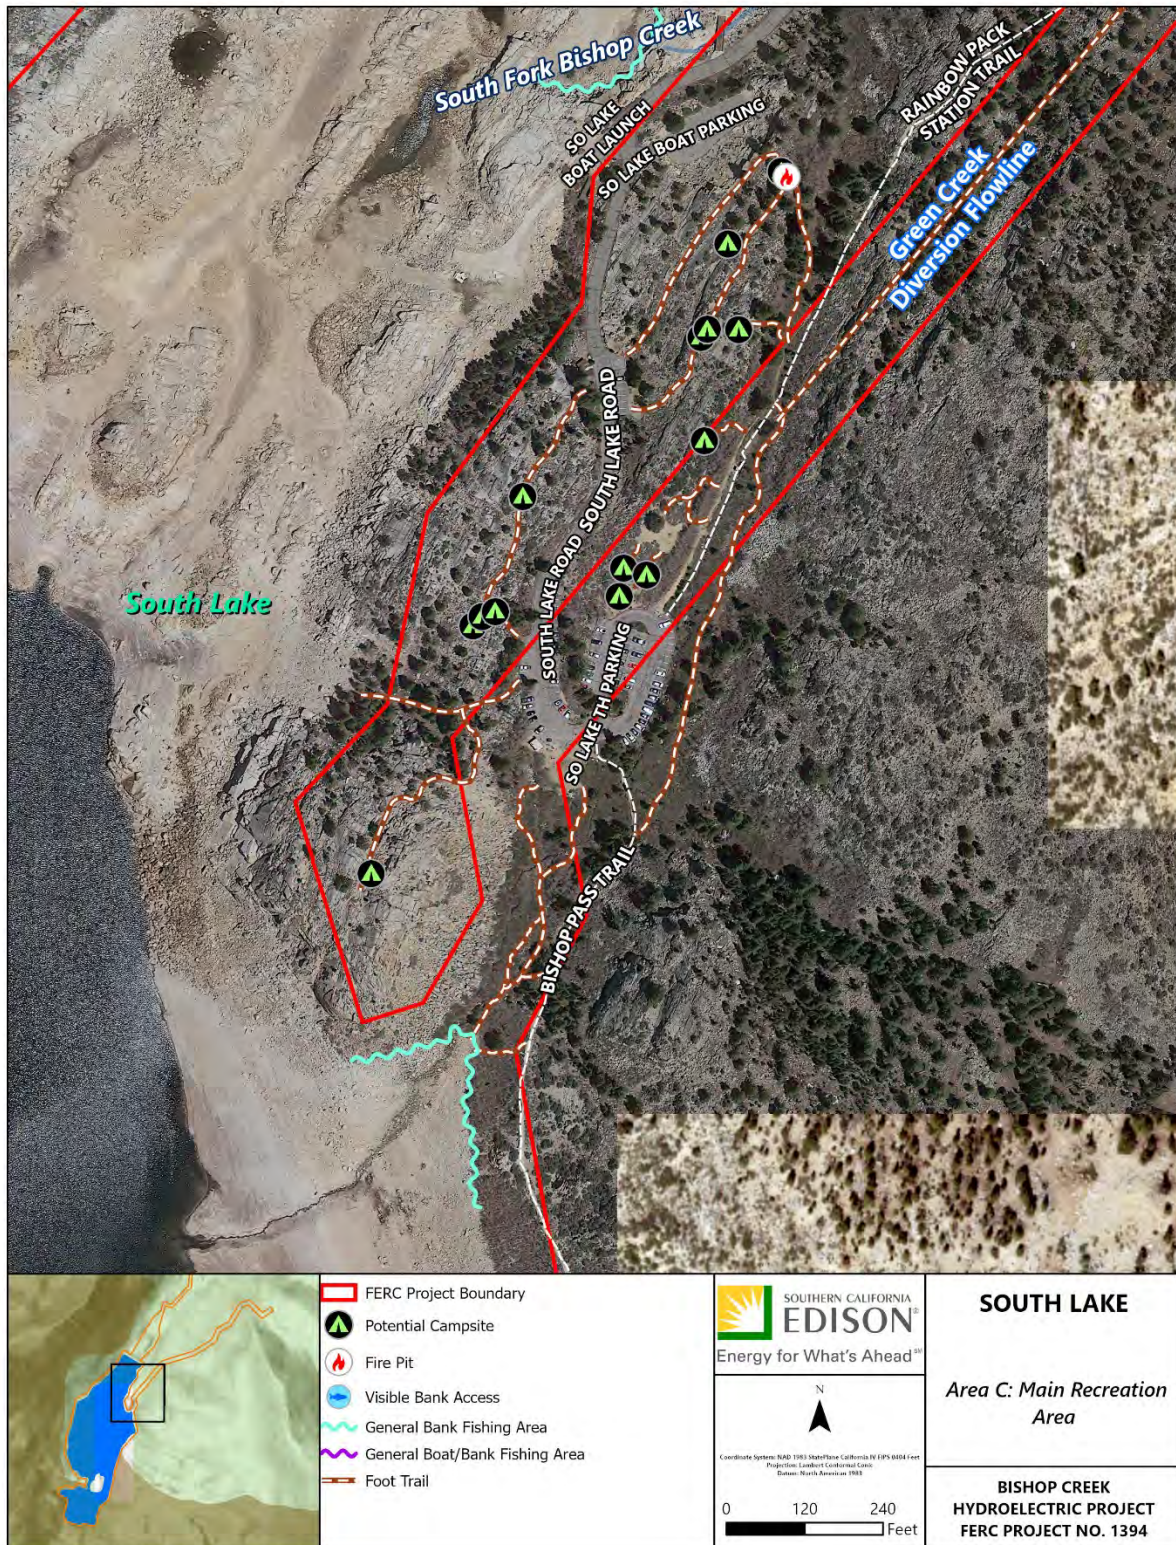
**Figure 5-8 Overview of Dispersed Use at South Lake Recreation Area.**

As depicted in Figure 5-8, the developed portion of the South Lake Recreation Area is primarily focused in this area, providing a boat ramp, marina, restrooms, picnic area, and trailheads to Bishop Pass and Rainbow Pack Station Trails, as well as an extensive arrangement of parking areas to accommodate the high activity. As expected with a high degree of use in developed areas, dispersed activity outside of those developed sites was observed. Approximately 14 potential campsites; one fire pit; and 4,373 feet of user created trails were observed in the area. Potential campsites were observed largely along the ridges to the east and west of the access road and above the developed facilities; the majority of the user created trails observed were leading to these locations. Just south of the Bishop Pass Trailhead, a small network of trails leads to a small cove that is popular for bank fishing along approximately 480 feet of shoreline. Activities observed are wholly within the Inyo National Forest and partially within the current FERC Project boundary, which represents the maximum operating level of the reservoir and a 150-foot buffer (75 foot to each side of centerline) around the Green Creek Diversion Pipeline at this location. See Photos 62 through 66 in Appendix F for representative photos of Area C.

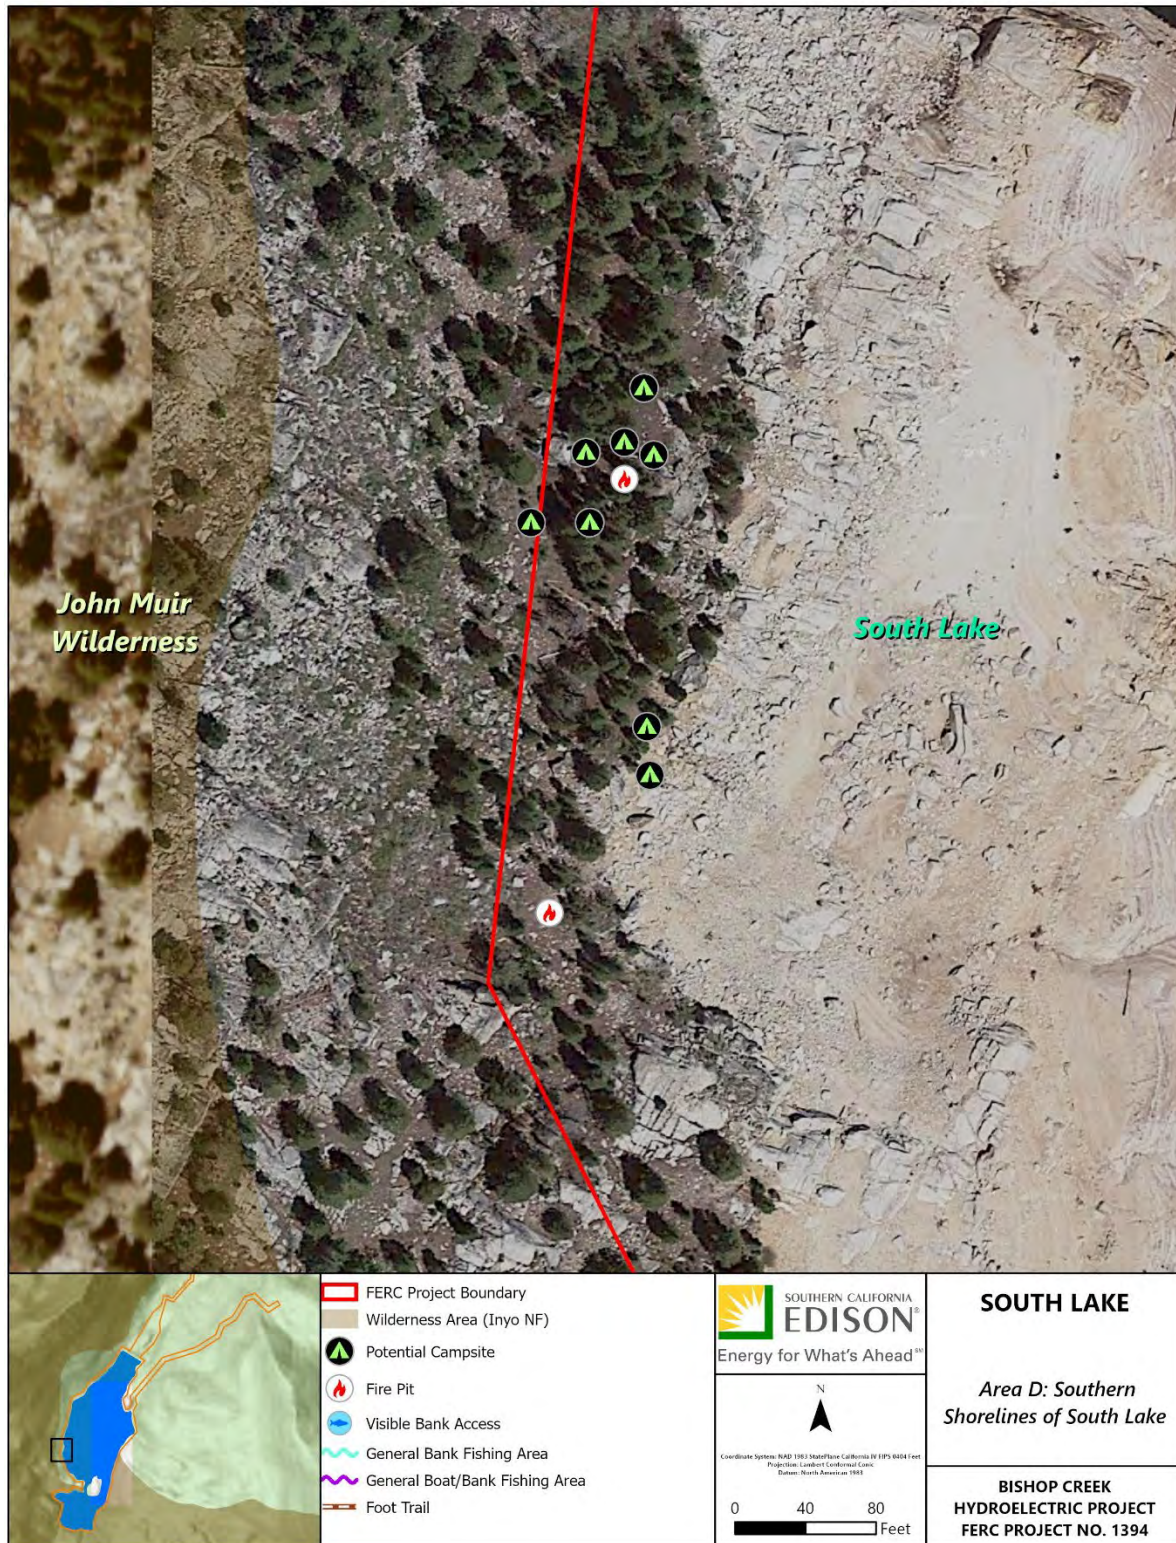
**Figure 5-9 Detail Figure of Area D.**

Area D (Figure 5-9) is one of a handful of areas along the southern shoreline of South Lake where potential camping and other day use activities were observed. Area D is located on the western shoreline of the lake, just upstream of the island. At this location, approximately eight potential campsites and two fire pits were observed. A tarp and nails in trees were also observed, which suggest long term camping activity may have occurred. All but one of the potential campsites appears to be within the current FERC Project boundary as it is currently drawn; however, that boundary represents the maximum operating level of the reservoir at this location. The observed activity is wholly within the Inyo National Forest. Activity is near the boundary of the John Muir Wilderness, and it is unclear whether the boundary in this location is also meant to represent the maximum operating level of South Lake or to provide a buffer on that water line. See Photos 67 through 71 in Appendix F for representative photos of Area D.

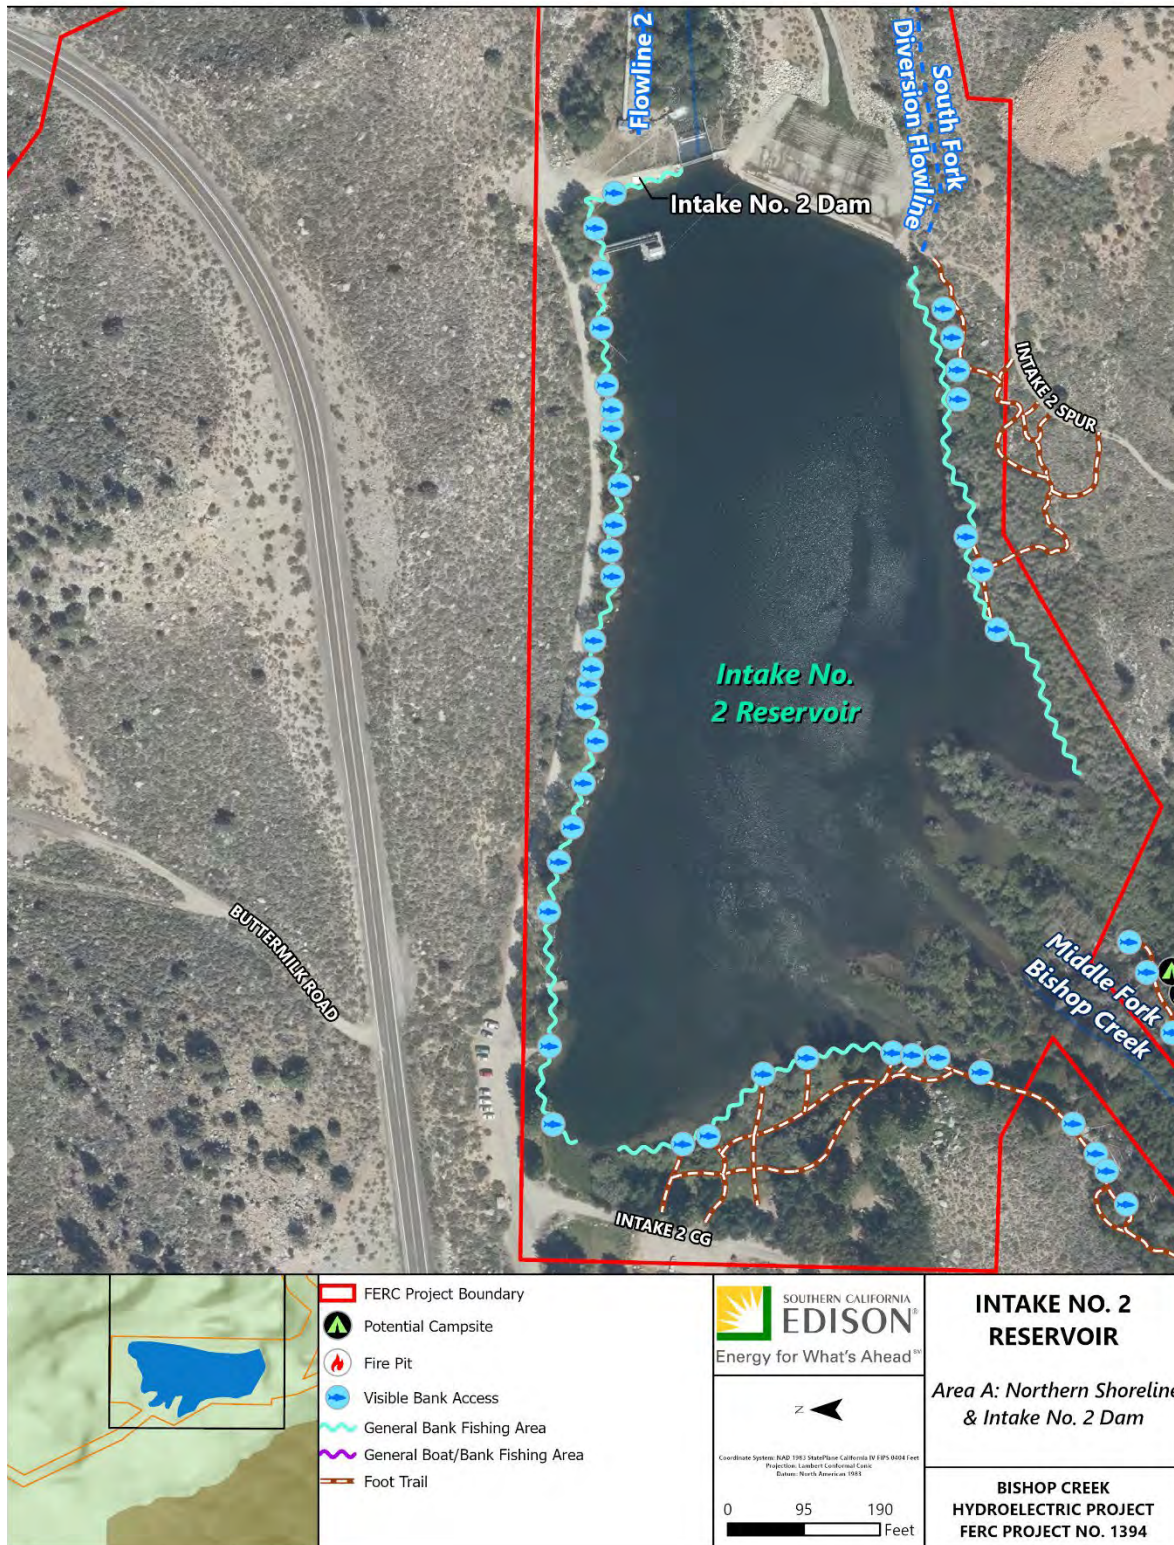
**Figure 5-15 Detail Figure of Area A.**

As depicted on Figure 5-15, the northern shoreline of Intake No. 2 Reservoir and the Intake No. 2 Dam are popular for bank fishing and general access to the water. While the access road along the northern shoreline is gated to preclude public vehicle access to the dam facilities, the shoreline is open to public access by foot. Along the 1,344-foot stretch of shoreline, approximately 22 visibly worn access points to the reservoir were observed. All observations are wholly within the FERC Project boundary and on SCE lands. See Photos 91 through 97 in Appendix F for representative photos of Area A.

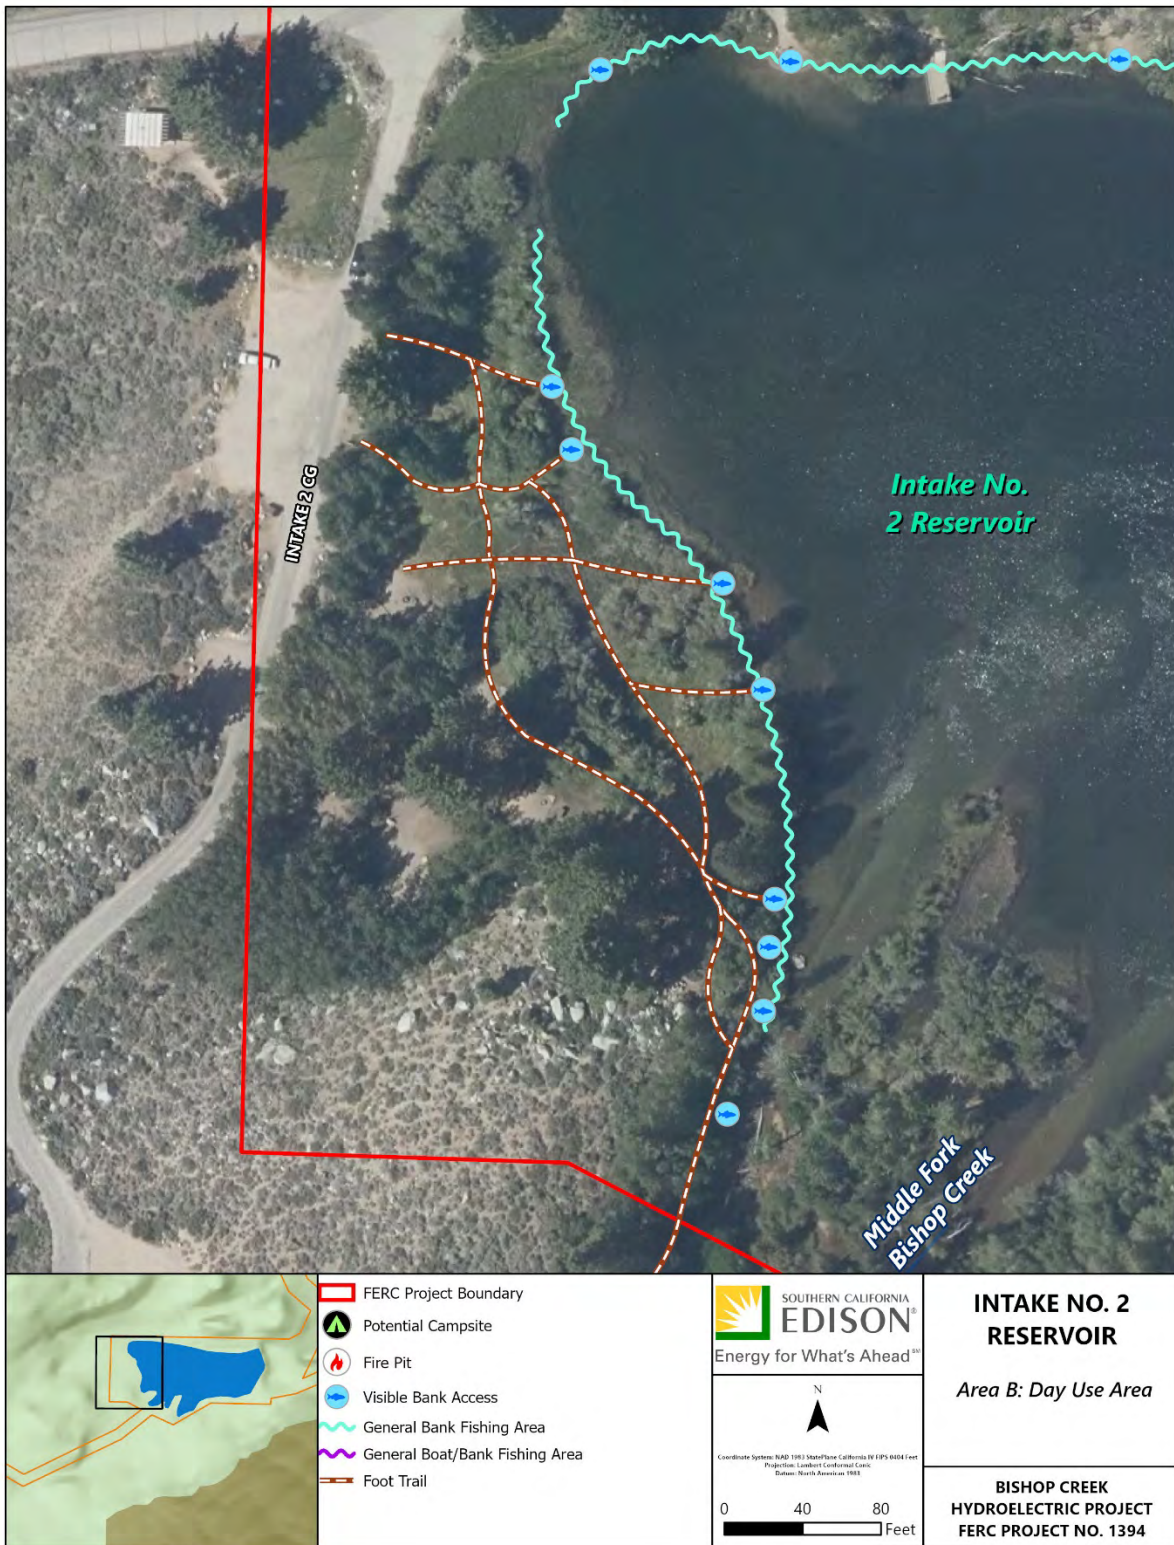
**Figure 5-16 Detail Figure of Area B.**

As depicted in Figure 5-16, access to the western shoreline of the reservoir at the day use area is popular for bank fishing and general access to the water. A network of approximately 1,201 feet of user-created foottrails leads between picnic areas and the shoreline, one of which appears to be commonly used as a kayak launching point. Along the 446-foot stretch of shoreline, approximately seven visibly worn access points to the reservoir were observed. All observations are wholly within the FERC Project boundary and on SCE lands. See Photos 98 through 100 in Appendix F for representative photos of Area B.

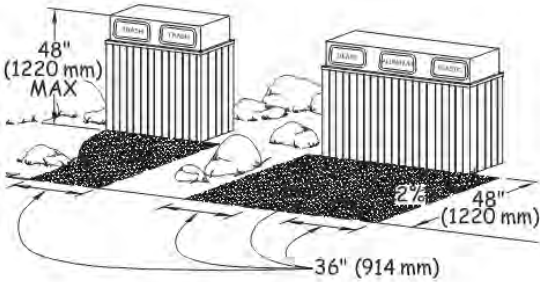
<input type="checkbox"/>	<input type="checkbox"/>	<input checked="" type="checkbox"/>	<b>Comments:</b> <ul style="list-style-type: none"> <li>Movable recycling and trash containers were located near the Lake Sabrina Boat Landing Building.               <ul style="list-style-type: none"> <li>Not located in a designated area with compliant approach and reach.</li> <li>Not compliant furnishing type.</li> </ul> </li> <li>2 dumpsters are located within parking lot.</li> </ul> <b>Possible Action:</b> <ul style="list-style-type: none"> <li>Fixed receptacles should be installed in a designated area(s) along an ORAR and adhere to FSORAG standards.</li> </ul>

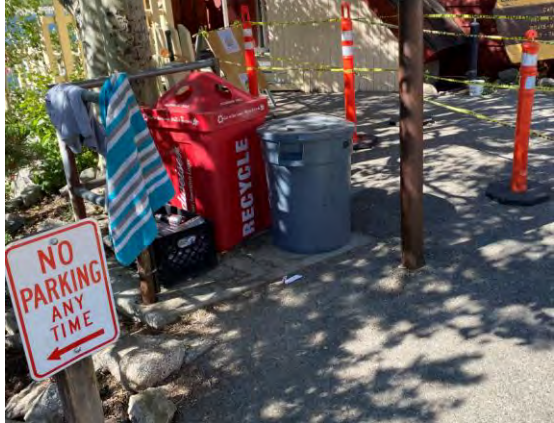
72. Are the Trash / Recycling containers themselves an ADA compliant model?	<input type="checkbox"/>	<input type="checkbox"/>	<input checked="" type="checkbox"/>	<b>Comments:</b> <ul style="list-style-type: none"> <li>Model of containers observed do not meet ADA compliance</li> </ul> <b>Possible Action:</b> <ul style="list-style-type: none"> <li>ADA compliant containers should be installed.</li> </ul>

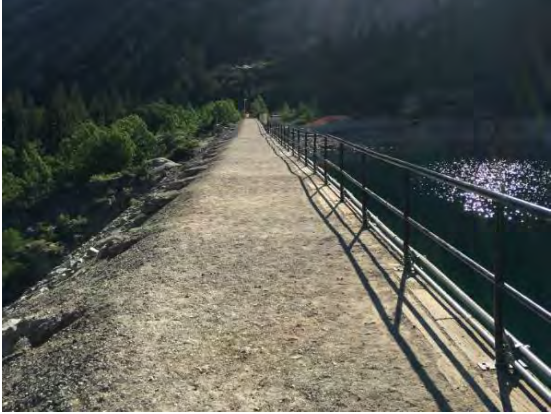
74. Are all viewing areas constructed to provide an unobstructed view?	<input type="checkbox"/>	<input checked="" type="checkbox"/>	<input type="checkbox"/>	<b>Comments:</b> <ul style="list-style-type: none"> <li>Railing does not significantly obstruct views.</li> </ul>

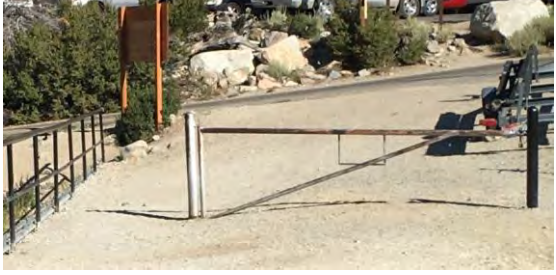
104. Gate openings and openings in barriers for pedestrian passage shall provide a clear width of 36" inches, complying with ODAAG section 1017.3 Clear Tread Width.	<input type="checkbox"/>	<input checked="" type="checkbox"/>	<input type="checkbox"/>	<b>Comments:</b> • There is one vehicular gate at the entrance to the top of the dam. • There is a min. 36" opening between the gate post and the guardrail.

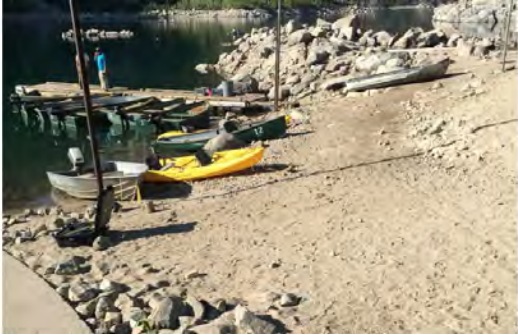
<input type="checkbox"/>	<input type="checkbox"/>	<input checked="" type="checkbox"/>	<p><b>Comments:</b></p> <ul style="list-style-type: none"> <li>• There are no accessible routes identified.             <ul style="list-style-type: none"> <li>◦ Floating docks are designed to be movable and not in permanently fixed locations.</li> <li>◦ No compliant ORAR to dock locations observed during this assessment.</li> </ul> </li> <li>• Depending on the fluctuation of the reservoir water elevation, and with the use of the floating gangways, there may be an opportunity for an accessible route.</li> </ul> <p><b>Possible Action:</b></p> <ul style="list-style-type: none"> <li>• Design and construct an ORAR to the dock locations that allow access during both high and low water conditions.</li> </ul>

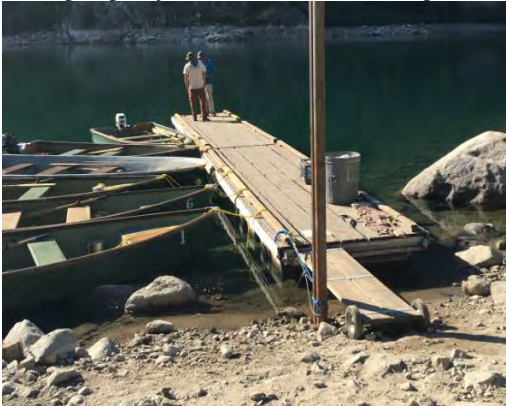
<input type="checkbox"/>	<input type="checkbox"/>	<input checked="" type="checkbox"/>	<p><b>Comments:</b></p> <ul style="list-style-type: none"> <li>• Conditions observed during site visit were at low water levels. These should be further assessed and evaluated during high water conditions.</li> </ul>

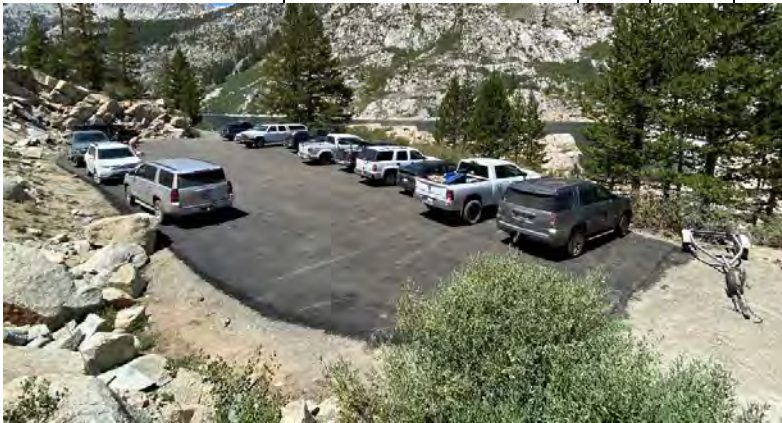
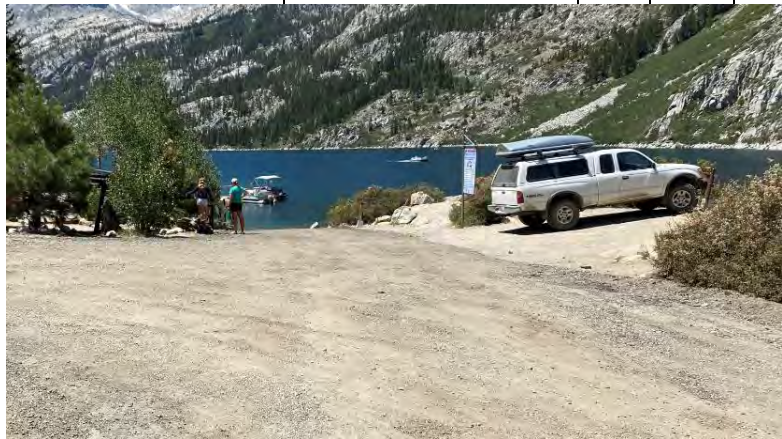
- Needs to be re-striped.
- No designated boat trailer spaces.
- There are no designated accessible parking spaces.
  - Minimum of 1 accessible space required, with at least one being Van Accessible.
  - No designated boat trailer spaces.
  - No accessible boat loading areas.

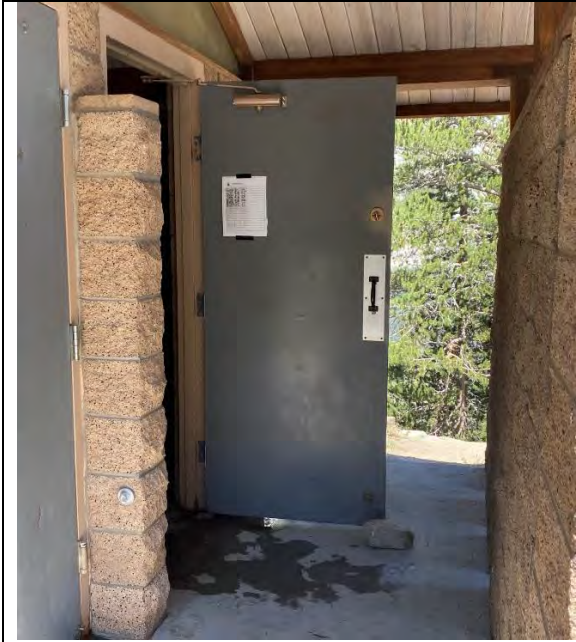
21. Are doors equipped with accessible handles (operable with a closed fist), 48 inches high or less?	<input type="checkbox"/>	<input type="checkbox"/>	<input type="checkbox"/>	<input checked="" type="checkbox"/>	<b>Comments:</b> <ul style="list-style-type: none"> <li>Loop style handle</li> <li>Lock is mounted too high</li> </ul> <b>Possible Action:</b> <ul style="list-style-type: none"> <li>Replace door hardware</li> </ul>

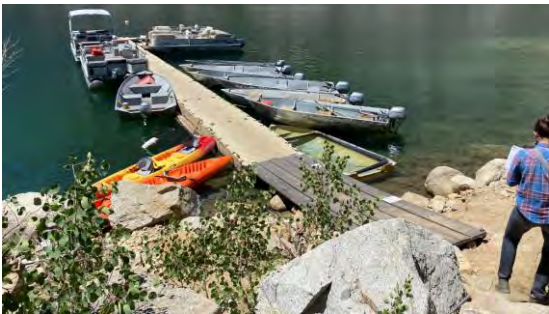
<input type="checkbox"/>	<input type="checkbox"/>	<input checked="" type="checkbox"/>	<p><b>Comments:</b></p> <ul style="list-style-type: none"> <li>• There are no compliant beach access routes that allow access to the lake edge. <ul style="list-style-type: none"> <li>◦ There is no ORAR to the water's edge due to surfacing, slopes and obstructions.</li> </ul> </li> </ul> <p><b>Possible Action:</b></p> <ul style="list-style-type: none"> <li>• Design and construct well-defined accessible routes.</li> </ul>

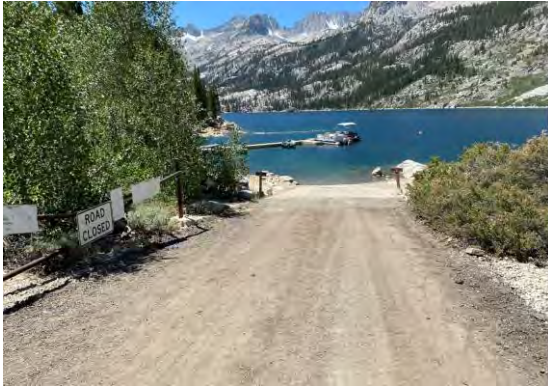
104. Gate openings and openings in barriers for pedestrian passage shall provide a clear width of 36" inches, complying with ODAAG section 1017.3 Clear Tread Width.	<input type="checkbox"/>	<input checked="" type="checkbox"/>	<input type="checkbox"/>	<b>Comments:</b> <ul style="list-style-type: none"> <li>There is one vehicular gate at the entrance to the top of the boat ramp</li> <li>There is no ORAR access around either side of gate.</li> </ul>

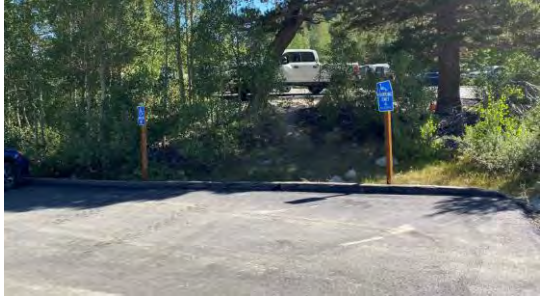
<ul style="list-style-type: none"> <li>○ All stalls need to be re-stripped with loading area and signs need to be updated.</li> <li>○ Pedestrian crossing should be added across drive aisle</li> </ul> <p><b>Possible Action:</b></p> <ul style="list-style-type: none"> <li>• Restripe all 4 ADA stalls and add the loading zones.</li> <li>• Add pedestrian crossing striping and truncated domes across drive aisle or relocate 2 ADA stalls on opposite side of drive aisle closer to restroom.</li> <li>• Modify layout or expand paving at front end of ADA stalls near restroom to provide accessible route to restroom that does not require users to use drive aisle for access.</li> <li>• Replace Parking signs with updated ADA standard signs at appropriate mounting heights.</li> </ul>

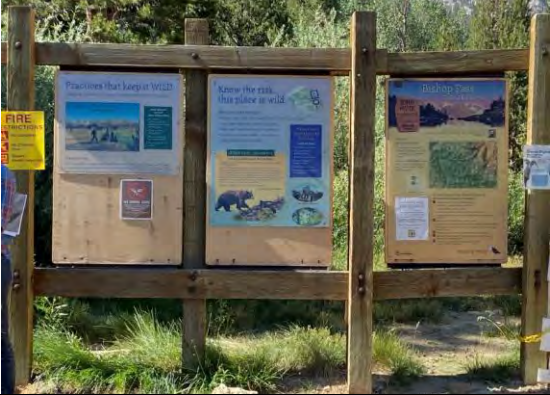
<ul style="list-style-type: none"> <li>• Informational signs do not meet contrast requirements, text size on some size is not compliant.</li> </ul> <p><b>Possible Action:</b></p> <ul style="list-style-type: none"> <li>• Review adopted sign standards and make sure they are ADA compliant.</li> <li>• Determine if standards need to be revised.</li> <li>• Replace signs based on compliance with adopted standards.</li> <li>• Adjust heights of signs as needed.</li> </ul>	
<p>62. Do directional and informational signs comply with legibility requirements? (Building directories or temporary signs need not comply.)</p>	<input type="checkbox"/>	<input type="checkbox"/>	<input checked="" type="checkbox"/> <p><b>Comments:</b></p> <ul style="list-style-type: none"> <li>• Informational signs do not meet contrast requirements, text size on some size is not compliant.</li> </ul> <p><b>Possible Action:</b></p> <ul style="list-style-type: none"> <li>• Review adopted sign standards and make sure they are ADA compliant.</li> <li>• Determine if standards need to be revised.</li> <li>• Replace signs based on compliance with adopted standards.</li> <li>• Adjust heights of signs as needed.</li> </ul>

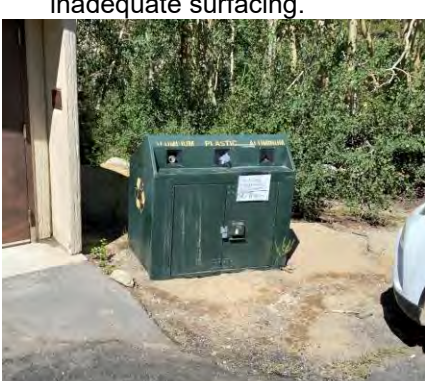
71. Is the clear floor or ground space for a forward approach 36 inches by 48 inches or for side approach 30 inches by 60 inches?	<input type="checkbox"/>	<input type="checkbox"/>	<input checked="" type="checkbox"/>	Comments: • The space is available, but there is inadequate surfacing.

<b>Possible Action:</b> <ul style="list-style-type: none"> <li>Fixed receptacles should be relocated or a stable surface should be installed that connects to ORAR.</li> </ul>

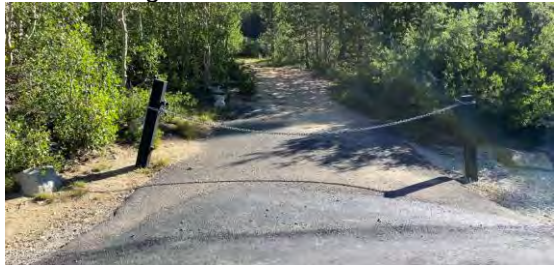
104. Gate openings and openings in barriers for pedestrian passage shall provide a clear width of 36" inches, complying with ODAAG section 1017.3 Clear Tread Width.	<input type="checkbox"/>	<input checked="" type="checkbox"/>	<input checked="" type="checkbox"/>	<b>Comments:</b> <ul style="list-style-type: none"> <li>There is one chain gate at entry to Rainbow Pack Station Trail from the upper parking lot that also serves as access to the picnic area.</li> <li>There is no pedestrian access around the gate when it is closed.</li> </ul>

<b>Possible Action:</b> <ul style="list-style-type: none"> <li>Extend the ORAR around the gate post on at least 1 end.</li> </ul>
<b>Boating Facilities</b>	<b>n/a</b>	<b>Yes</b>	<b>No</b>	<b>Comments / Possible Action</b>
<input checked="" type="checkbox"/> Check here if section does not apply to this site and move to next section.

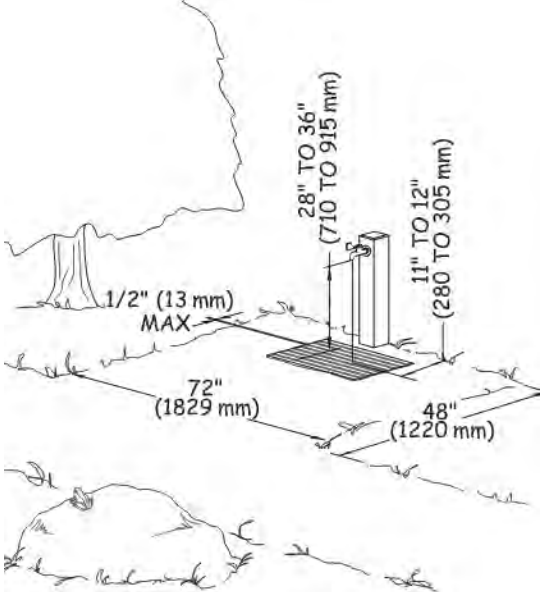
<p>it does not clearly adjoin the ORAR.</p> <ul style="list-style-type: none"> <li>The Water Valve Box and raised, rock-filled drain structure obstruct the ground space.</li> </ul> <p><b>Possible Action:</b></p> <ul style="list-style-type: none"> <li>Formalize a defined clear ground space around the hydrant.</li> <li>Adjust the valve box to be flush with ground.</li> <li>Replace the drain structure with structure that is flush with ground.</li> </ul>

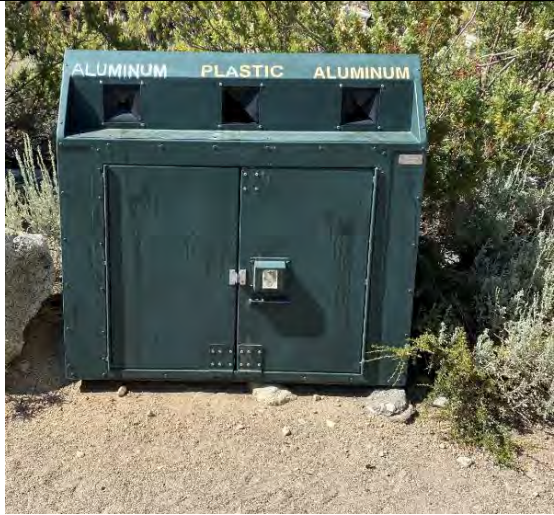
72. Are the Trash / Recycling containers themselves an ADA compliant model?	<input type="checkbox"/>	<input checked="" type="checkbox"/>	<input type="checkbox"/>	<p><b>Comments:</b></p> <ul style="list-style-type: none"> <li>• Recycling container is compliant model.</li> </ul> <p><b>Possible Action:</b></p> <ul style="list-style-type: none"> <li>• Supplement with ADA compliant trash receptacle.</li> </ul>

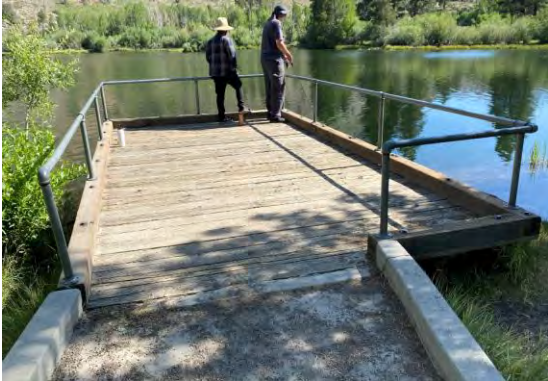
95. Where railings are provided on fishing piers or platforms, do they comply with ADAAG provisions?	<input type="checkbox"/>	<input checked="" type="checkbox"/>	<input type="checkbox"/>	<b>Comments:</b> <ul style="list-style-type: none"> <li>There is a railing provided which does not serve as a guard rail.</li> </ul>

96. Where railings are provided, are there multiple locations where the railing is 34 inches high maximum to offer a variety of fishing location options?	<input type="checkbox"/>	<input checked="" type="checkbox"/>	<input type="checkbox"/>	<b>Comments:</b> <ul style="list-style-type: none"> <li>Railing is consistently 32" high around entire pier.</li> </ul>

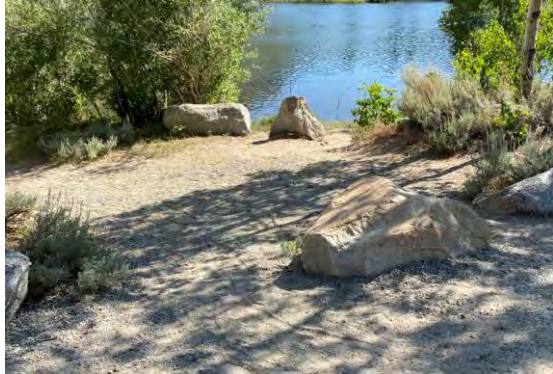
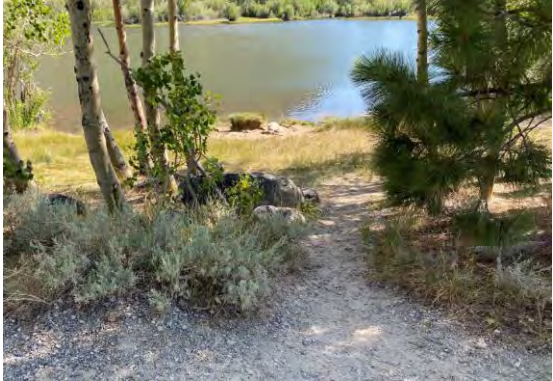
<input type="checkbox"/>	<input type="checkbox"/>	<input checked="" type="checkbox"/>	<p><b>Comments:</b></p> <ul style="list-style-type: none"> <li>• There are no compliant beach access routes that allow access to the lake edge with the exception of the Accessible Fishing Pier.</li> <li>• There are numerous small access points along the ORAR/Parking Access drive, but none of them are accessible due to excessive slopes and/or obstructions such as unstable surface, boulders, width restrictions, etc.</li> </ul> <p><b>Possible Action:</b></p> <ul style="list-style-type: none"> <li>• Identify existing access points that require the least amount of modifications to make them accessible.</li> <li>• Provide a well-defined accessible route from the picnic area to the lake's edge.</li> </ul>

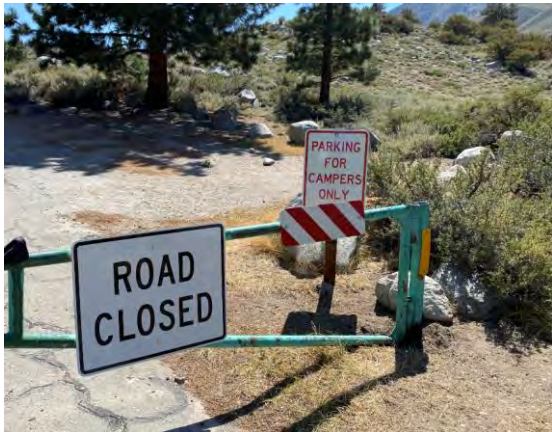
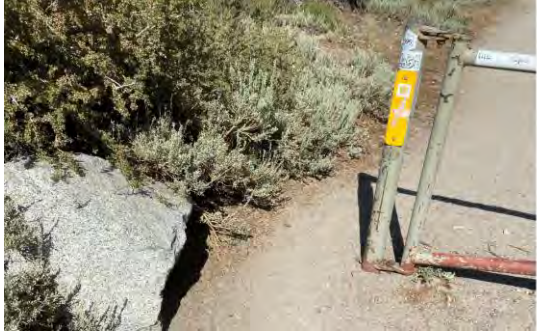
105. Gate openings and openings in barriers for pedestrian passage shall provide a clear width of 36" inches, complying with ODAAG section 1017.3 Clear Tread Width.	<input type="checkbox"/>	<input type="checkbox"/>	<input checked="" type="checkbox"/>	<b>Comments:</b> <ul style="list-style-type: none"> <li>There are 2 vehicular gates located on the access drive. Neither specifically serves to restrict pedestrian access, however there are no compliant routes around the ends of the gate.</li> </ul> <b>Possible Action:</b> <ul style="list-style-type: none"> <li>Provide accessible pedestrian route around at least one end of each gate.</li> </ul>

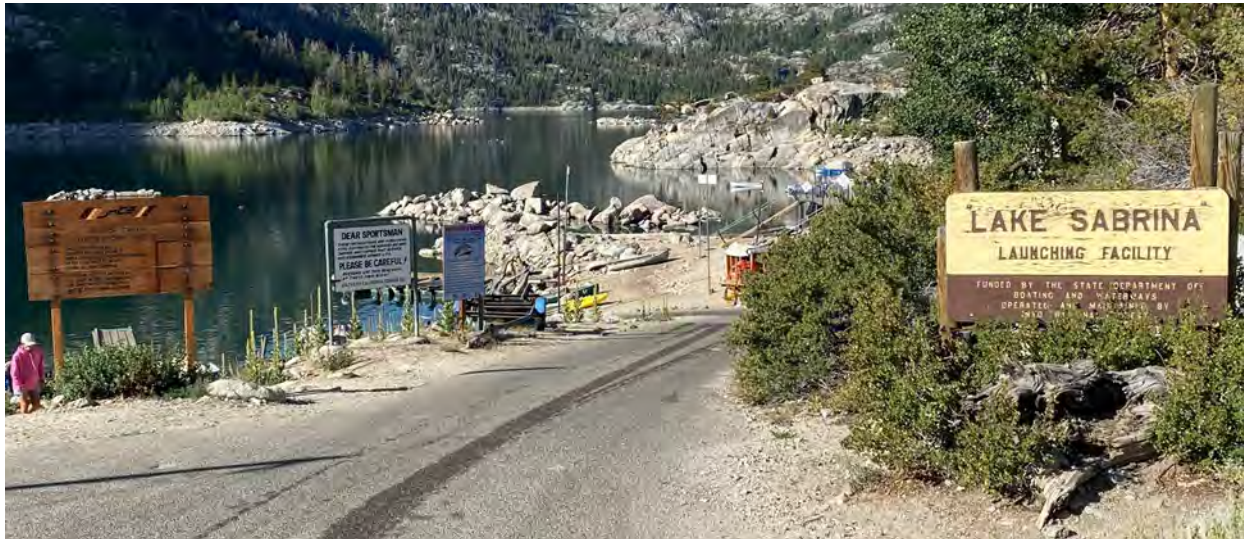
Photo 8 Signage at Boat Ramp

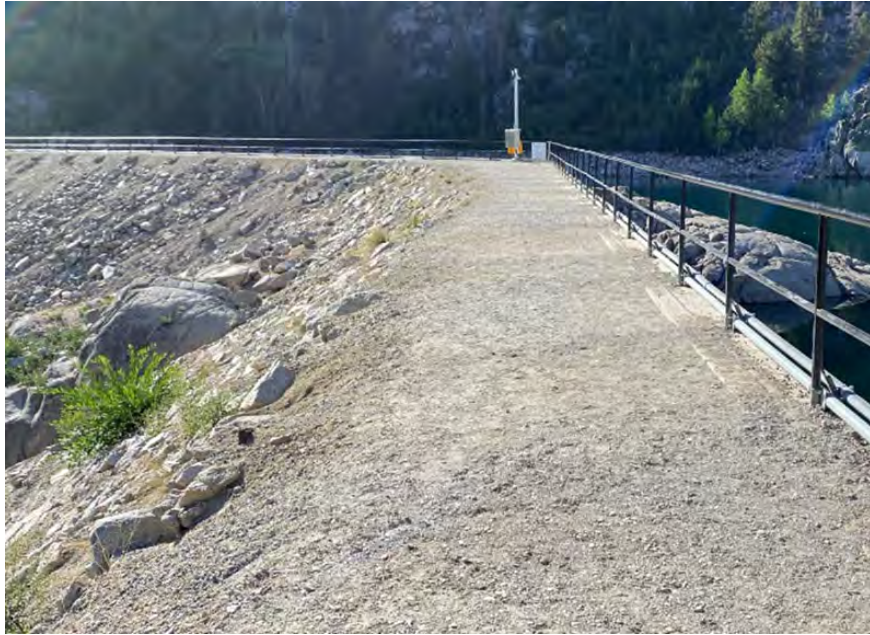
**Photo 10 Crest of Sabrina Dam**

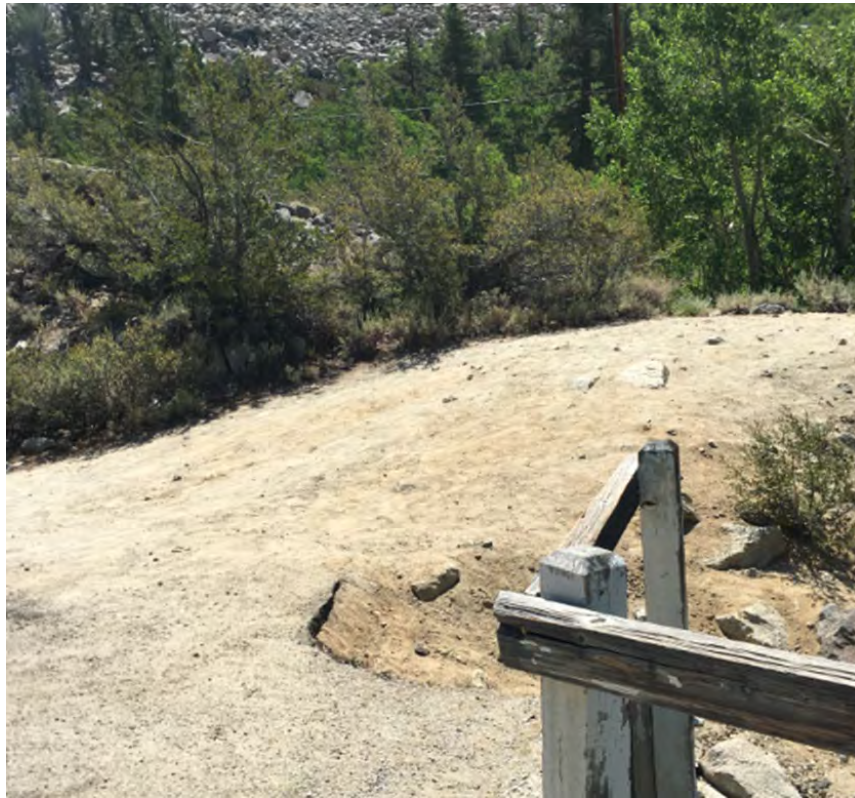
**Photo 11 Eroding Edge of Roadway**

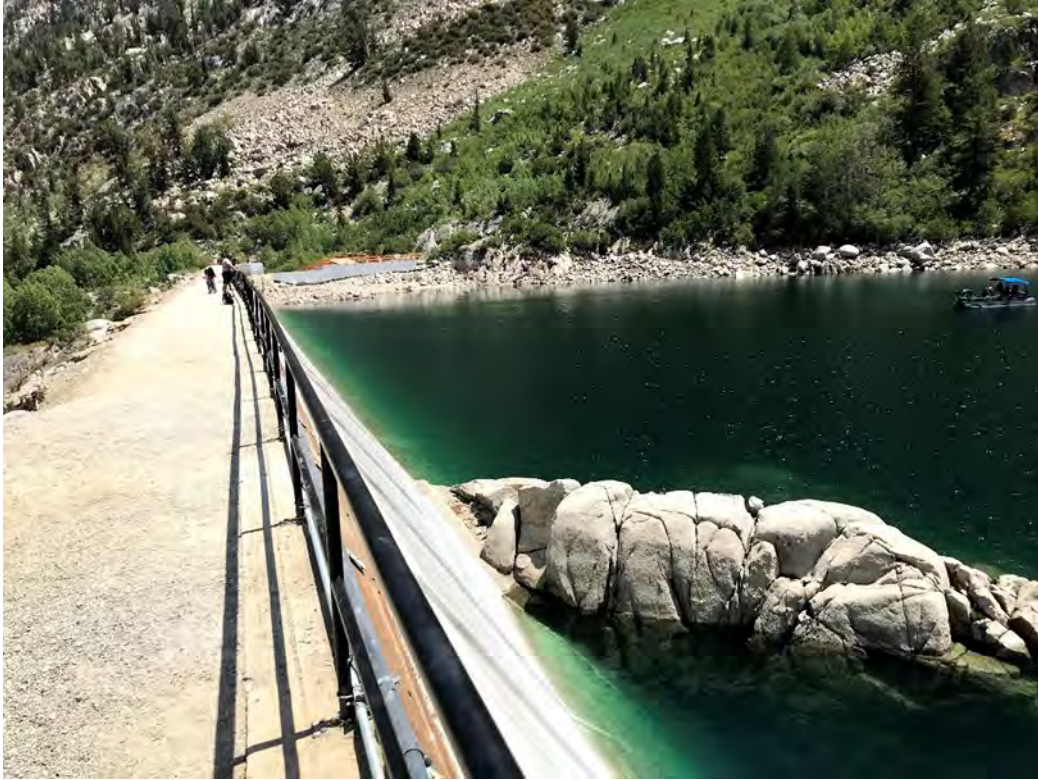
**Photo 21 Sabrina Dam**

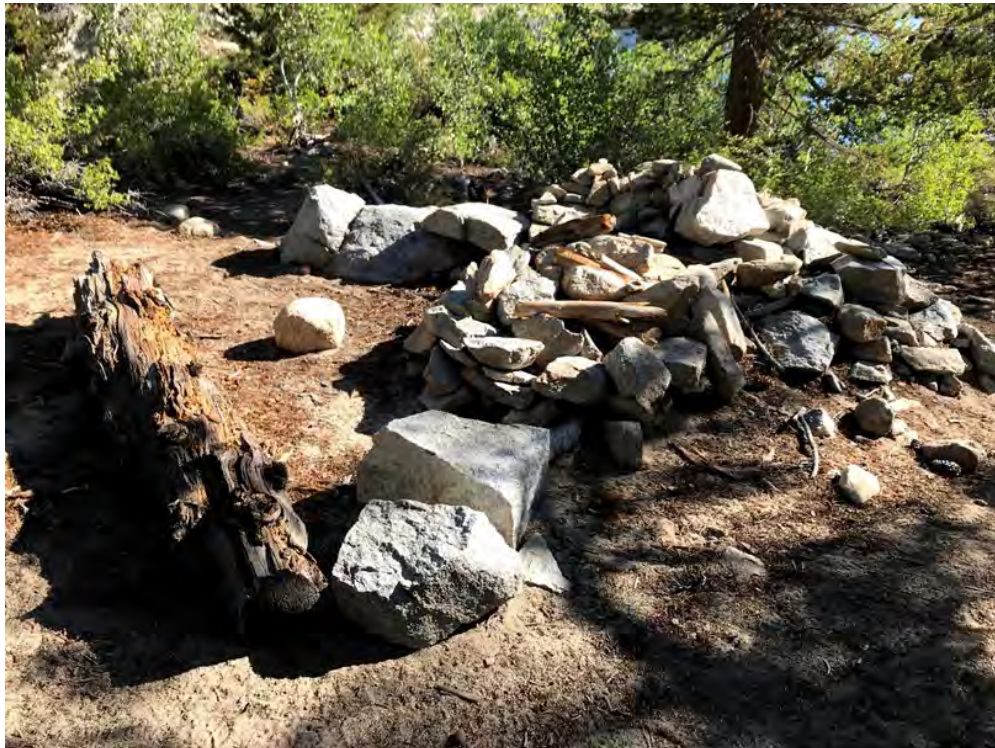
**Photo 33 Fire Ring**

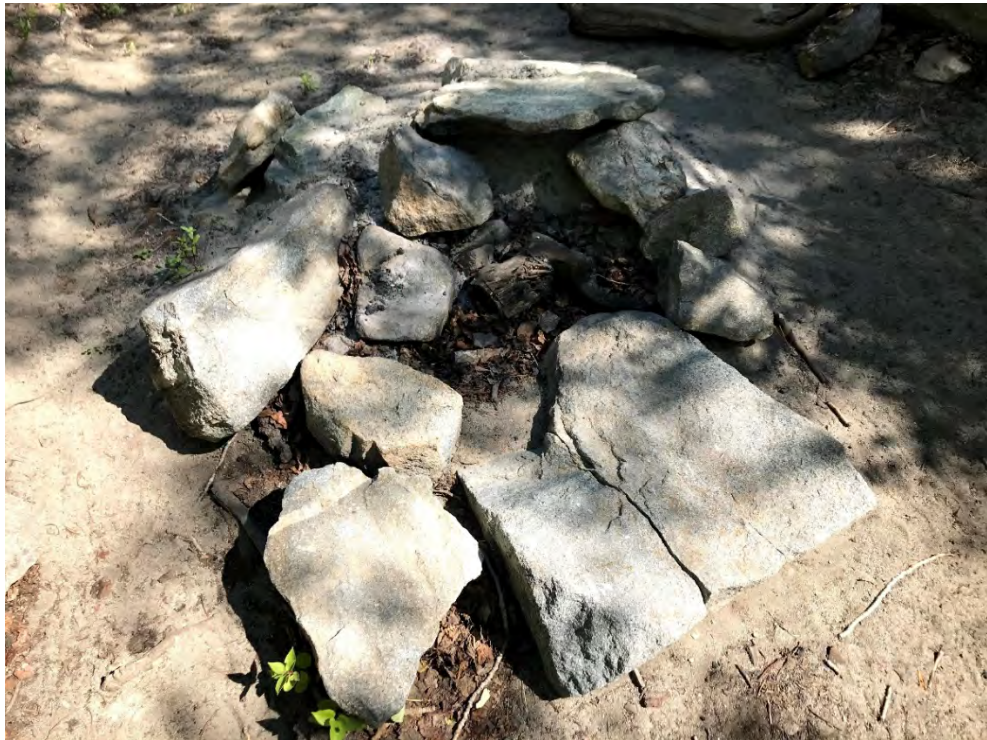
**Photo 38 Fire Pit on Beach**

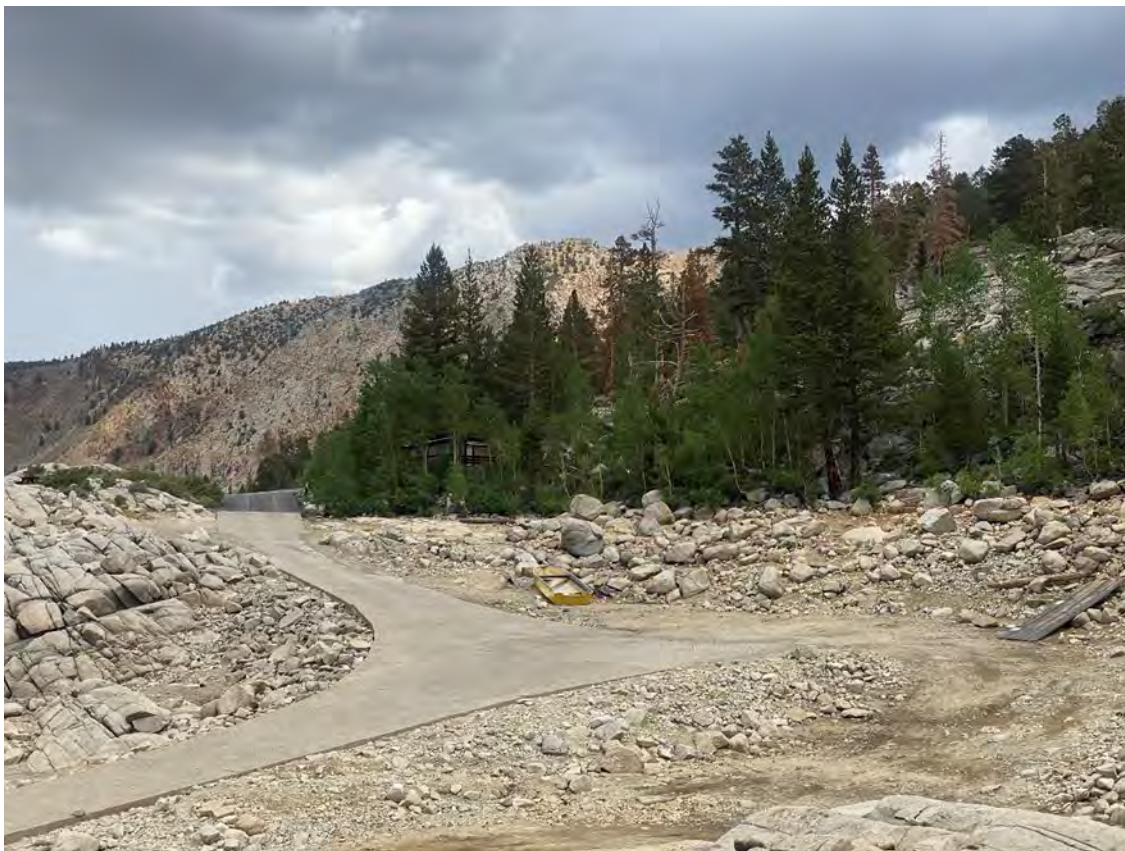
**Photo 42 End of New Paving at South Lake Boat Ramp**

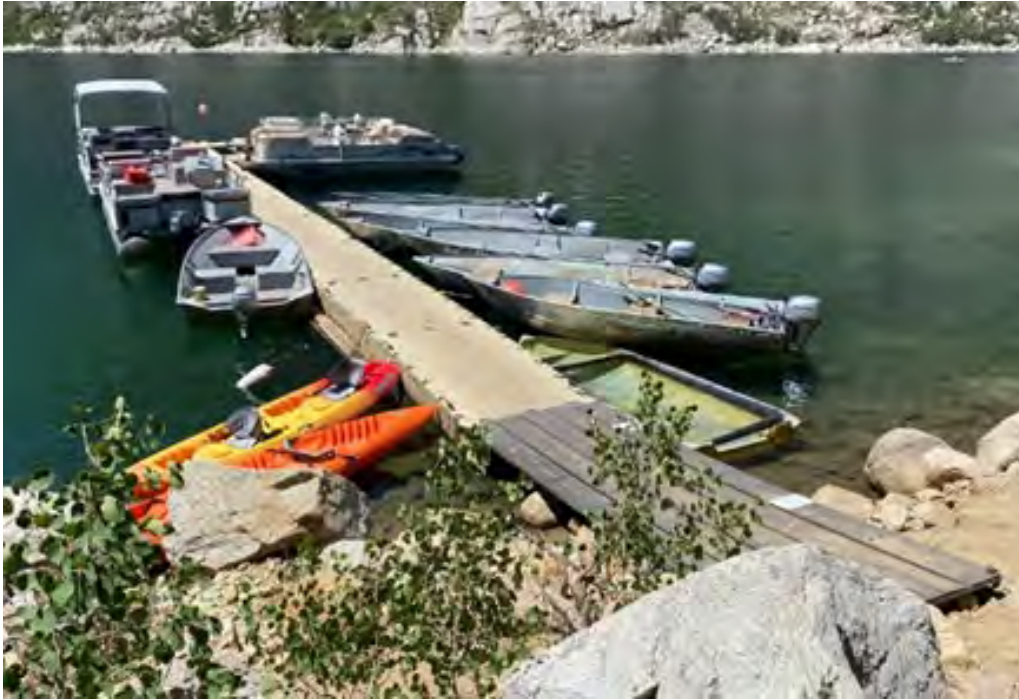
**Photo 43 Portable Boat Slips/Docks**

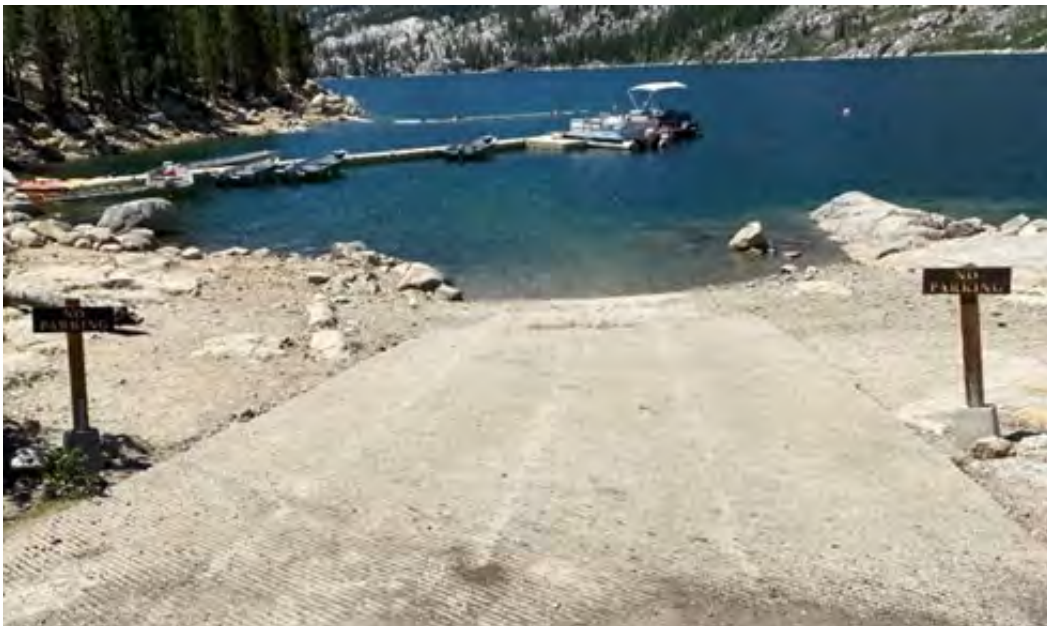
**Photo 44 Boat Launch**
