**Subject: Updated Study Report  
Bishop Creek Hydroelectric Project, FERC Project No. 1394**

**UPDATED STUDY REPORT**  
**ATTACHMENT 5**  
**REC 2 – RECREATION FACILITIES CONDITION AND PUBLIC ACCESSIBILITY**

### **RECREATION FACILITIES CONDITION**

#### **RECREATION FACILITIES CONDITION AND PUBLIC ACCESSIBILITY STUDY**

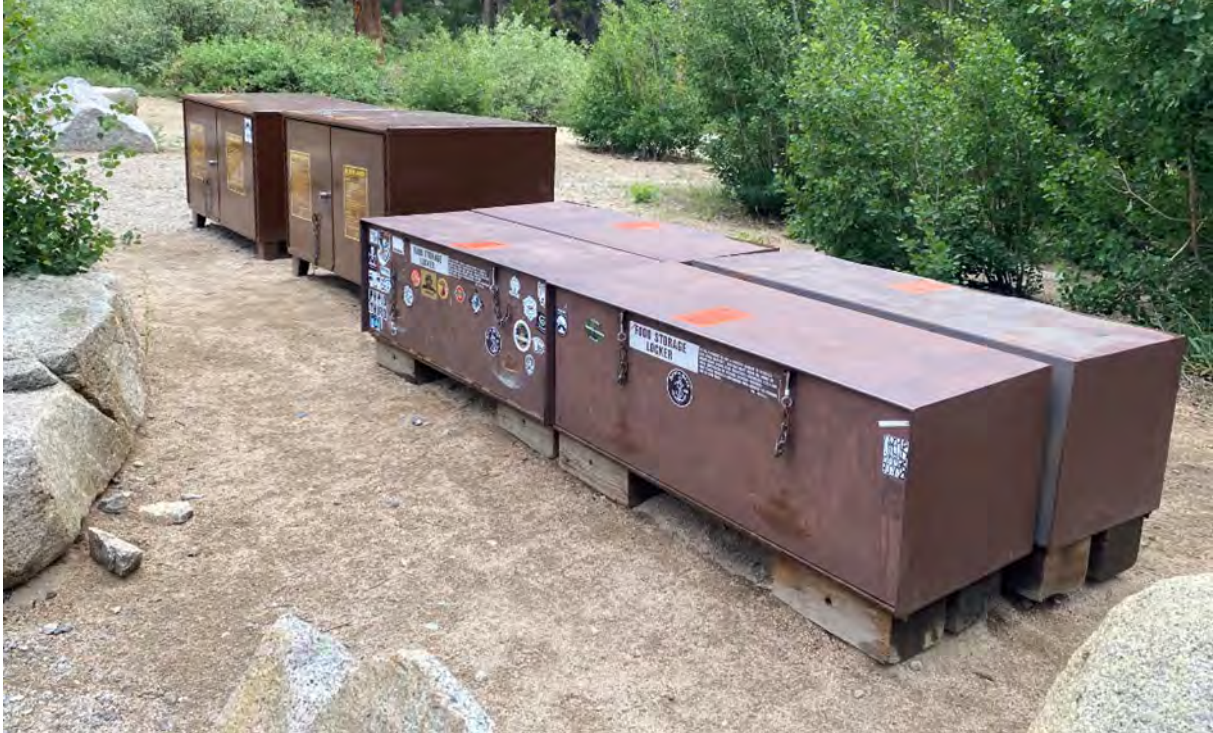
**Photo 45 Food Lockers**

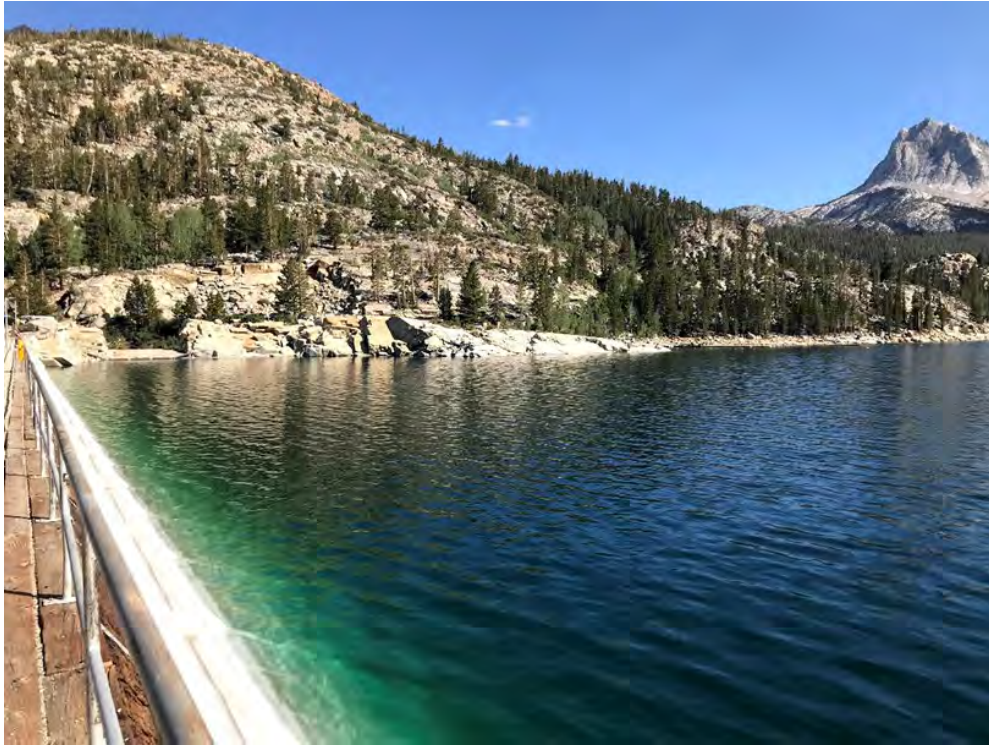
**Photo 52 Upstream Face of Hillside Dam**

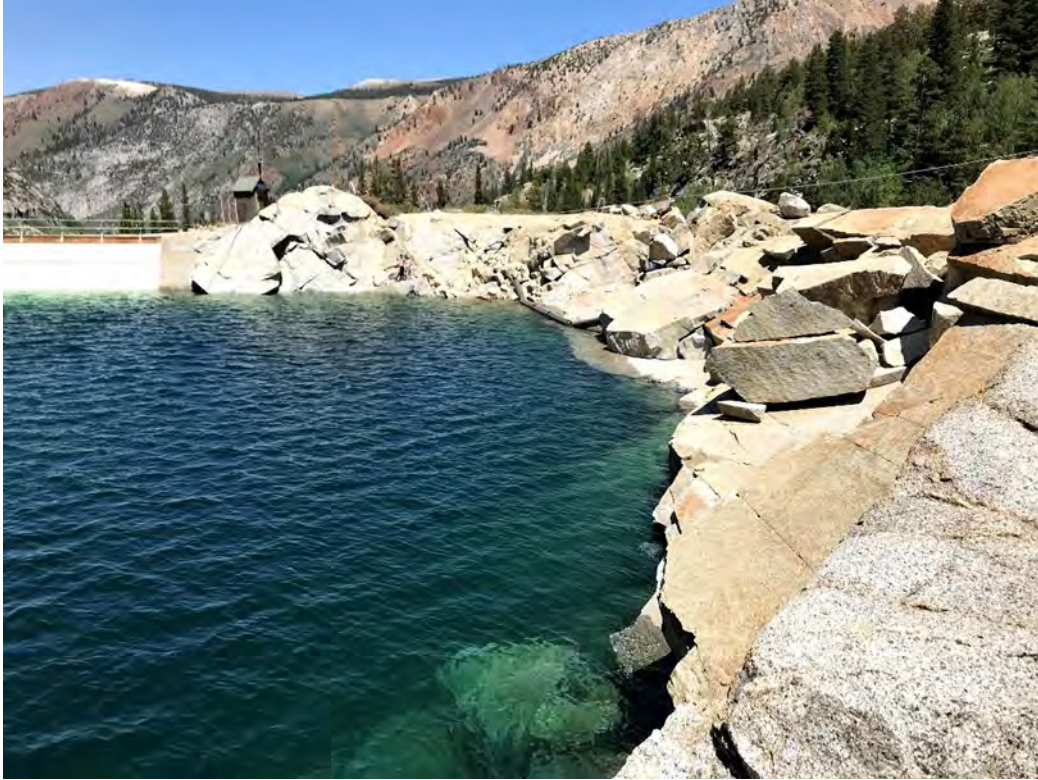
**Photo 54 Spillway Area Used for Fishing**

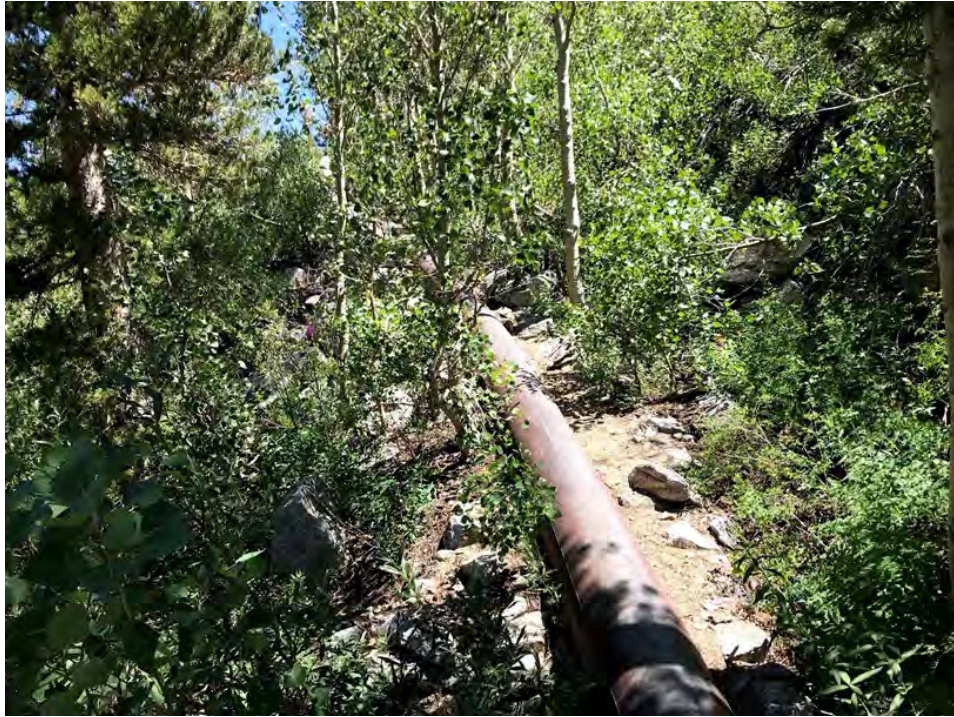
**Photo 55 Green Creek Diversion Pipeline Adjacent to Rainbow Pack Station Trail**

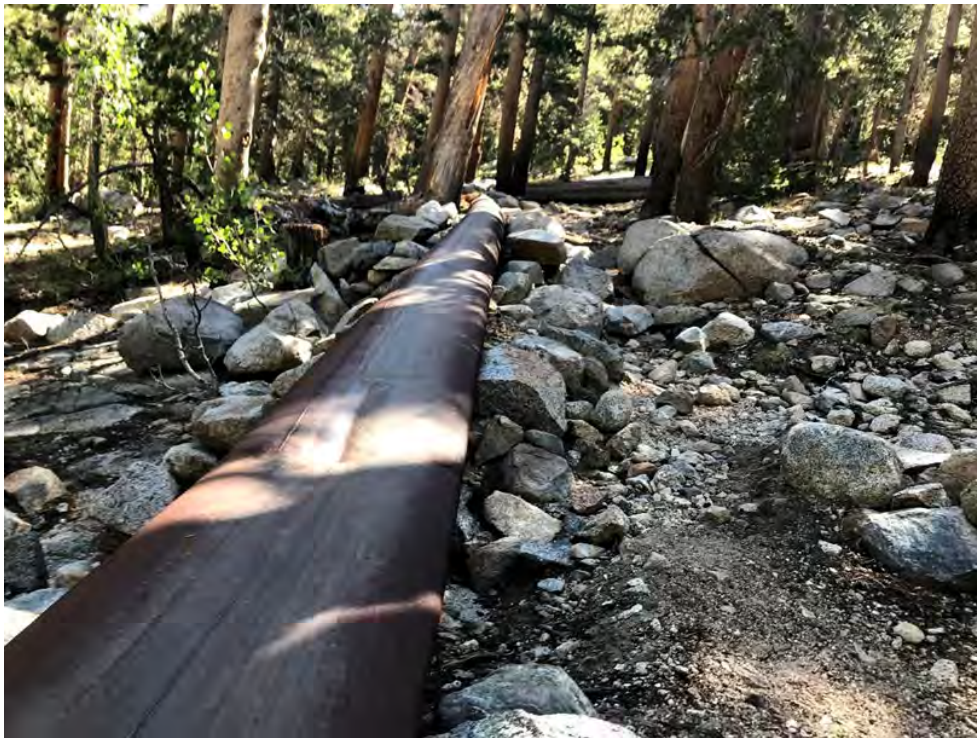
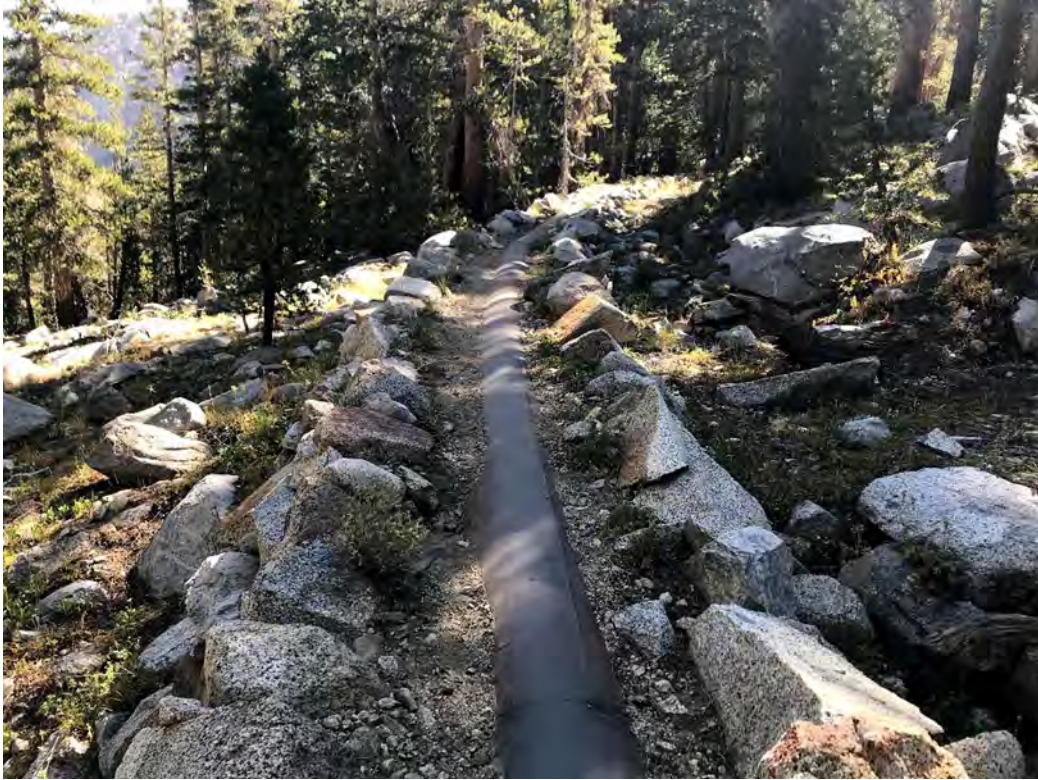
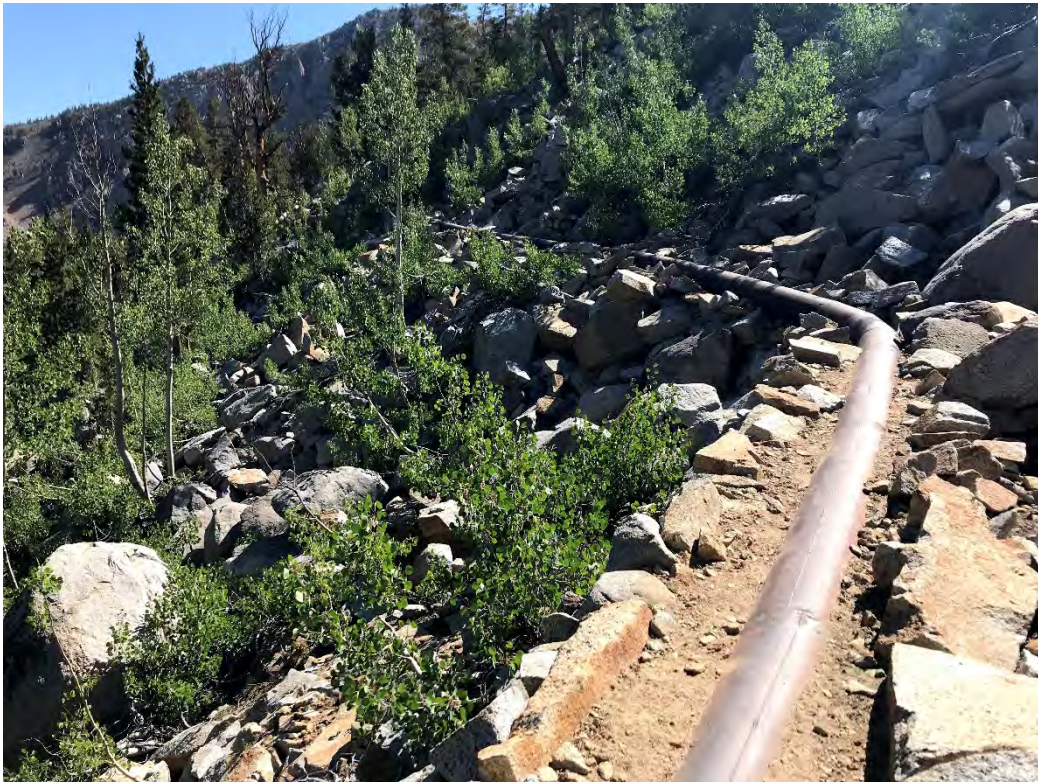
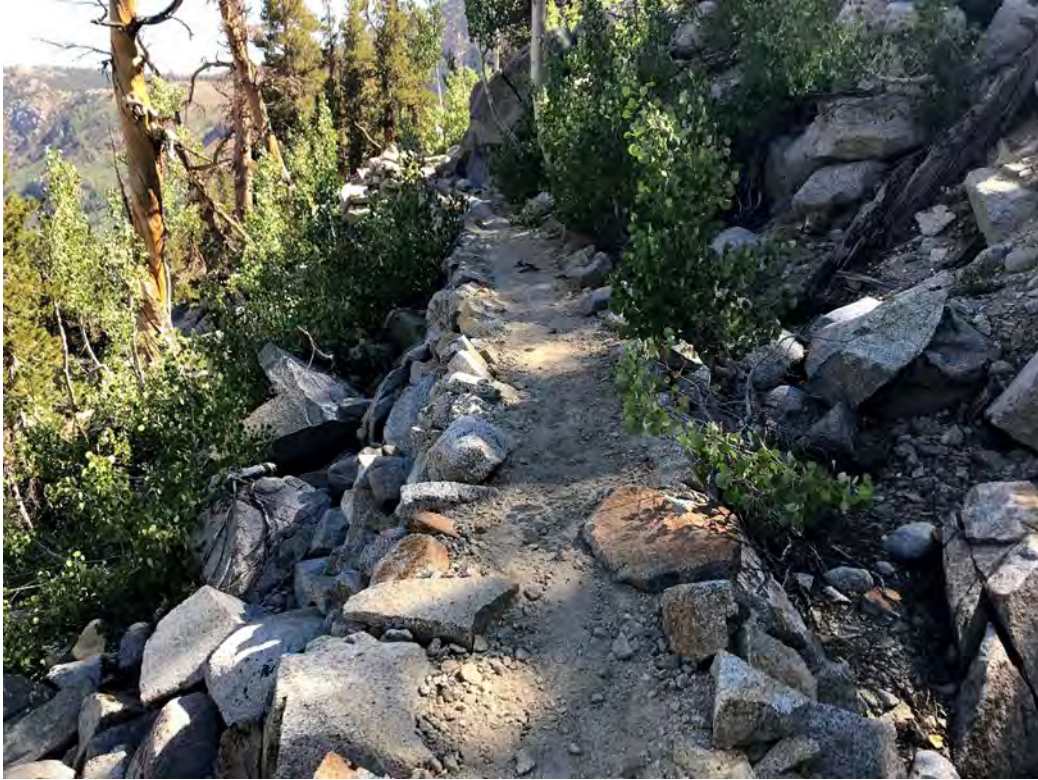
**Photo 56 Access Along Pipeline**

**Photo 57 Access Along Pipeline**

**Photo 58 Access Along Pipeline**

**Photo 59 Access Along Pipeline**

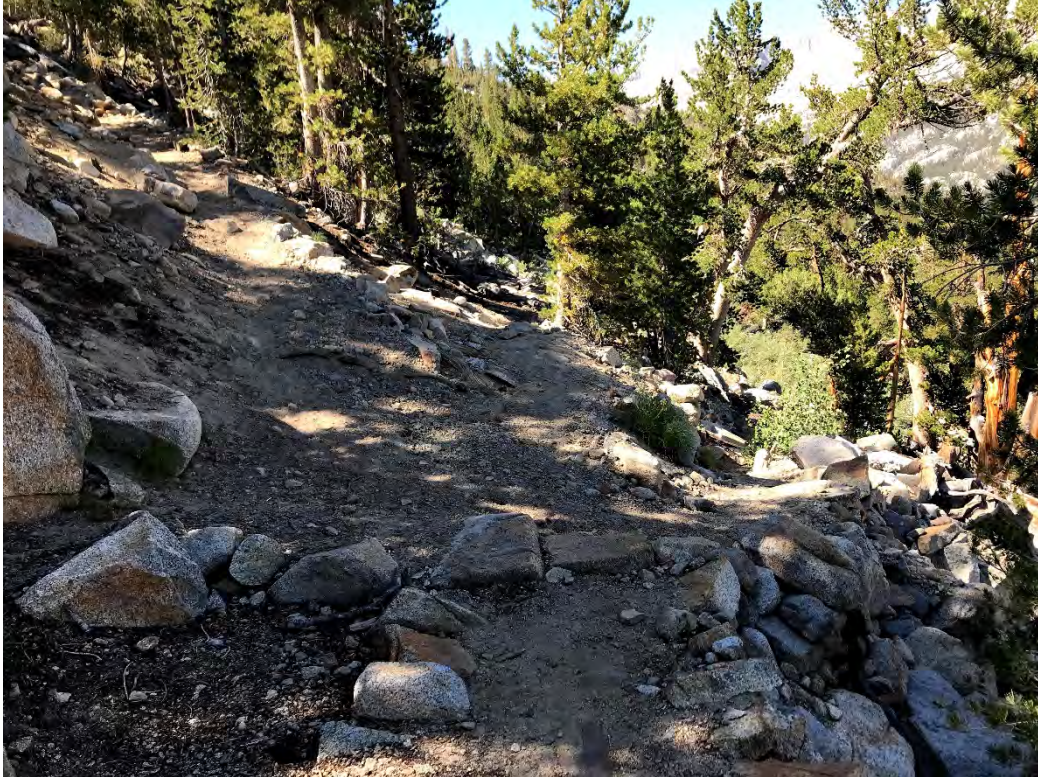
**Photo 61 Pipeline Crossing USFS' Baker Summit Trail**

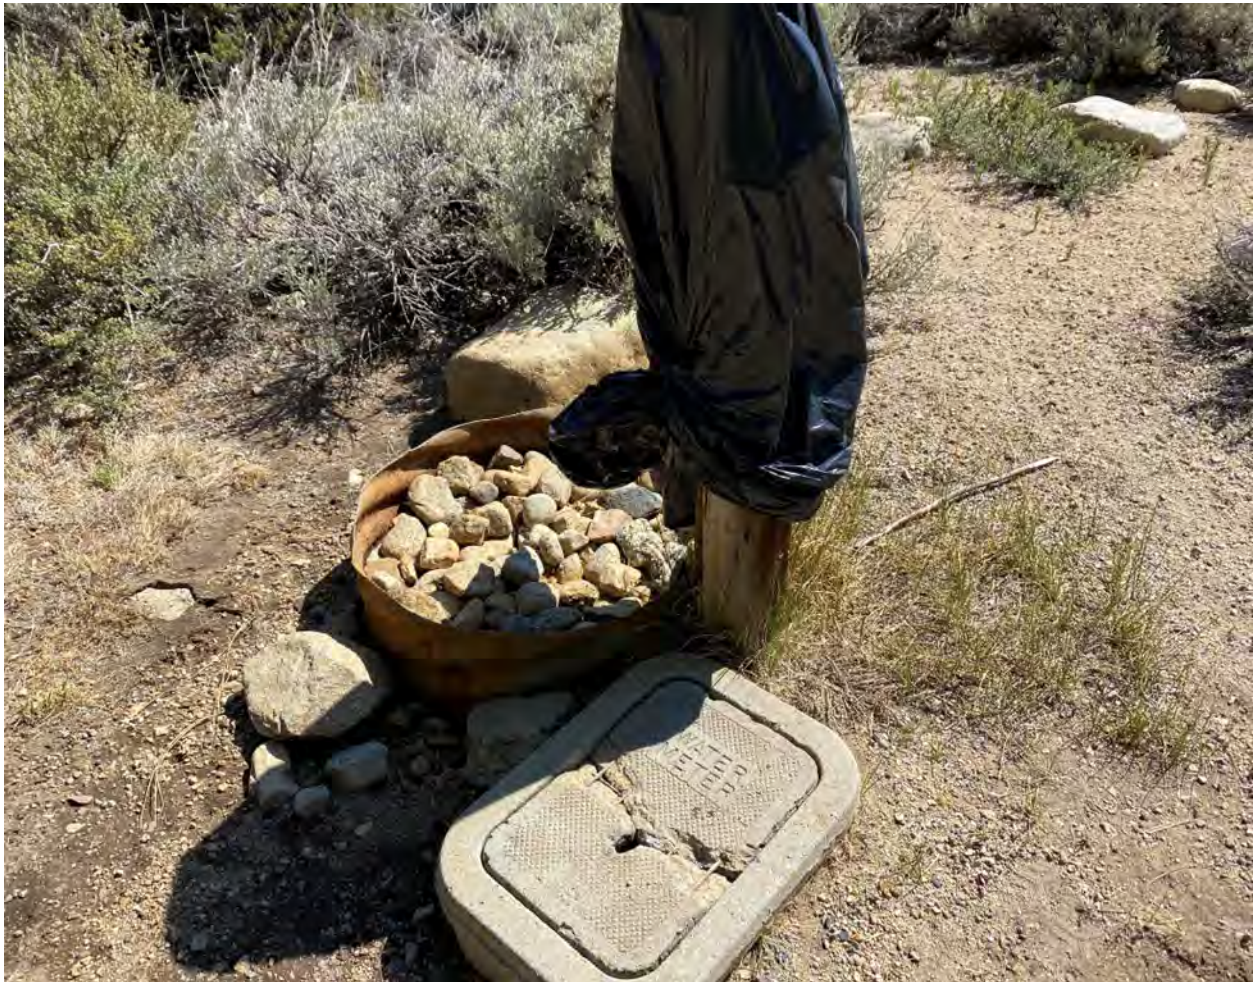
**Photo 88 Water Hydrant**

Table 5-15 provides a detailed inventory of all elements assessed at this site. The BBQ grills appeared to be in fair/good condition. They were not located along accessible routes and they have been further assessed in the ADA assessment documentation located in Appendix E of this report. The water hydrant was inoperable and is not ADA accessible (Appendix F, Photo 88).

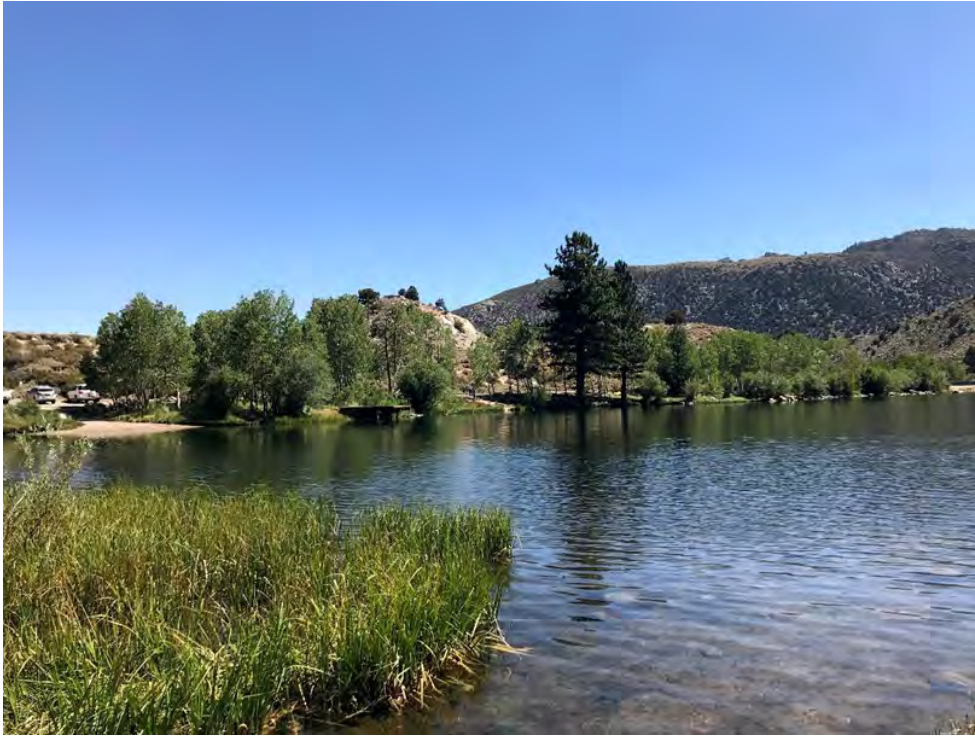
Photo 91 Northern Shoreline of Intake No. 2 Reservoir

As depicted on Figure 5-15, the northern shoreline of Intake No. 2 Reservoir and the Intake No. 2 Dam are popular for bank fishing and general access to the water. While the access road along the northern shoreline is gated to preclude public vehicle access to the dam facilities, the shoreline is open to public access by foot. Along the 1,344-foot stretch of shoreline, approximately 22 visibly worn access points to the reservoir were observed. All observations are wholly within the FERC Project boundary and on SCE lands. See Photos 91 through 97 in Appendix F for representative photos of Area A.

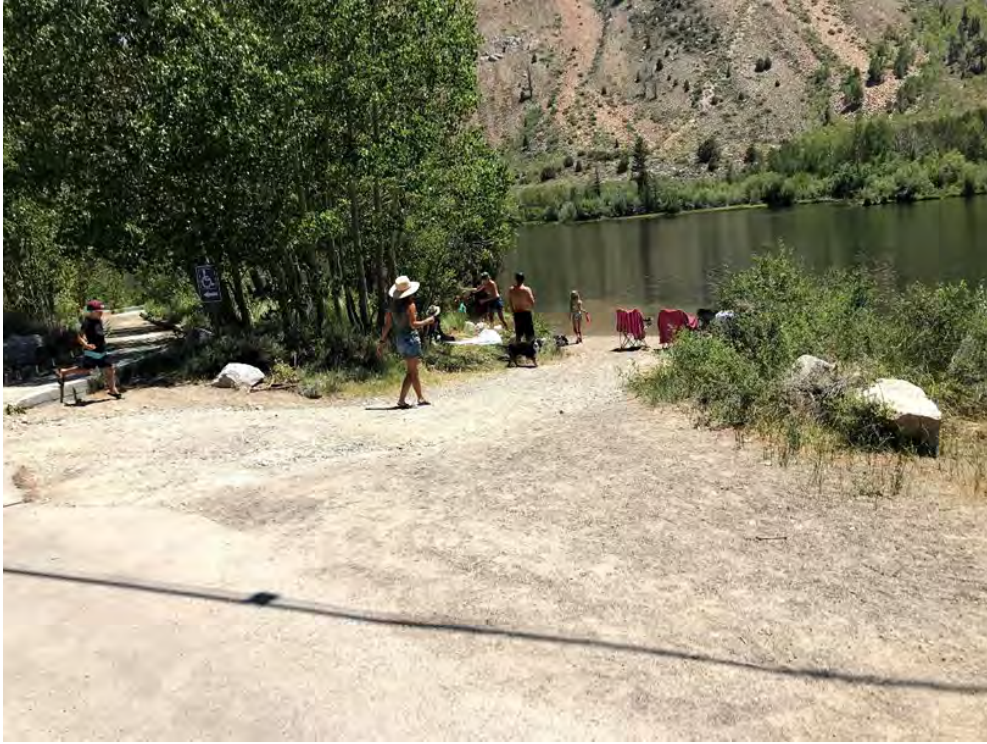
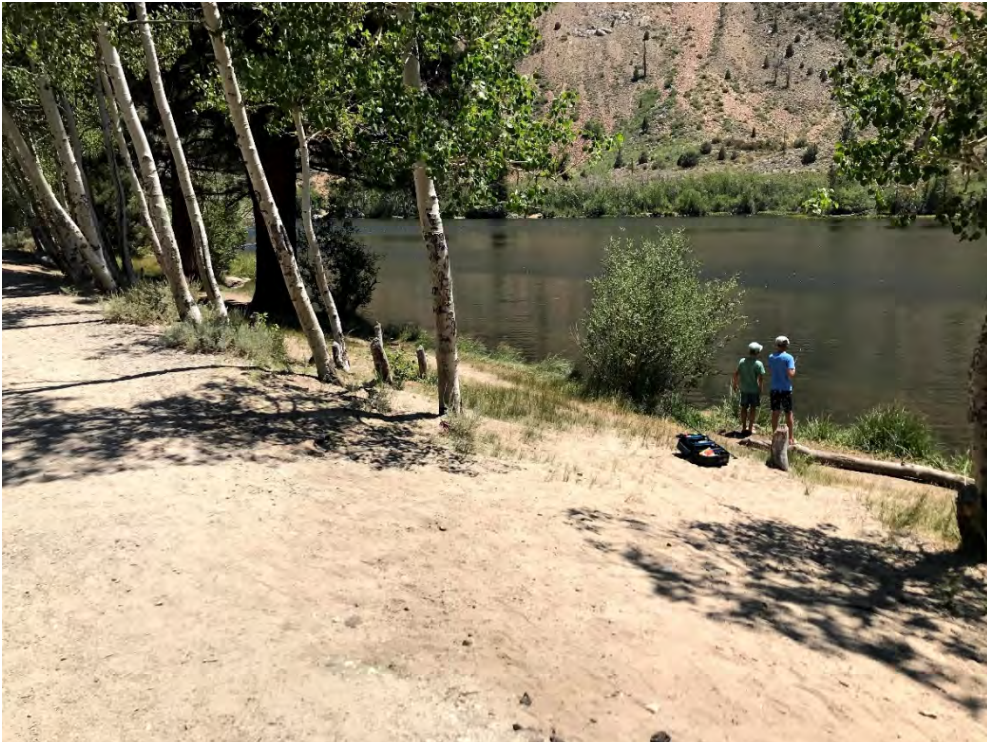
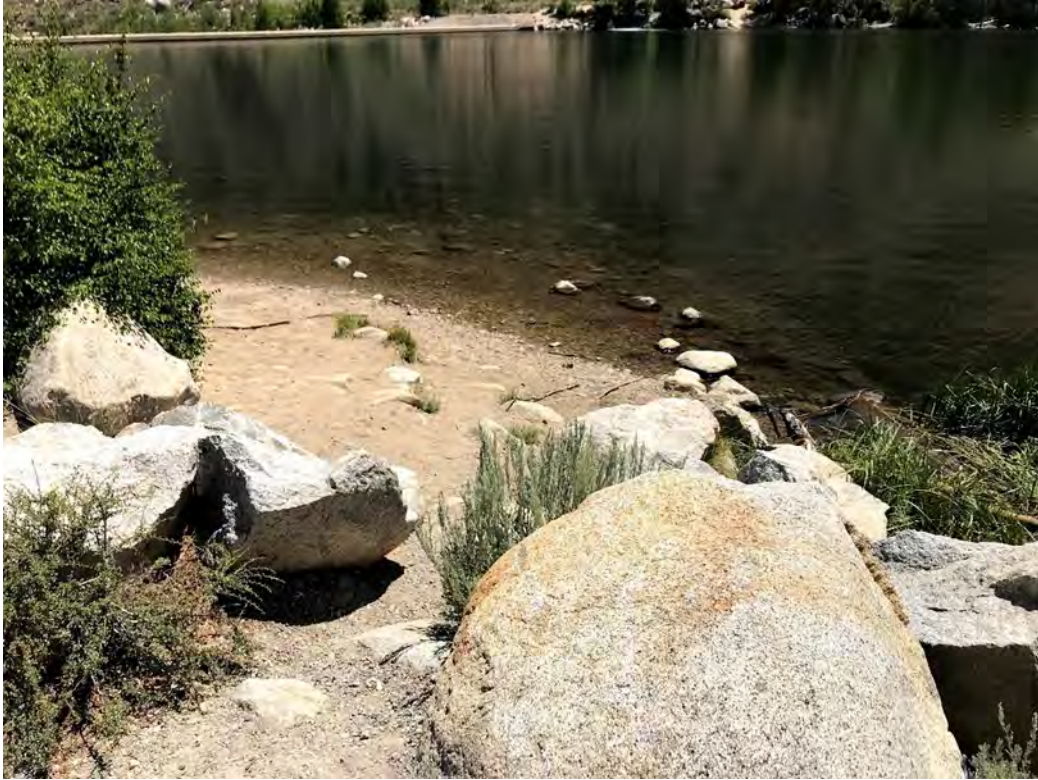
**Photo 93 Access to Northern Shoreline**

**Photo 94 Access to Northern Shoreline**

**Photo 95 Access to Northern Shoreline**

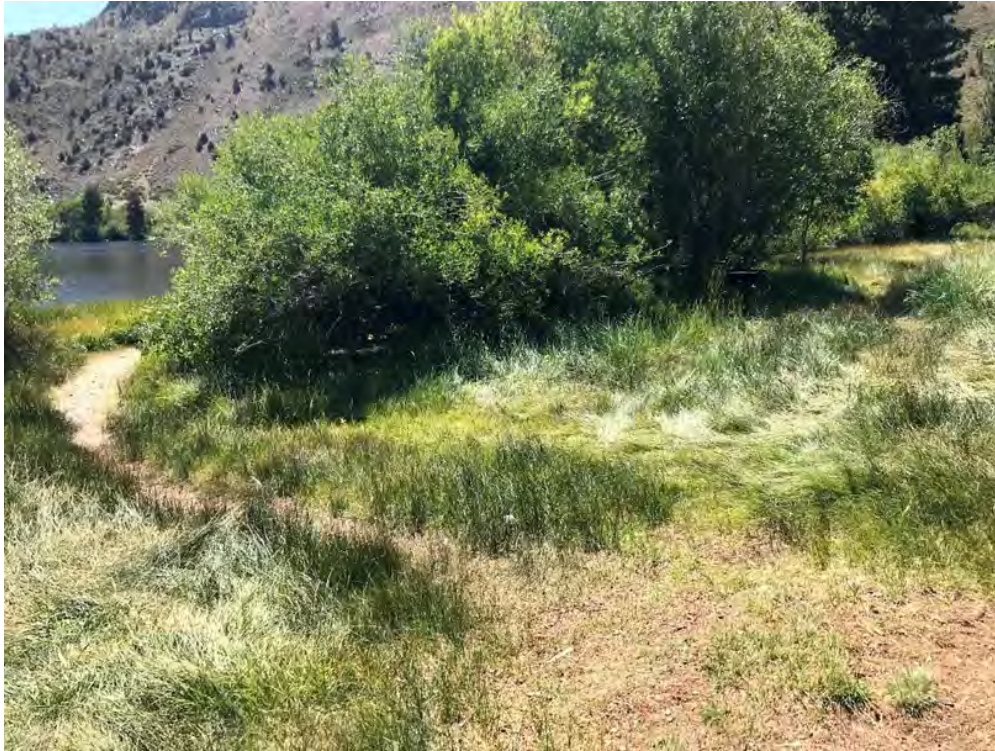
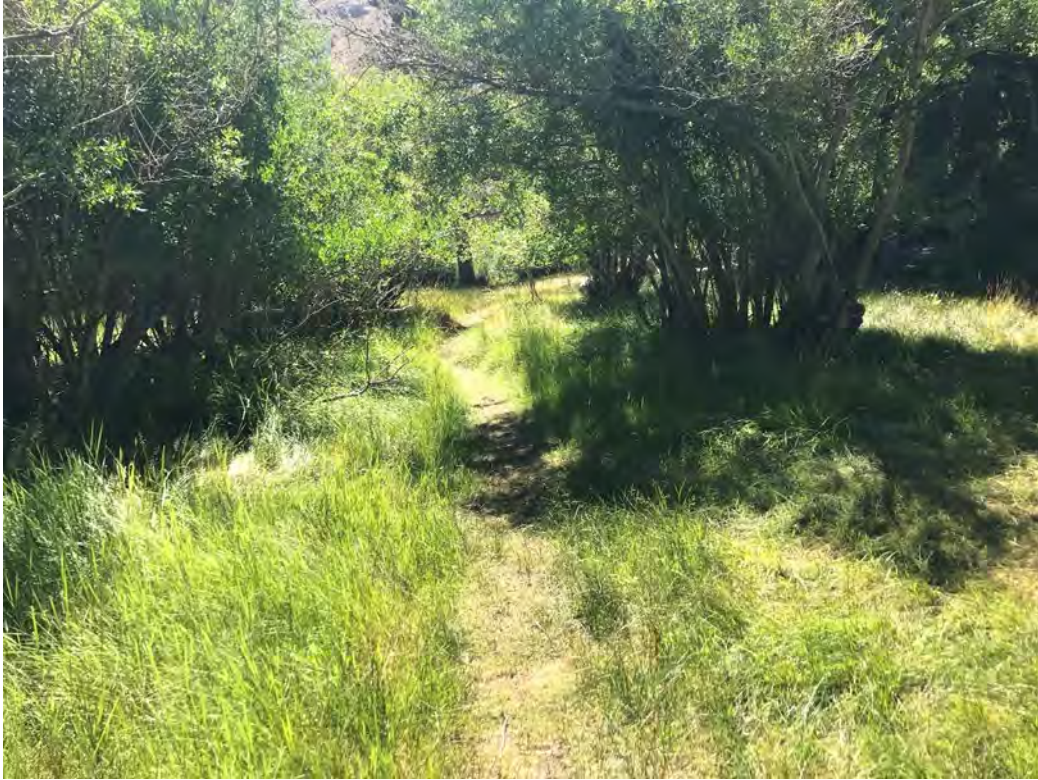
As depicted in Figure 5-16, access to the western shoreline of the reservoir at the day use area is popular for bank fishing and general access to the water. A network of approximately 1,201 feet of user-created foottrails leads between picnic areas and the shoreline, one of which appears to be commonly used as a kayak launching point. Along the 446-foot stretch of shoreline, approximately seven visibly worn access points to the reservoir were observed. All observations are wholly within the FERC Project boundary and on SCE lands. See Photos 98 through 100 in Appendix F for representative photos of Area B.

**Photo 98 Trails to Shoreline in Day Use Area**

**Photo 100 Trails to Shoreline in Day Use Area**

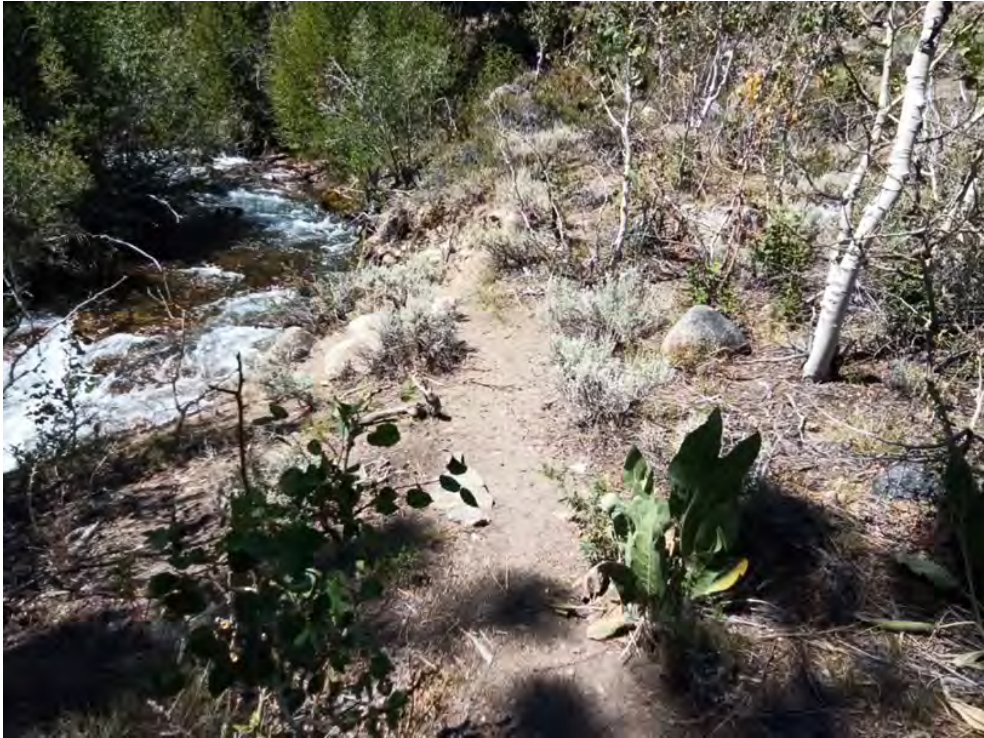
**Photo 101 Foot Path Along Middle Fork Bishop Creek**

As depicted in Figure 5-17 the approximately 1,244-foot reach of Middle Fork Bishop Creek between Intake No. 2 Reservoir and Intake No. 2 Campground is heavily used for general bank and fishing access on both sides of the creek. A network of approximately 3,222 feet of user-created foottrails leads along the creek and to approximately 25 access points to the creek. Five potential campsites were observed along this reach, including presumed use of the remnants of a chimney as a fire pit on the southern shore of the creek just before its confluence with the reservoir. All observations are wholly within the FERC Project boundary and on SCE lands. Activities observed are located wholly on the Inyo National Forest lands and partially within the current FERC Project boundary, which is intended to represent a 100-foot buffer (50 feet to each side of centerline) around the creek at this location. See Photos 101 through 107 in Appendix F for representative photos of Area C.

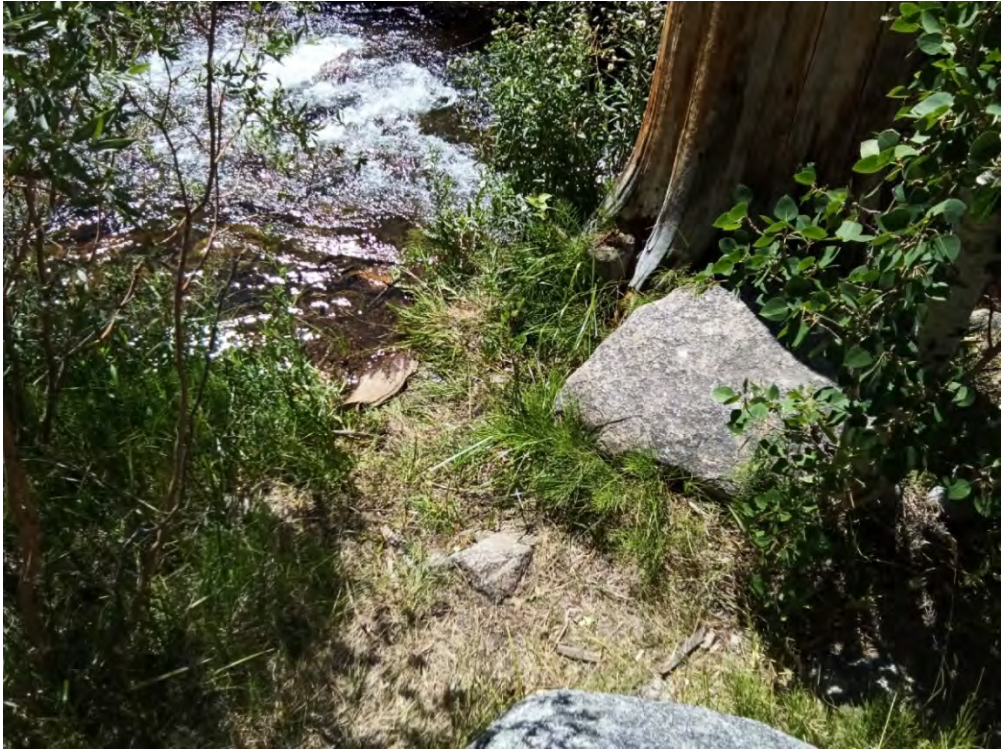
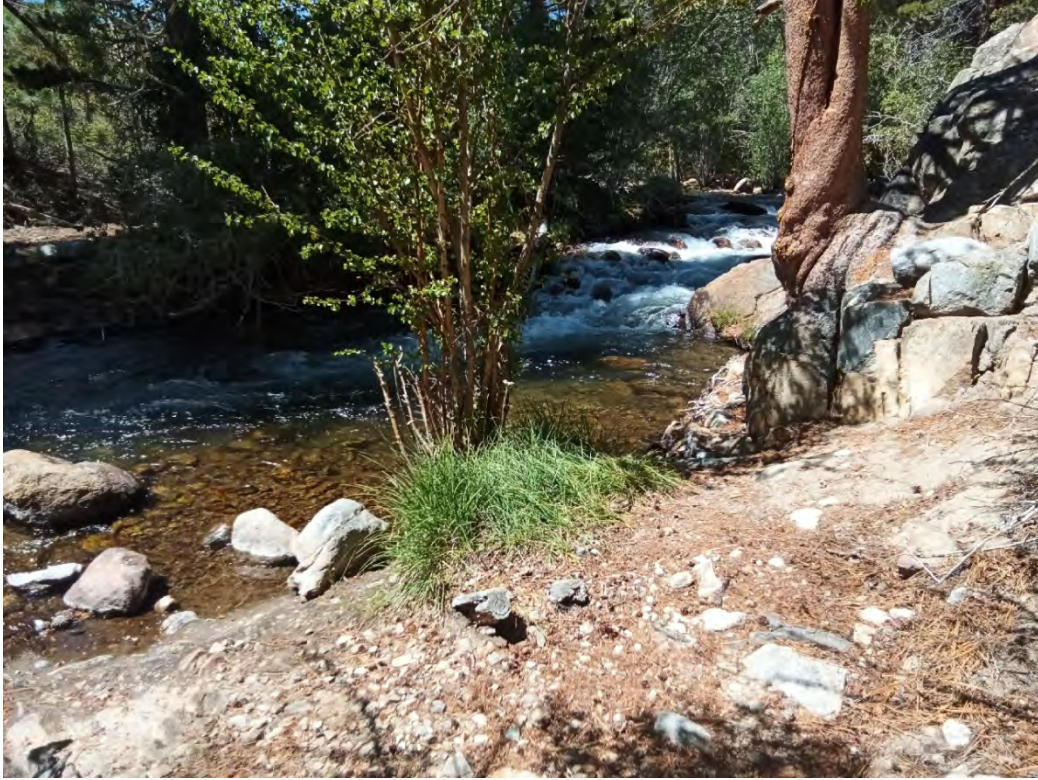
**Photo 102 Access to Creek**

**Photo 103 Access to Creek**

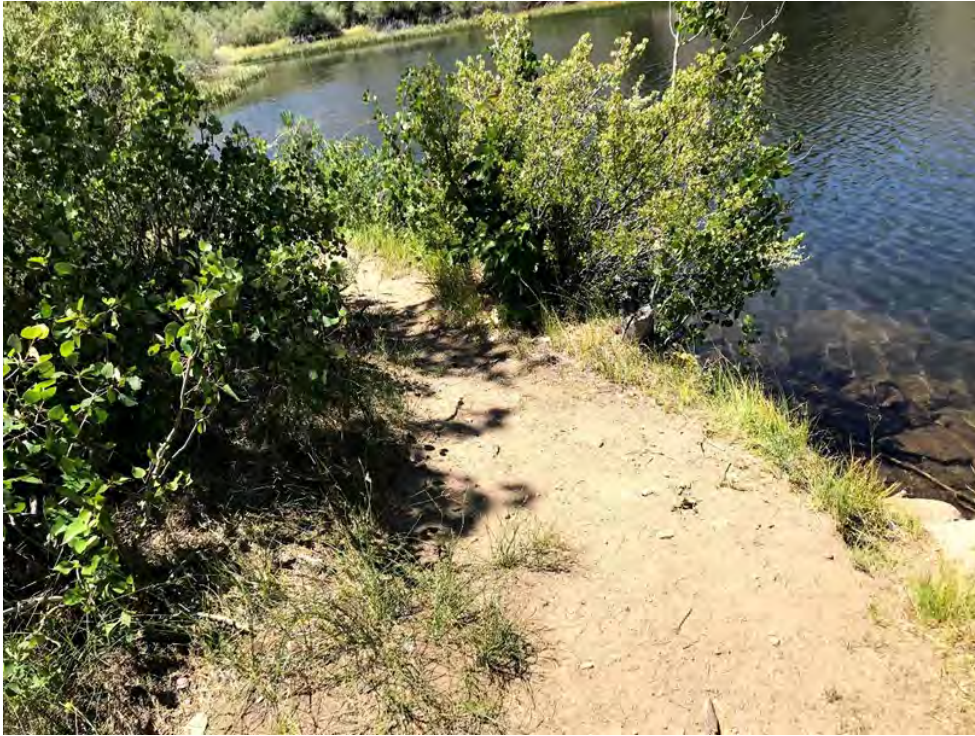
**Photo 108 Foot Trail Along Shoreline**

As depicted in Figure 5-18, the southeastern shoreline of Intake No. 2 Reservoir is popular for bank fishing and general access to the water. The southeastern shoreline is generally accessed through a series of approximately 1,062 feet of user-created trails leading from the spur road that runs east to west to the south of the reservoir. Along the approximately 690-foot stretch of shoreline, approximately seven visibly worn access points to the reservoir were observed. Activities observed are located on both Inyo National Forest and SCE lands and partially within the current FERC Project boundary. See Photos 108 through 112 in Appendix F for representative photos of Area D.

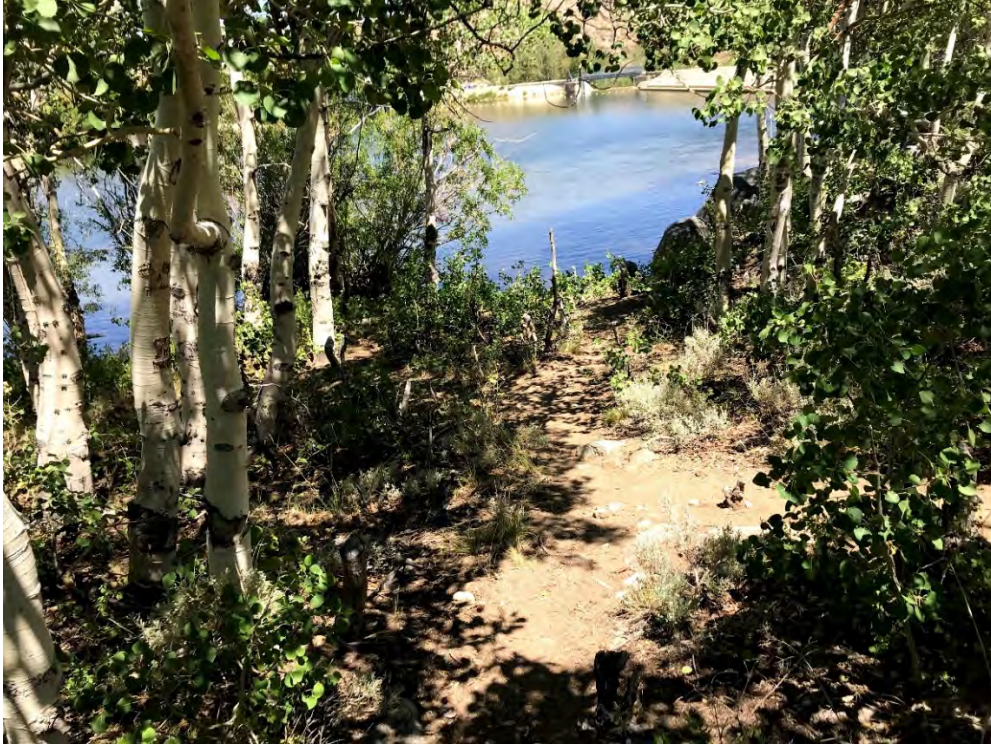
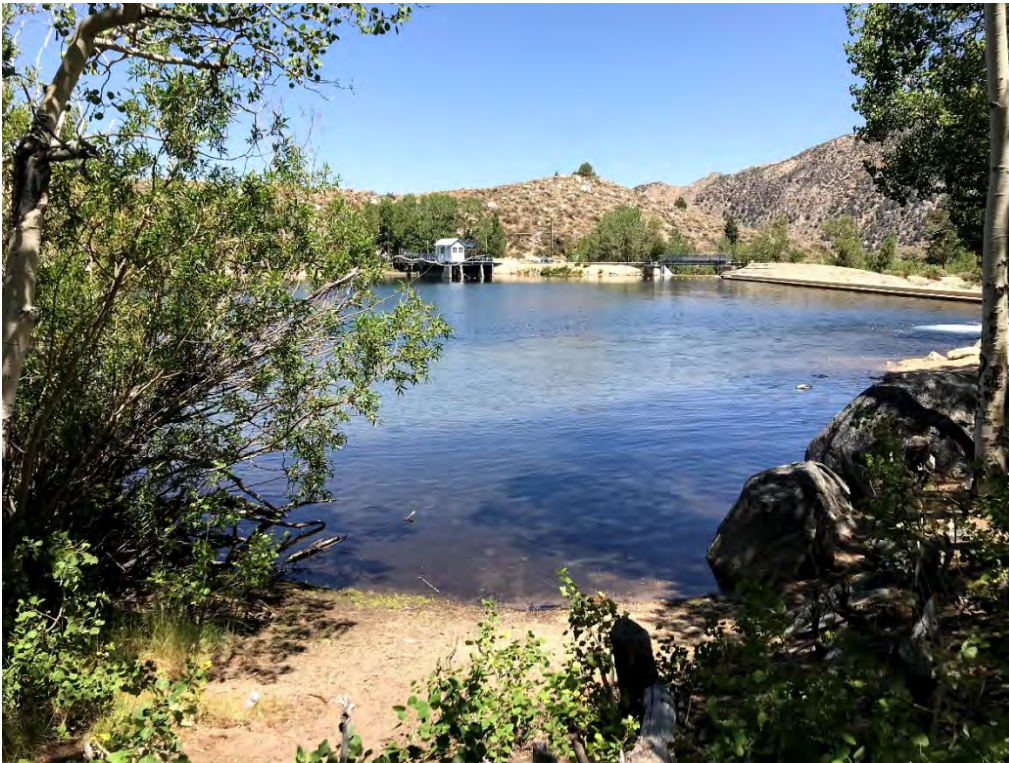
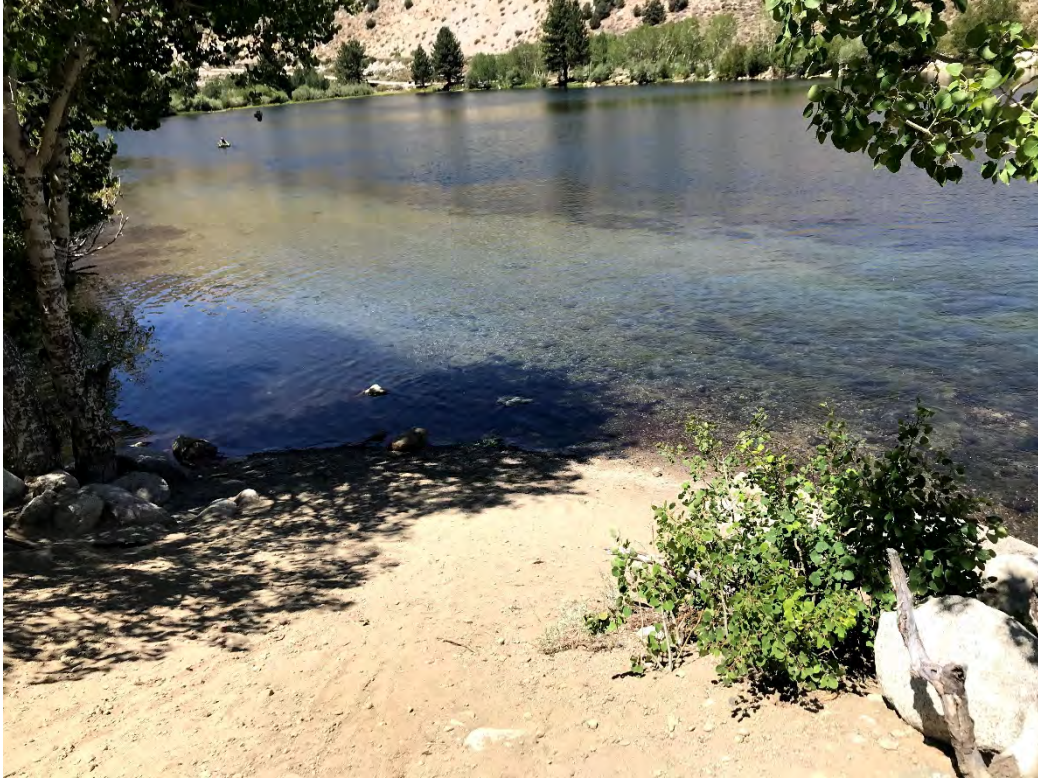
**Photo 110 Access to Shoreline**

**Photo 111 Access to Shoreline**

**Photo 112 Access to Shoreline**
