T5 UNDER-CABINET LIGHT DURABILITY TEST

FINAL REPORT

Statewide Codes & Standards Program

Southern California Edison

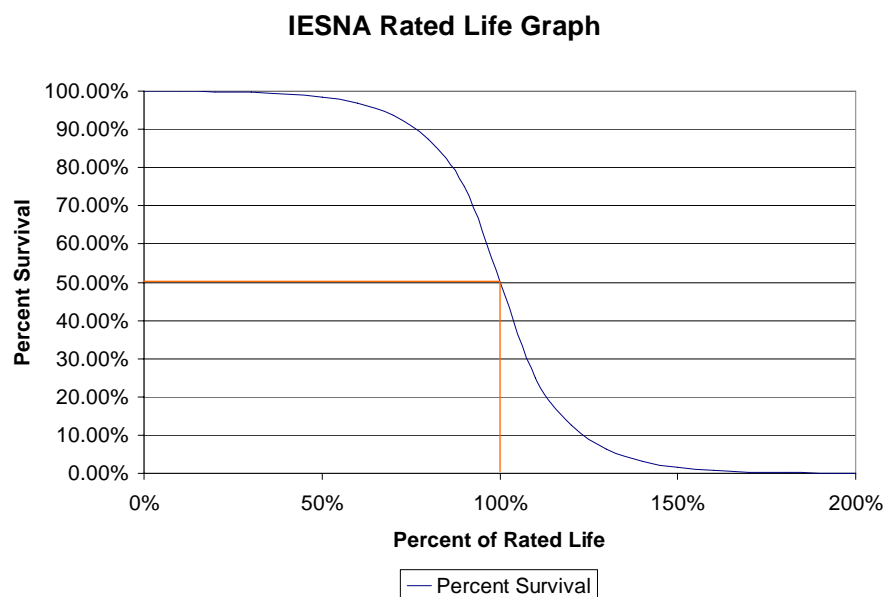
Figure ES-1: IESNA Rated Life Graph

The life of the T-5 lamps was investigated by conducting an accelerated life cycle test. The test protocol, as delineated by The Illuminating Engineering Society of North America (IESNA) requires that lamps be cycled at three hours of operation per start at room temperatures. The IESNA defines the rated life of the lamp as the number of hours at which 50% of the population fails, as seen in Figure ES-1. The orange lines in the figure show that there are 50% failures at 100% of the rated life.

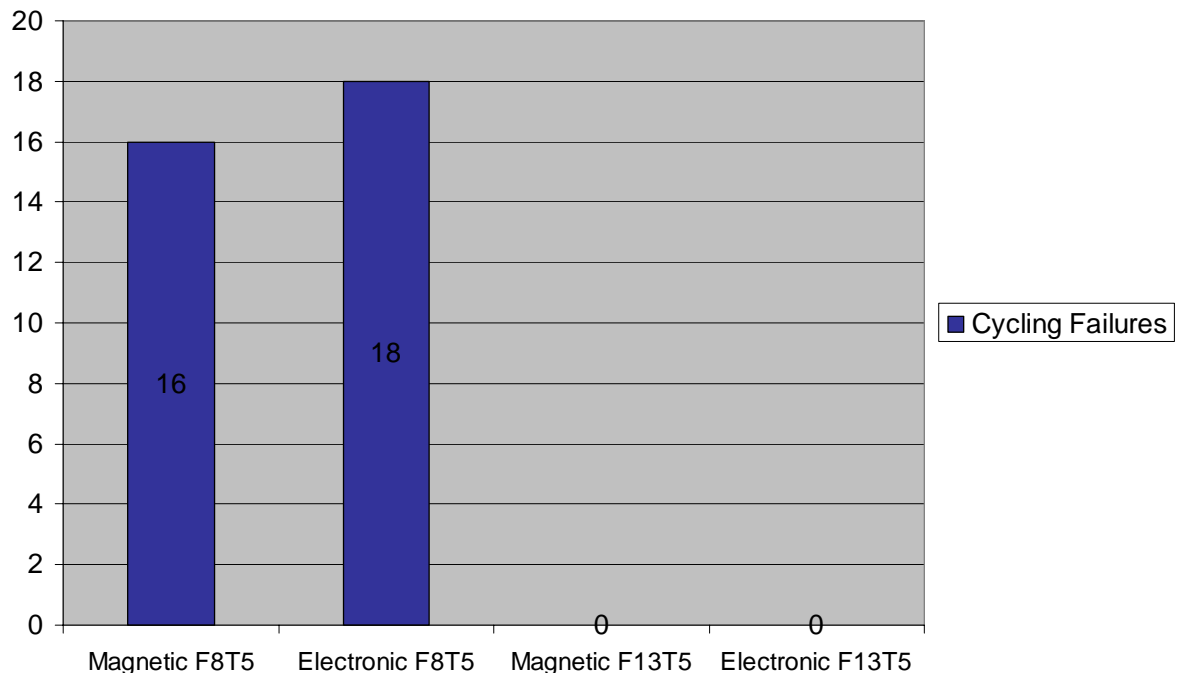
Figure ES-3: Cycling System Failures After 4729 Hours

It was noticed that of all the cycling lamp failures, all were F8T5s and none were F13T5s, regardless of the ballast type. Figure ES-3 shows a graph of the cycling system failures after 4729 hours.

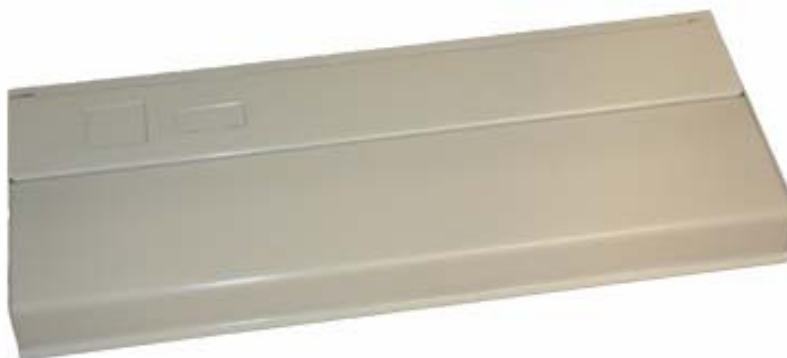
Figure PF-1: Typical Under-Cabinet Fixture

In order to represent what is out in the market and what customers would typically buy for their homes, we went to electrical wholesalers for their high-selling under-cabinet fluorescent systems. The fixtures came off the shelf with brand name lamps and all the mounting and wiring hardware as well. Figure PF-1 shows a picture of the typical 12" fixture.

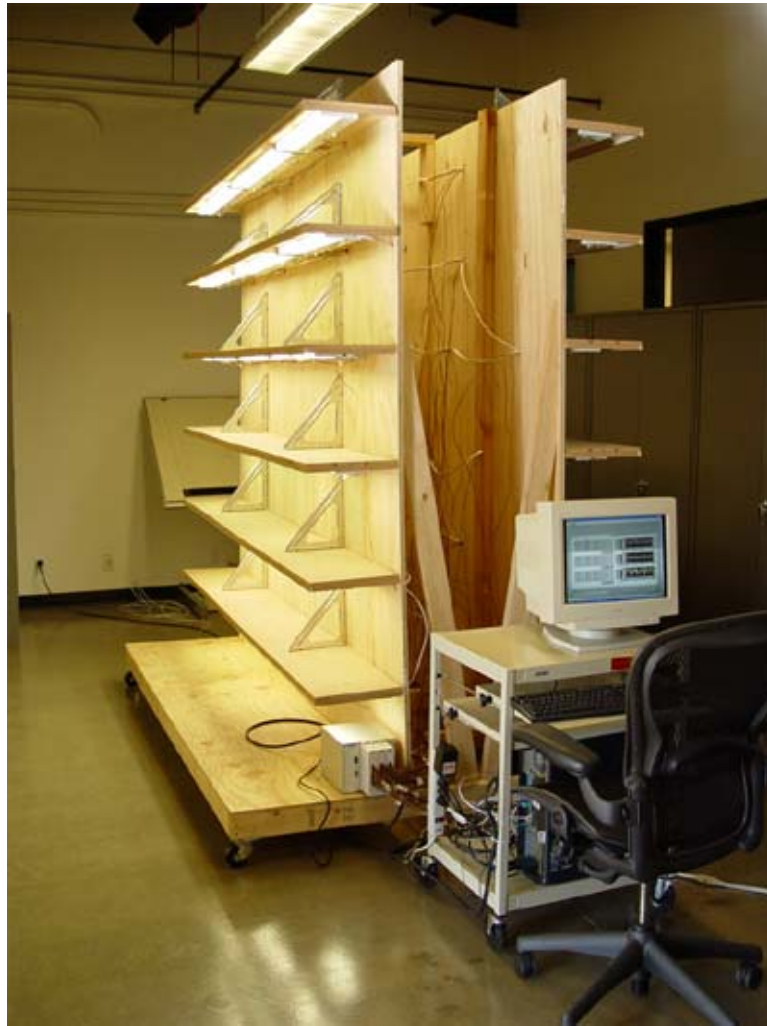
Figure PF-2: T5 Under-Cabinet Test Rack and Instrumentation System

A two-sided under-cabinet test rack was constructed to simulate under-cabinet conditions. A picture of the test rack and instrumentation system is shown in Figure PF-2.

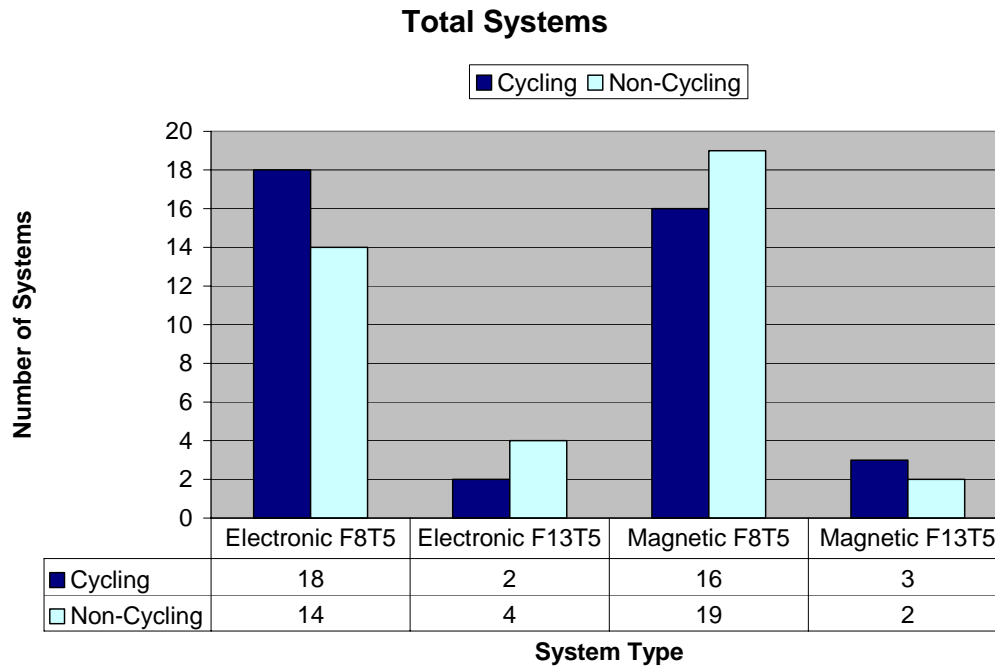
Figure PF-3: Total Number of Systems

A total of 48 various fixtures and 78 lamps were used for the test. Each side of the test rack housed half of the total number of fixtures and lamps. Figure PF-3 shows the location and number of different lamp and ballast systems that were installed.

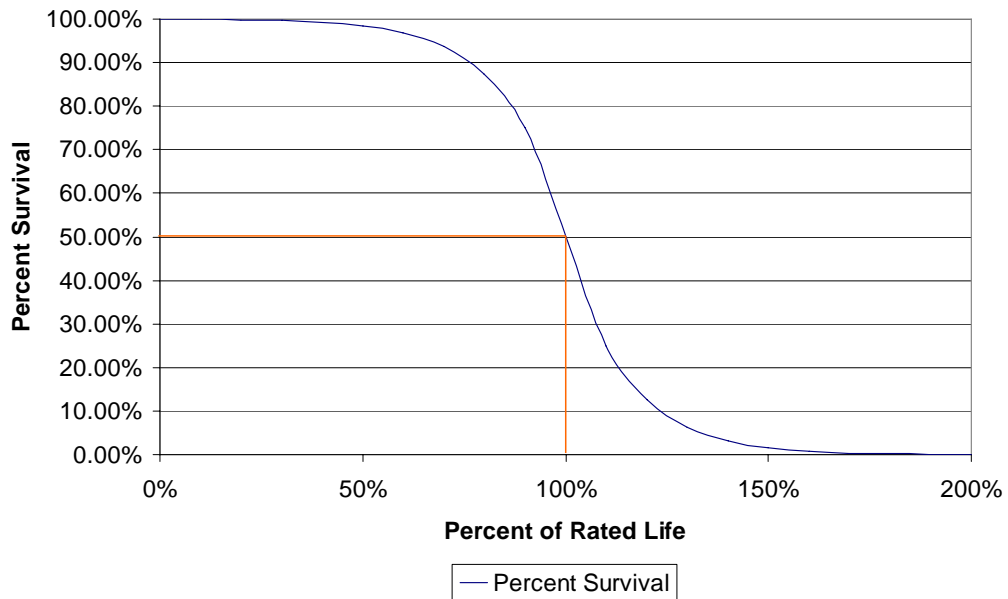
Figure PF-4: IESNA Rated Life Graph

The lamp life was investigated by conducting an accelerated life cycle test using the standard 3 hours on, 20 minutes off cycling rate. An actual life cycle test would be prohibitive in the time-frame of the project. The Illuminating Engineering Society of North America (IESNA) defines the rated life of the lamp as the number of hours at which 50% of the population fails at 3 hours of operation per start at room temperatures. Figure PF-4 shows a rated life graph for fluorescent lamps. The orange lines in the figure show that there are 50% failures at 100% of the rated life. In other words, half of the lamps would fail before the rated life and half would fail after the rated life.

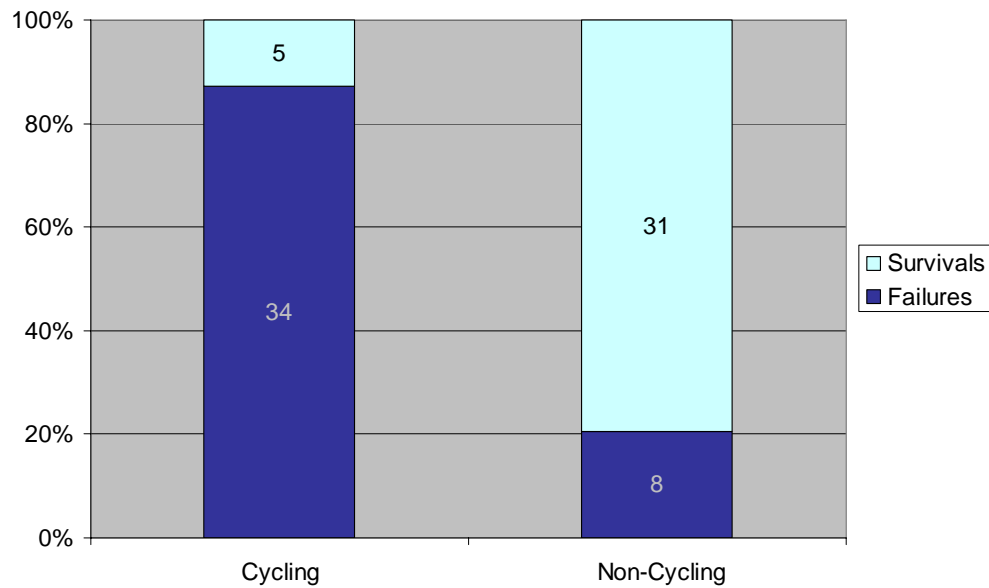
Figure PF-7: Cycling Versus Non-Cycling Systems

One of the obvious trends that was noticed from the Measured Rated Life Graph in Figure PF-6 was the difference in the failure rates between the cycling and non-cycling systems. The cycling systems had many more failures compared to the non-cycling systems in the duration of the test. Figure PF-7 shows the total number of failures for both systems at the conclusion of the test.

The higher failure rate of the cycling systems was expected due to the increased number of starts. The life of fluorescent lamps is directly related to the number of starts that the fluorescent lamp experiences. Starting the lamps involves a high voltage spike, which deteriorates the cathode inside the lamp by sputtering off the cathode material onto the inside of the tube. Figure PF-8 shows the blackened ends of the lamps caused by the sputtered cathode material deposited on the inside of the lamp.

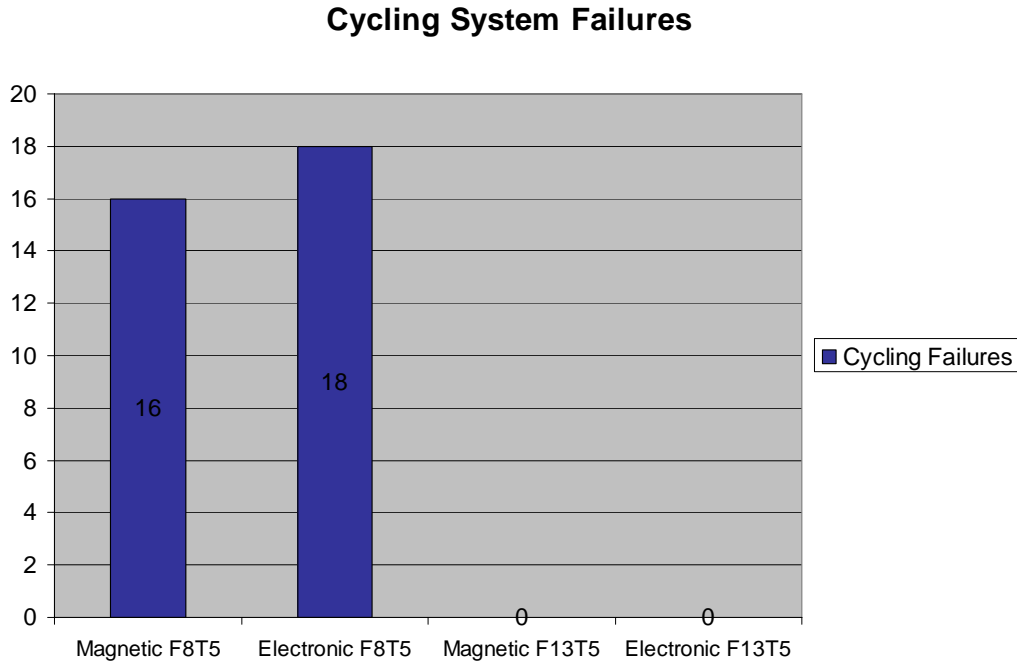
Figure PF-9: F8T5 versus F13T5 Cycling System Failures

Another apparent trend was the number of failures of the cycling F8T5 and F13T5 systems. Figure PF-9 shows a graph of the failed cycling systems.

One hundred percent of the cycling F8T5 lamps failed at the conclusion of the test while none of the cycling F13T5 systems failed. The ballast technology, whether electronic or magnetic, did not make a difference. At this point in the test, it was not clear why the cycling F8T5 and F13T5 systems were failing in this manner. The cause of the 100% F8T5 failures and 0% F13T5 failures was later determined after the in-depth lamp and ballast analysis.

The instant start starting method is more damaging to the smaller 12" F8T5 lamps than the larger 21" F13T5 lamps. There is a higher arc resistance in the F13T5 lamp due to the larger distance between the two cathodes. The larger resistance reduces the cathode material sputter during the voltage spike. Applying the 13-Watt starting voltage on the smaller F8T5 lamp creates a much larger spark from the cathode which sputters more material off the cathode, drastically increasing the deterioration rate of the cathode, and causing it to fail prematurely.

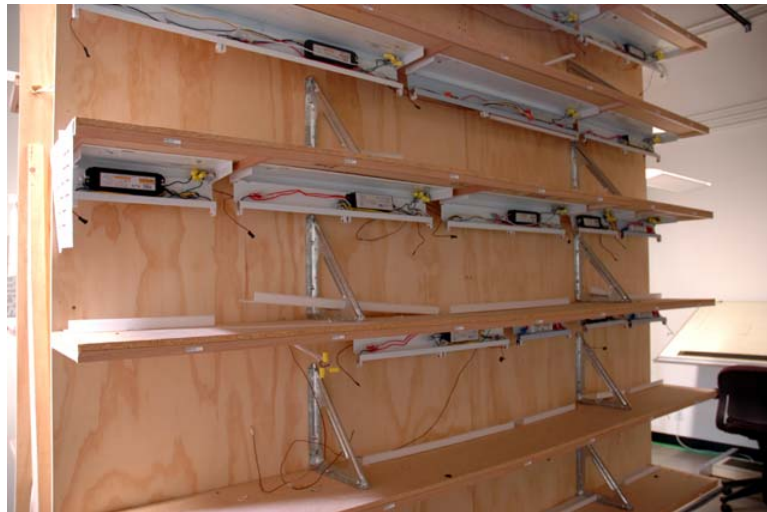
Figure PF-10: T5 Under-Cabinet Test Rack Lamp and Ballast Analysis

There were a variety of ballasts in the population. Every fixture was opened in order to see the labeling for each of the ballasts. Figure PF-10 shows the test rack with the fixtures opened for individual lamp and ballast analysis.

The lamp and ballast analysis revealed that there was a mismatch between the components of the system. It was found that the ballasts were instant start type ballasts and the F8T5 and F13T5 lamps were preheat lamps. This mismatch explains the cause of the premature failures.

The cathodes of preheat lamps are designed to warm up before striking. The preheat start method initially warms up the cathodes by running current through them before striking them with high voltage to turn the lamp on. Warming up the cathode reduces the amount of cathode material sputter during the voltage spike of the preheat starting mechanism.

The instant start starting method does not preheat the cathodes. The instant start starting mechanism lights up the lamp by striking it with a much higher voltage without preheating the cathodes and causes the cathode material to sputter off more rapidly. Therefore, the life of the lamp suffers drastically compared to the preheat starting method.

It is recommended that manufacturers be notified of the problem to see what solutions are available on their side regarding the lack of instant start solutions to F8T5 and F13T5 systems. The market potential for properly matched fluorescent T5 systems will play a large role in the manufacturer's interest in the solution to the problem.

On the codes and standards side, it is recommended that additional language be introduced to "Title 24 Section 150 – Mandatory Features and Devices" to require matching lamp and ballasts for fluorescent residential lighting systems. This requirement would help manufacturers bring about instant start solutions for the lower wattage T5 systems.
