PG&E Covered Conductor Testing

Covered Conductor Effectiveness supplemental report to WMP finalized in Feb 2022

Test Results Summary

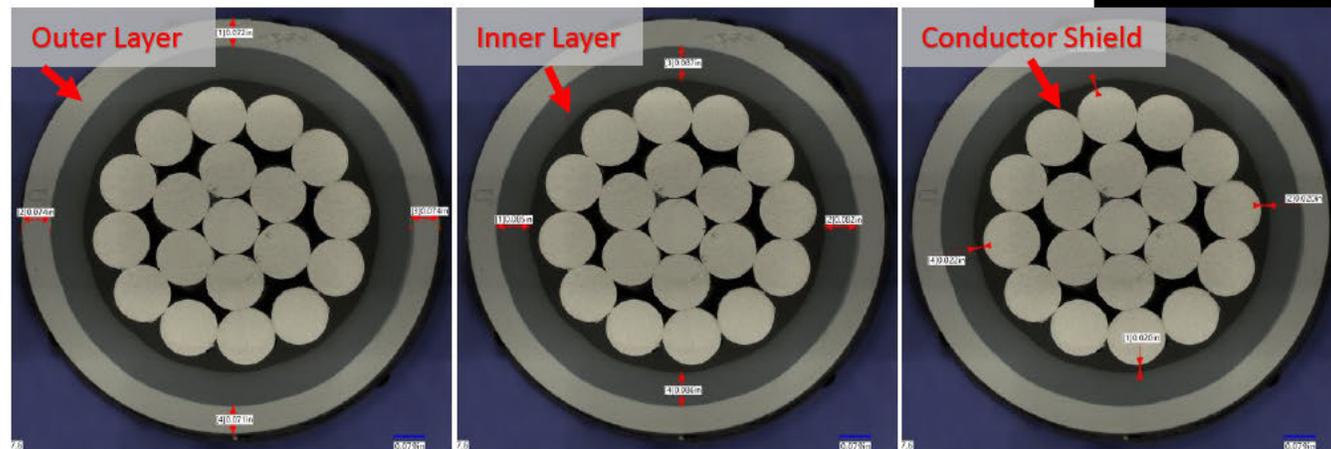
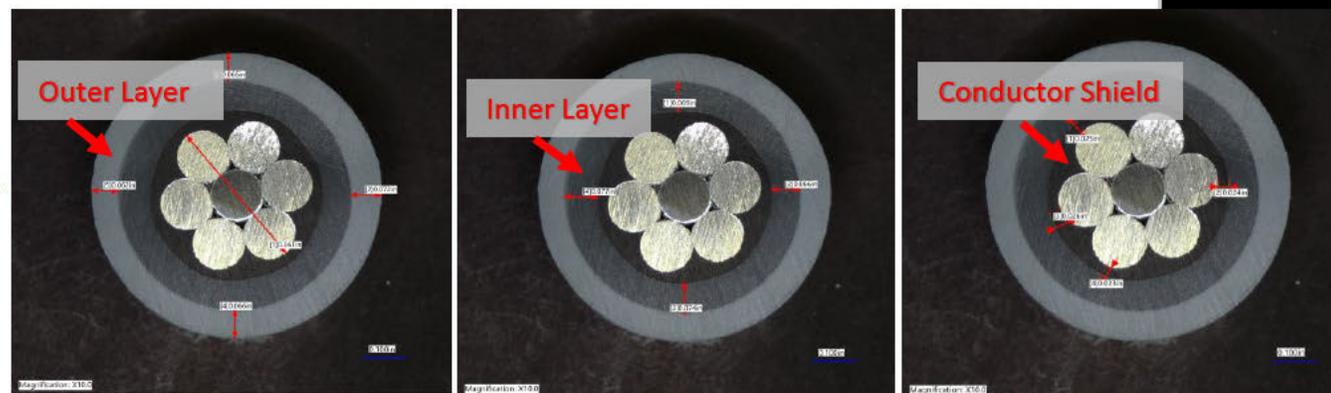
1. Dimensional Analysis (Required per ANSI/ICEA S-121-733)

- ██████████ 397 AAC
 - Outer layer thickness: 73 Mils
 - Inner layer thickness: 85 Mils
 - Total cover (insulation) thickness: 158 Mils
 - Conductor shield thickness: 21 Mils
- ██████████ 1/0 ACSR
 - Outer layer thickness: 67 Mils
 - Inner layer thickness: 72 Mils
 - Total cover thickness: 138 Mils
 - Conductor shield thickness: 26 Mils
- Per ANSI/ICEA S-121-733
 - Cover thickness Nom=150 Mils, Min=135 Mils
 - Shield thickness Nom=15 Mils, Min=12 Mils

The insulation thickness for both ██████████ and ██████████ covered conductors meets the requirements per ANSI/ICEA S-121-733 Table 4-1. The shield thicknesses exceeds the requirement per ANSI/ICEA S-121-733 Table 3-1.

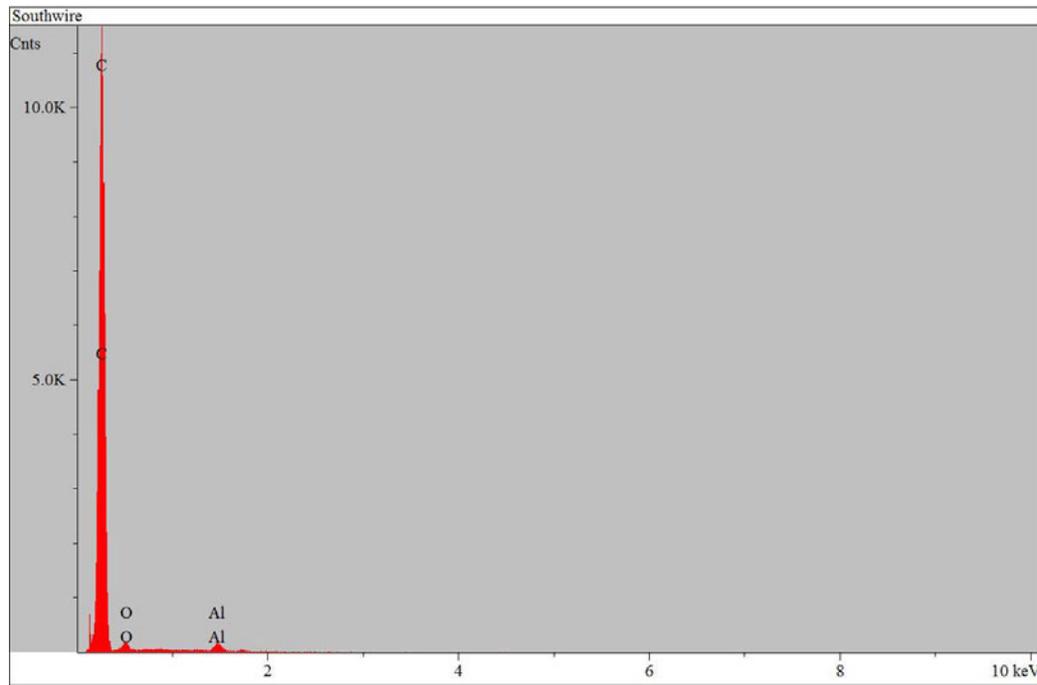
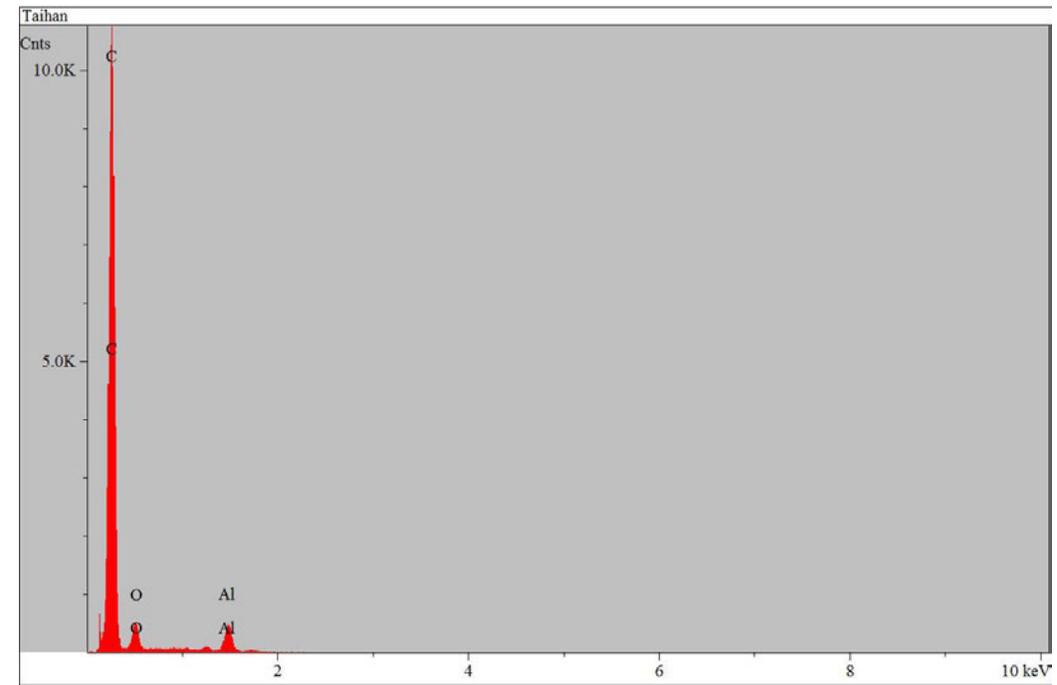
- Scanning Electron Microscopy (SEM) / Energy Dispersive Spectroscopy (EDS) Analysis of outer layer

The inorganic filler content in the outer layer appears to be aluminum trihydrate (ATH), which is intended for flame retardancy and/or tracking resistance.

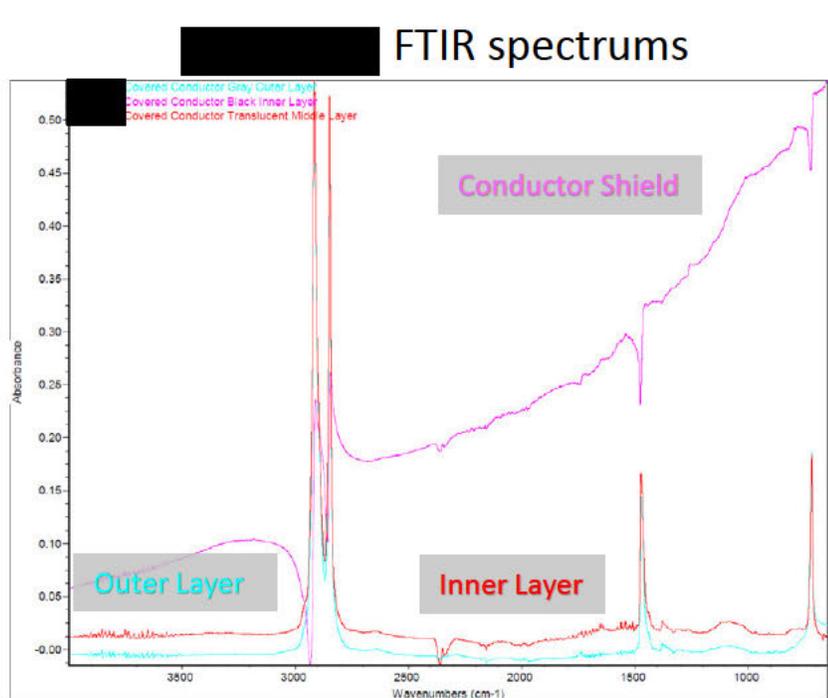
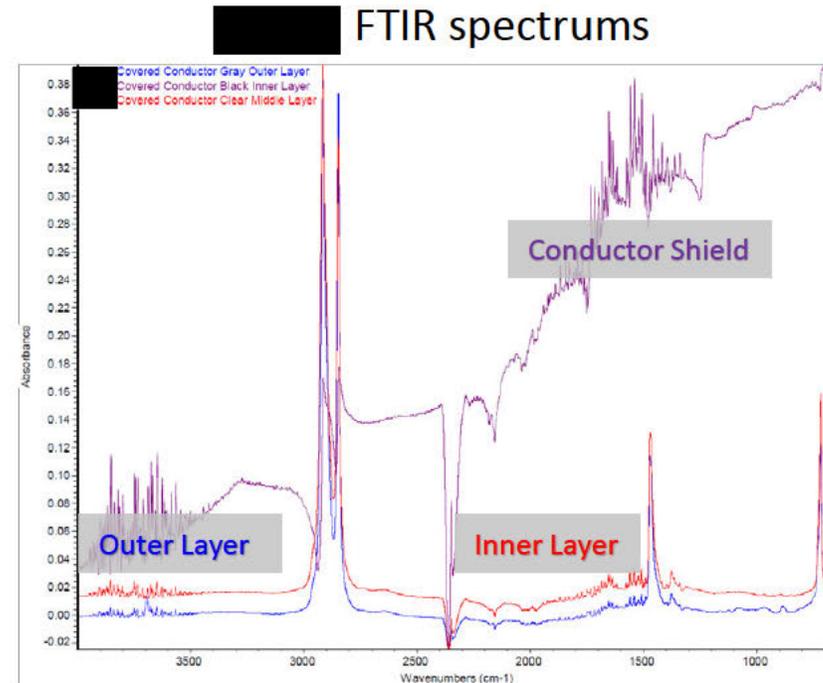
4. Layer Identification (Not Required per ANSI/ICEA S-121-733)

- Intent of test: Characterize and baseline layer materials
- Test setup: The cable sections were dissected, and each polymer layer was tested with Fourier-transform infrared spectroscopy (FTIR)

and inner and outer layers exhibit characteristics of XLPE. Each shield layer was more complex and could not be determined.

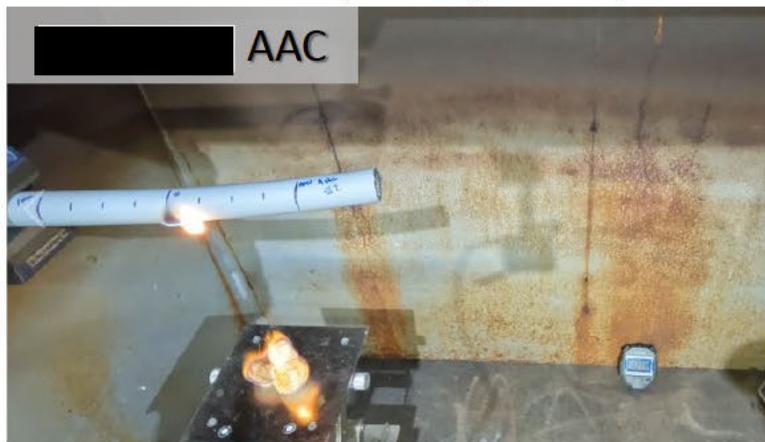
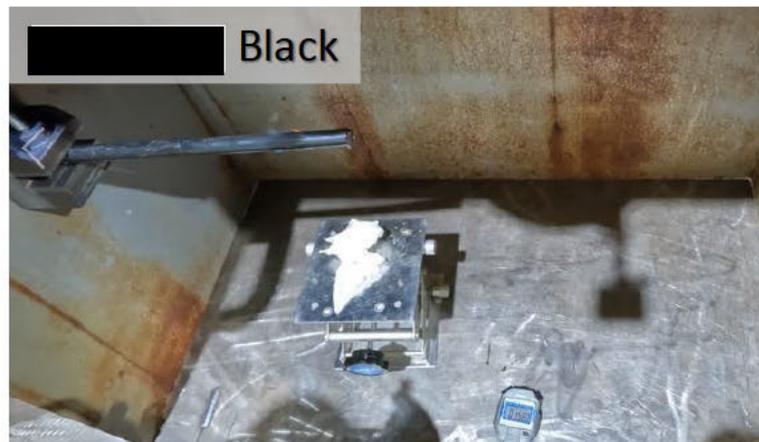
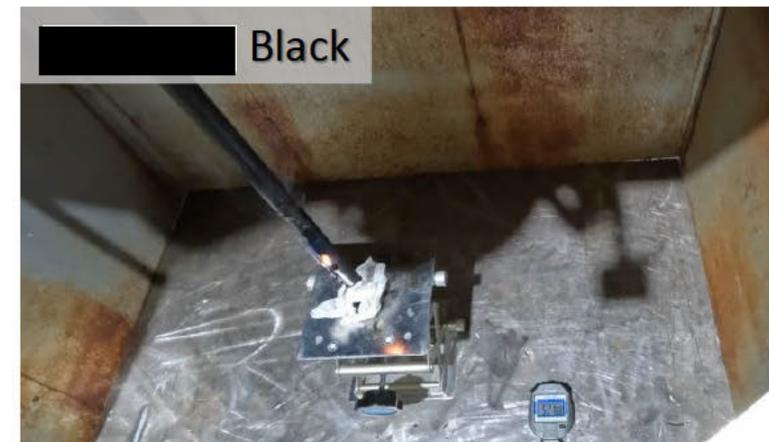
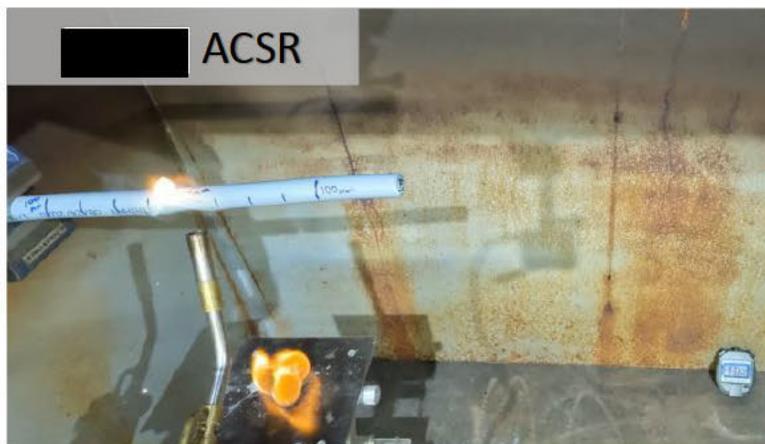
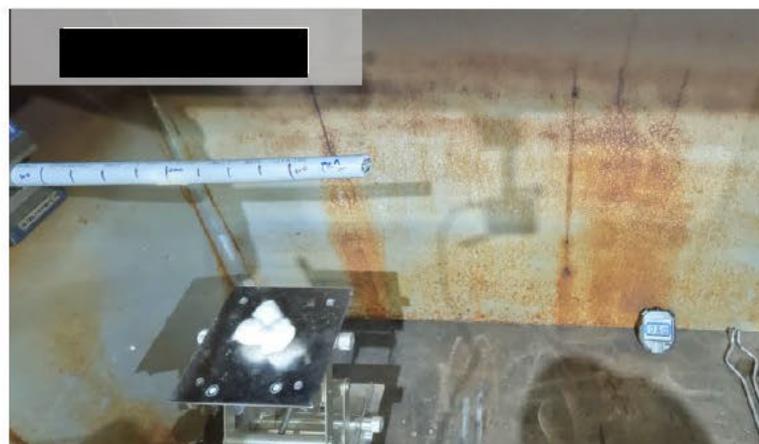
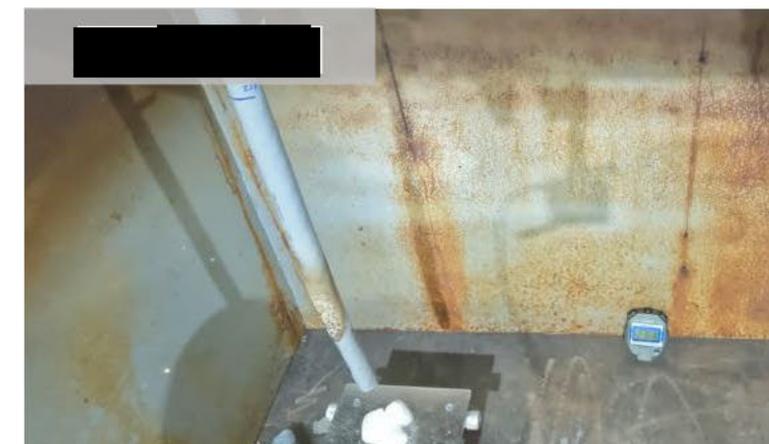
7. Flammability Test (cont'd)

Black and Black covered conductors may be susceptible to catching on fire from fault(s) and/or lightning. The resulting droplets could catch vegetation on fire.

- ATS recommends performing additional heat shrinkage testing with full span length
- Flammability Testing
 - The tested covered conductors showed that the cable insulation had no flame resistance and was dripping molten materials after ignition.

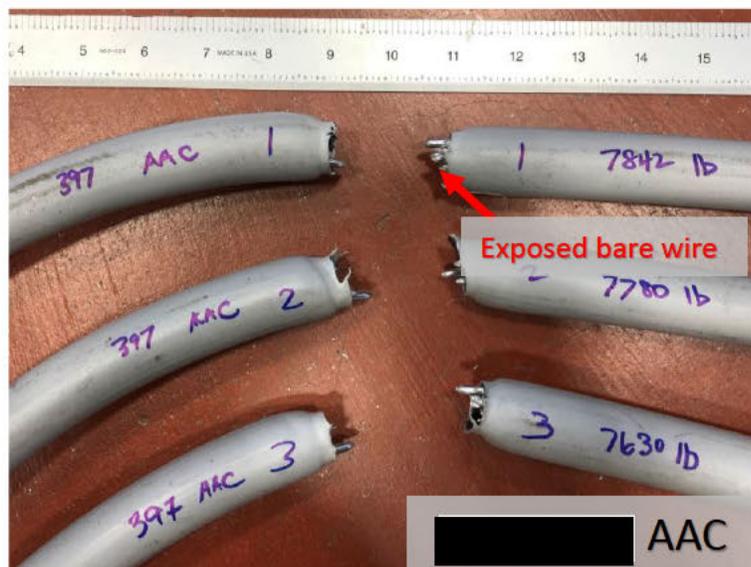
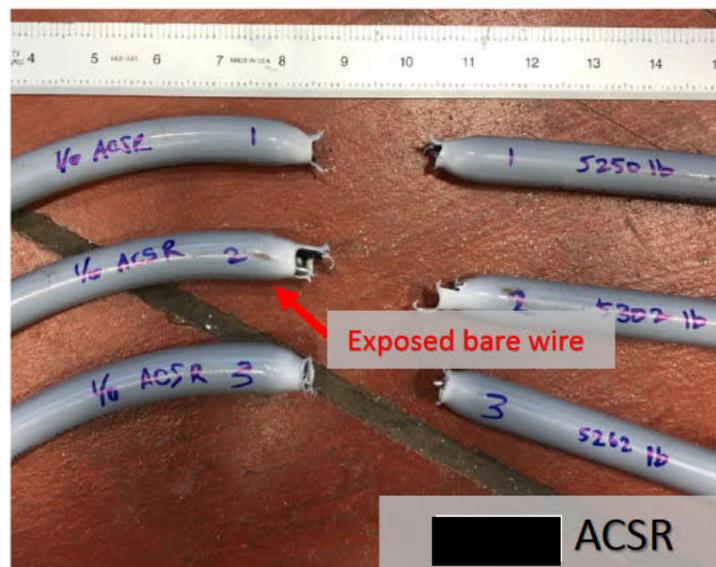
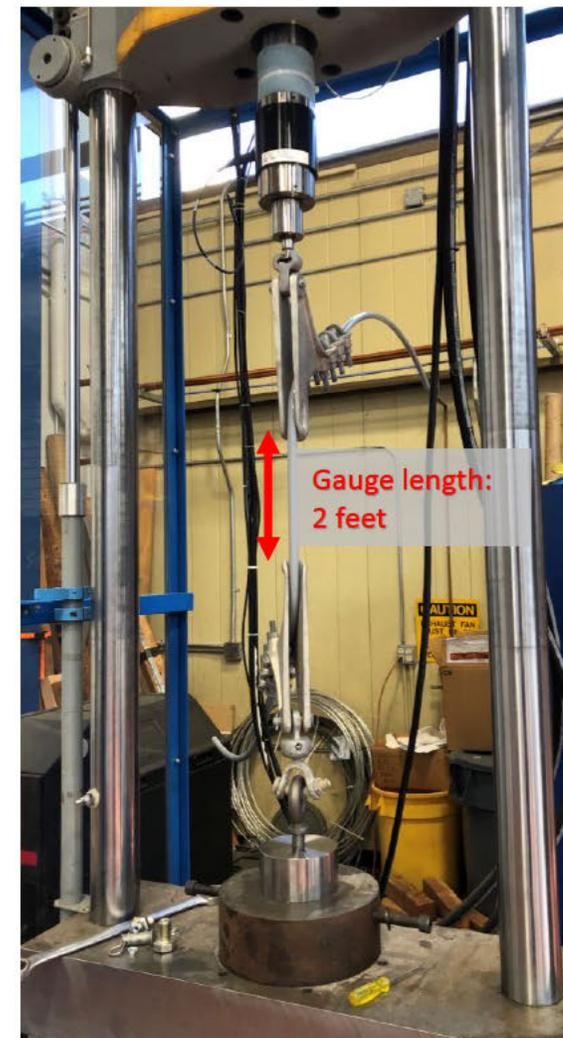
8. Tensile Strength (Required per ANSI/ICEA S-121-733)

- Intent of test: Confirm conductors meet rating and characterize fractures
- Test guideline: Test RBS per ASTM B231 & ASTM B232

Both ██████████ and ██████████ samples met the required RBS. Fractures are susceptible to exposing metallic conductor.

- Tensile Overload Testing
 - The tested covered conductors showed bare aluminum strands exposed after tensile overload testing.
 - The covered conductors pose the hazard of arcing during a wire-down event.

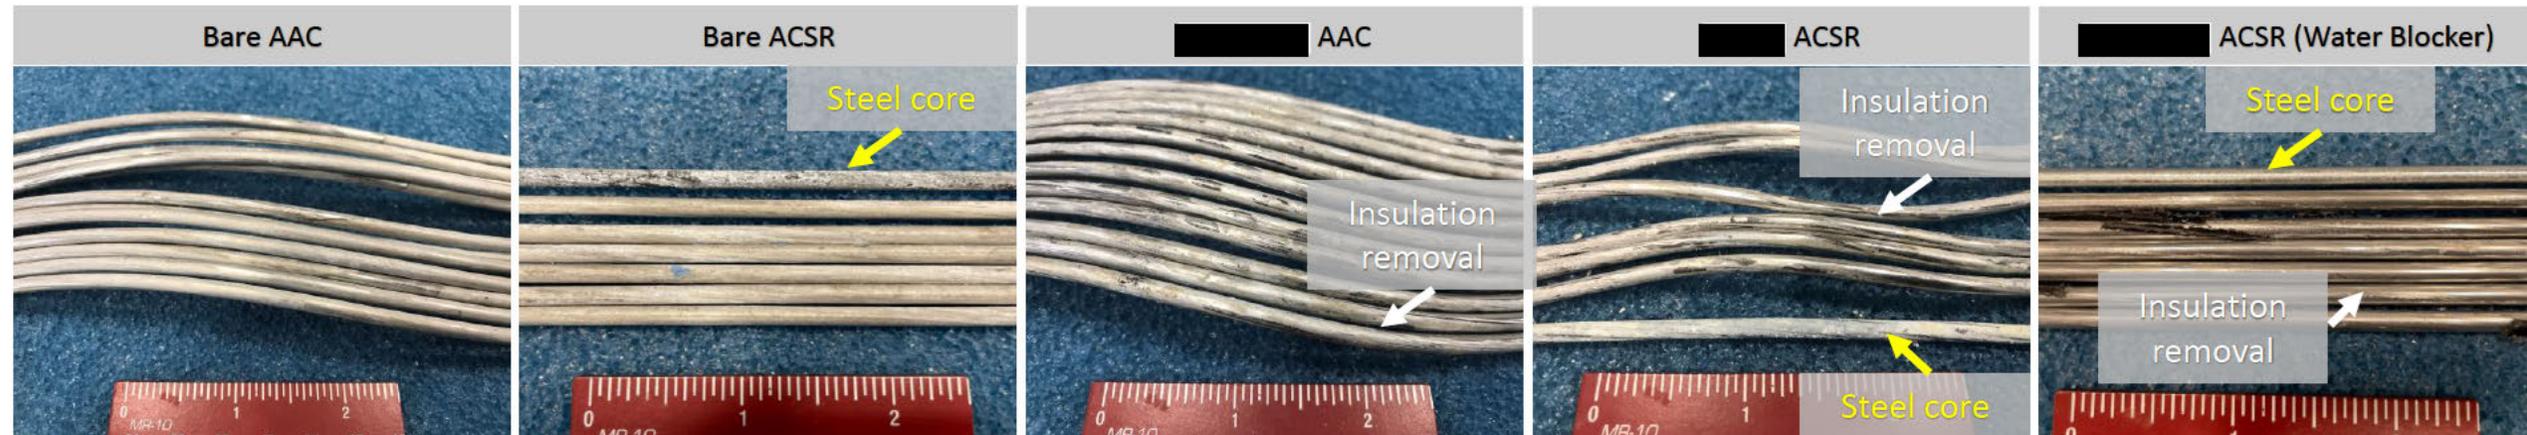
9. Atmospheric Corrosion Test (cont'd)

- Visual Results after 1000 hours (insulation removed)
 - Aluminum strands had more corrosion in covered conductors relative to bare
 - Steel strands had significant white rust present; had not progress to red rust
 - Water blocker inhibited moisture ingress

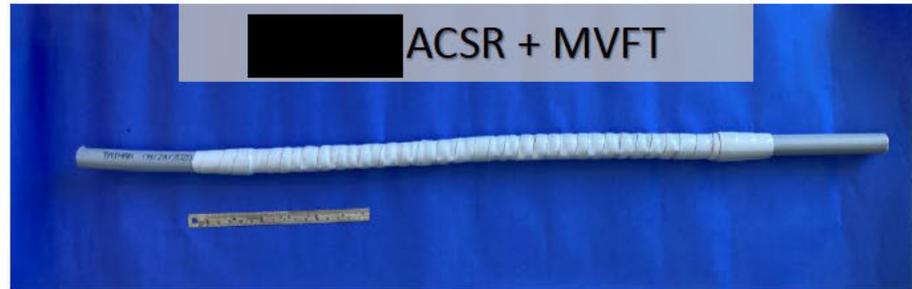
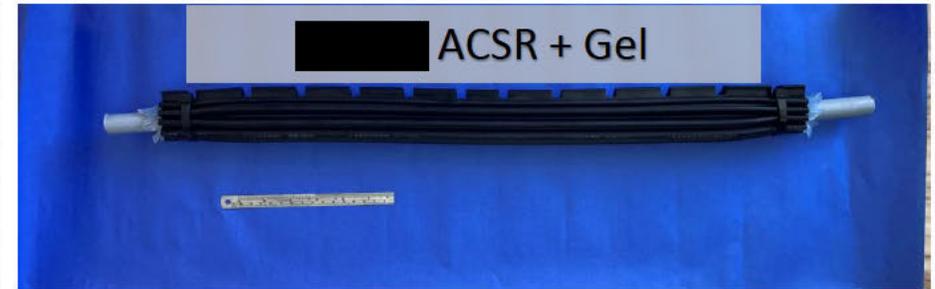
Splice cover removed
after 1000 hrs

- Splice Results: Gel splice wraps performed better at inhibiting moisture ingress

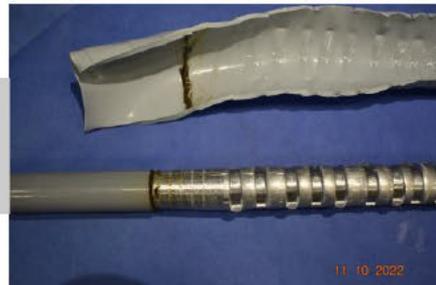
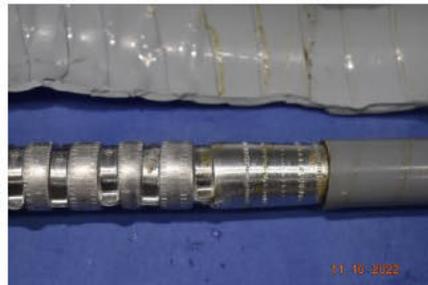
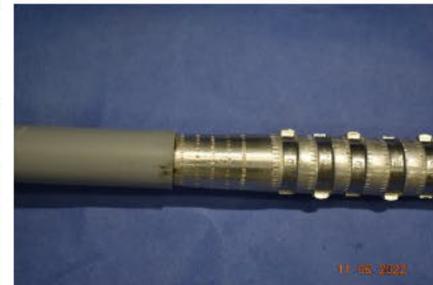
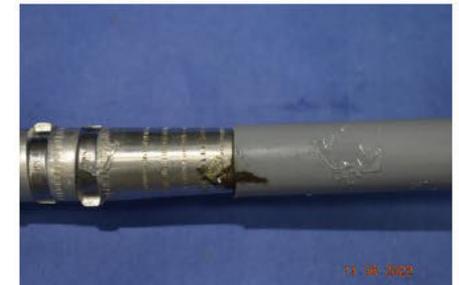
Ends at increased
magnification

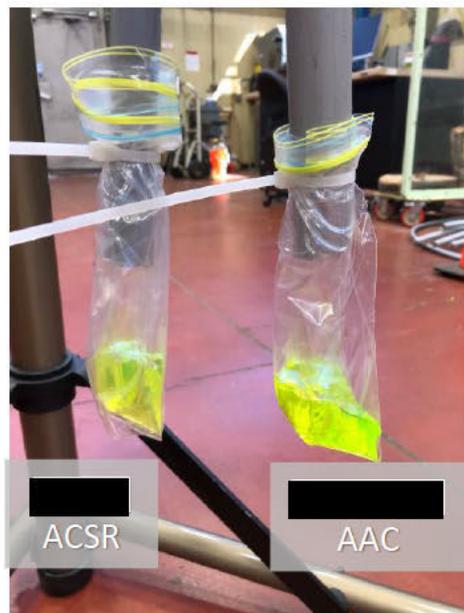
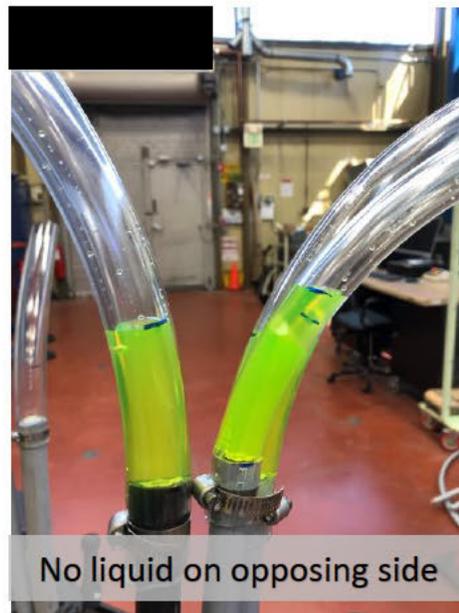
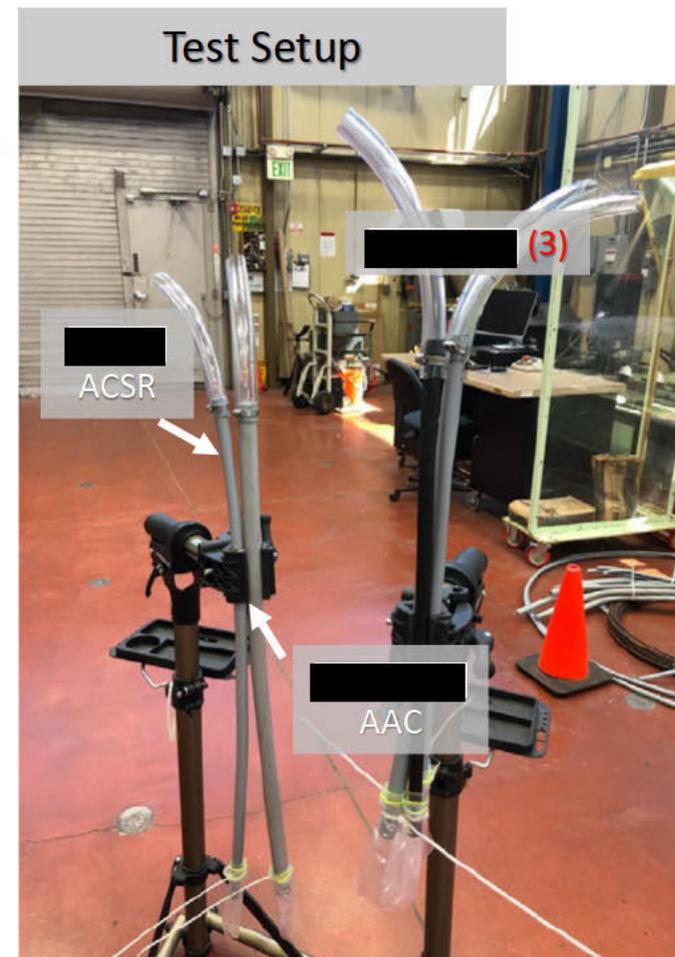
10. Water Ingress Test (Not Required per ANSI/ICEA S-121-733)

- Intent of test: Understand the role of water blocking
- Test guideline: ANSI/ICEA T-31-610-2018 Section 4.
 - Fluorescent water was introduced to the end of a vertically mounted 36in length covered and assess penetration after 2 hours.
 - Sample tested: [REDACTED] (No Water Blocking), [REDACTED] (No Water Blocking), and [REDACTED] (Water Blocked).
- Results:

Water blocking agents can prevent moisture ingress in covered conductors, otherwise, moisture travels unimpeded accelerating internal corrosion.

- Corrosion and Water Ingress Testing
 - The tested covered conductors which had no water-blocking technology are more vulnerable to corrosion.
 - ATS recommends assessing the covered conductors with water-blocking technology (for example ██████████ or ACSR-covered conductors with better galvanized layers).

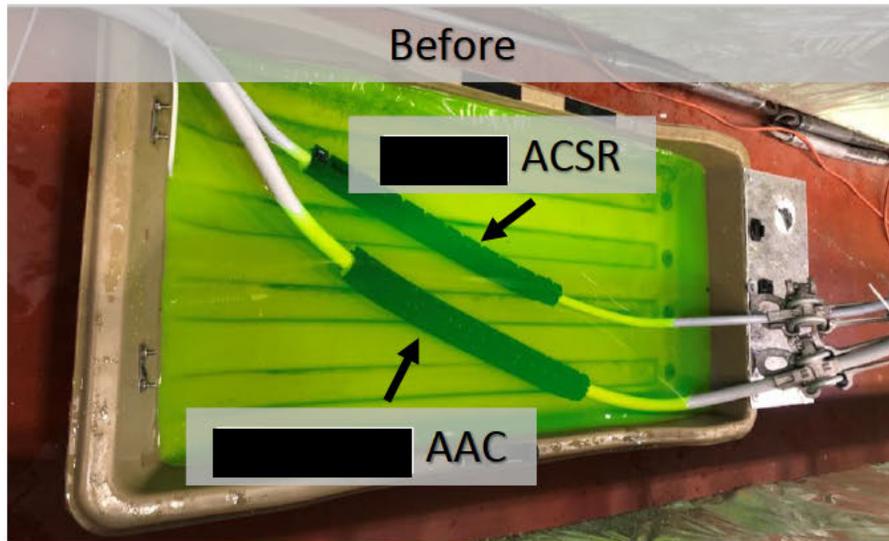
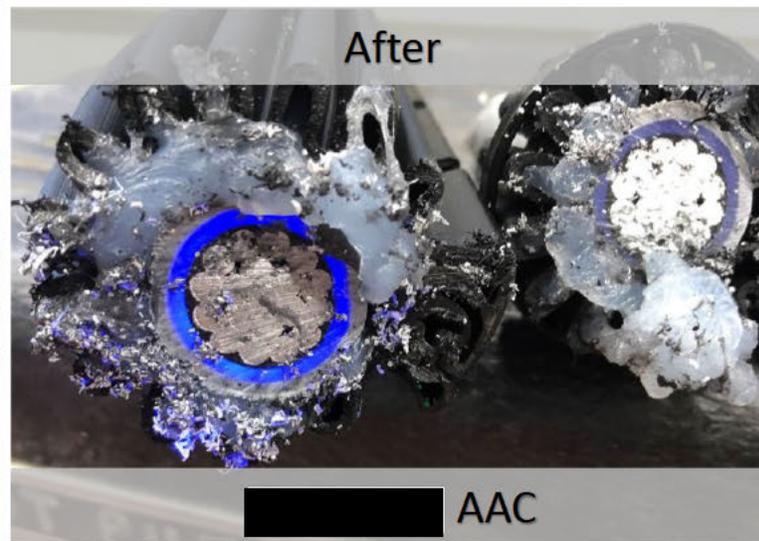
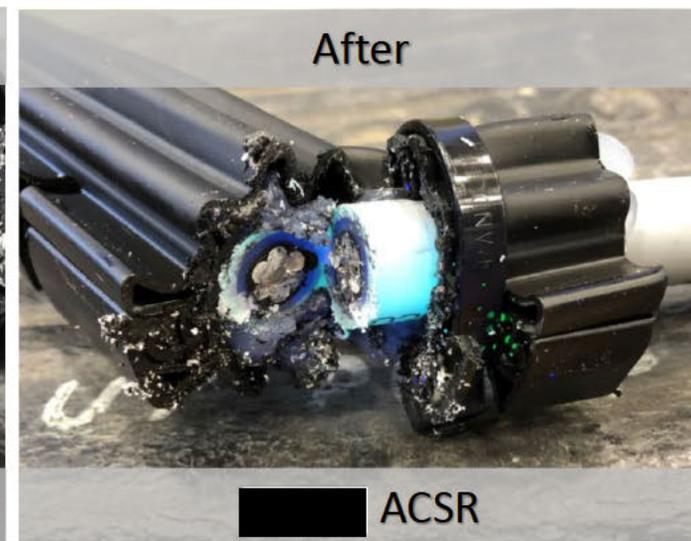
11. Water Immersion Test

- Intent of test: Evaluate effectiveness of splice gel wraps
- Test setup (No relevant standard): Covered conductors with gel wraps fully submerged in fluorescent water for 2.5 hours. Then dissected and inspected with UV light for water intrusion
- Results: Both samples did not exhibit any signs of water intrusion.

█ and █ splice gel wraps effective at inhibiting external water intrusion to splice.

- Immersion Testing
 - Gel wraps on splices provide sufficient protection to prevent water ingress during the immersion test.
- UV weathering Testing
 - The tested covered conductors show significant degradation in mechanical properties after UV exposure. The covered conductors' insulation materials became more brittle and had reduced toughness after the UV weathering test.

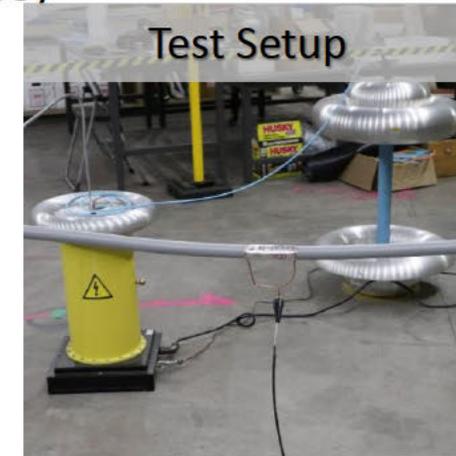
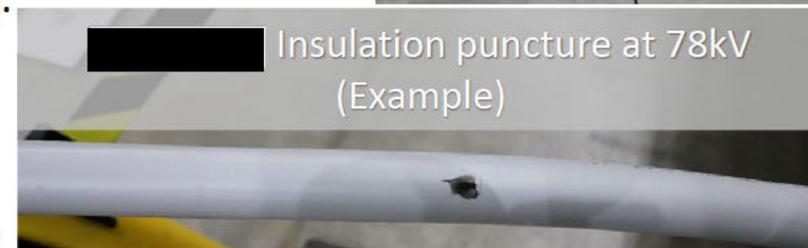
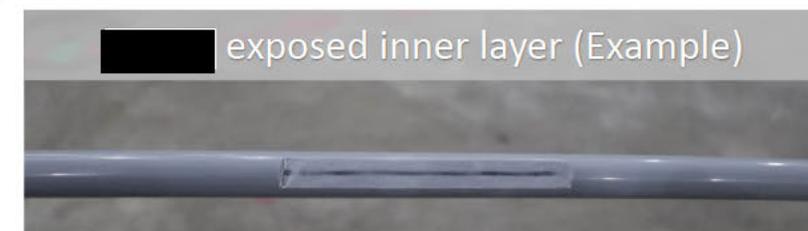
13. Leakage Current and Dielectric Withstand Test (Not Required per ANSI/ICEA S-121-733)

- Intent of test: Understand replacement strategy for compromised jacket
- Test guideline: European Standard EN 50397-1:2020
- Test setup: Test at full insulation and 50% abraded insulation
- Requirements: Leakage current not to exceed 1mA at rated voltage.
- Results: All components tested exceeded the electrical specified dielectric rating.
 - [REDACTED] 15kV rated 397 AAC covered conductor
 - Insulation failed at 78kV. This calculates to 520% of the insulation rating.
 - For the 50% abraded insulation, the insulation failed at 68kV. This calculates to 453% of the insulation rating.
 - [REDACTED] 15kV rated 1/0 ACSR covered conductor
 - Insulation failed at 90kV. This calculates to 600% of the insulation rating.
 - For the 50% abraded insulation, the insulation failed at 40kV. This calculates to 266% of the insulation rating.

Both [REDACTED] and [REDACTED] covered conductors are expected to meet leakage current per European Standard EN 50397-1:2020, and maintain a 2X insulation rating even with compromised outer layer exposing inner layer.

- Damaged/Abraded Insulation Testing
 - Both conductors expected to meet leakage current per European Standard EN 50397-1:2020 and maintain a 2X insulation rating even with compromised outer layer exposing inner layer.

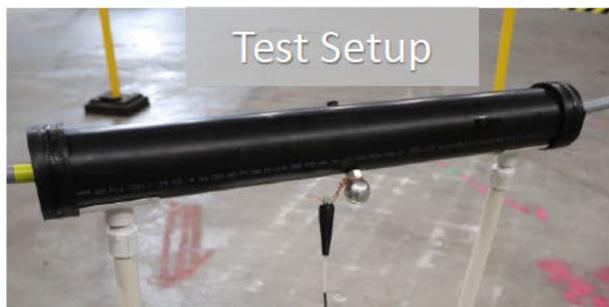
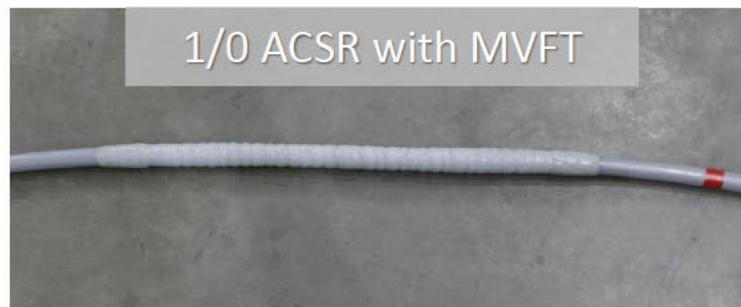
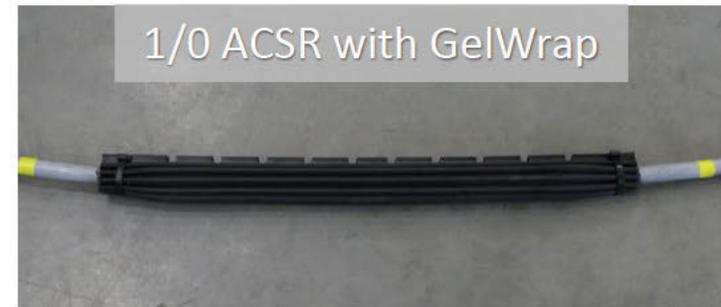
13. Leakage Current and Dielectric Withstand Test (Not Required per ANSI/ICEA S-121-733)

- Intent of test: Understand electrical insulating properties of splice coverings
- Test setup: Splice covering placed in 4" PVC conduit embedded in No 8 steel shot which served as the measuring electrode. Voltage applied to conductor and the return lead connected to the measuring electrode. Leakage current measured as voltage ramped up until dielectric breakdown.
- Results:
 - Compression splice with Gel Wrap: Withstood a minimum of 23kV between the splice and the outer electrode.
 - Compression splice with MVFT: Withstood a minimum of 19kV between the splice and the outer electrode.
 - Fired Wedge connector with cover: Withstood a minimum of 19kV between the wedge connector the electrode.

The splice covering maintains or exceeds the rating of the covered conductor insulation rating.

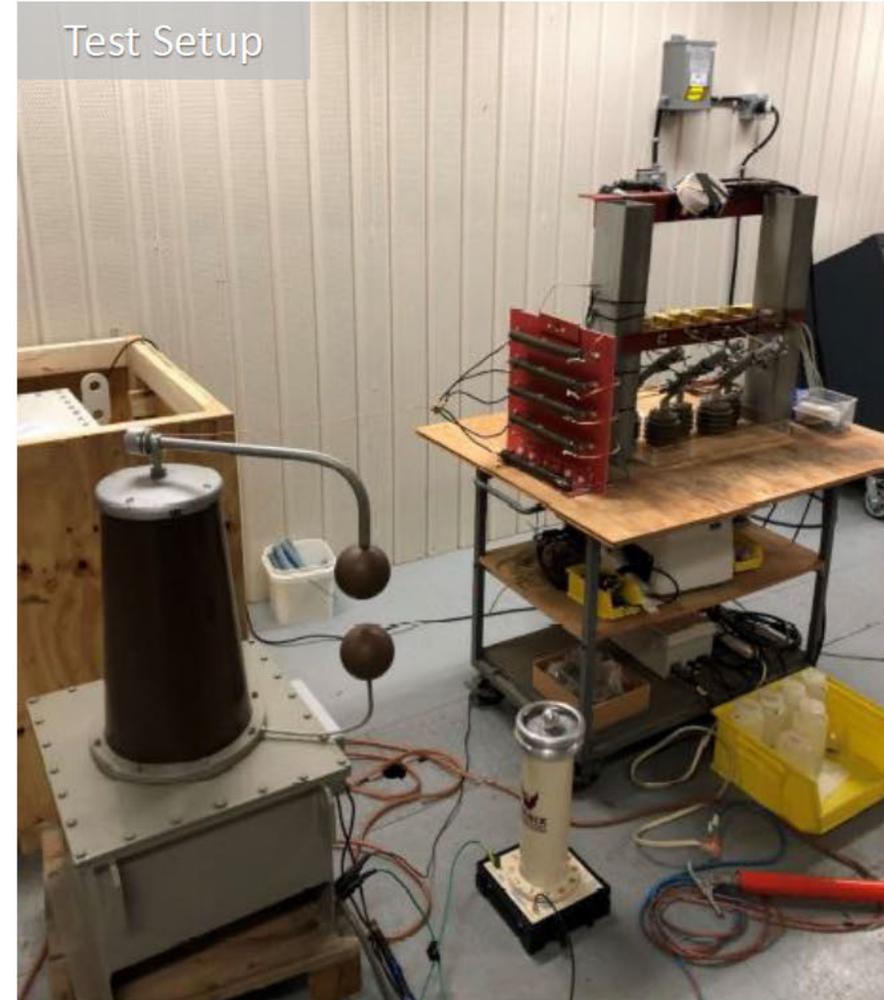
- XXXXXXXXXX conductor after the test:

- Intent of test: Better understand susceptibility to tracking damage
- Test guideline: EN 50397-1:2020, Annex B.
- Test setup: Test voltage: 3.5 kV, Duration of the test: 6.0 h, Series resistor: 22 k Ω , Contaminant flow rate: 0.3 mL/min
- Requirements: The test is successful if the current in the high-voltage circuit does not exceed 60 mA for any of the 5 samples for 6 hours.
- Results: Both covered conductor types passed the test.
- Erosion depth (mm):

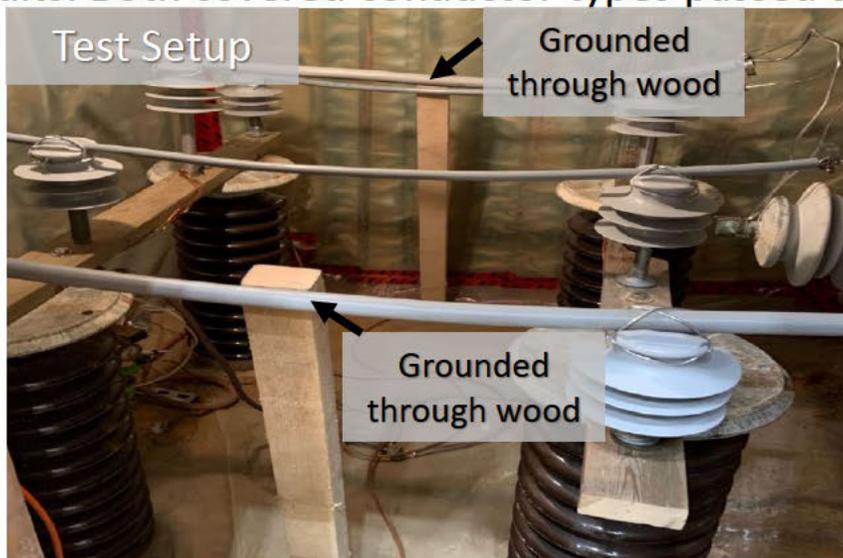
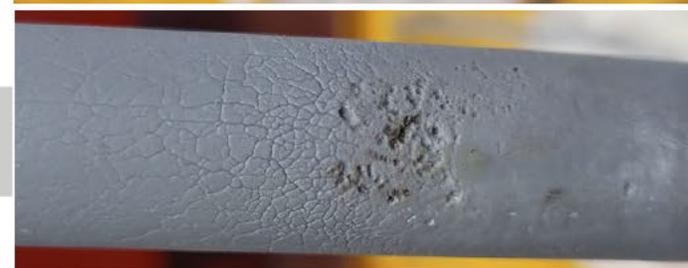
15. Tracking Resistance with Salt Fog (Not Required per ANSI/ICEA S-121-733)

- Intent of test: Understand implications of long-term vegetation contact
- Test guideline: from IEC 62217:2012, Clause 9.3.3
- Test setup: Duration of the test: 1004.5 hours, Test voltage: $12.1\text{kV}_{\text{rms}}$, Initial NaCl content of water: $8\text{kg}/\text{m}^3$, Precipitation rate: $1.75\text{ mL}/\text{hr}$
- Requirements: A sample passes the test if no tracking occurs; for composite insulators: erosion depth is less than 3 mm and does not reach the core (if applicable), and no shed, housing, or interface is punctured.
- Results: Both covered conductor types passed the test. [REDACTED] had a higher erosion depth than Taihan.

Long term vegetation contact can cause damage and/or erosion on both [REDACTED] and [REDACTED] covered conductors.

- Tracking Resistance Testing
 - Tracking could occur with phase-to-phase or phase-to-ground contact. This will degrade the cable insulation over time contributing to increased leakage current and potentially causing a fault.

- Tracking is more likely to occur at the connection points with insulators. Tracking damage could completely compromise covering equating to performance similar of bare conductor.

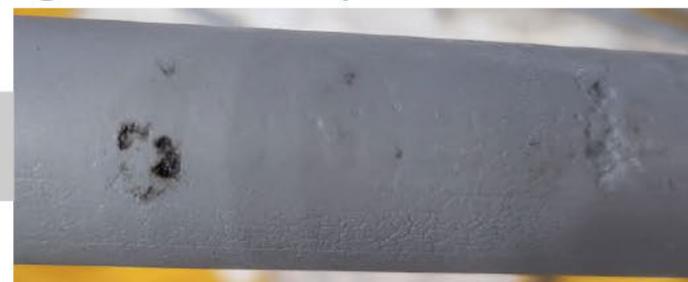
Wood Placement on [REDACTED]

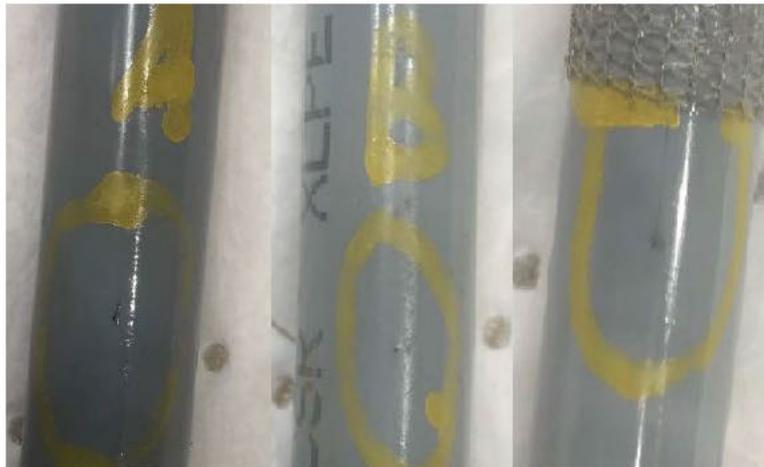
16. Lightning (Impulse Test, cont'd)

- Lightning impulse puncture locations - [redacted] conductor

- Lightning Testing
 - Both insulations could be damaged by lightning. Damaged expected to be localized and is not expected to propagate through continued auto-ignition.

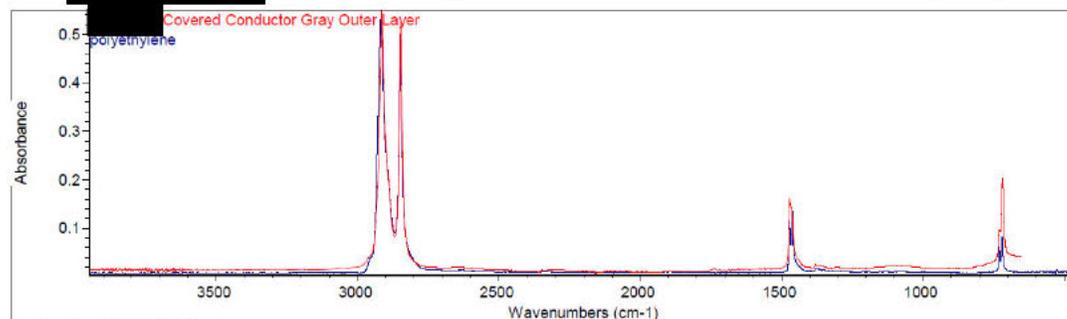
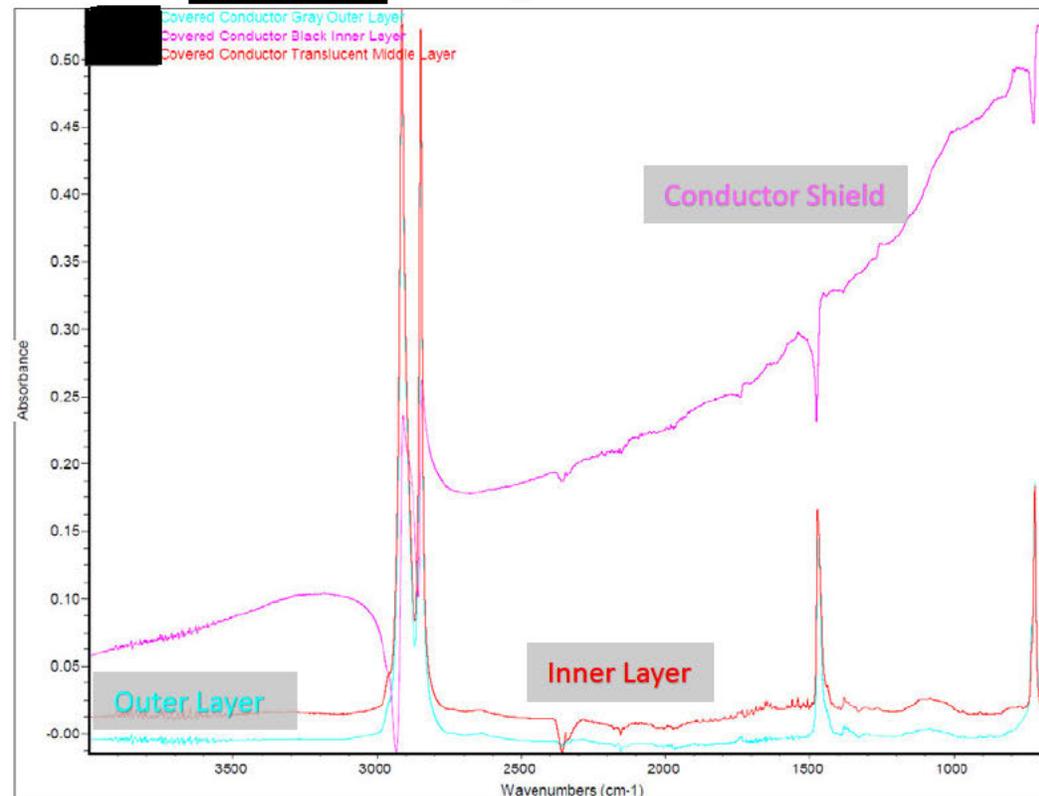
4. Fourier-transform infrared spectroscopy (FTIR)

— **Outer Layer FTIR: consistent with polyethylene**

— **FTIR spectrum raw data**

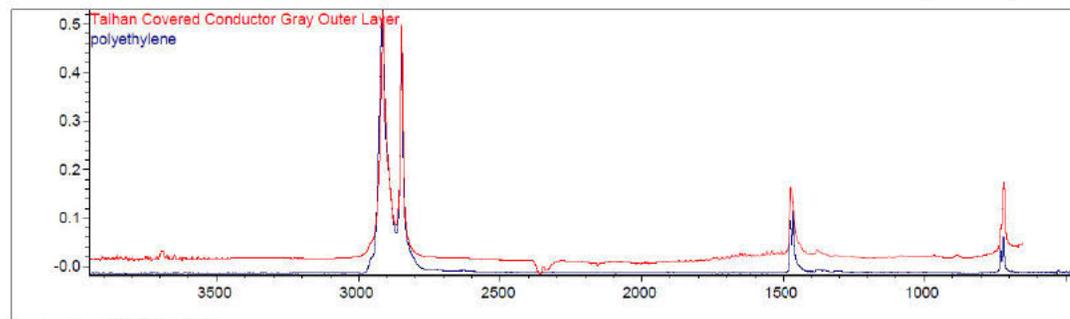
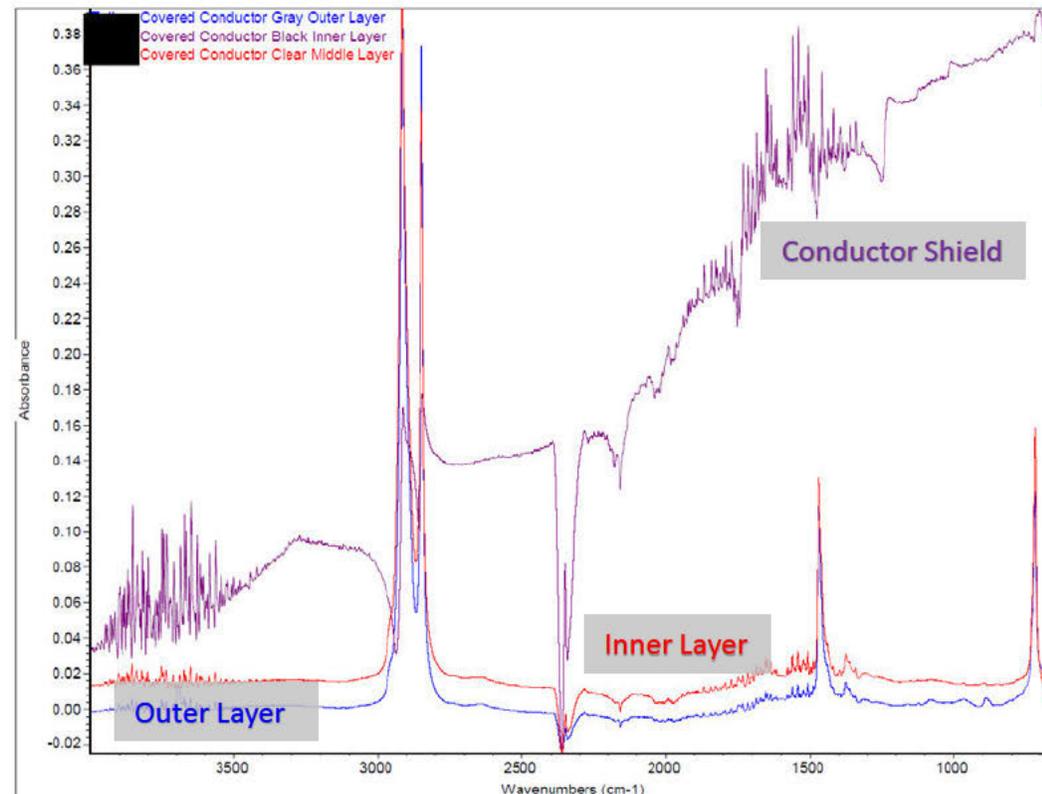
4. Fourier-transform infrared spectroscopy (FTIR)

- Outer Layer FTIR: consistent with polyethylene

- Taihan FTIR raw data

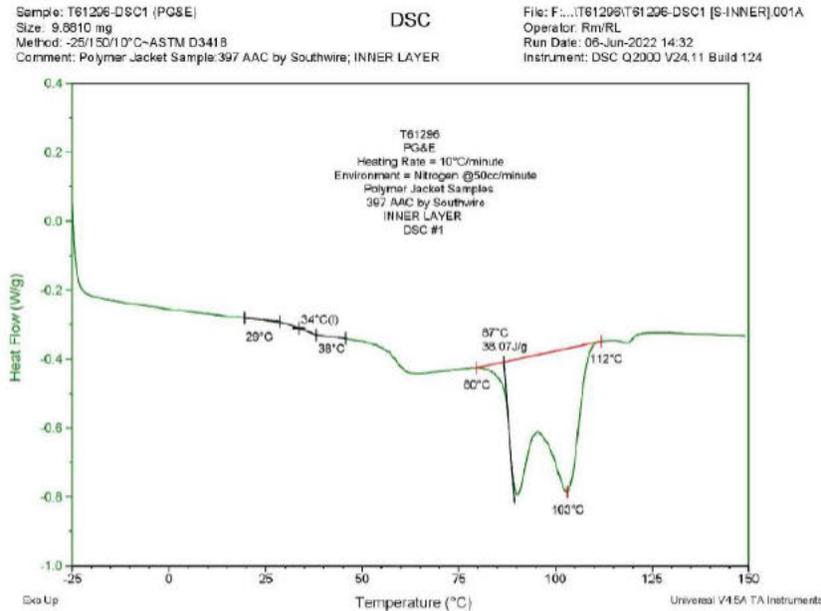
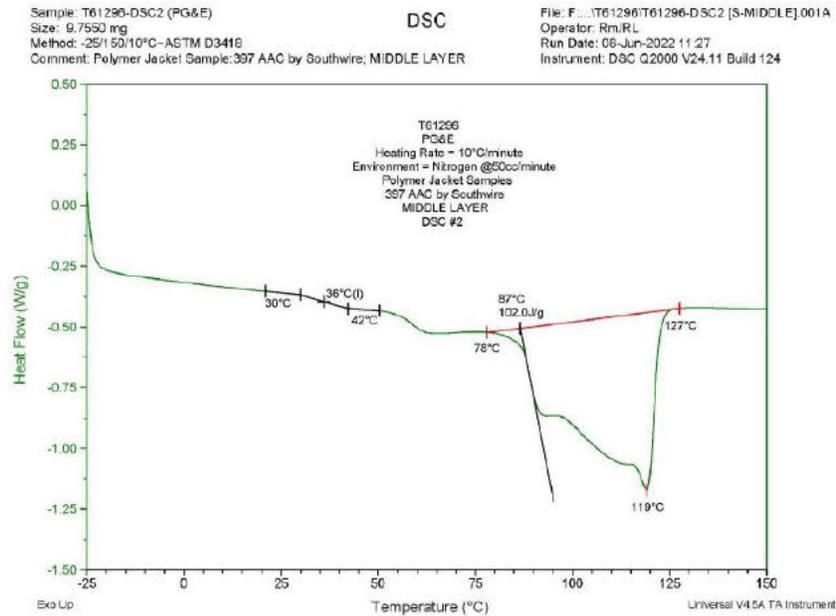
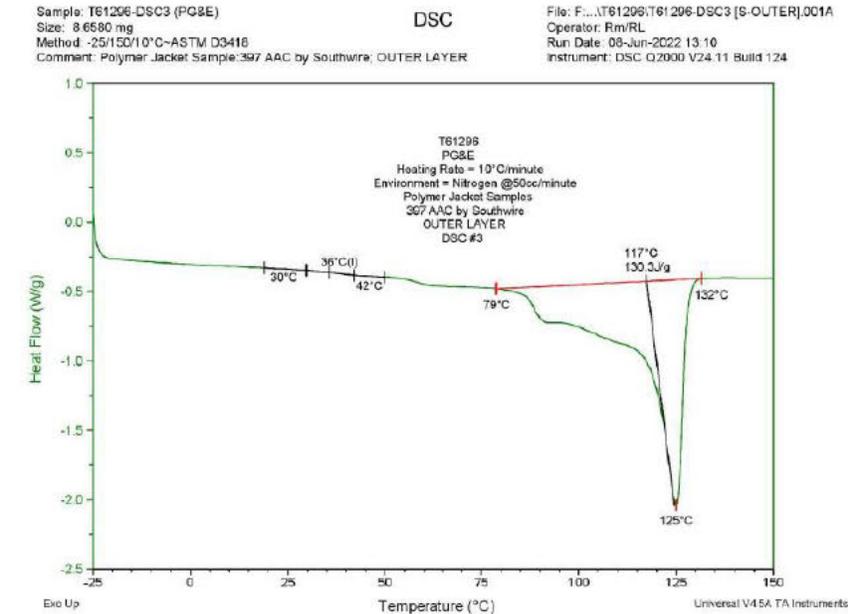
5. Thermal Properties of Layers (Not Required per ANSI/ICEA S-121-733)

- Thermal measurements were performed with Differential Scanning Calorimetry (DSC) on each layer

DSC Thermogram (DSC 1 ~ SOUTHWEST INNER LAYER)

DSC Thermogram (DSC 2 ~ SOUTHWEST MIDDLE LAYER)

DSC Thermogram (DSC 3 ~ SOUTHWEST OUTER LAYER)

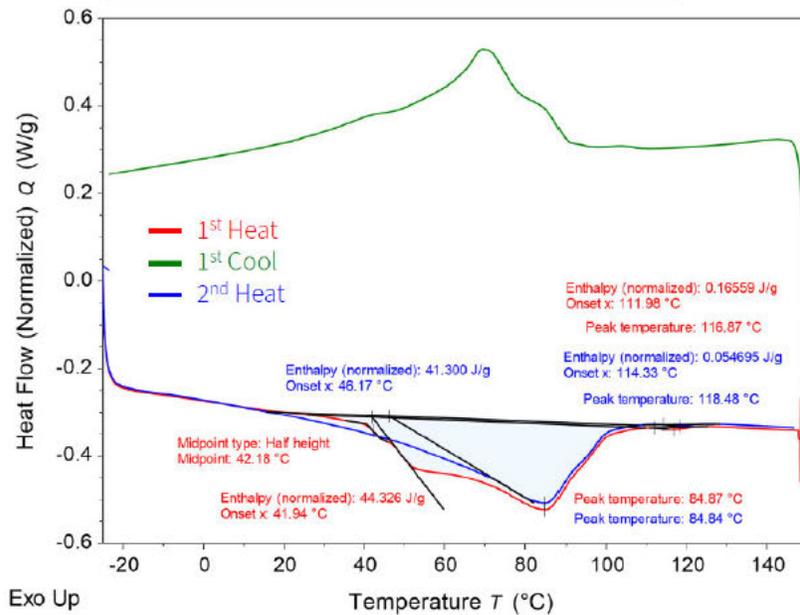
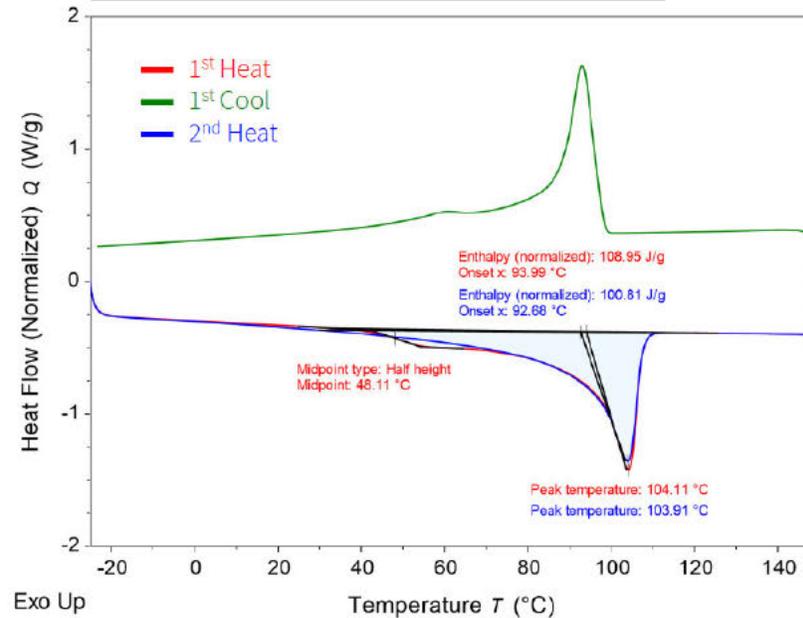
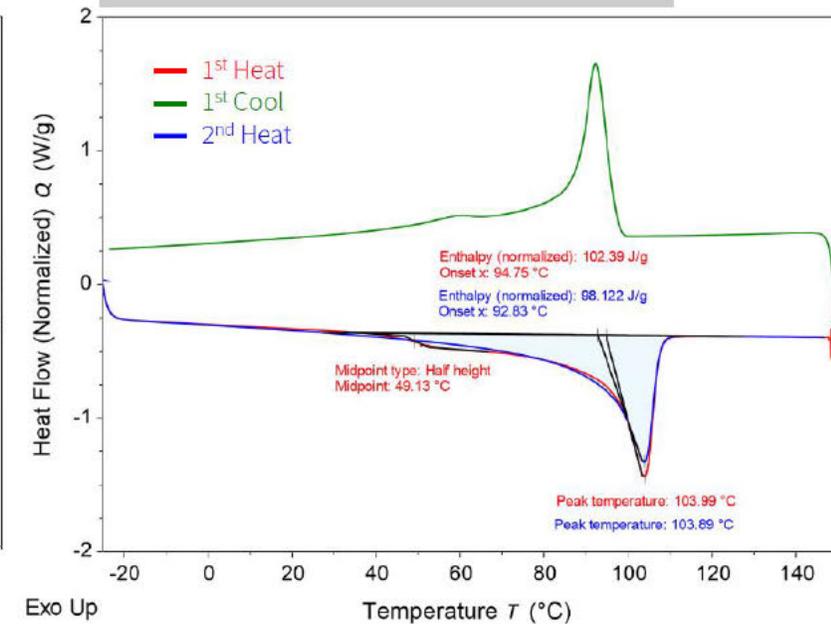
5. Thermal Properties of Layers (Not Required per ANSI/ICEA S-121-733)

- Thermal measurements were performed with Differential Scanning Calorimetry (DSC) on each layer

Taihan Inner Layer

Taihan Middle Layer

Taihan Outer Layer
