PG&E Covered Conductor Testing

Covered Conductor Effectiveness supplemental report to WMP finalized in Feb 2022

Test Results Summary

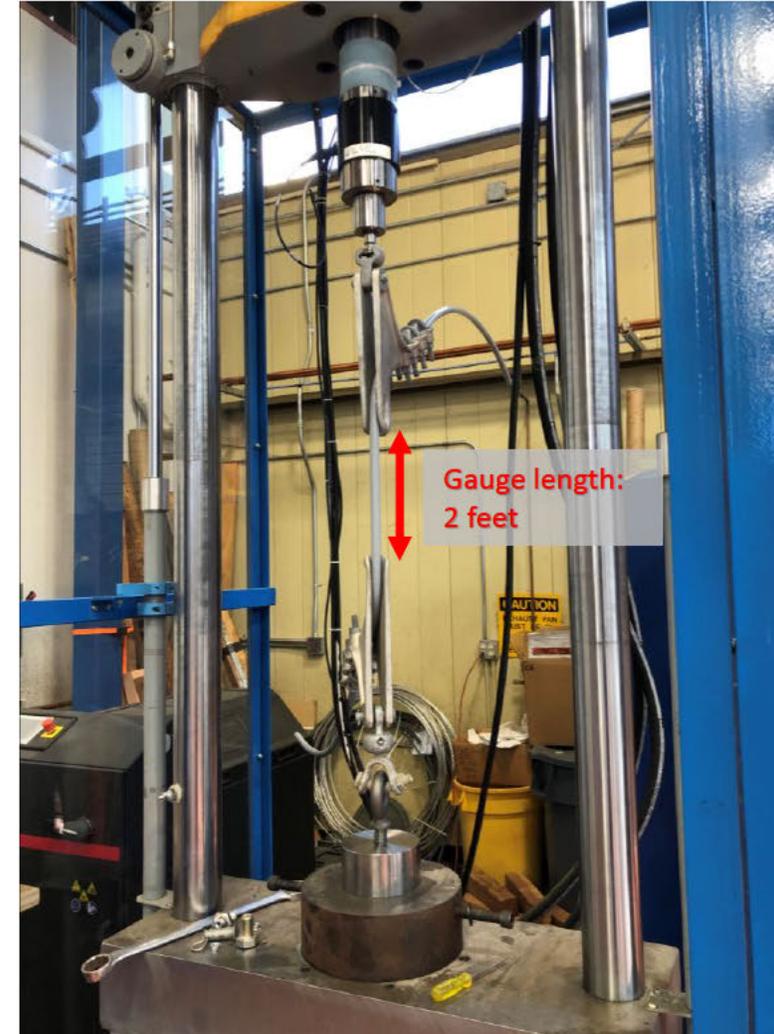
8. Tensile Test

- An MTS 50kip vertical load frame was used to apply tensile loading for all samples.
- Samples were preloaded to 1,000lbf, then manually overloaded with displacement control until complete separation of the sample.
- All samples loaded from 1,000lbf to complete separation in approximately three seconds. All samples exceeded rated breaking strength, which indicates a successful tensile test without excessive stress concentrations.

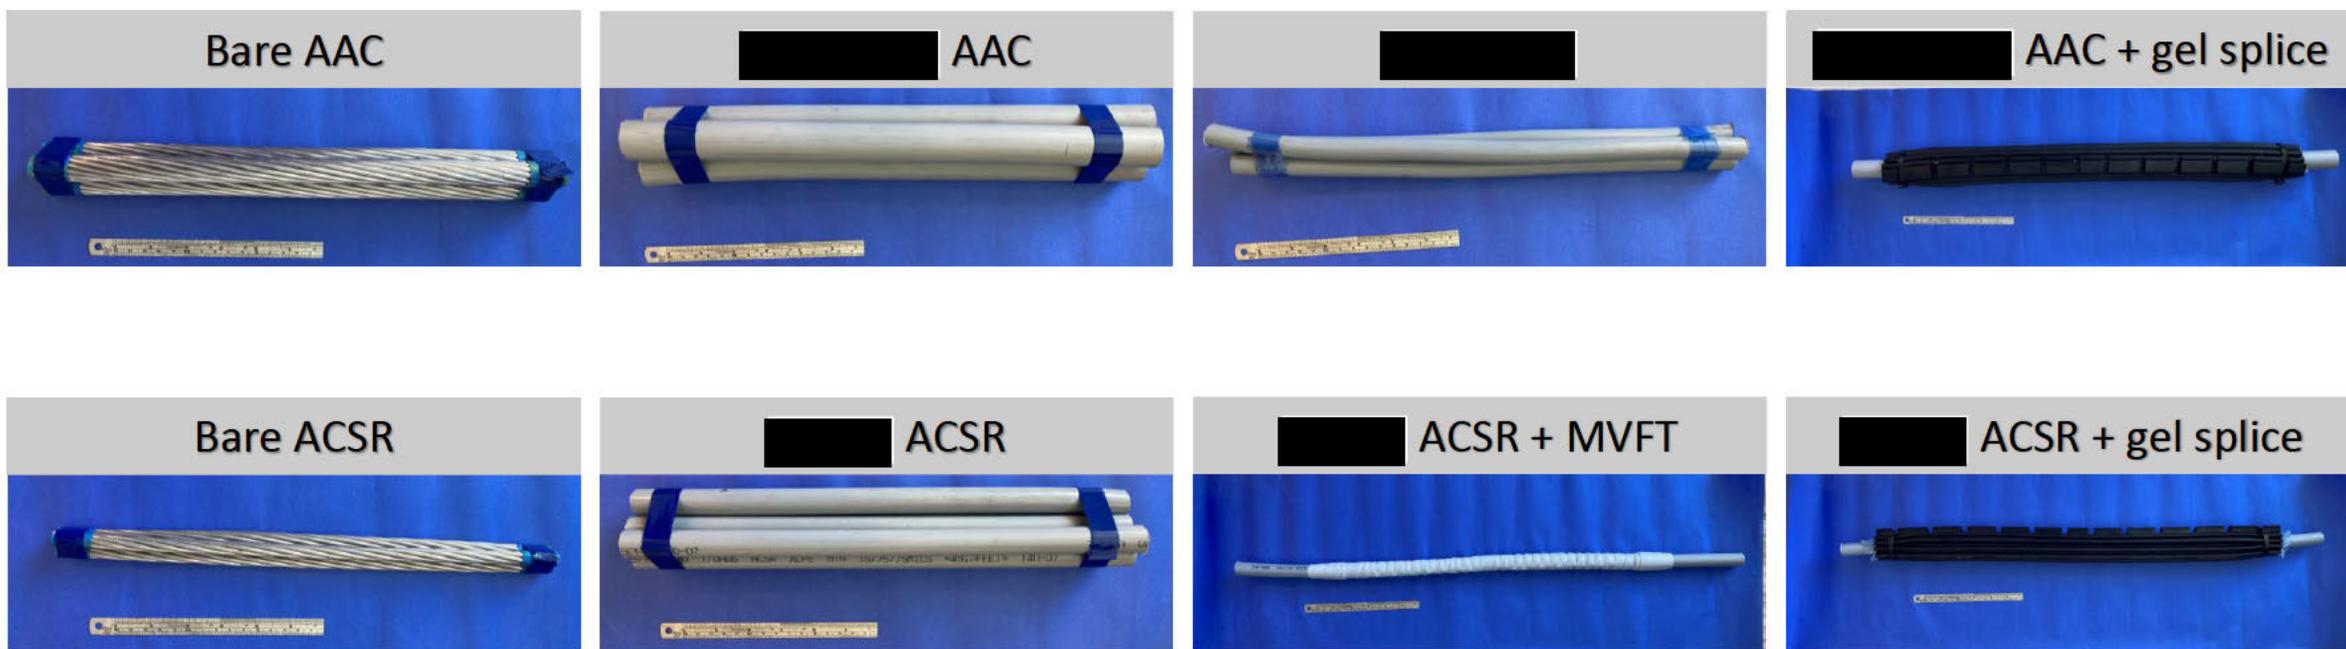
9. Accelerated Atmospheric Corrosion Test

ASTM B117: Atmospheric Corrosion for 1000 total hours of exposure at $35 \pm 2^\circ\text{C}$ chamber temperature continuous 5% neutral NaCl fog solution.

- Samples tested: Bare AAC, bare ACSR, [redacted] AAC, [redacted] ACSR, [redacted] I, [redacted] ACSR + MVFT (medium voltage fusion tape), [redacted] AAC + gel splice, [redacted] ACSR + gel splice.

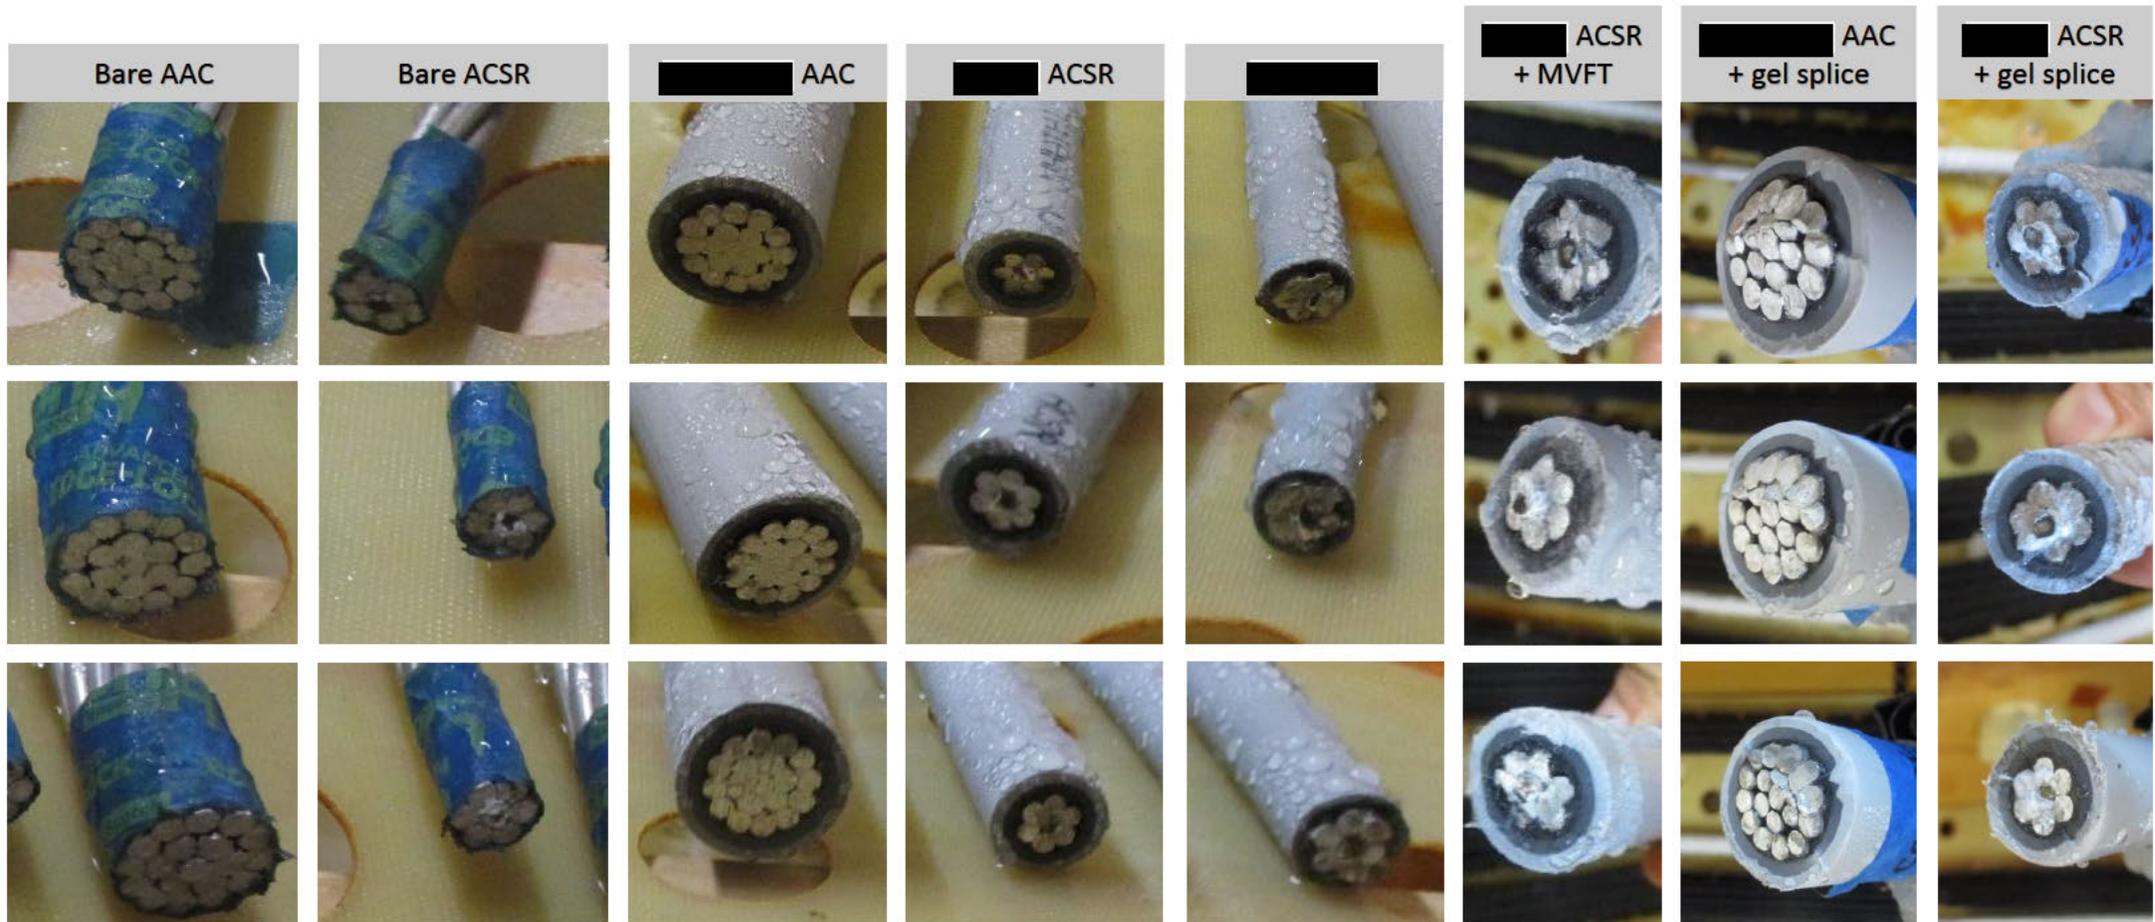
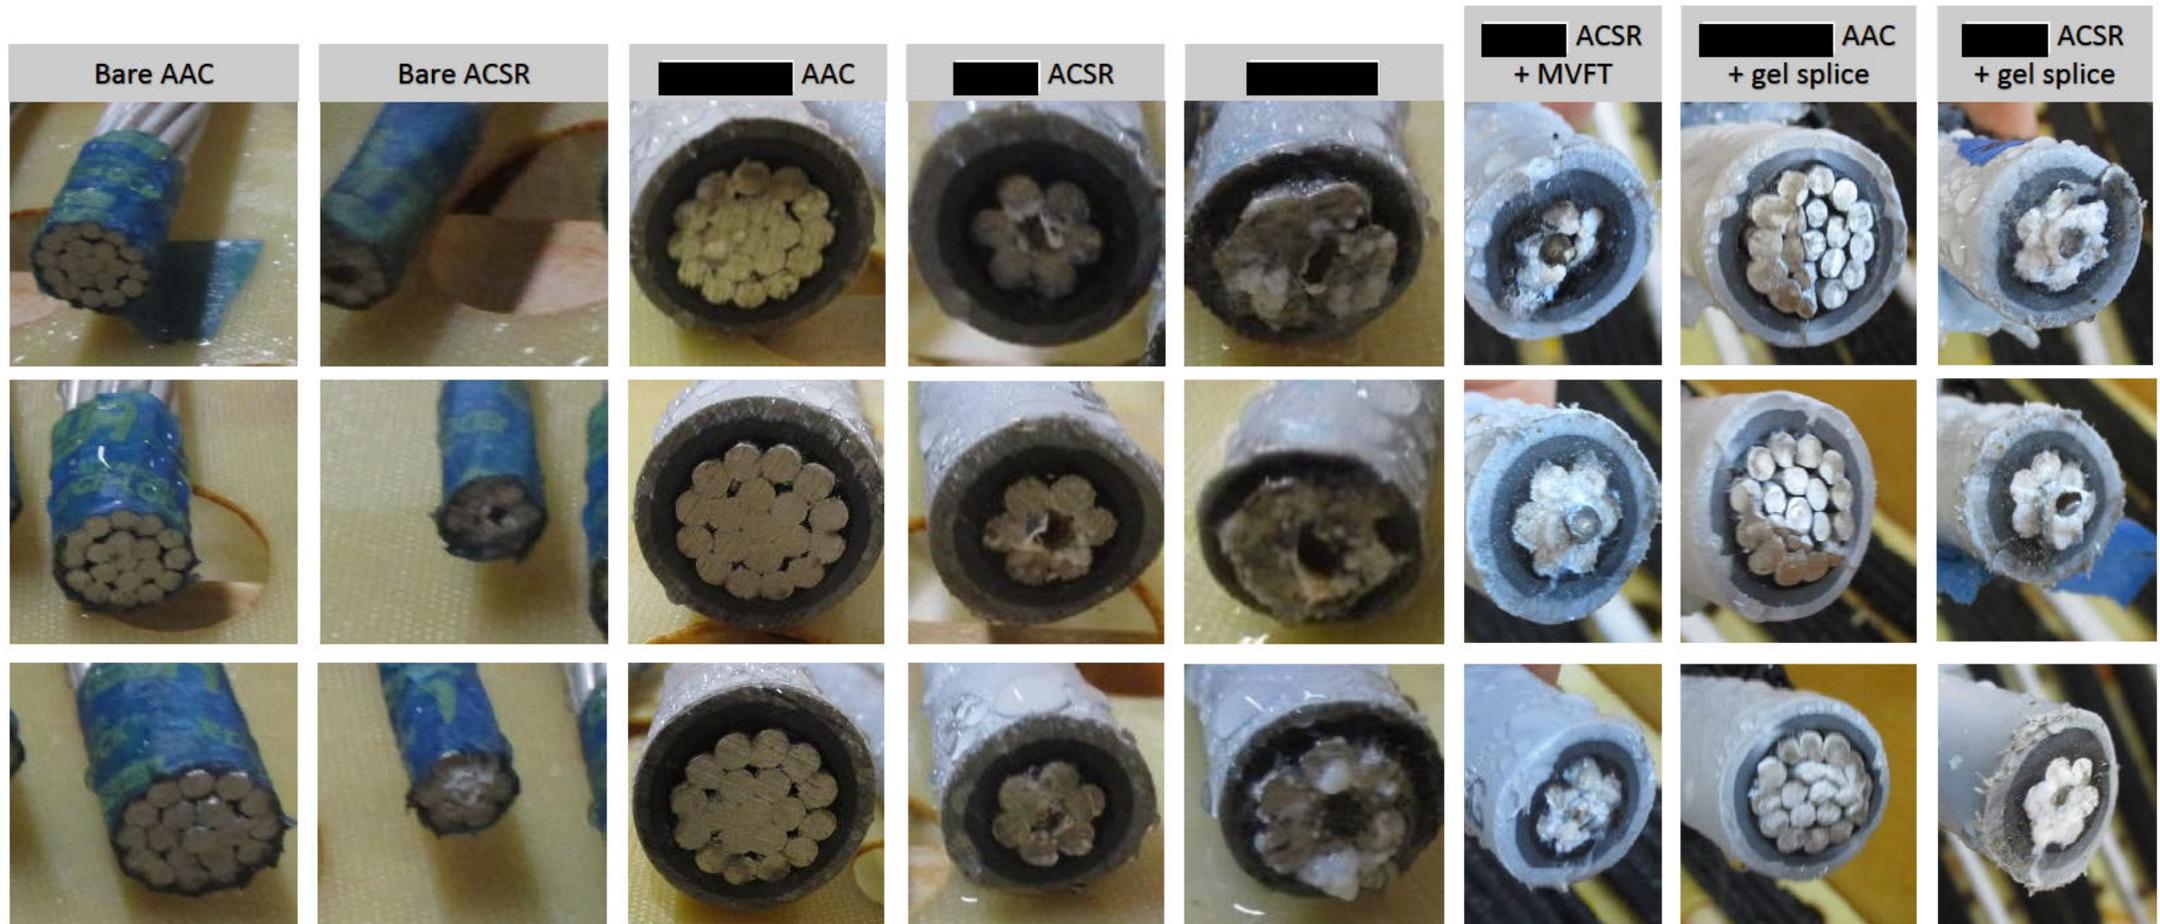
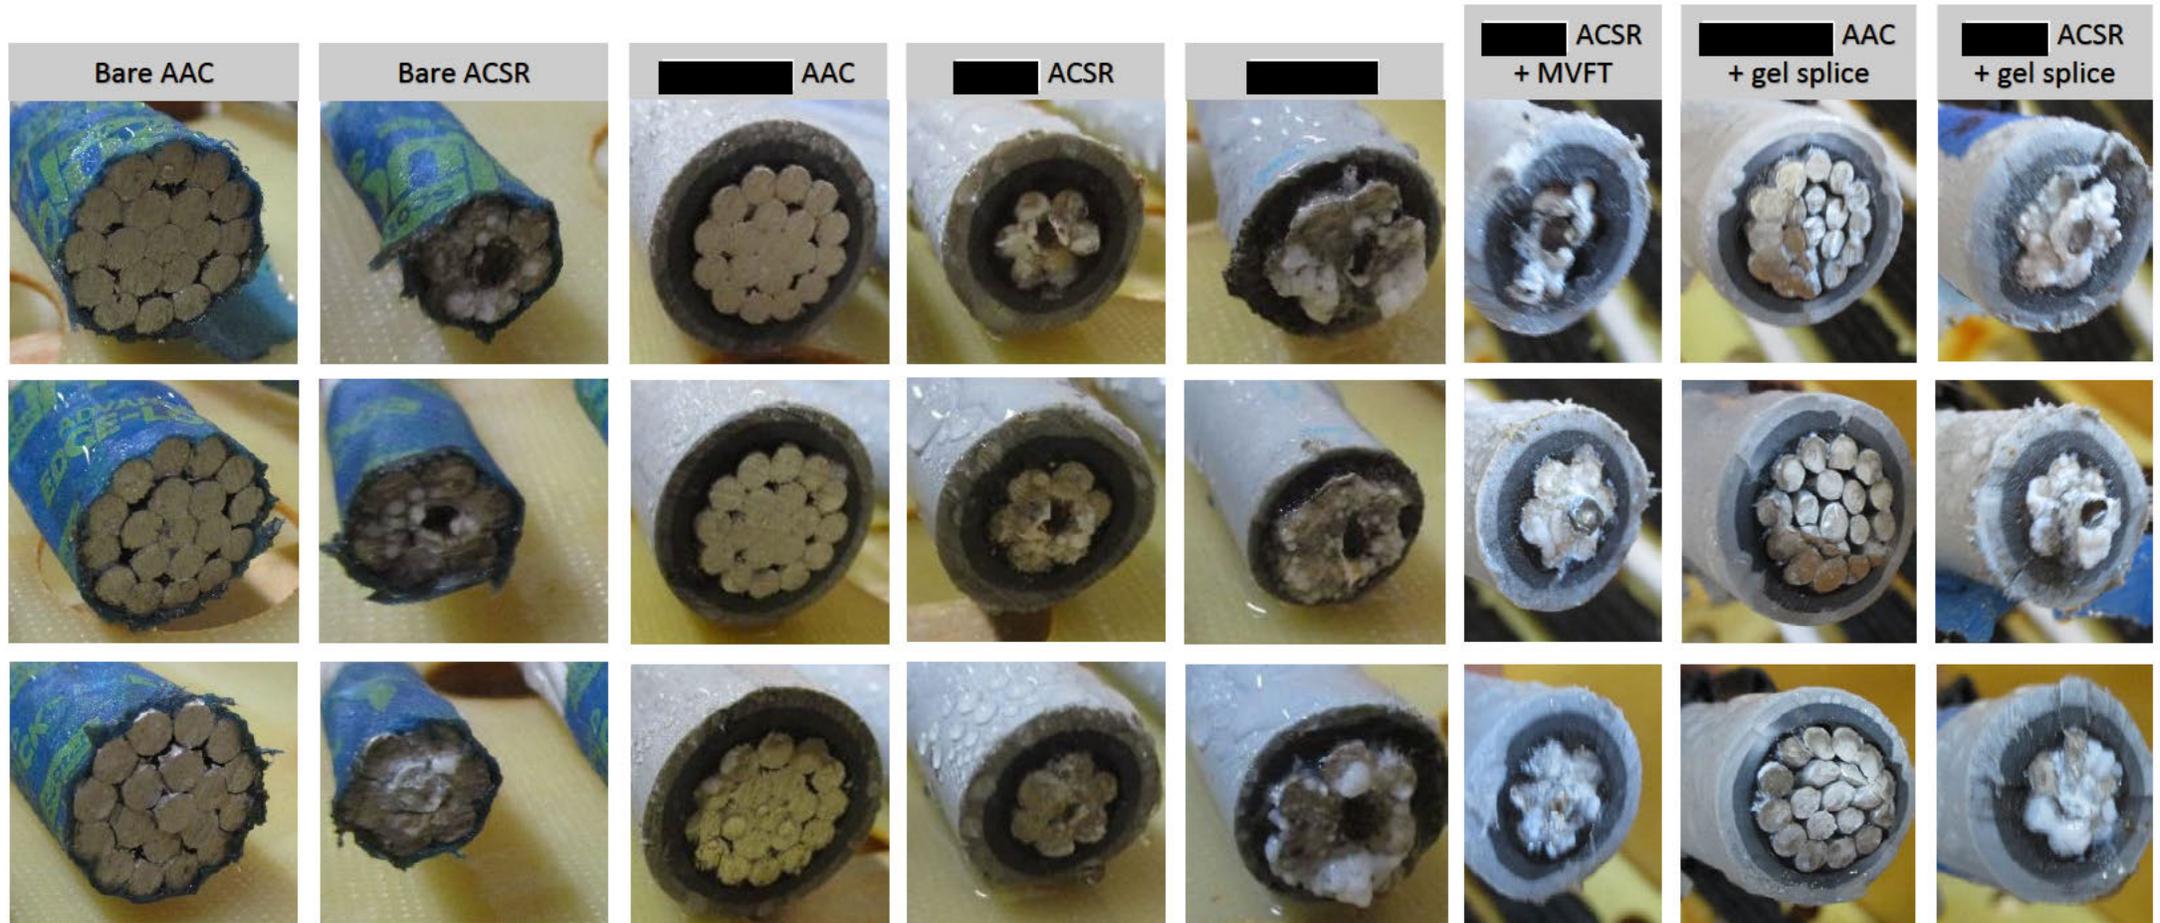
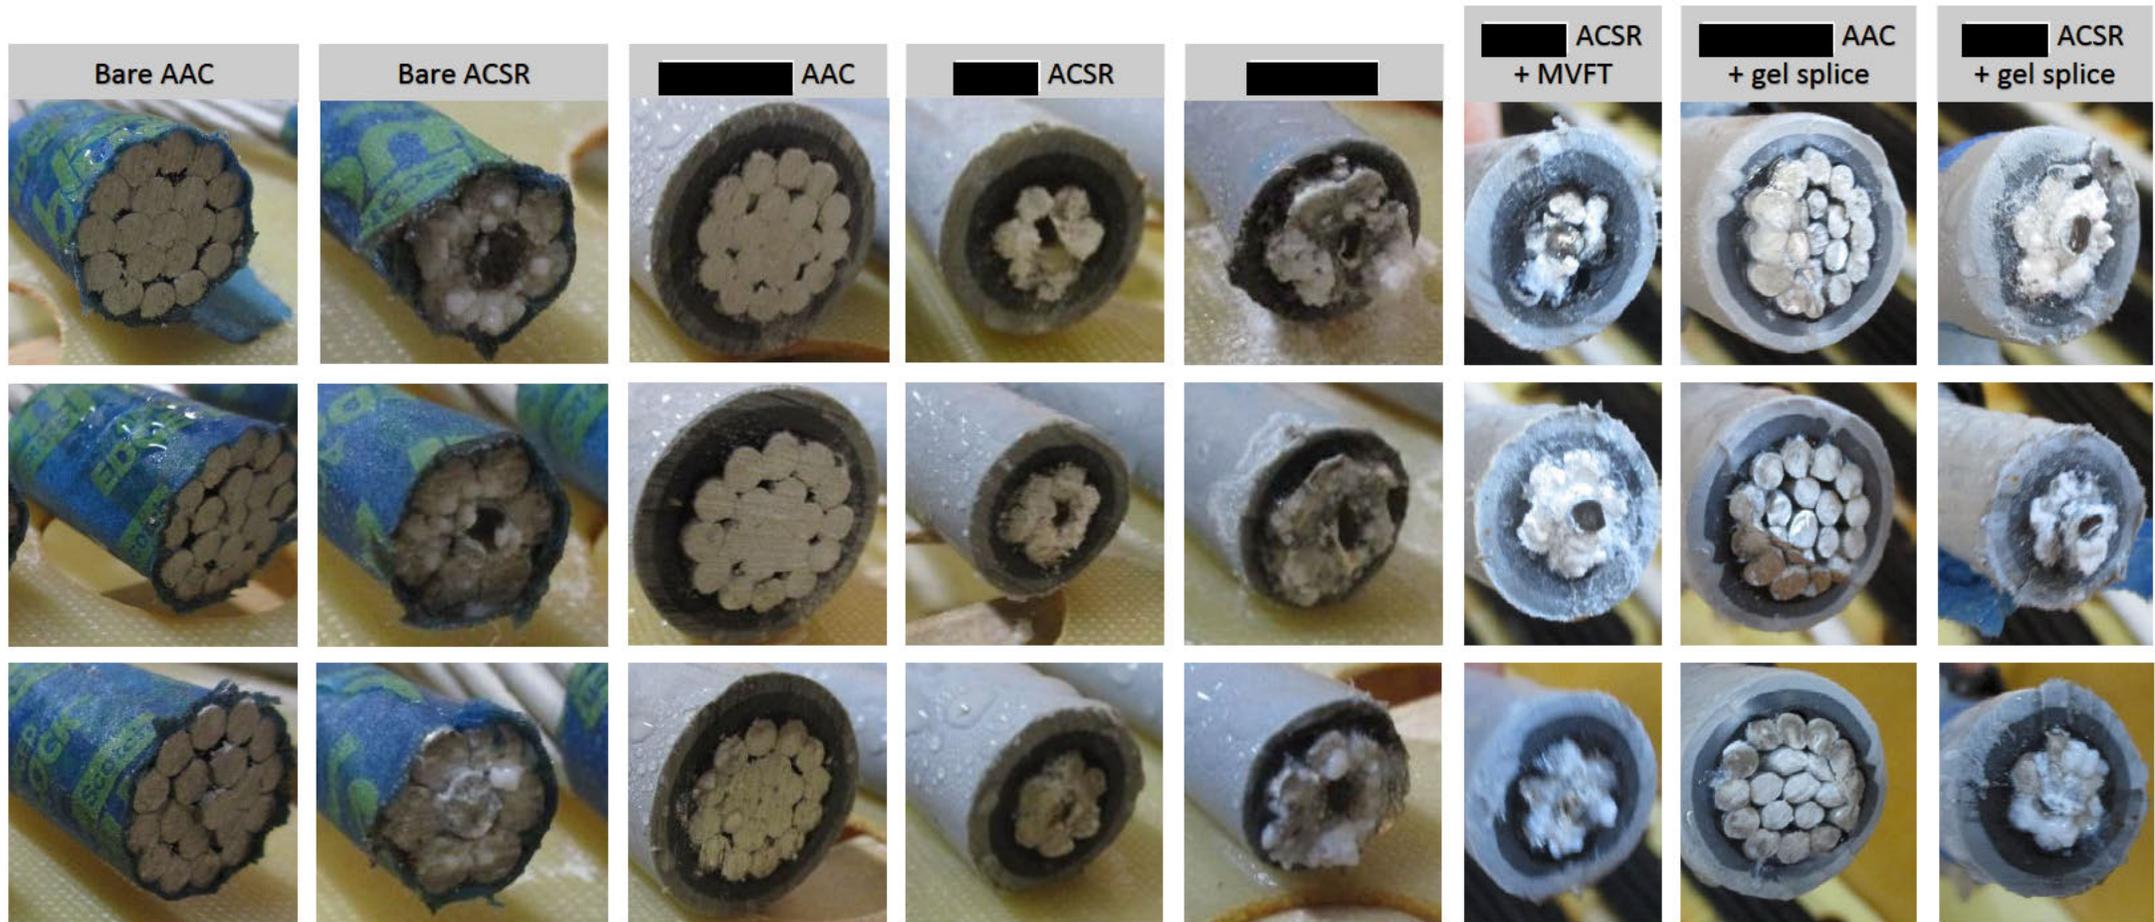
9. Accelerated Atmospheric Corrosion Test (cont'd)

– 7-day exposure

– 14-day exposure

– 21-day exposure

- Atmospheric Corrosion Test (cont'd)
 - 28-day exposure

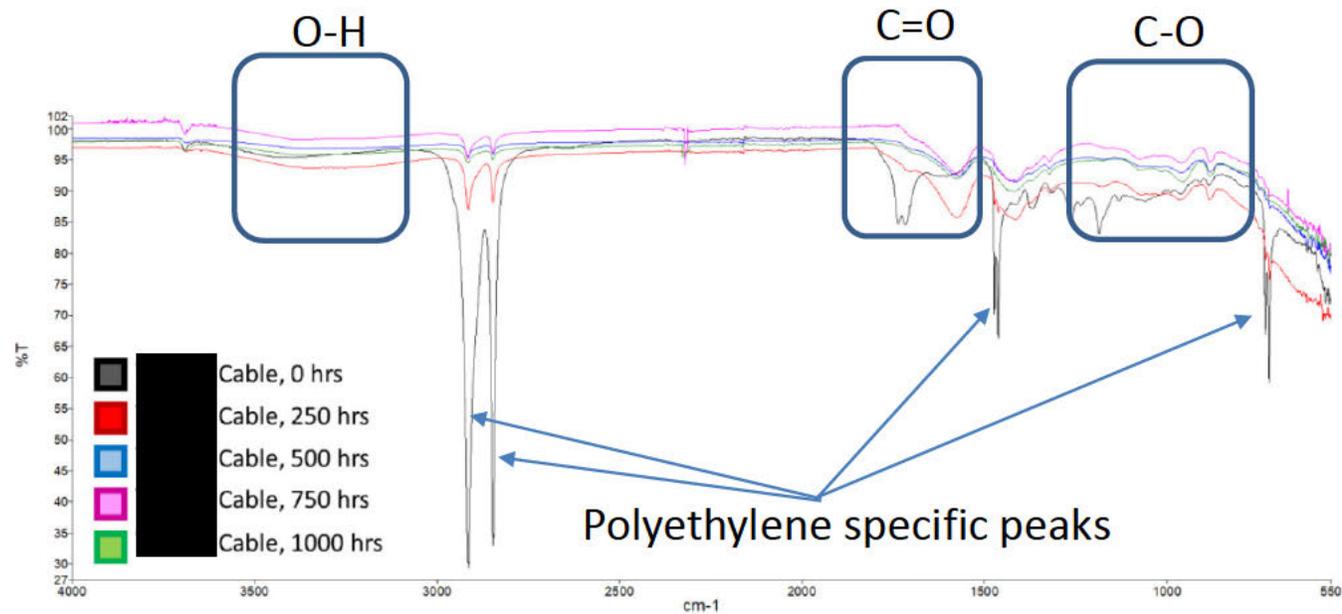
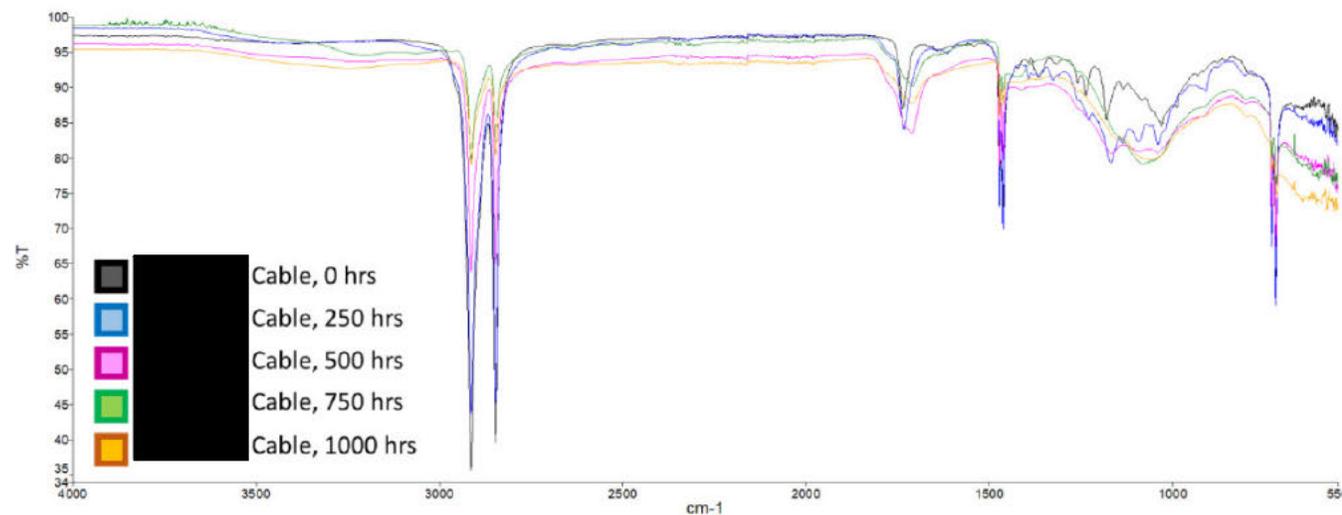
12. UV Weathering test

- FTIR data

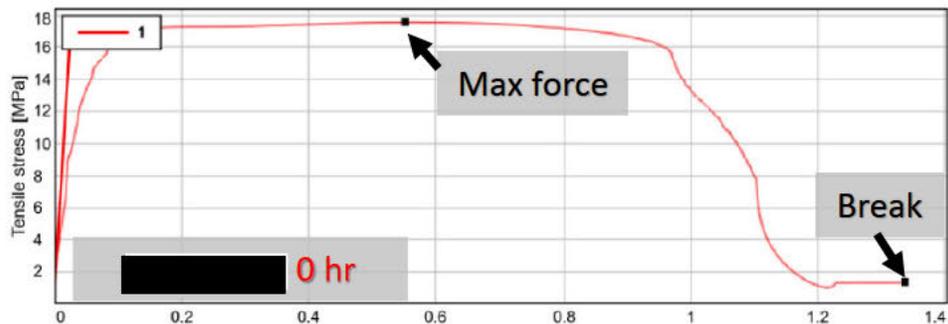
12. UV Weathering test (cont'd)

- Tensile test data

- Test guideline: Up to 1000hr Exposure to ASTM G155-21 (Table X3.1 Cycle 8)
- Test setup: 4hr @ 0.55 W/m²•nm light, 340nm λ, 50% relative humidity, 62°C chamber temp; 1hr dark, 95% humidity, 62°C temp (Sequentially).
- Requirements: Per ANSI/ICEA S-121-733, outer jacket considered sunlight resistant if ratio for original to aged tensile and elongation is >= 80% after 720h
- Results: Surface crazing occurred on both conductors by end of test*

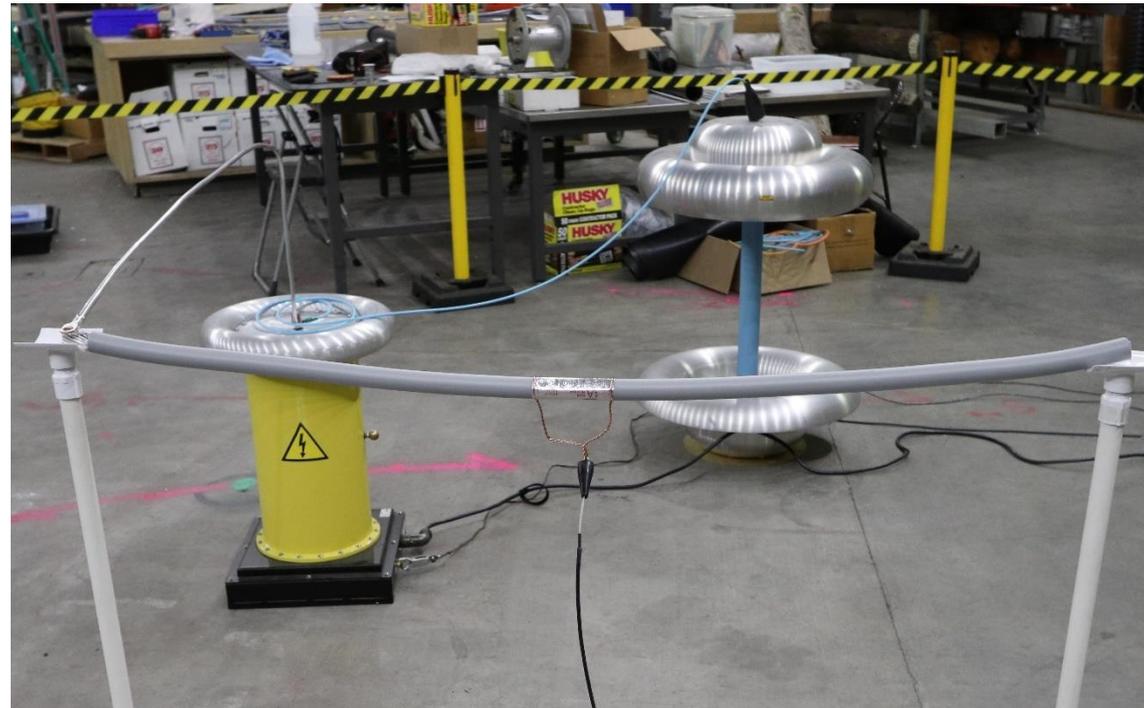
- Covered Conductor Test setup

- Per European Standard EN 50397-1:2020, the setup for the leakage current test was followed. However, instead of using a wound copper conductor as the measuring electrode, an aluminum tape of the same 100mm diameter wrapped around the covered conductor was used. The European standard specified the leakage current must not exceed 1mA at U (rated voltage). Voltage was applied to the conductor and the return lead was connected to the measuring electrode. Leakage current was measured as the voltage ramped up until dielectric breakdown.

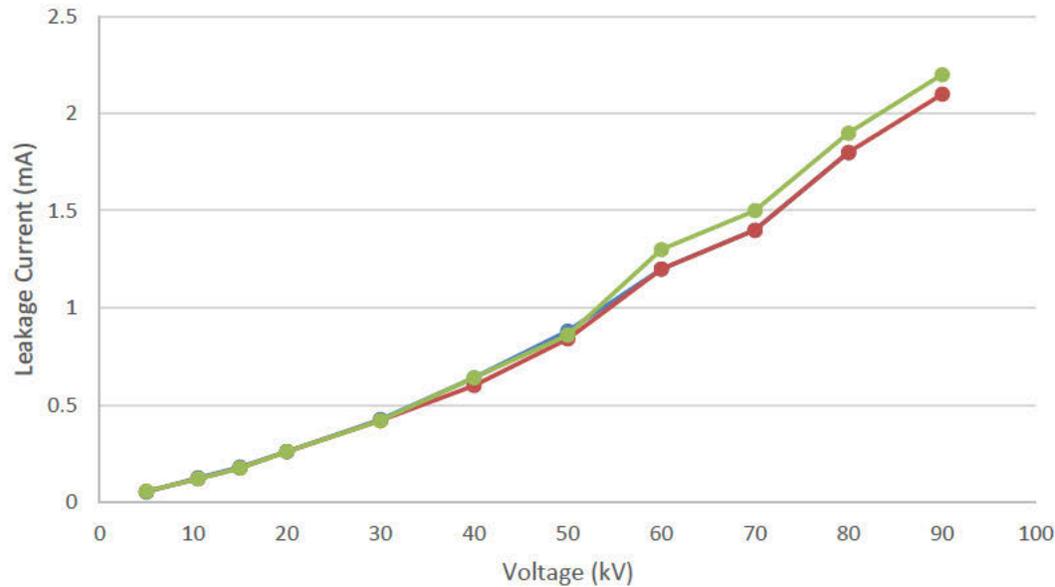
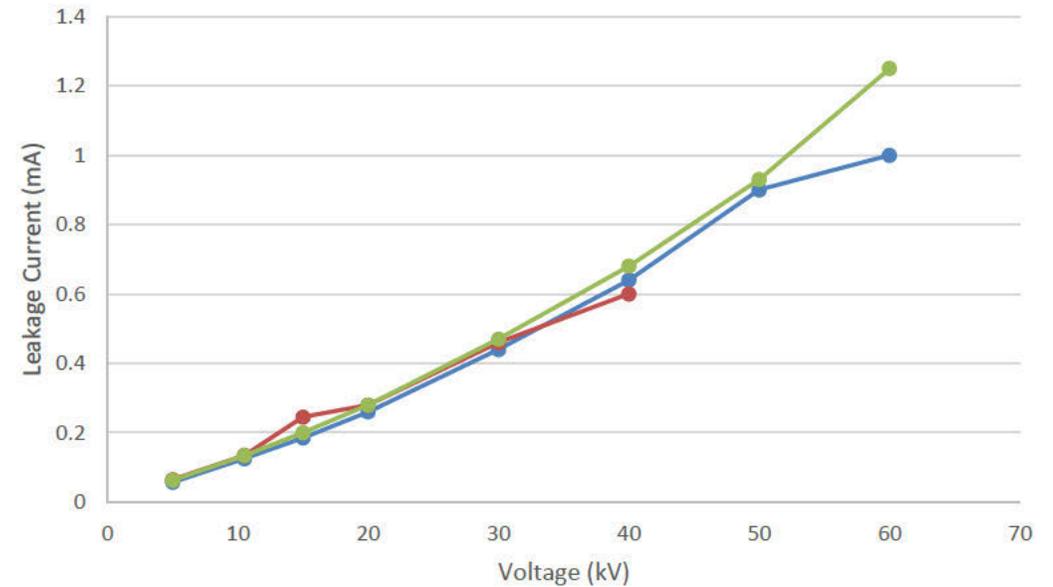
- [REDACTED] 1/0 ACSR Full and 50% Insulation- Voltage vs. Leakage Current Plot

1/0 ACSR @ 100% Insulation

1/0 ACSR @ 50% Insulation

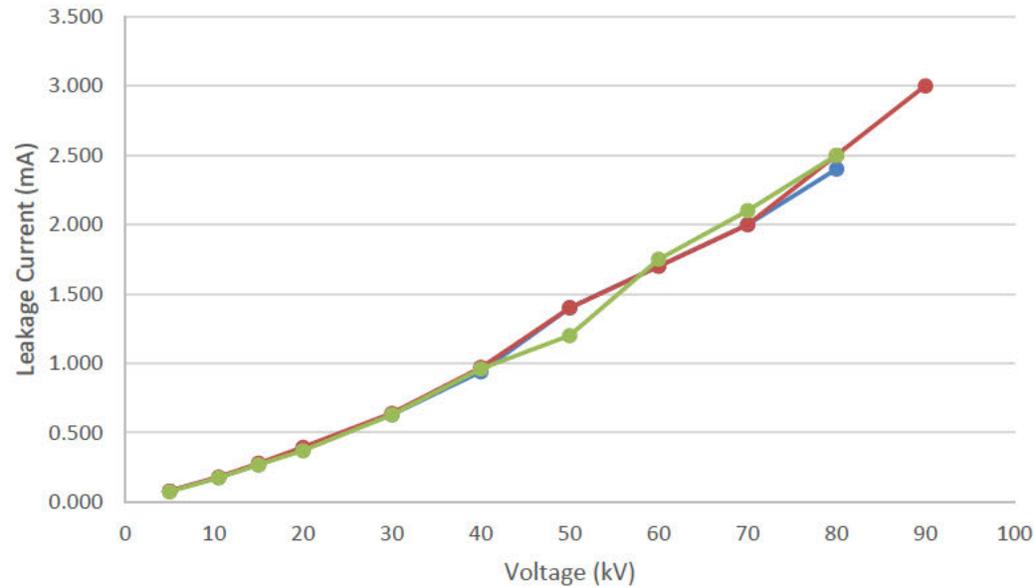
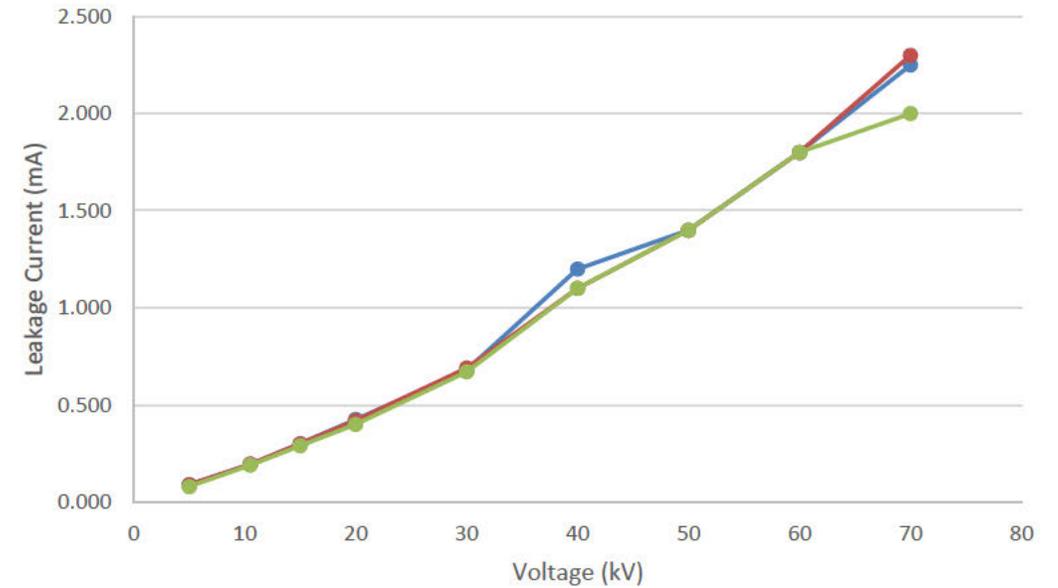
- [REDACTED] 397 AAC Full and 50% Insulation- Voltage vs. Leakage Current Plot

397 AAC @ Full Insulation

397 AAC @ 50% Insulation

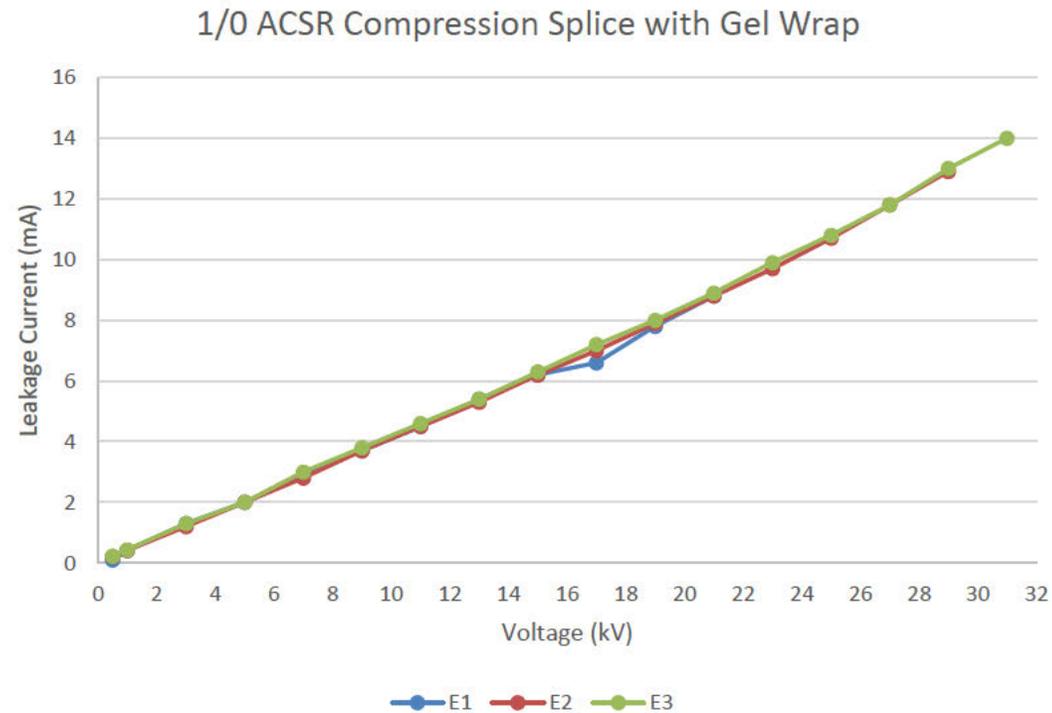
- 1/0 ACSR Compression Splice with Gel Wrap – Voltage vs. Leakage Current Plot

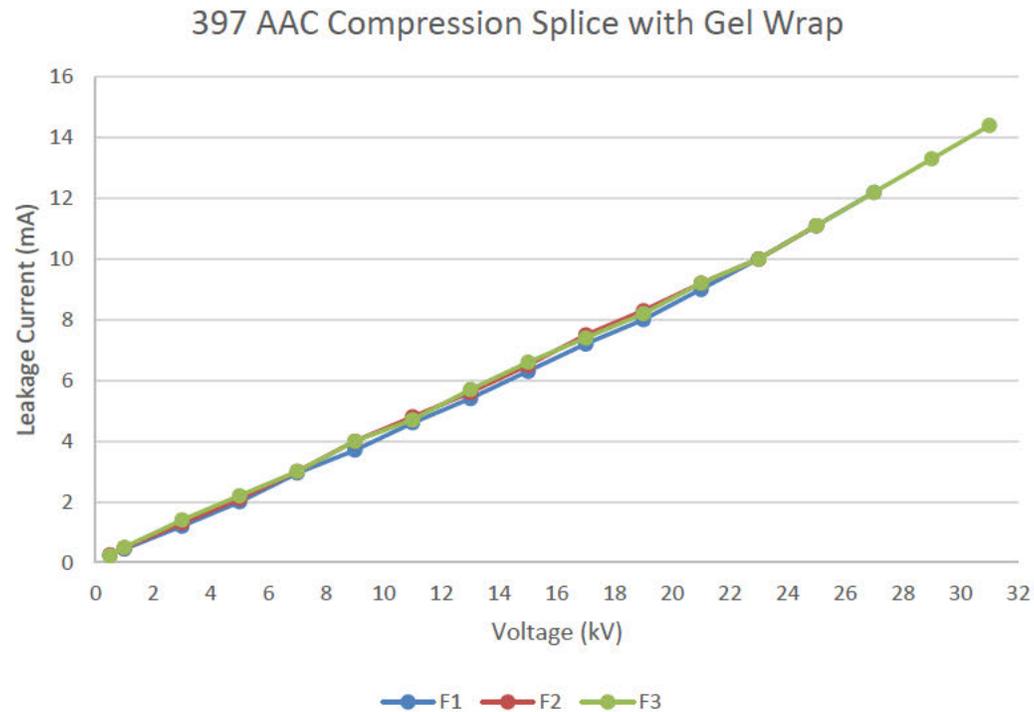
- 397 AAC Compression Splice with Gel Wrap – Voltage vs. Leakage Current Plot

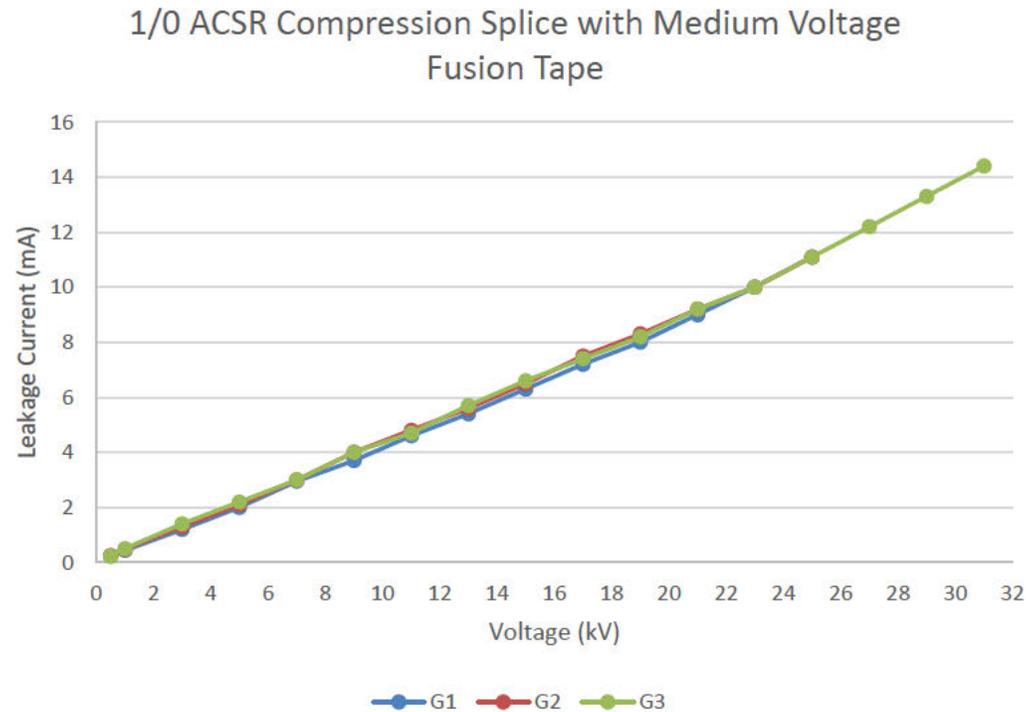
- 1/0 ACSR Compression Splice with MVFT – Voltage vs. Leakage Current Plot

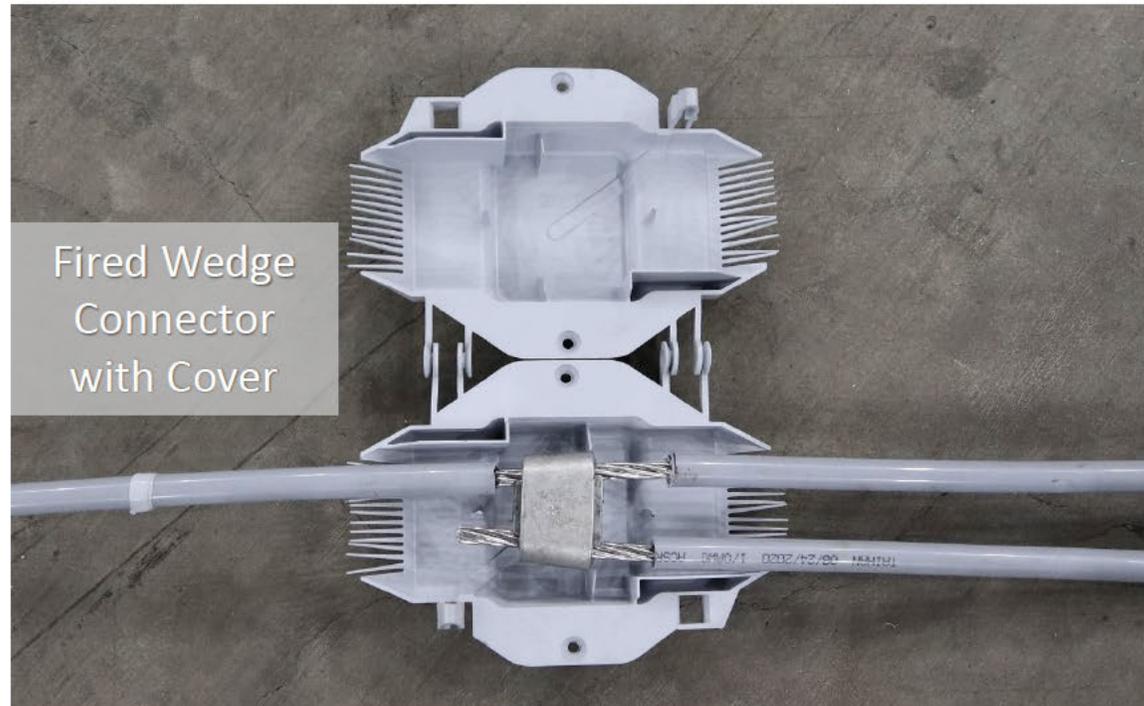
– Fired Wedge Connector Cover

- Leakage current and dielectric strength tests were performed on a PG&E approved fired wedge connector cover. The wedge connector sized for a 1/0 to 1/0 connection was placed in the center of the cover.

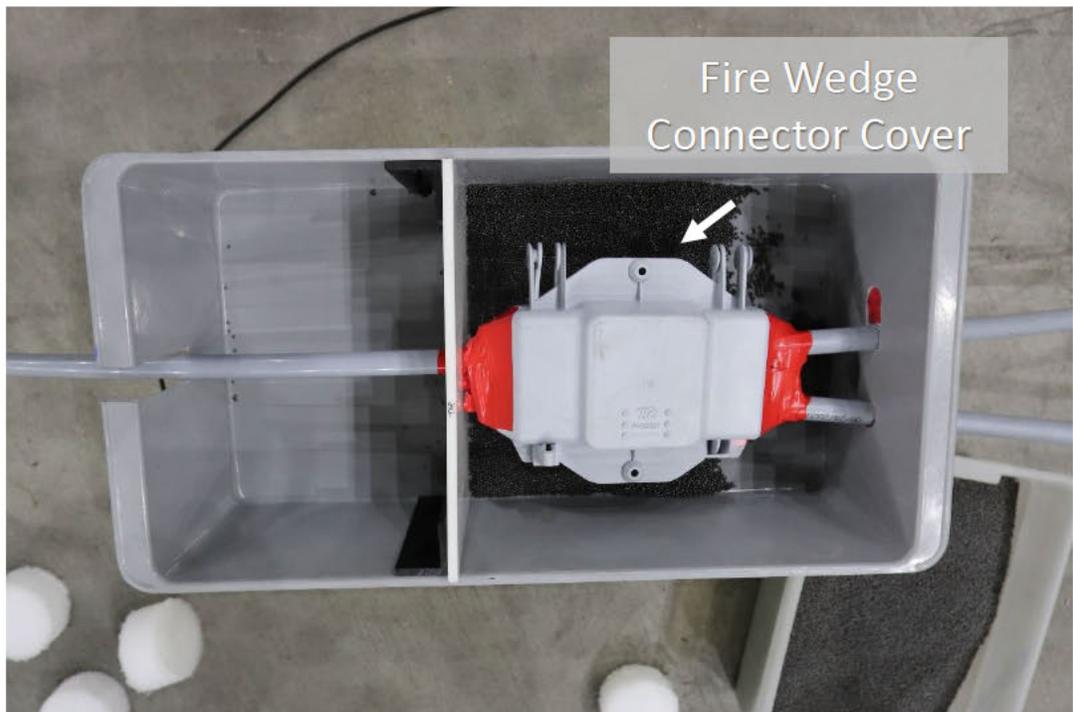
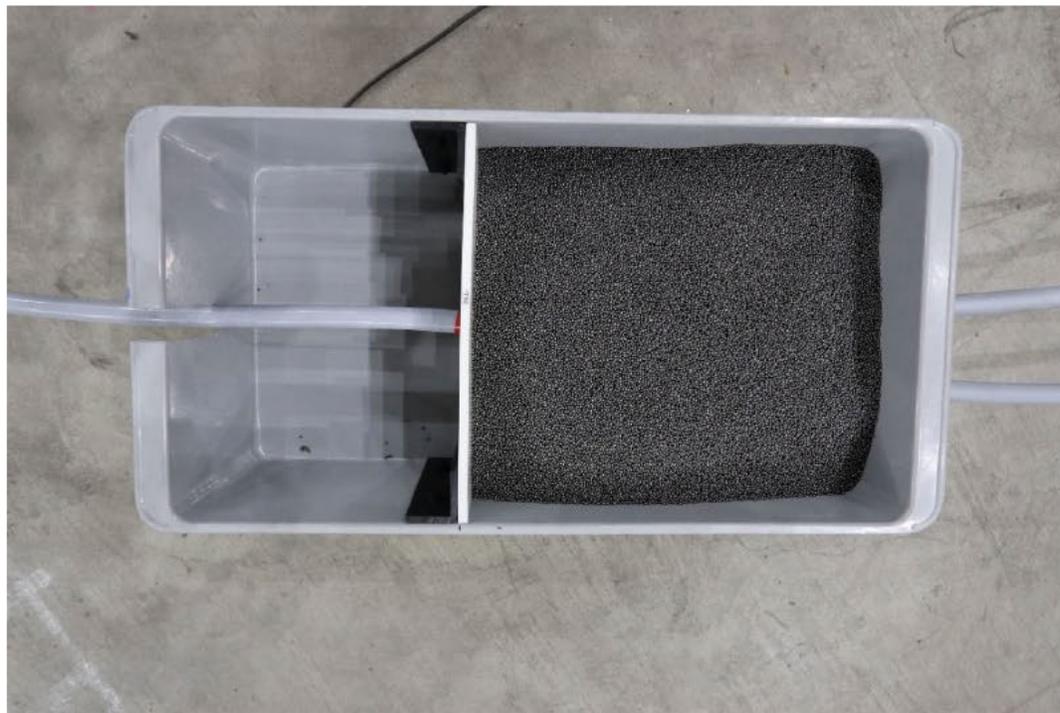
– Fire Wedge Connector Cover Test setup

- The fire wedge connector with the cover was embedded in No 8 steel shot which served as the measuring electrode. Electrical tape was used to cover areas where shot was able to enter. Voltage was applied to the conductor and the return lead was connected to the measuring electrode. Leakage current was measured as the voltage ramped up until dielectric breakdown. .

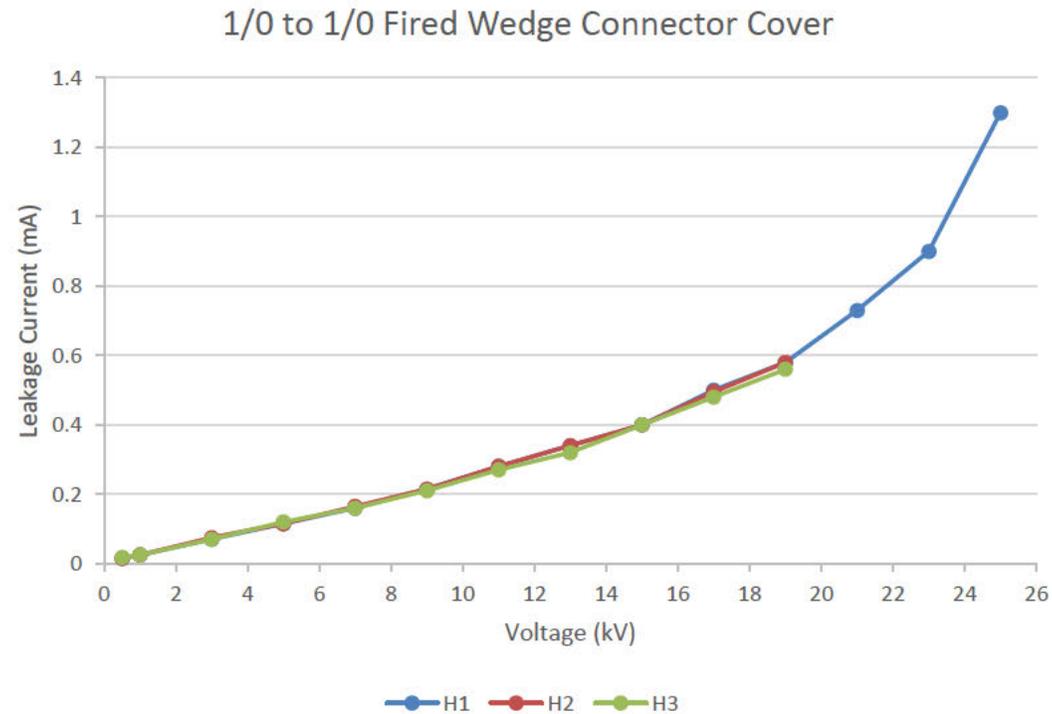
- 1/0 to 1/0 Fired Wedge Connector Cover – Voltage vs. Leakage Current Plot
