LAND 2 – EROSION AND SEDIMENTATION TECHNICAL MEMORANDUM

KERN RIVER No. 1 HYDROELECTRIC PROJECT
FERC PROJECT No. 1930

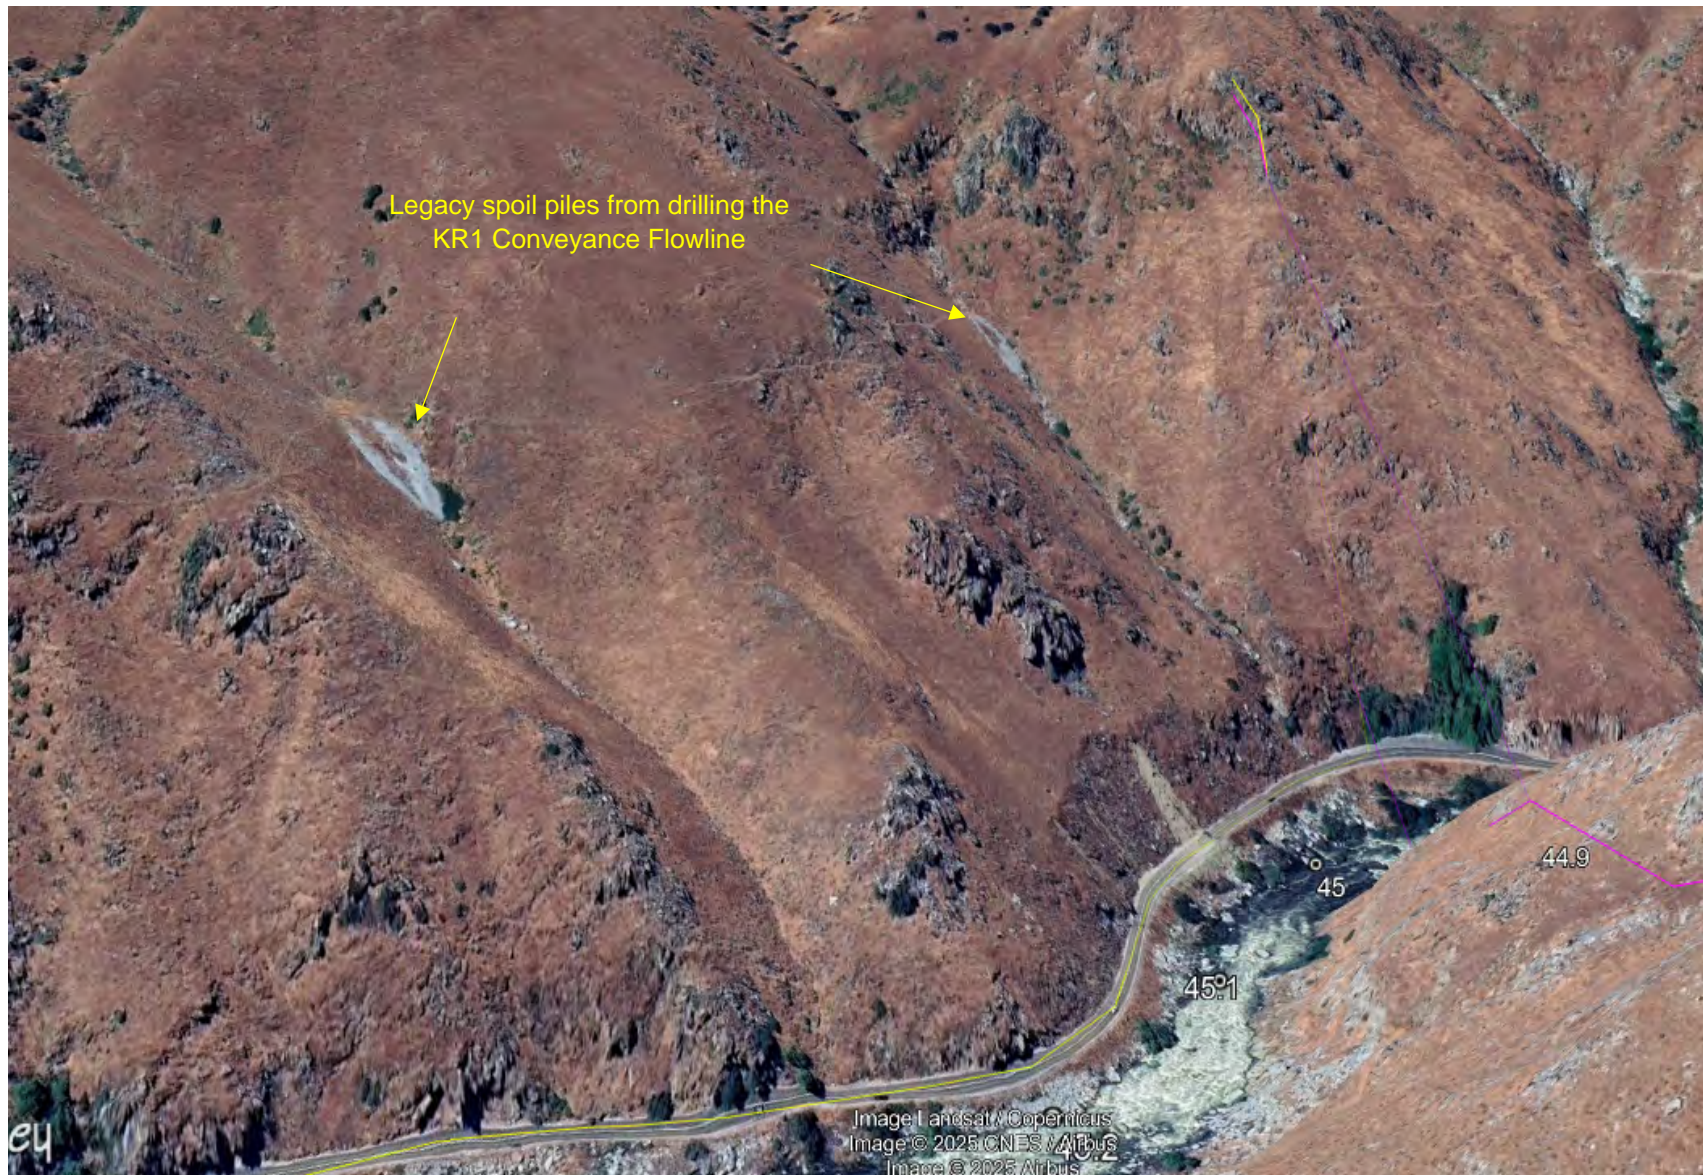
Figure 5-1. Example of Legacy Spoil Piles from Drilling the KR1 Conveyance Flowline.

A review of historical aerial imagery and field observations indicated that potential erosion and sedimentation related to Project features was small scale and remained stable from 2002 to 2023 (availability of imagery). The only Project-related features that were identified as locations of potential ongoing erosion and sedimentation were the legacy spoil piles from drilling the KR1 Conveyance Flowline. These spoil piles were visible in all

photo sets and appear largely unchanged between 2002 and 2023. An aerial image of a few of the spoil piles is provided in Figure 5-1 (January 2025).

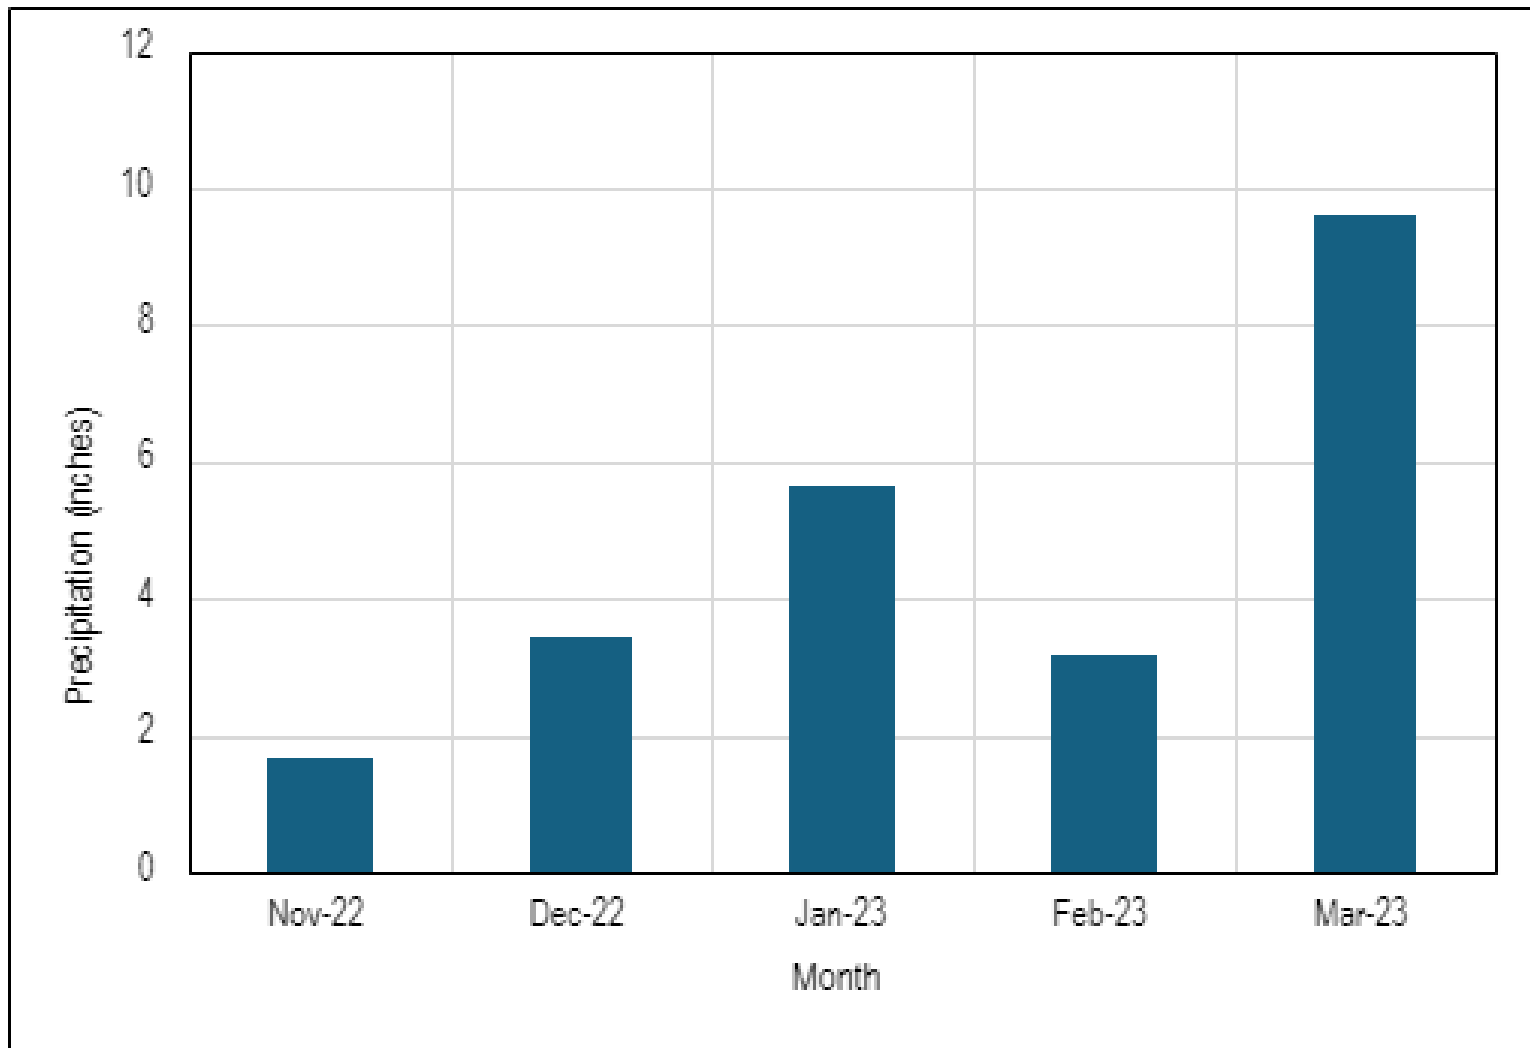
Figure 5-2. Monthly Peak Precipitation at Lake Isabella from November 2022–March 2023

Peak monthly rainfall of approximately 5.62 inches in January 2023, and 9.61 inches in March 2023 was measured at Lake Isabella (California Nevada River Forecast Center [CNRFC] 2024) (Figure 5-2). On March 10, 2023, flows in the Kern River at Kernville peaked at 15,700 cubic feet per second (cfs) (U.S. Geological Survey [USGS] 2024) (Figure 5-3). This was the second highest peak flow recorded at Kernville for the period of record spanning from 1961–2023, with the peak flow of 33,600 cfs occurring on December 6, 1966 (USGS 2024).

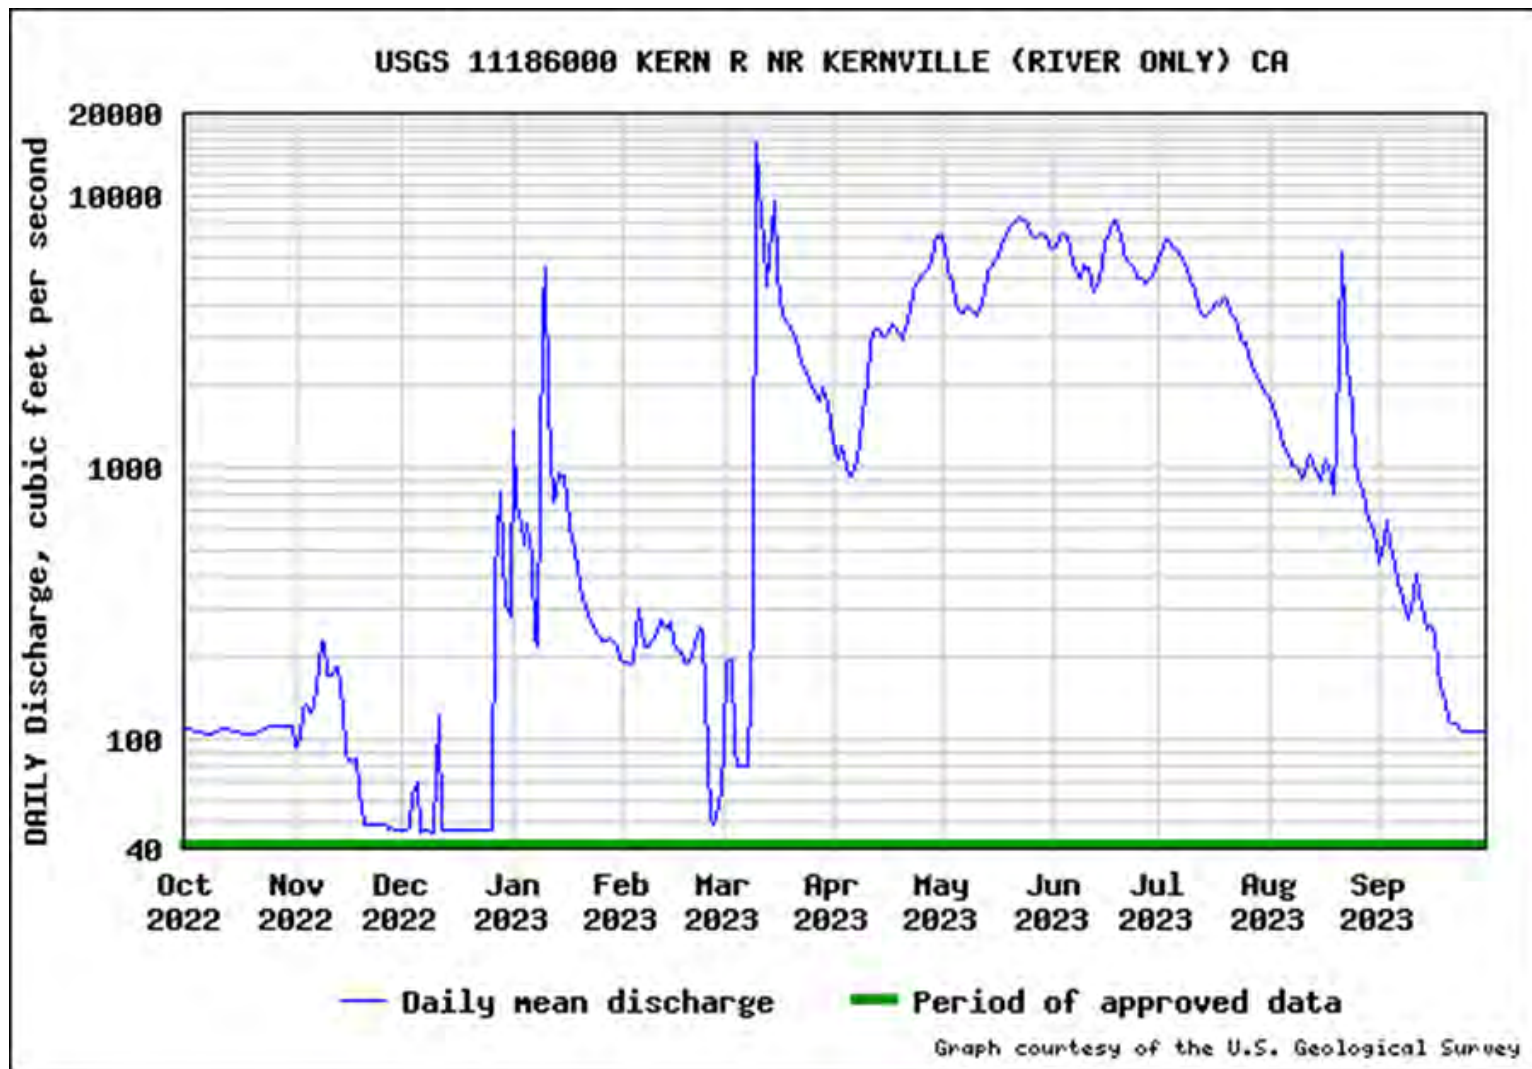
Figure 5-3. USGS Water Year Summary for Site USGS 11186000 at Lake Isabella Dam

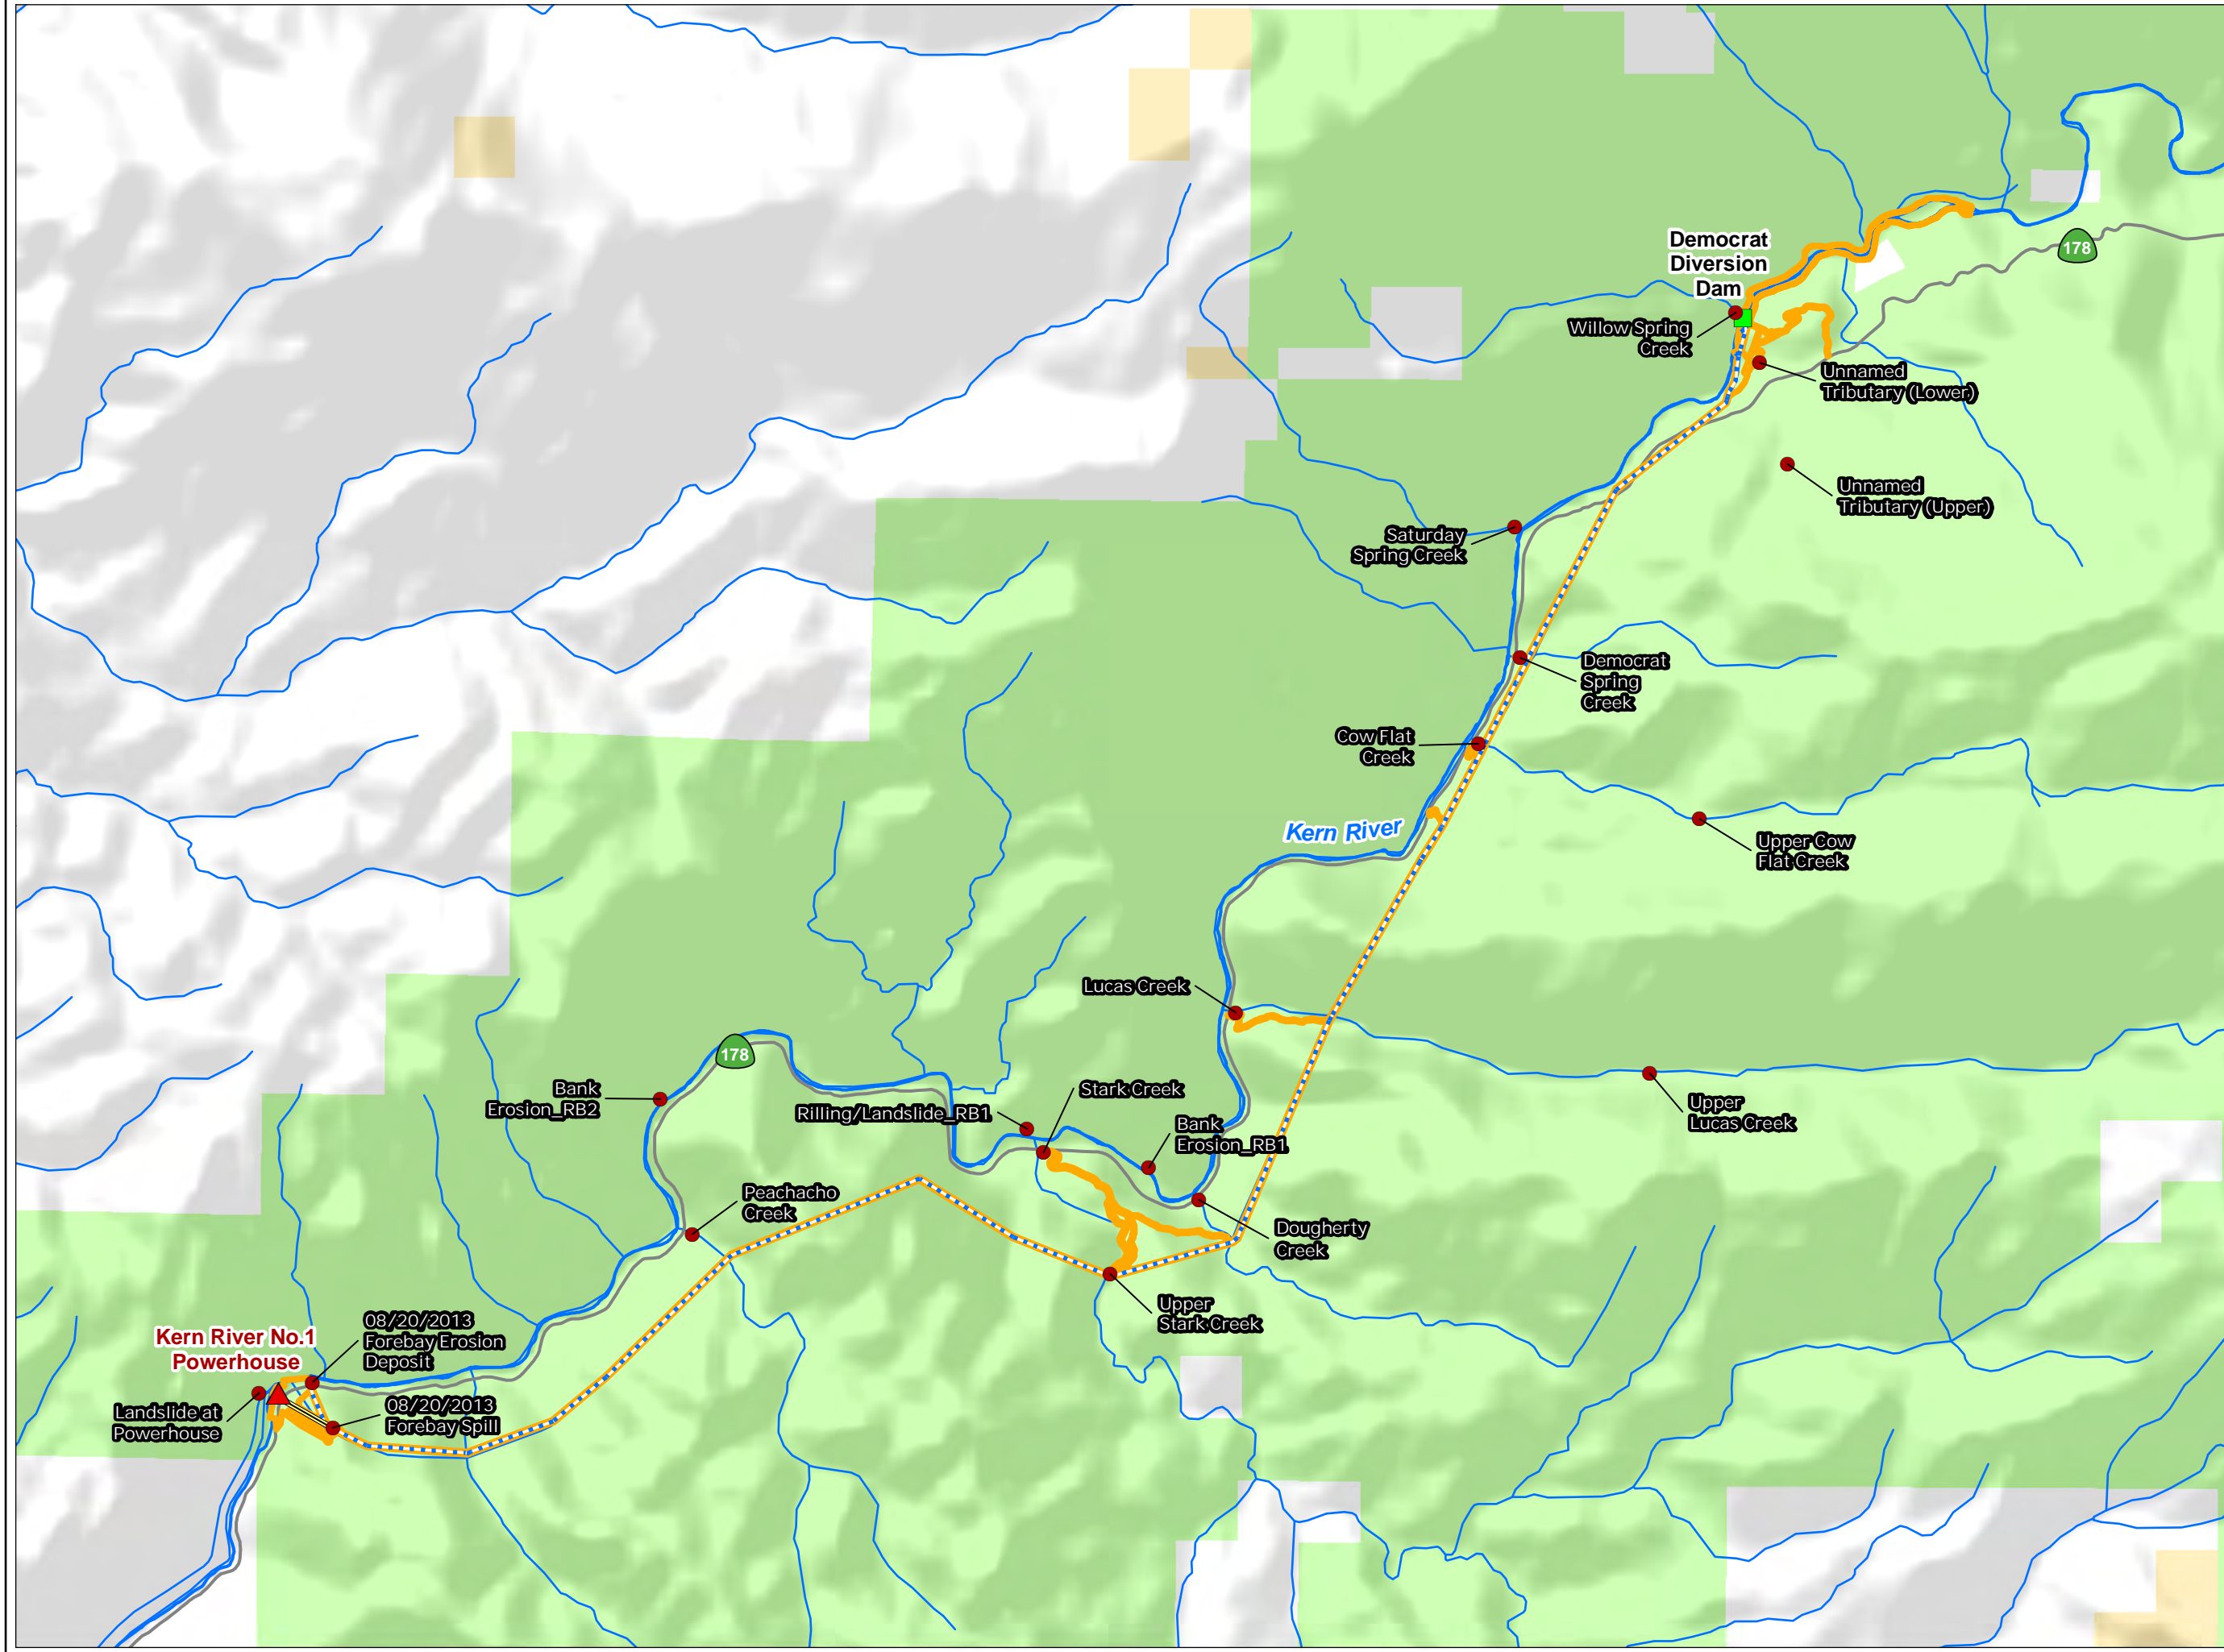
Erosion and Sedimentation Survey

Observation Sites

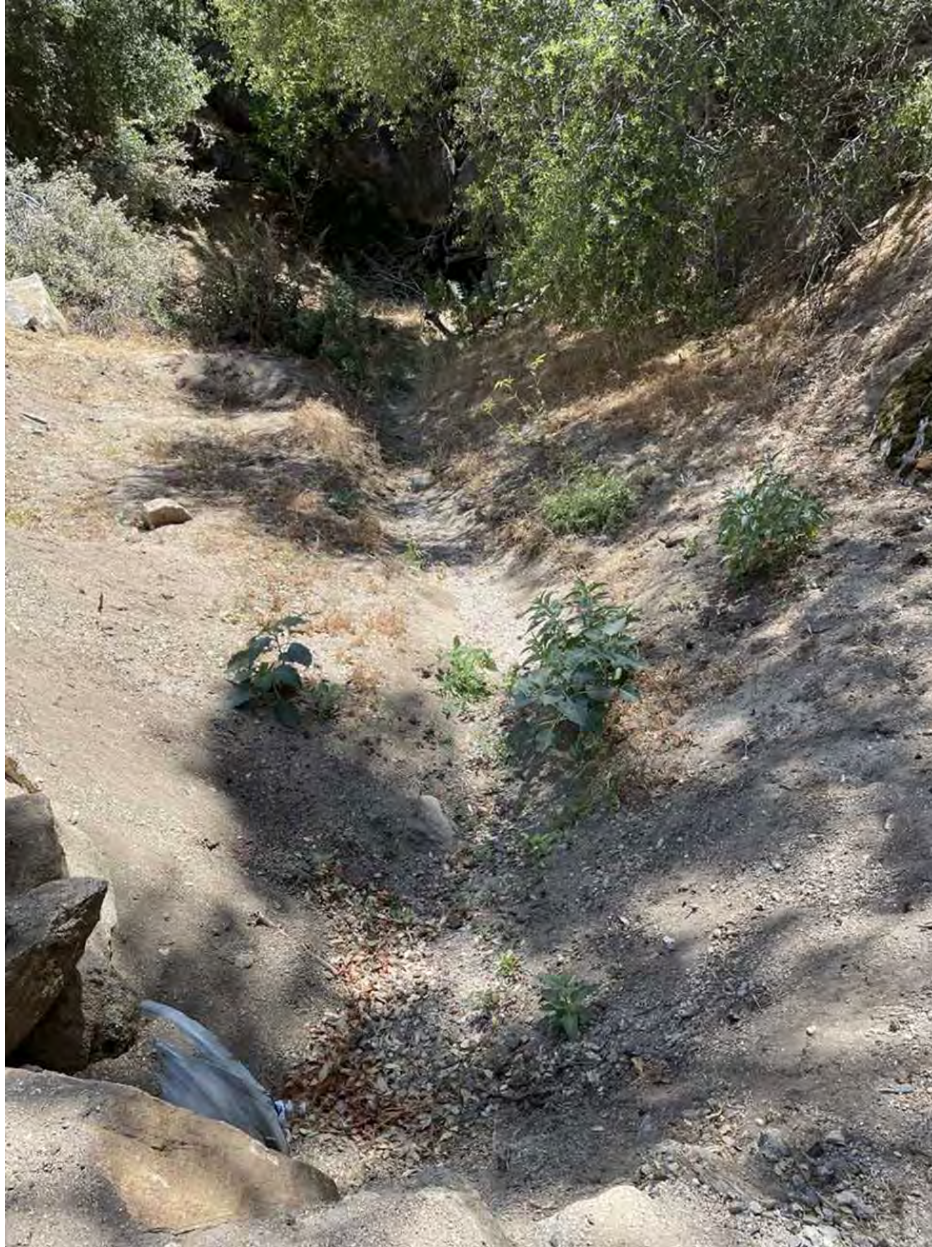
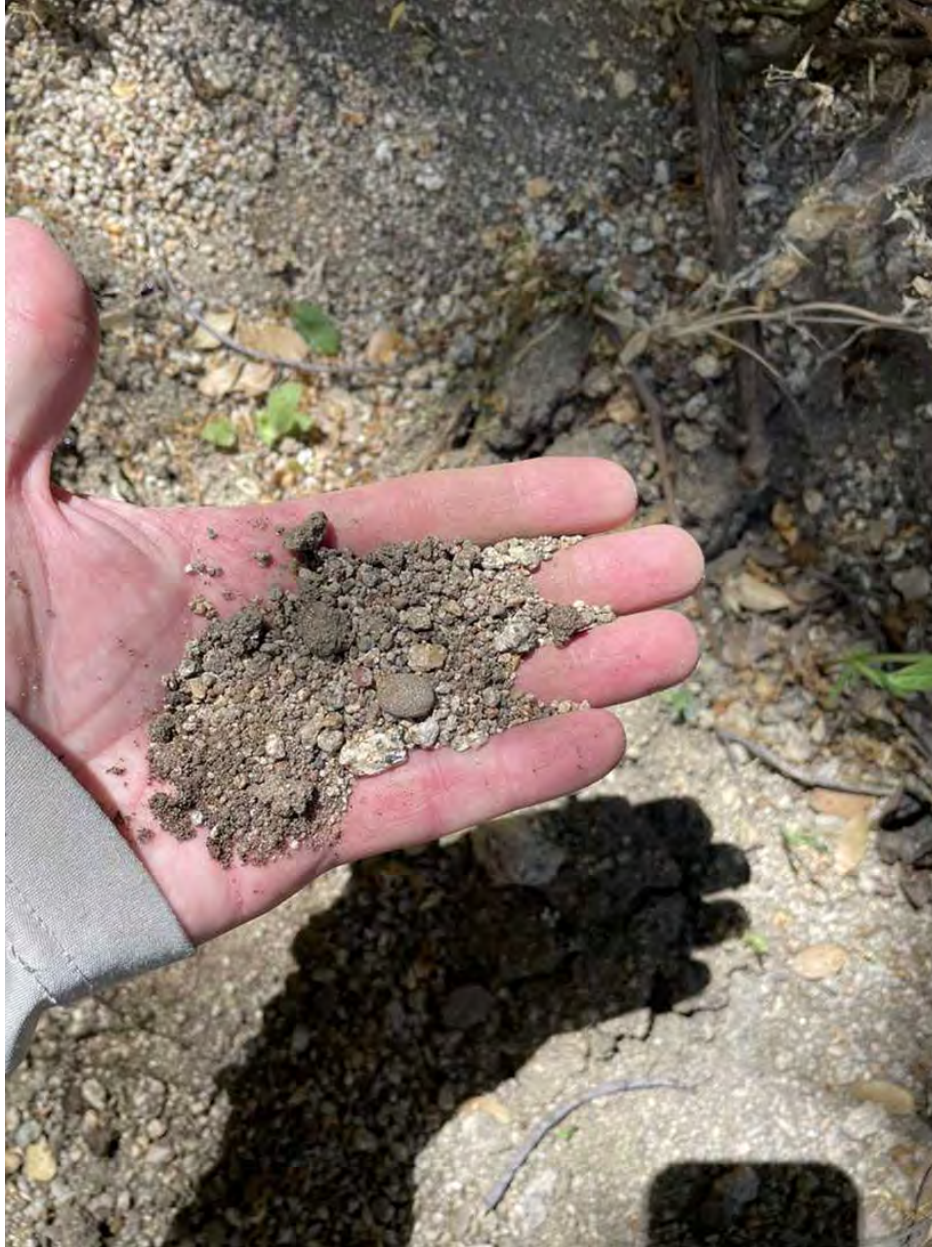
Photo A-1. Unnamed tributary on Democrat Dam Flowline Access Road

Photo A-2. Unnamed tributary on Democrat Dam Flowline Access Road

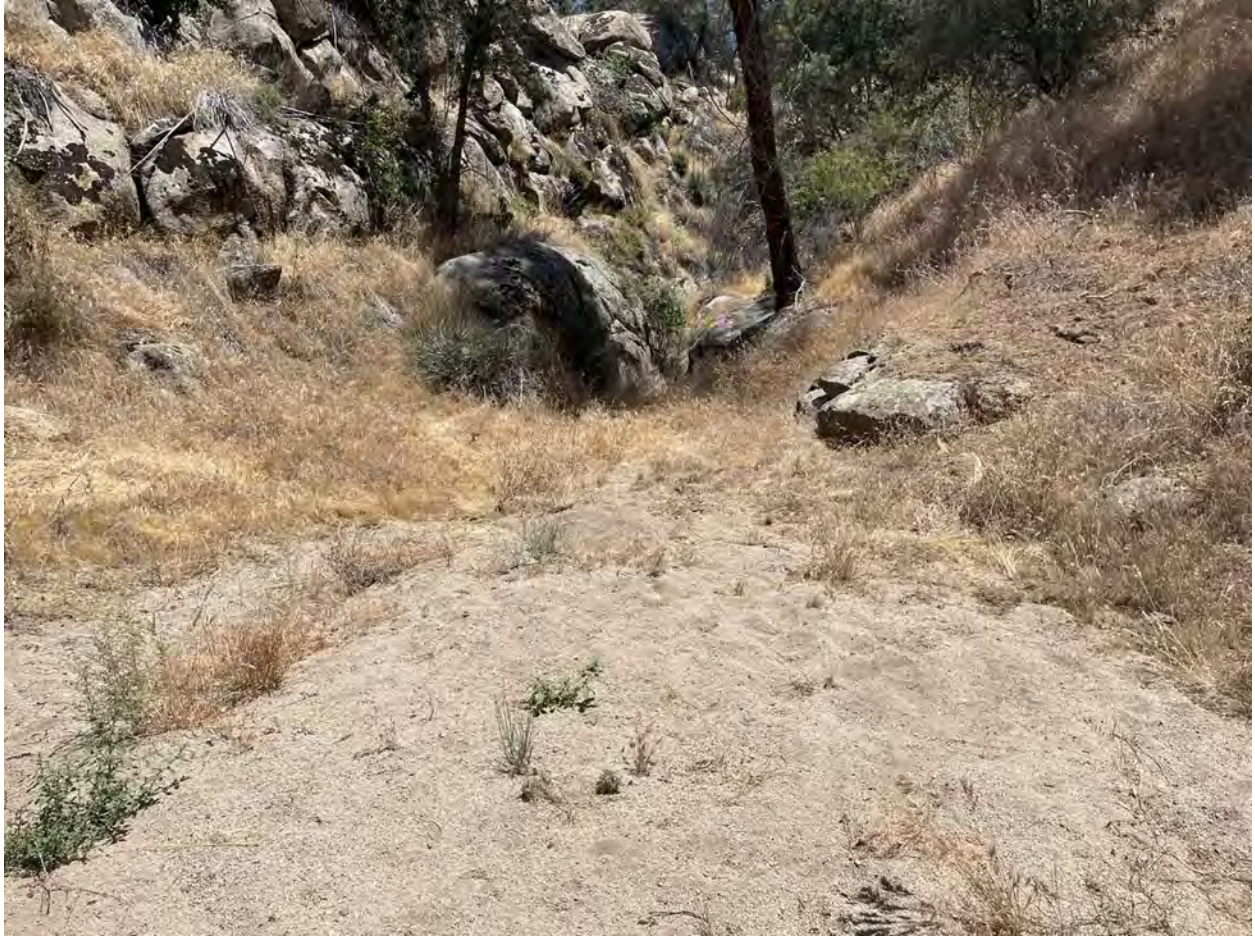
Photo A-3. Unnamed tributary at water crossing on Cow Flat Road

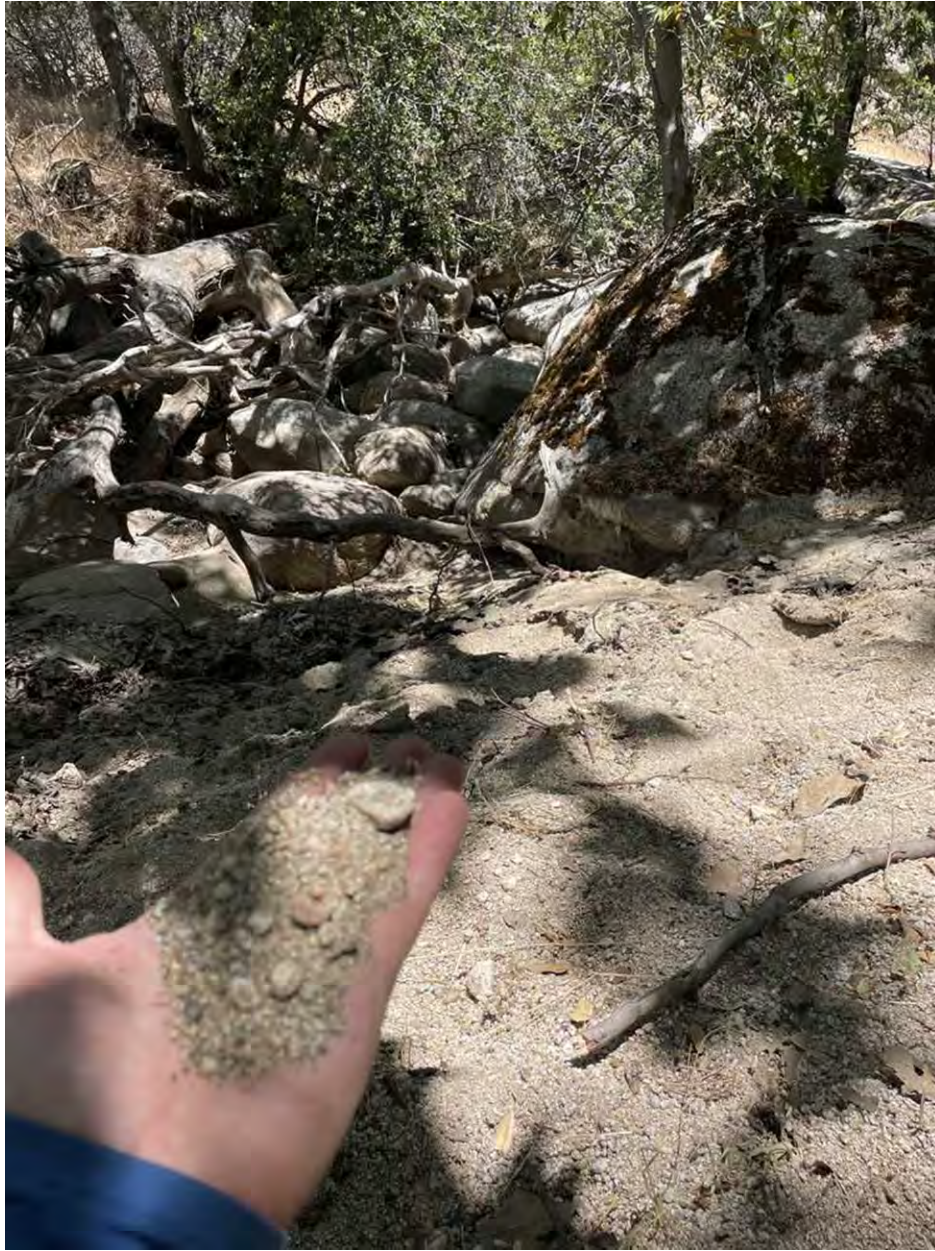
Photo A-4. Upper Cow Flat Creek

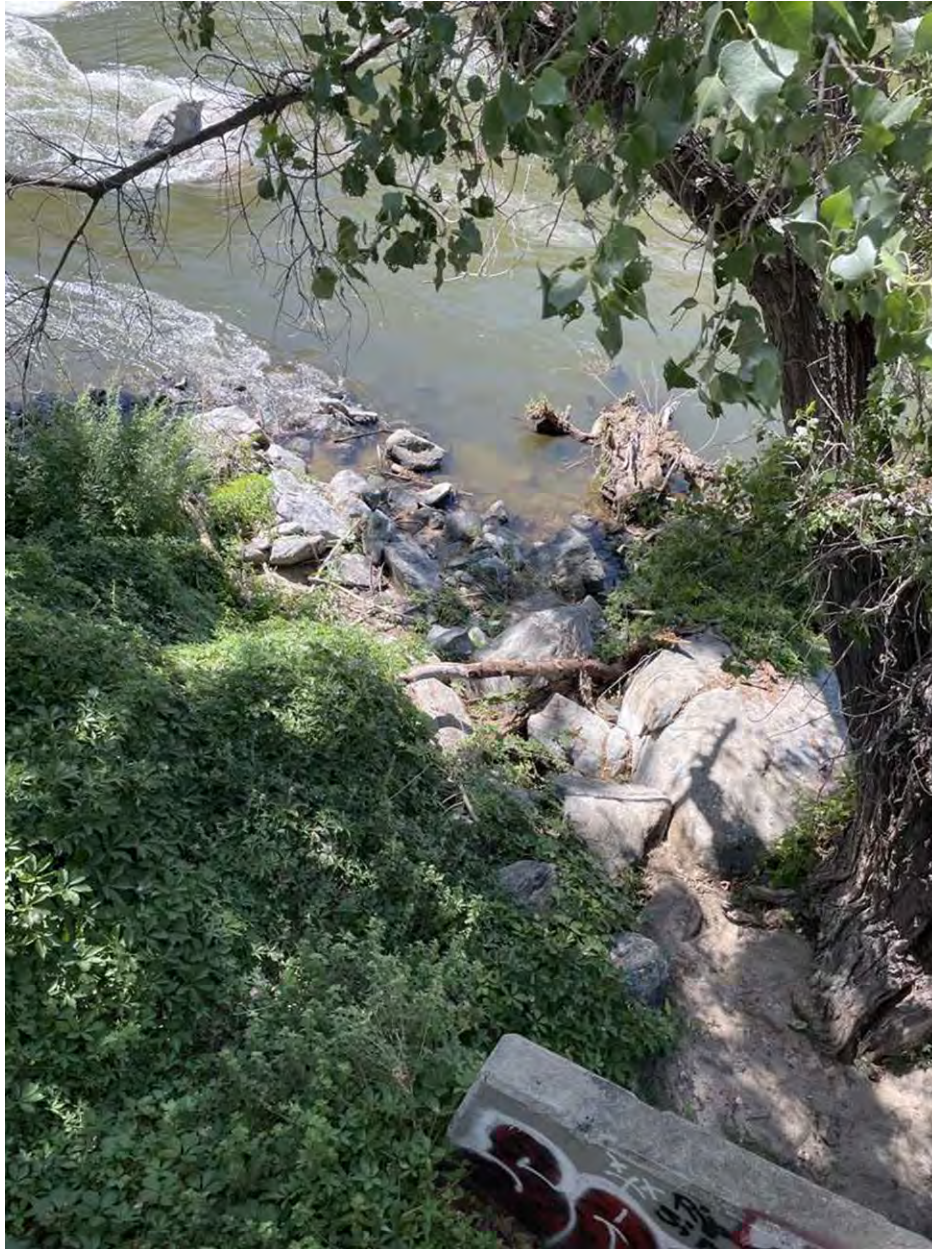
Photo A-5. Cow Flat Creek at SR-178 and confluence with mainstem channel

Photo A-6. Cow Flat Creek at SR-178 and confluence with mainstem channel

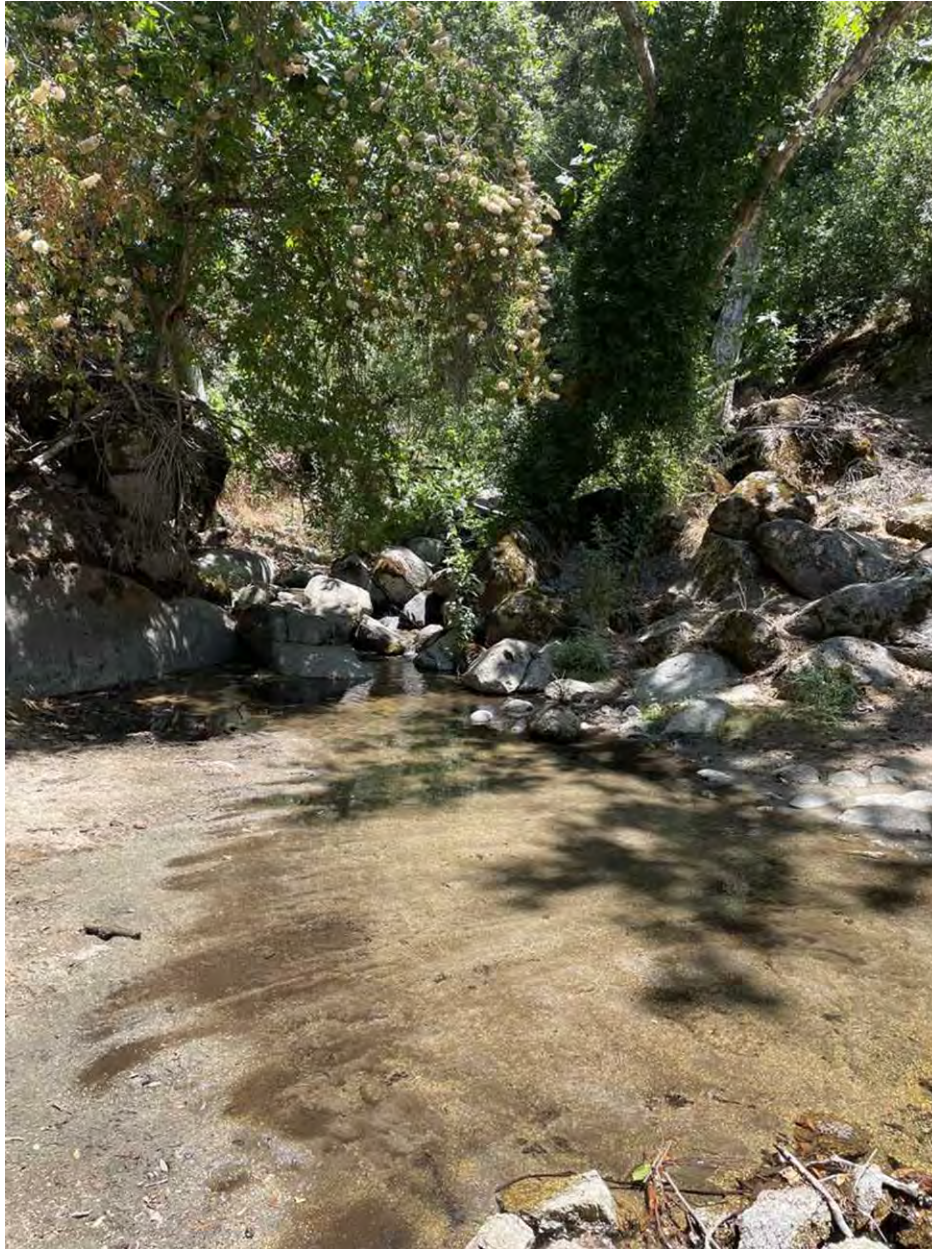
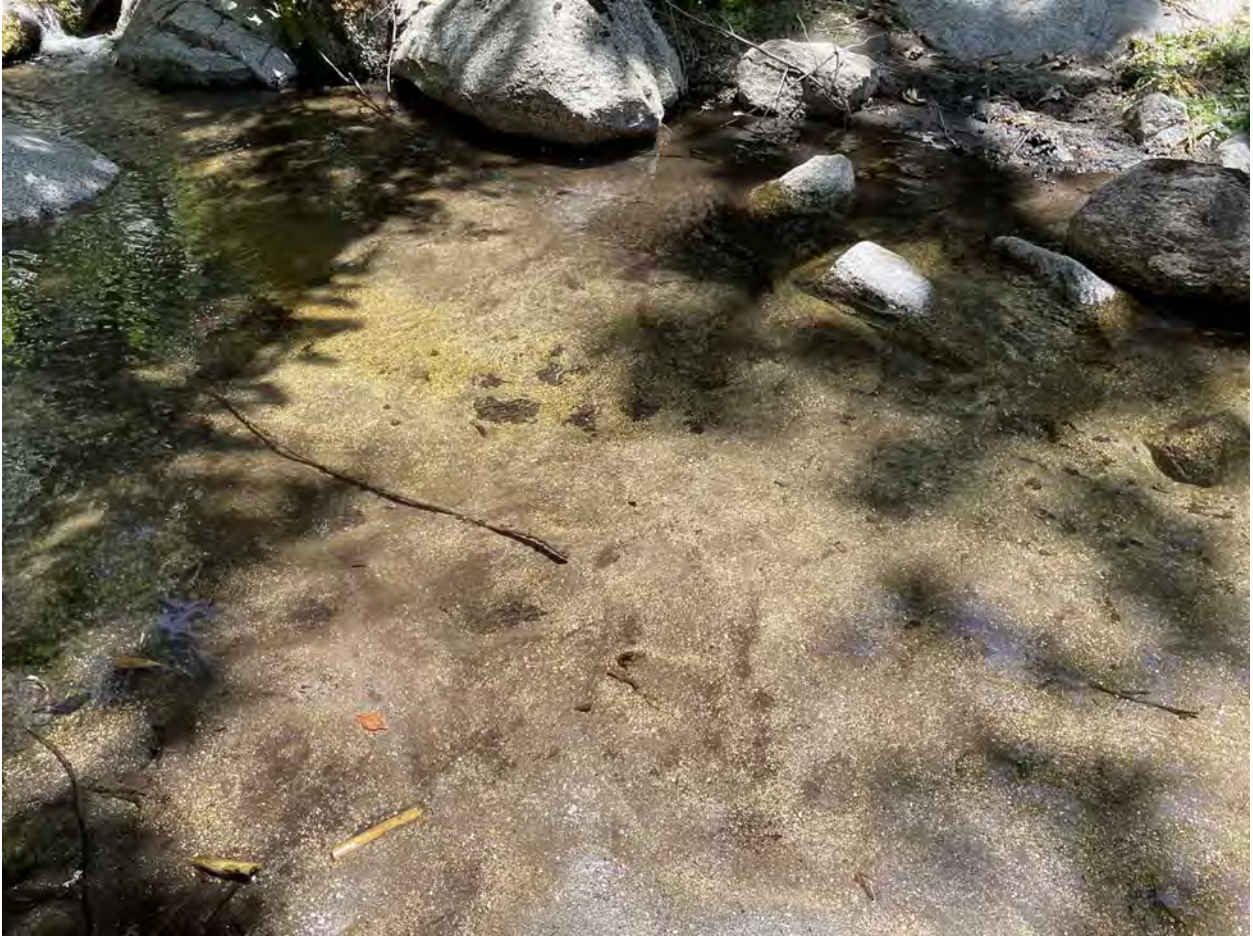
N/A	N/A	Flowing	No	Yes	Lucas Creek at SR-178 culvert and confluence with mainstem channel. Cobbles, sand, and gravel deposited below culvert adjacent to confluence suggests significant potential for sediment transport during high-flow conditions.
Dougherty Creek	A-9	N/A	Flowing	No	Yes	Dougherty Creek at SR-178 culvert and confluence with mainstem channel. Steep drainage with rilling suggests significant potential for erosion and sediment transport during high-flow conditions. Boulders, cobbles, gravel, and sand deposited below culvert.
Bank Erosion_RB1	A-10 to A-11	N/A	N/A	No	Yes	Bank erosion at the confluence of an ephemeral drainage and the mainstem channel on RB. Steep cut bank composed of loose cobbles, gravel, and sand with rilling, slumping, and potential for significant erosion and sediment deposition.
Stark Creek	A-12	N/A	Dry	No	Yes	Upper Stark Creek at the end of the flowline access road. Scoured bedrock channel and matrix supported cobbles suggest potential for significant episodic erosion and sediment transport. Deposits of fine sand and gravel that would likely be transported during high-flow conditions.

Photo A-7. Upper Lucas Creek at water crossing on Cow Flat Road

Photo A-8. Upper Lucas Creek at water crossing on Cow Flat Road

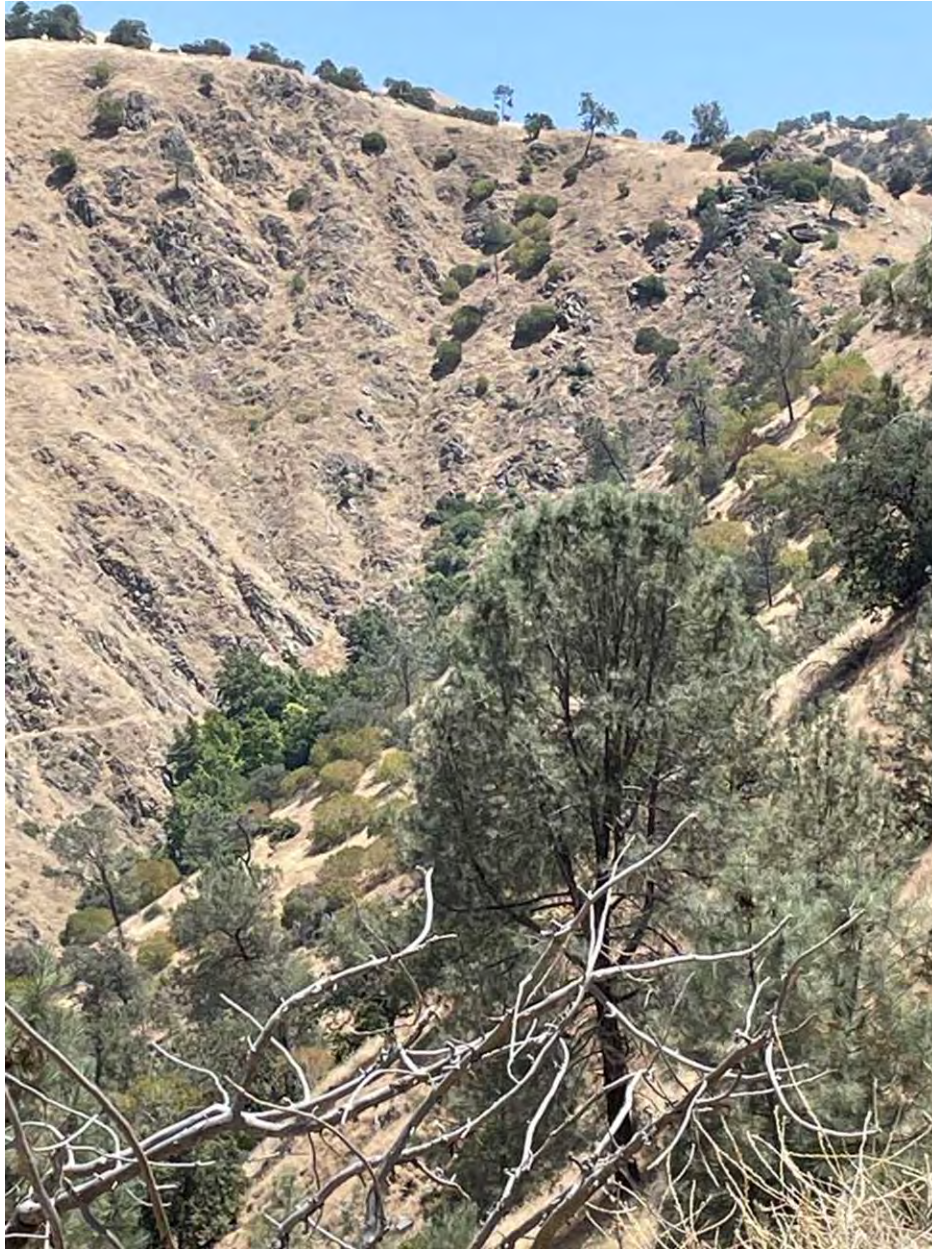
Photo A-9. Dougherty Creek drainage above SR-178

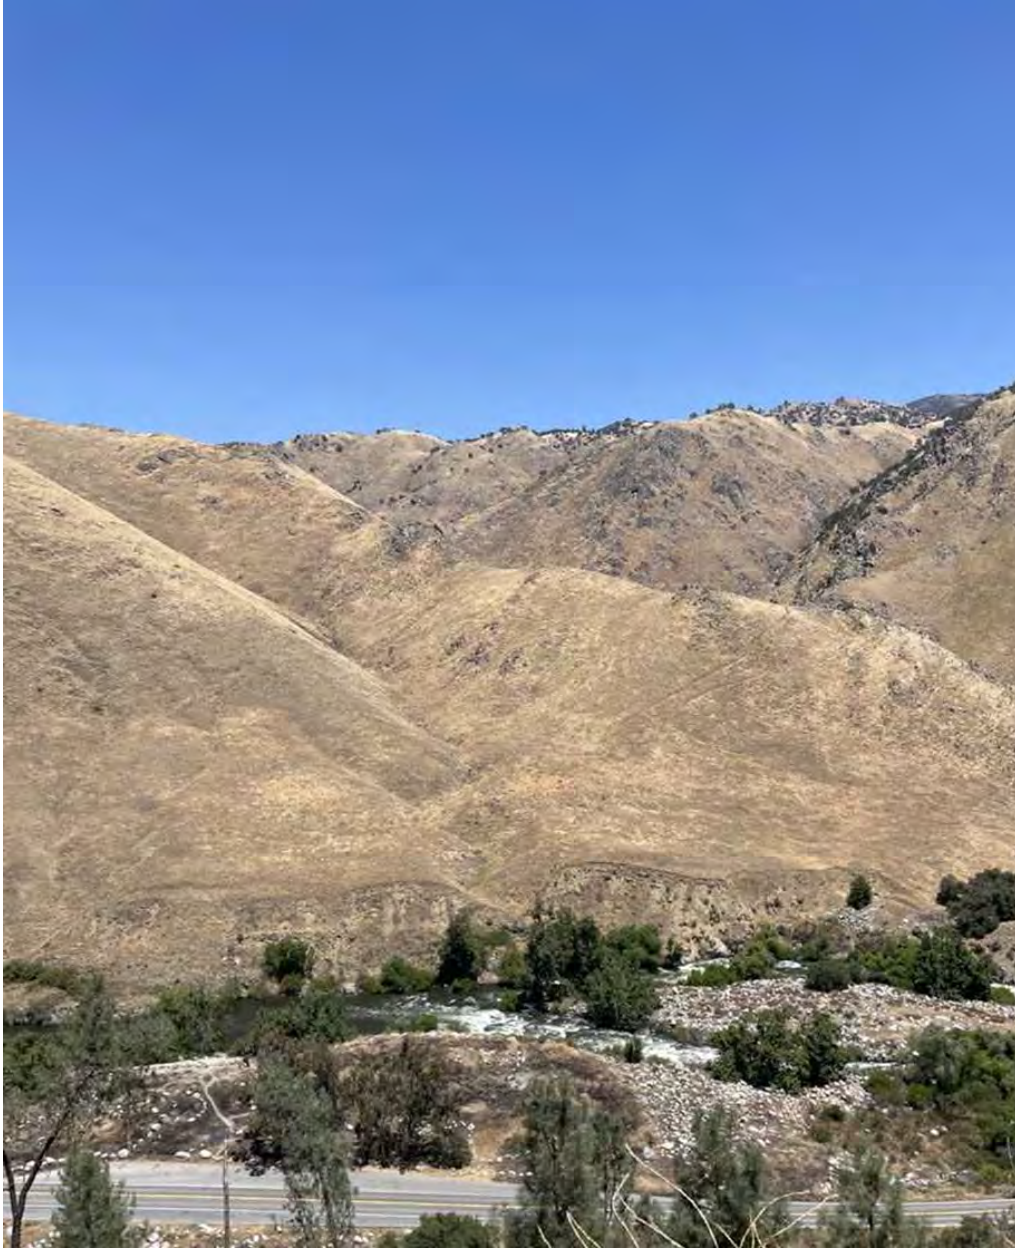
Based on field observation, few of the sites were actively eroding, with the only exceptions being two sites where active bank erosion was observed (Bank Erosion RB_1, and Bank Erosion RB_2 in Table 5-1). The few drainages that had flowing water (low flows) were not actively contributing sediment to the stream channel. The sites presented in Table 5-1 were classified as having high sediment delivery potential during high flow / heavy precipitation events. Hazards related to debris flows, landslides, and rock falls during heavy precipitation are a distinct possibility throughout the canyon. Project-Related Sediment Sources

Photo A-10. Bank Erosion RB_1

Photo A-11. Bank Erosion RB_1

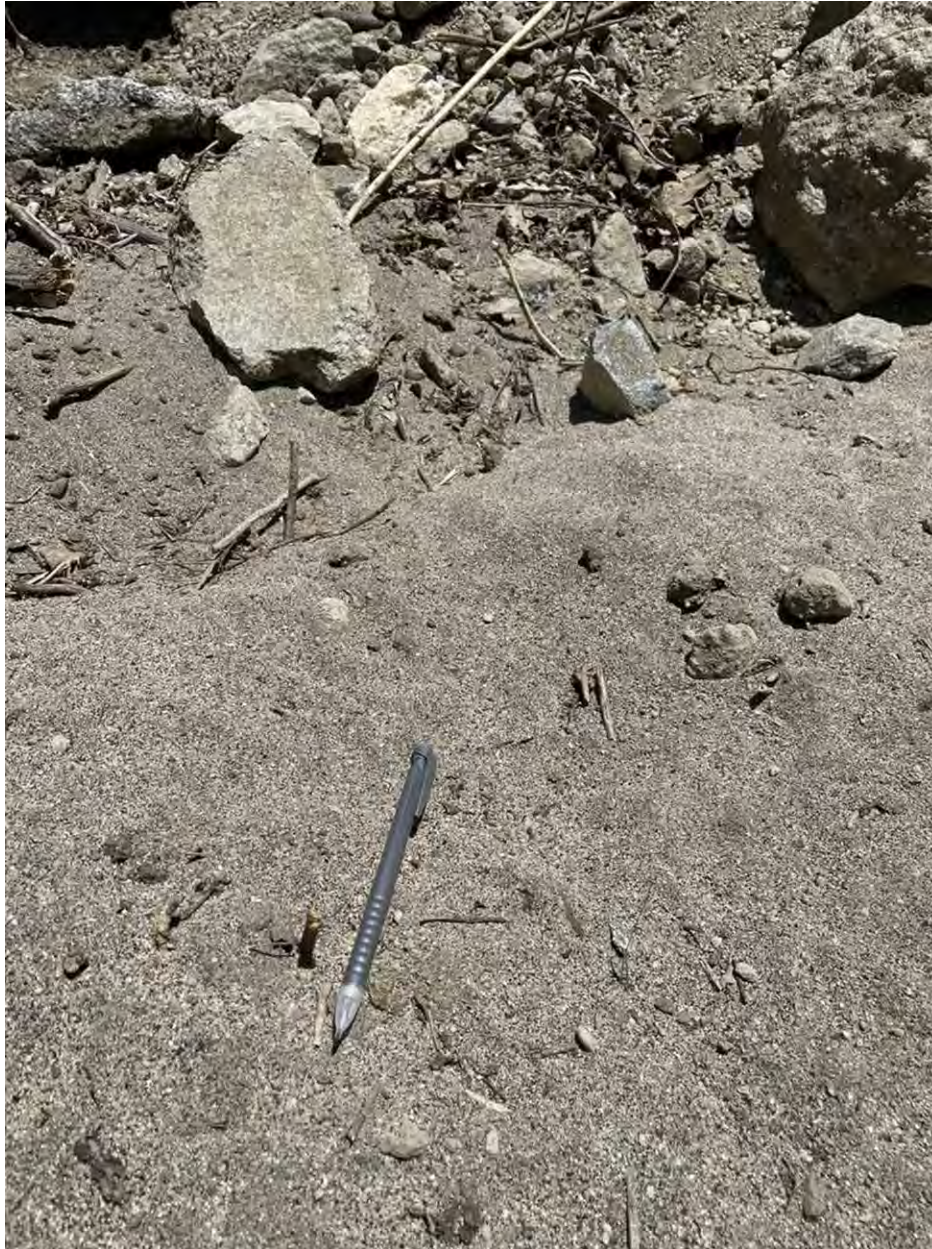
Photo A-12. Fine sediment in Stark Creek at end of flowline access road

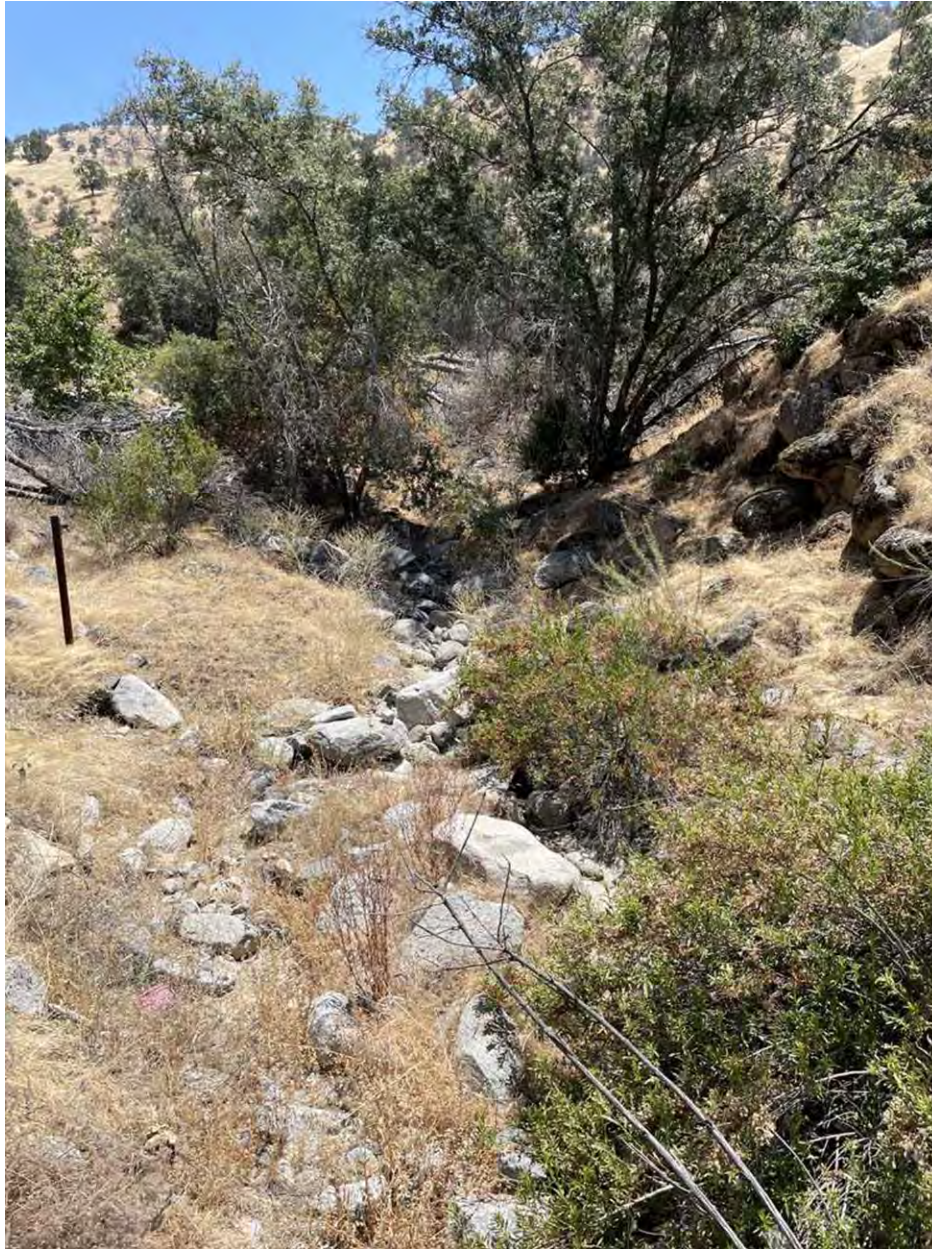
A-13	N/A	Dry	No	Yes	Stark Creek at SR-178. Boulder and cobble bed with some sand and gravel. Observations of the upper drainage and channel geometry suggest the potential for episodic debris flows and sediment transport that could impact travel on SR-178. Confluence with mainstem channel not accessible for visual observation or photos.
Rilling/Landslide_RB1	A-14 to A-15	N/A	N/A	No	Yes	Landslide scar with rilling on RB across from Lower Richbar Day Use Area. Potential for episodic erosion and sediment delivery directly into mainstem channel.
Bank Erosion_RB2	A-16	N/A	N/A	No	Yes	Steep eroding cut bank on RB. Composed of boulders and cobbles supported by sand and gravel matrix.
Peachacho Creek	N/A	N/A	Dry	No	Yes	Peachacho Creek at SR-178. Steep, deeply incised drainage. Considered to be a potentially significant source of sediment during high flows based on observations of other creeks in the canyon and aerial imagery. Not accessible for visual observation or photos.

Photo A-13. Stark Creek at SR-178
