LAND 2 – EROSION AND SEDIMENTATION TECHNICAL MEMORANDUM

KERN RIVER No. 1 HYDROELECTRIC PROJECT
FERC PROJECT No. 1930

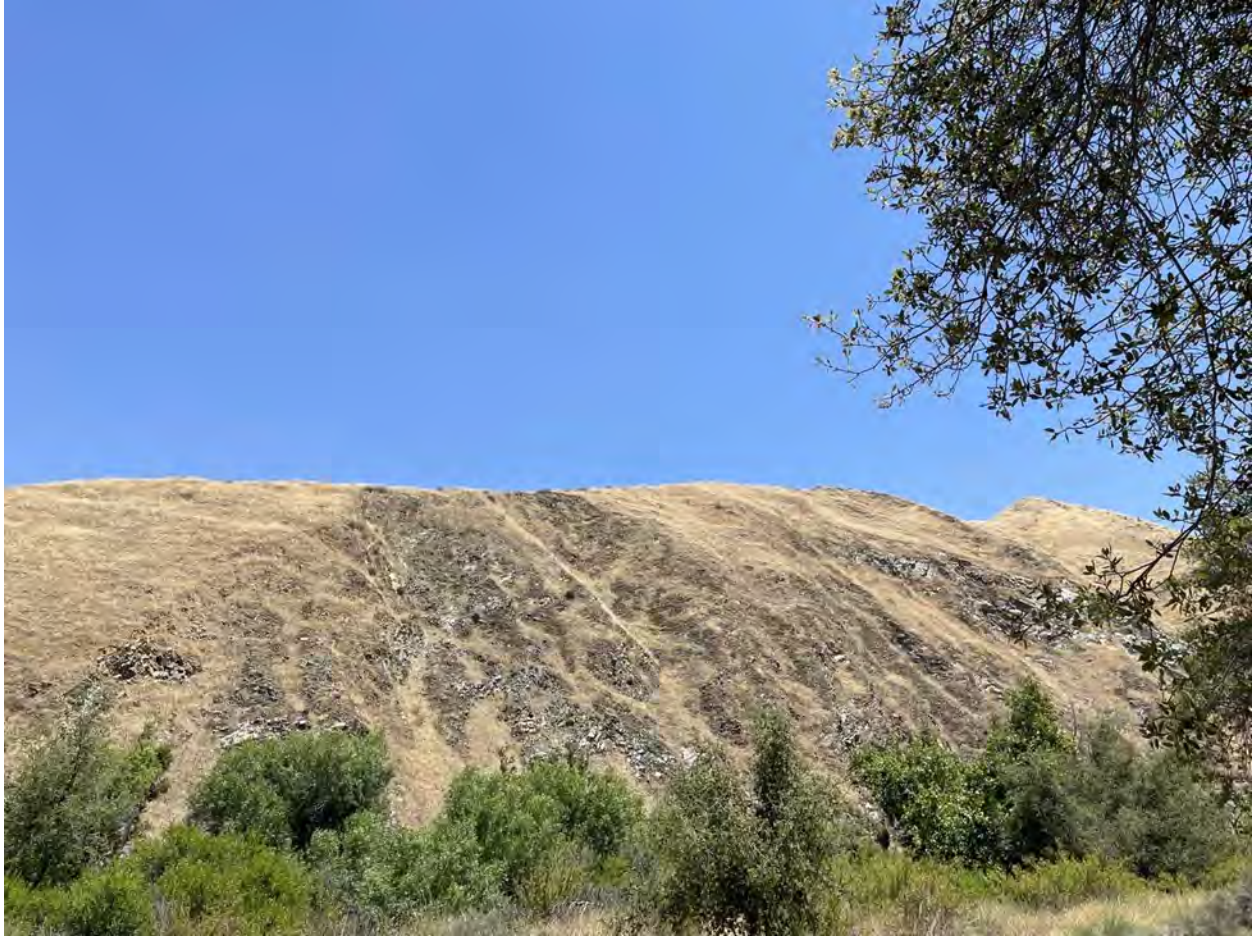
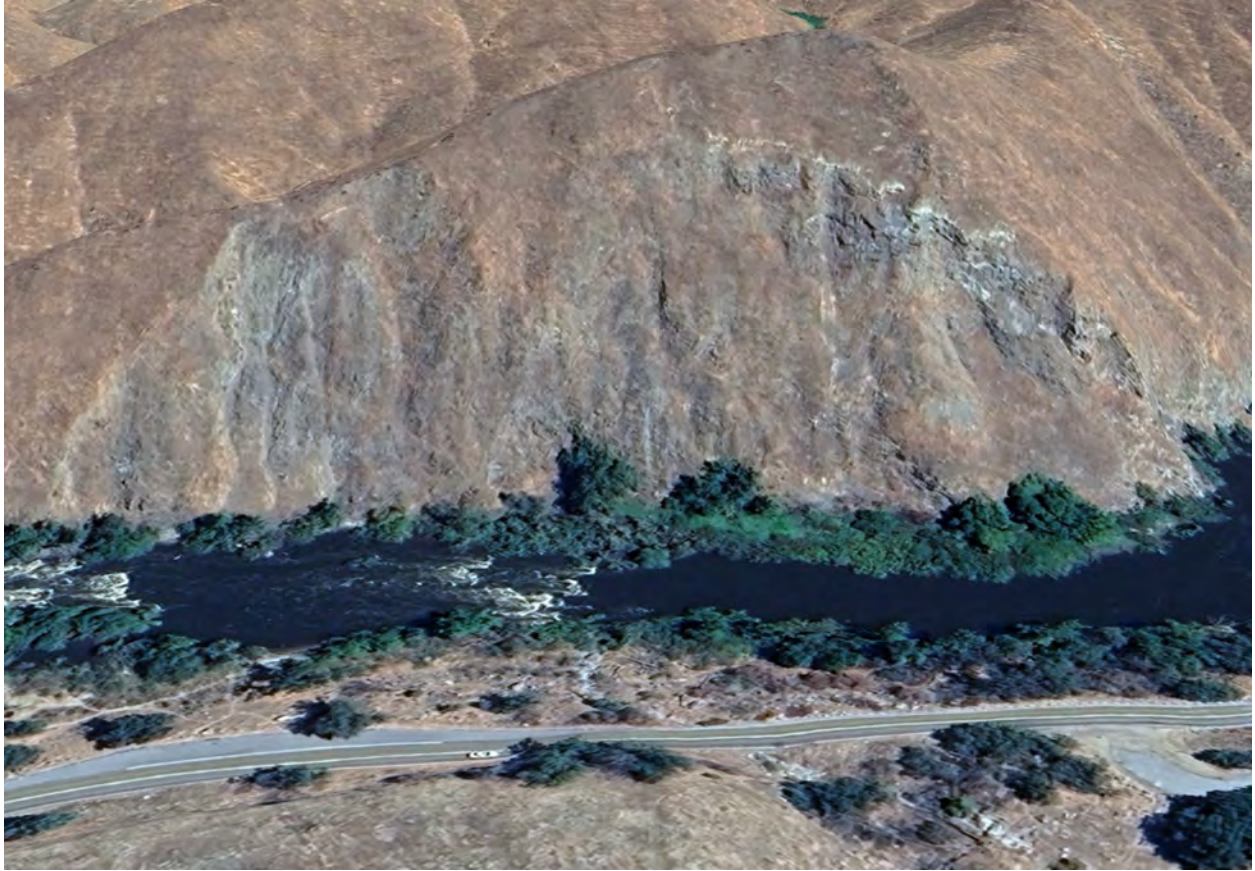
Photo A-14. Rilling/Landslide RB-1

Photo A-15. Rilling/Landslide RB-1 (Google Earth Image, Date: 8/24/23)

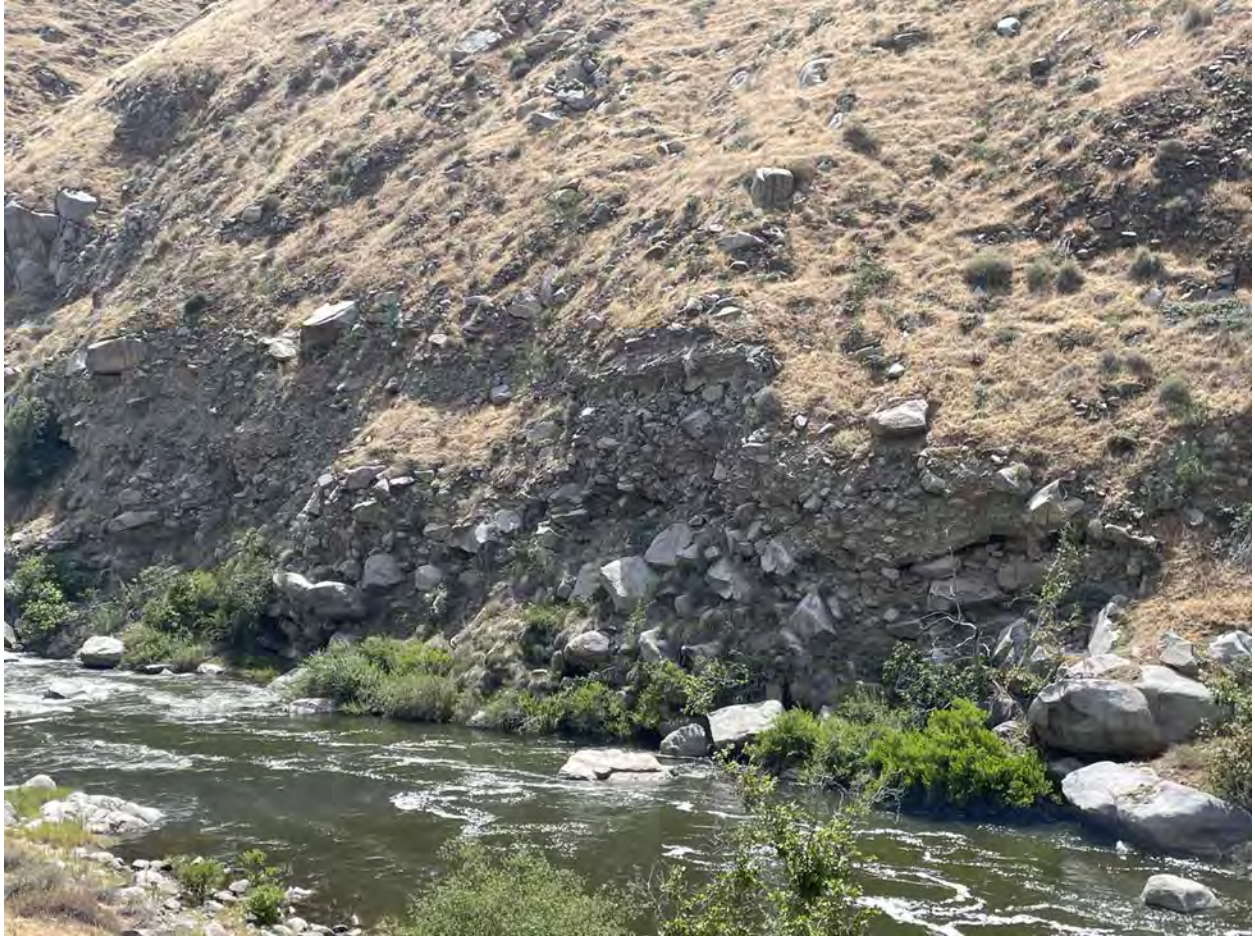
Based on field observation, few of the sites were actively eroding, with the only exceptions being two sites where active bank erosion was observed (Bank Erosion RB_1, and Bank Erosion RB_2 in Table 5-1). The few drainages that had flowing water (low flows) were not actively contributing sediment to the stream channel. The sites presented in Table 5-1 were classified as having high sediment delivery potential during high flow / heavy precipitation events. Hazards related to debris flows, landslides, and rock falls during heavy precipitation are a distinct possibility throughout the canyon. Project-Related Sediment Sources

Photo A-16. Bank Erosion RB-2

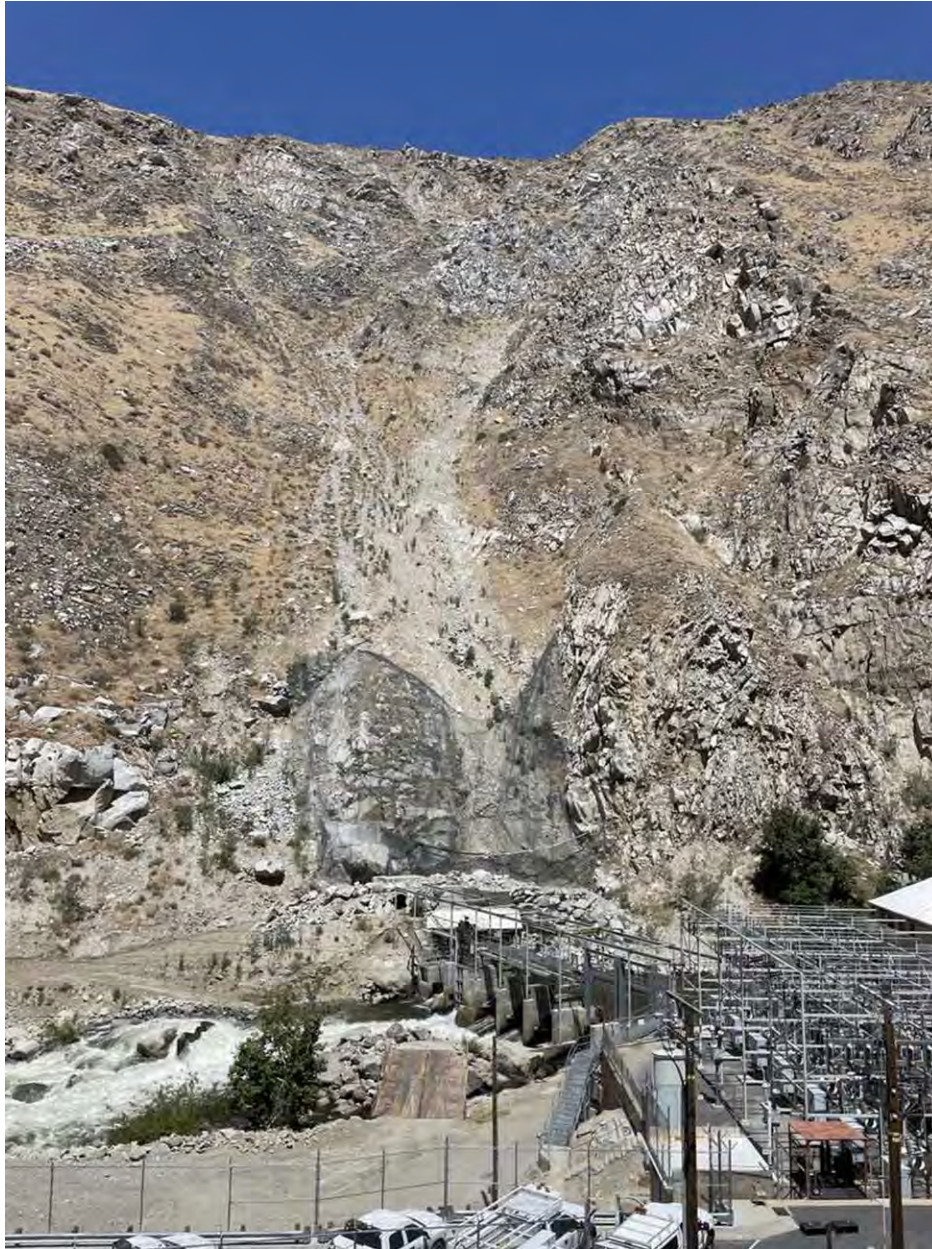
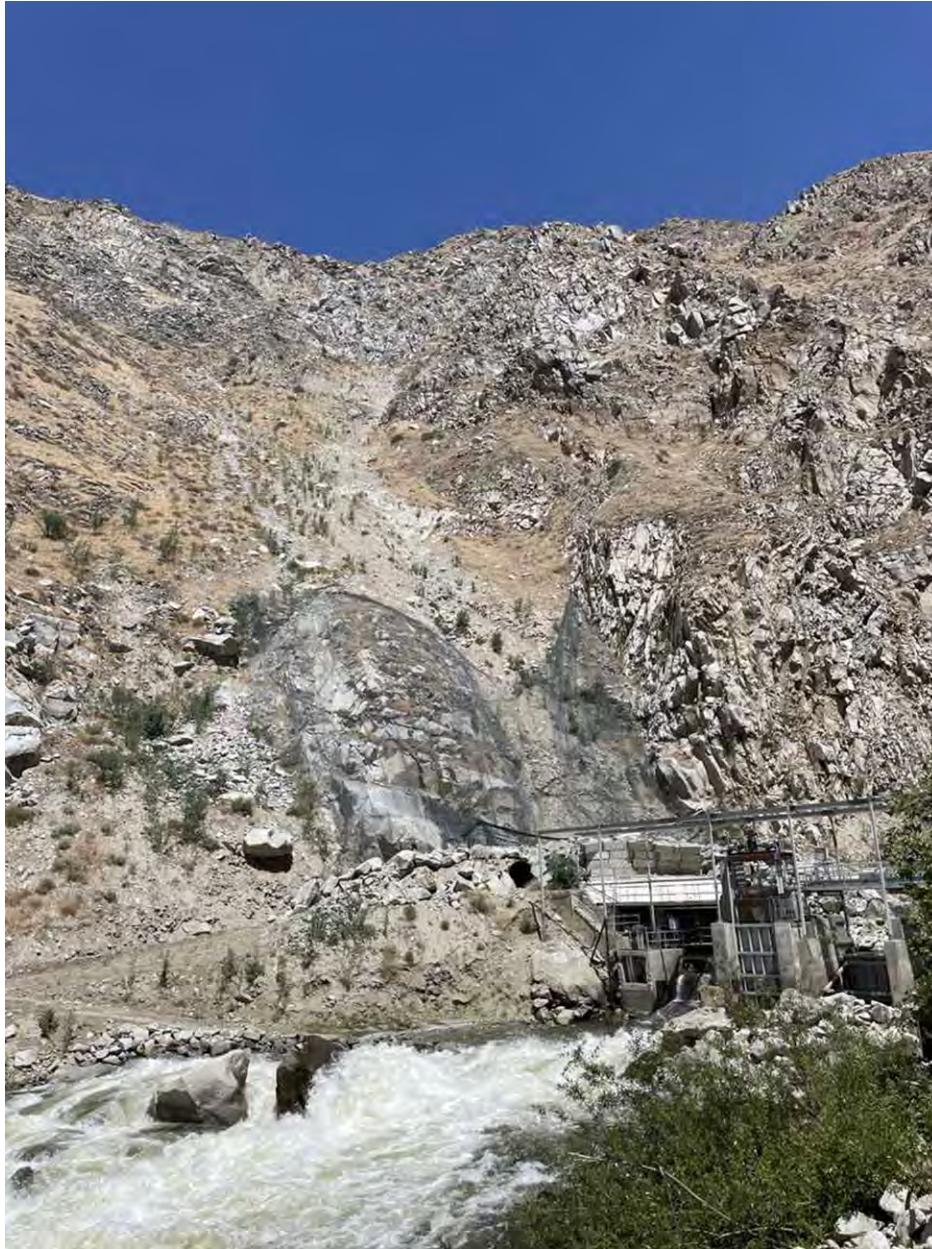
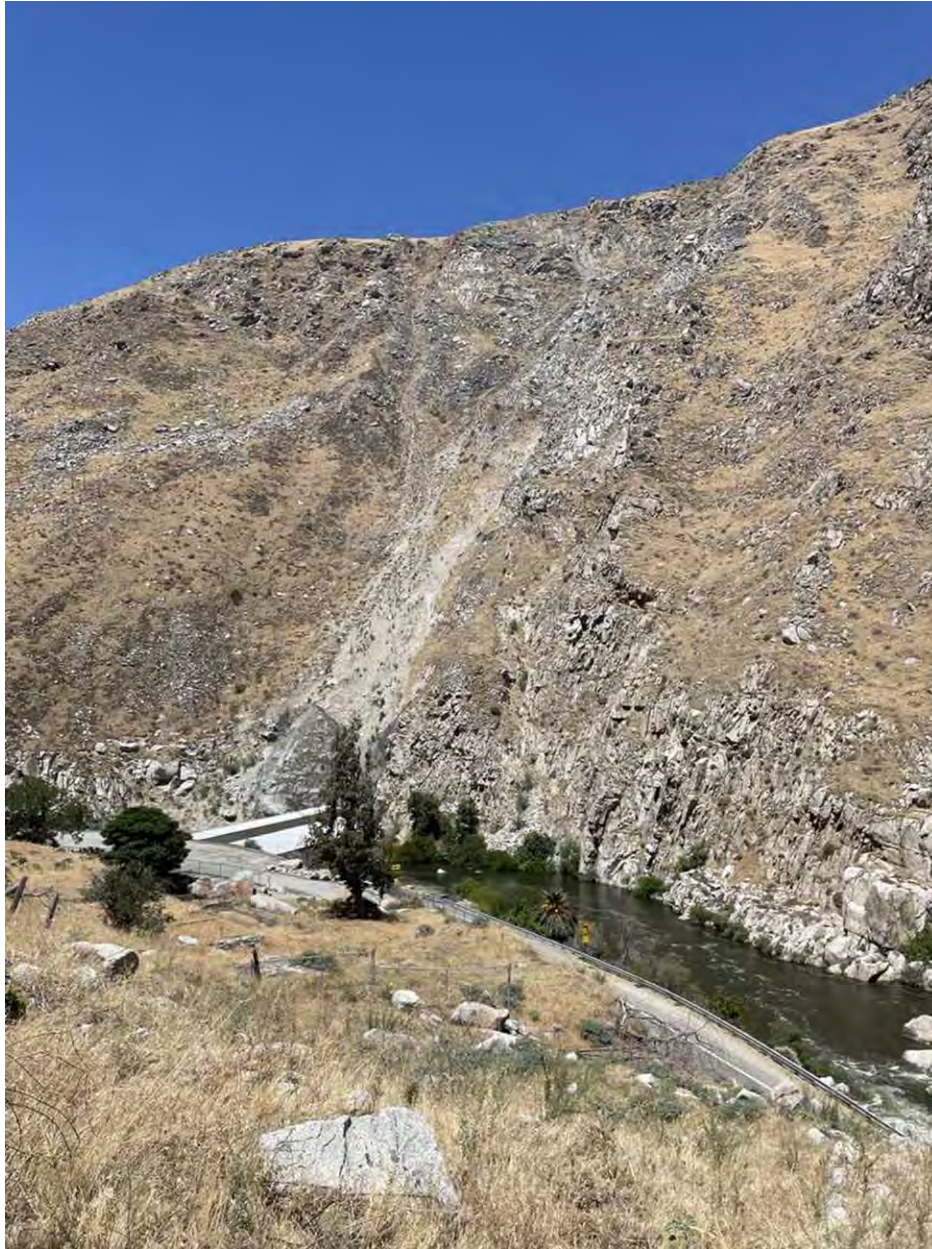
At the time of field observation there was no active erosion occurring at any Project facilities. The forebay spill event discussed in Section 5.2.1 was the most significant documented erosion that has occurred in the vicinity of the Project. There is rockfall area on the other side of the river from the KR1 Powerhouse that has potential to affect the powerhouse. A steel rockfall mitigation fence has been installed to help protect the powerhouse (Appendix A, Photos A-17 to A-19). The rockfall area is not caused by Project facilities.

Natural Rockslide near KR1 Powerhouse	A-17 to A-19	N/A	N/A	No	Yes	Large rockslide above the KR1 powerhouse.

Photo A-17. Natural Rockslide at KR1 Powerhouse

Photo A-18. Natural Rockslide at KR1 Powerhouse

Photo A-19. Natural Rockslide at KR1 Powerhouse

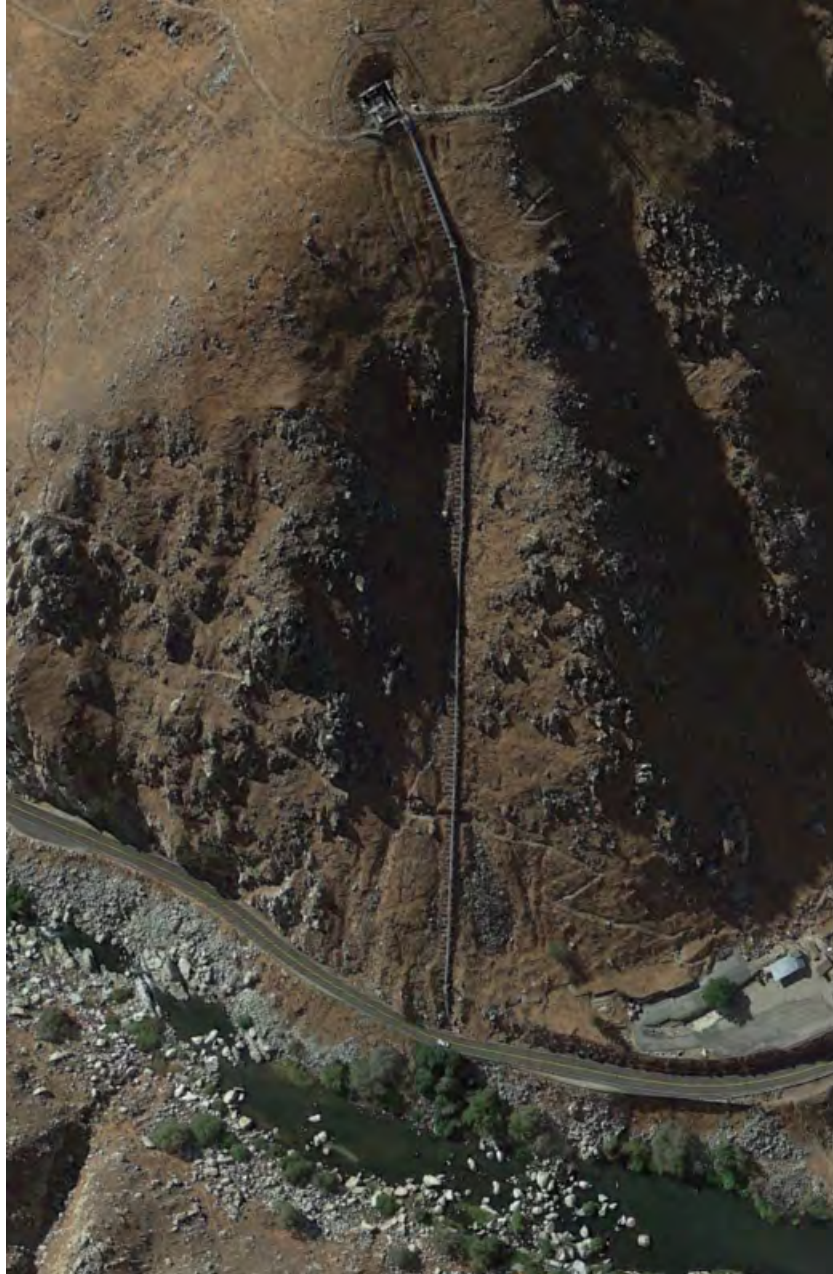
During the storm, however, rock, mud, water, and plant material from a debris flow entered the KR1 conduit approximately 1 mile upstream of the forebay. This debris flow (mud and plant material) entered the flowline at Adit 17/18, which is an open-air vent location in the flowline. At Adit 17/18 the debris flow passed over and into the flowline at the vent location and this temporary surge of flow (with mud and plant material) continued down the flowline to the forebay. At the forebay an overflow spillway pipe would have handled the flow surge except for the mud and plant material caused the intake to the spillway pipe to plug. The overflow spillway pipe conveys flow surges to the Kern River. Due to the plugged intake the forebay was overtopped resulting in erosion of the hillside below the forebay and along (parallel to) the overflow spillway pipe (SCE 2013). Refer to Appendix A, Photos A-20 to A-22.

Site	Photographs (Appendix A)	Approximate Volume (CY)	Hydrology at the Time of the Survey	Project Related	Natural Causes	Description
8/20/2013 Forebay Spill	A-20	N/A	N/A	No*	Yes*	Rock, mud, water, and plant material from a landslide entered the KR1 conduit approximately 1 mile upstream of the forebay. This material continued downstream in the tunnel creating a temporary surge in flows at the forebay, causing the pipe spillway to plug and forebay to spill. This resulted in erosion of the hillside below the forebay and along the pipe spillway. This area is not subject to erosion/sedimentation due to ongoing, regular Project operations. Rather, the erosion was due to a unique, one-time event. At the time of field observations for this study, there was no evidence of ongoing erosion observed at this location.
8/20/2013 Forebay Erosion Deposit	A-21 to A-22	N/A	N/A	No*	Yes*

Photo A-21. KR1 Penstock before the August 20, 2013, Forebay Spill Event (Google Earth Image, Date: 8/12/2013)

Photo A-22. KR1 Penstock Erosion and Sediment Deposition in the Kern River Channel After the August 20, 2013, Forebay Spill Event (Google Earth Image, Date: 4/15/2014)

Following this event, SCE completed modifications to the flowline to prevent recurrence of a similar event. SCE has made modifications at the vent opening at Adit 17/18 to redirect any upslope runoff or debris flows over the opening and preventing flow, mud or plant material from entering the flowline. At the forebay measures were completed to prevent future overtopping by removing the screen/rack at the intake to the overflow spill pipe thus preventing plugging to allow any surge flow to enter the overflow pipe. Thus, this area is not subject to erosion/sedimentation due to ongoing, regular Project operations. Rather, the erosion was due to a unique, one-time event. At the time of field observations for this study, there was no evidence of ongoing active erosion observed at this location.

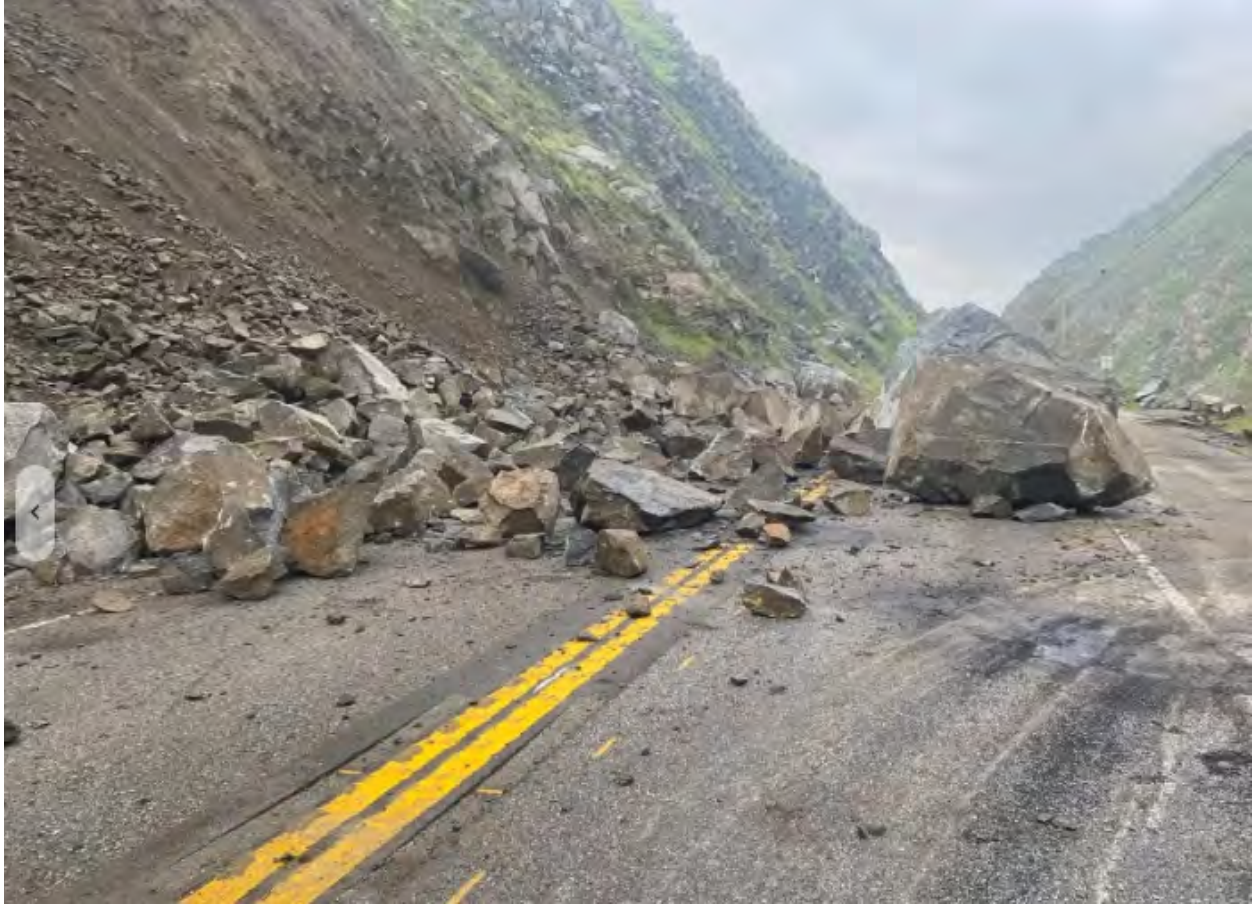
Heavy rainfall on a record snowpack in the upper watershed's drainages caused debris slides and rockfalls which closed SR-178 for several days on March 1 and March 15, 2023 (Appendix A, Photos A-23 to A-24).

Photo A-23. Debris Slide Closing SR-178 on March 1, 2023 (Caltrans 2023)

Photo A-24. Debris Slide Closing SR-178 on March 15, 2023 (Caltrans 2023)
