Rush Creek Project, FERC Project No. 1389

LAND 1 – Aesthetics Technical Study Report

January 2025

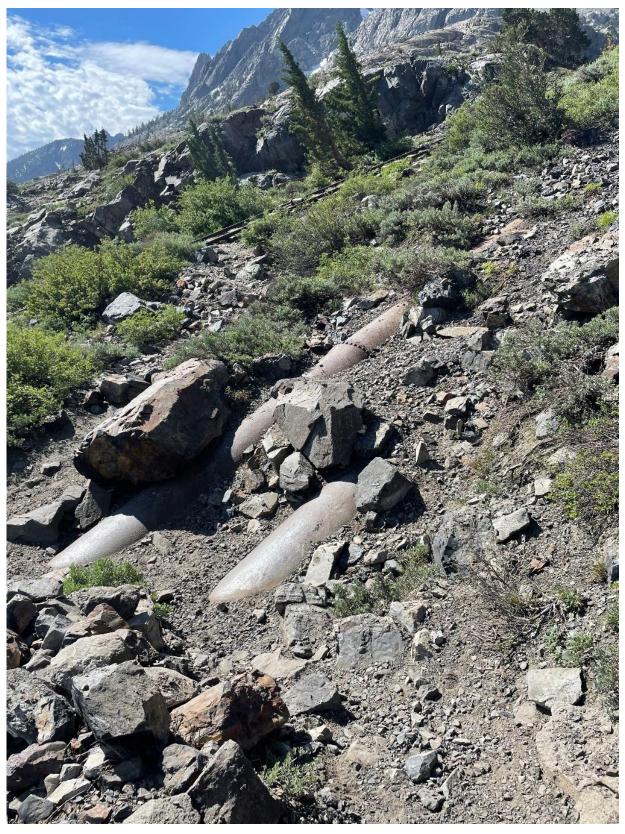
Photo 1. Key Observation Point 1, Penstock and Tram Tracks

Note: July 17, 2023 (37.7655, -119.13)

- GPS Coordinates: 37.7655, -119.13
- Location Description: Rush Creek Trail heading toward Horsetail Falls
- Viewshed Description: Horsetail Falls is the prominent view heading up the trail. Obviously, visible Project facilities include the tram tracks, Agnew 4-kilovolt (kV) line, and penstock/flowline. The Agnew 4-kV line and associated poles are a component of the middleground view. Looking east from the trail into the valley, the developed areas of the June Lake Loop are visible to the south of Silver Lake. The tram tracks and partial views of the penstock/flowline are among the elements in the foreground while walking. Project facilities, while contrasting in line and form with the natural landscape are generally consistent with other landscape colors (not contrasting).

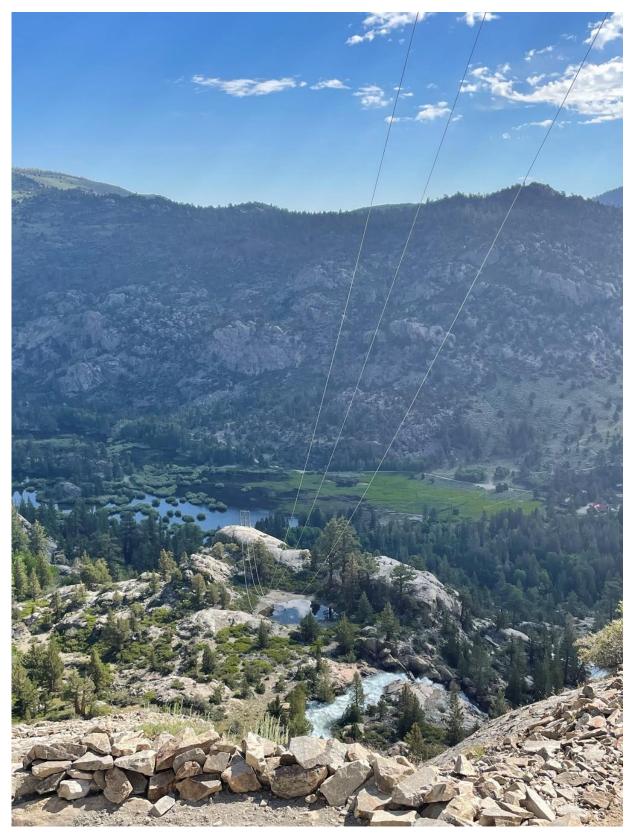
Photo 2. Key Observation Point 2, Agnew 4-kV Line

Note: July 17, 2023 (37.7628, -119.129)

- GPS Coordinates: 37.7628, -119.129
- Location Description: Viewpoint along the Rush Creek Trail with views directly down the Agnew 4-kV line east into the valley.
- Viewshed Description: Steep slope of the mountain to the west and views over the
 valley to the east as the trail climbs toward Horsetail Falls. The slope is rocky talus
 with large granite outcroppings and occasional shrubby vegetation, though there
 are few trees along the trail. The developed background of the valley limits visual
 awareness of facility infrastructure, though the tram tracks and Agnew 4-kV line
 are present at the viewpoint and all along the trail.

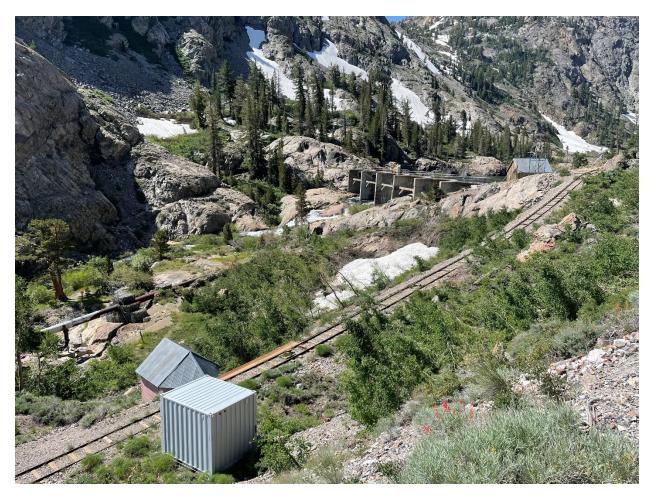
Photo 3. Key Observation Point 3, Agnew Dam and Ancillary Facilities—View from Downstream

Note: July 17, 2023. (37.7593, -119.132)

- GPS Coordinates: 37.7593, -119.132
- Location Description: Along the Rush Creek Trail above Rush Creek just east and above Agnew Junction.
- Viewshed Description: From this location perched along the trail above Rush Creek multiple Project facilities are visually prominent within the foreground and middleground, including the flowline, and tram tracks (below the trail), the downstream view of Agnew Dam, stand pipe, valve house, Agnew flume, and various other buildings and infrastructure. While contrasting in line, form and texture with the natural landscape, the weathered historical feel of buildings and of the tram tracks lessen their contrast with the natural setting – a backdrop of high Sierra rocks and mountains.

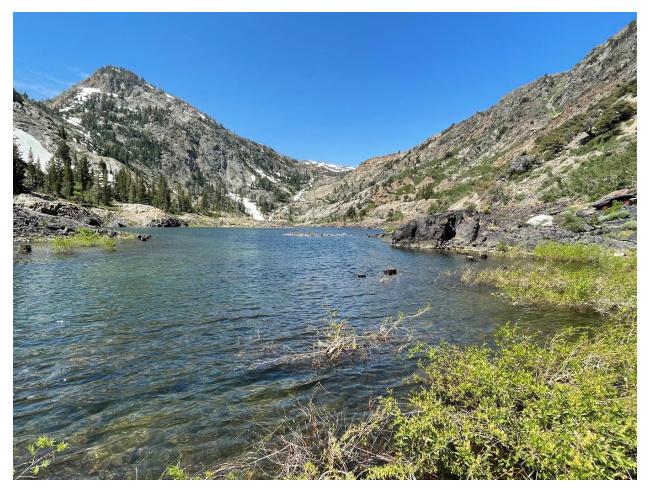
Photo 4. Key Observation Point 4, Agnew Lake and Dam at Shoreline—(looking upstream toward Gem Dam)

Note: July 17, 2023 (37.7579, -119.132)

- GPS Coordinates: 37.7579, -119.132
- Location Description: Directly adjacent to the upstream end of Agnew Dam along the shoreline of the lake.
- Viewshed Description: Views upstream (southwest) are across Agnew Lake toward Gem Dam which is just visible at the top of the drainage (a uniform gray against the red/tan rock and green vegetation). Downstream views are dominated by the foreground of the Agnew Dam, while the boathouse and other ancillary facilities take up most of the visual foreground space when looking toward the Rush Creek Trail. The Agnew Lake motor barge is a prominent visual element when standing at the shoreline looking out across the lake and contrasts sharply in form, line, shape, and color (the barge is red) with the surrounding lake and granite rock. Surrounding mountains rise steeply several thousand feet above the facilities. Shoreline vegetation includes minimal grasses and some shrubs.

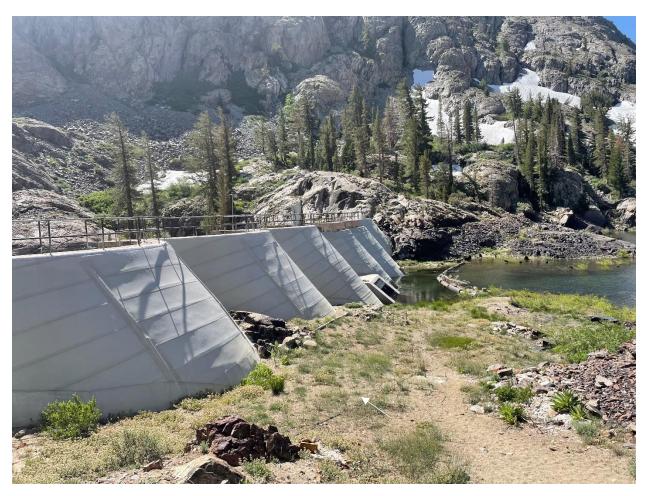
Photo 5. Key Observation Point 4, Agnew Dam at Shoreline

Note: July 17, 2023 (37.7579, -119.132)

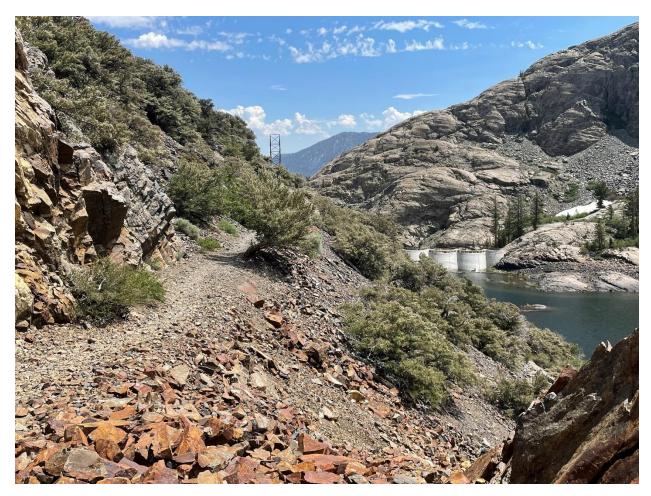
Photo 6. Key Observation Point 5, Agnew Lake—View from Upstream

Note: July 17, 2023 (37.7574, -119.135)

- GPS Coordinates: 37.7574, -119.135
- Location Description: Along the Rush Creek Trail above Agnew Lake looking towards the upstream face of Agnew Dam.
- Viewshed Description: The Rush Creek Trail runs mid-slope along the rocky talus
 of the mountain that climbs above Agnew Lake on its northeast shoreline.
 Vegetation is sparse. The white geomembrane of Agnew Dam contrasts sharply
 against the grey and tan of the surrounding rocky environment. A powerline tower
 is visible in the skyline to the north of the dam.

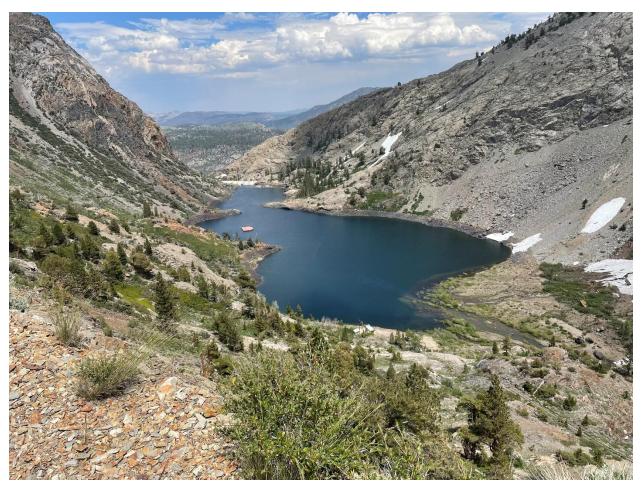
Photo 7. Key Observation Point 6, Agnew Lake and Dam—View from Above

Note: July 17, 2023 (37.7528, -119.141)

- GPS Coordinates: 37.7528, -119.141
- Location Description: Rush Creek Trail at the top of the drainage immediately north of Gem Dam (Gem Dam not visible).
- Viewshed description: Exposed ridgetop with expansive view encompassing all of Agnew Lake to the east. Agnew Dam's white geomembrane is visible at the eastern end of the lake and the red motor barge is a prominent visual element in the lake itself. Swimmers are visible below along the western shoreline of Agnew Lake. Rush Creek Trail and Spooky Meadows Trail are linear features that rise away from the lake to the west along the talus slopes that create the lake basin. Topography and vegetation obstruct any views of Gem Dam to the west.

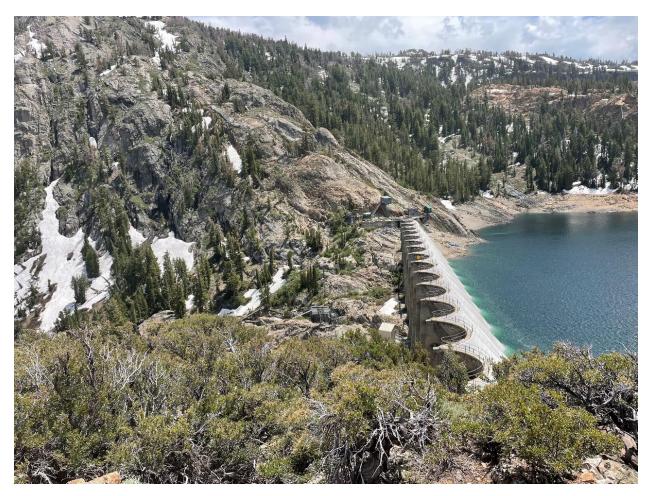
Photo 8. Key Observation Point 7, Gem Dam

Note: July 17, 2023 (37.7525, -119.141)

- GPS Coordinates: 37.7525, -119.141
- Location Description: Top of the ridge between Gem Lake and Agnew Lake south of Rush Creek Trail.
- Viewshed Description: View from a rocky exposed ridge above Gem Dam approximately one hundred yards south and above the Rush Creek Trail. The entirety of Gem's Dam crest is visible from the ridge as is Rush Creek and many of the ancillary facilities on the downstream side of the dam. The generation facilities are weathered, like the landscape, though the angular forms of the buildings and some of the equipment, especially at the landing area across the other side of the dam, create an industrial sense of place. Dominant landscape elements in the foreground include red and tan rocks, and shrubby vegetation, while the backdrop includes towering mountains to the west. Gem Lake appears as an obvious reservoir with a clear gap of several feet in elevation between the edge of the water and the line of vegetation around its shore.

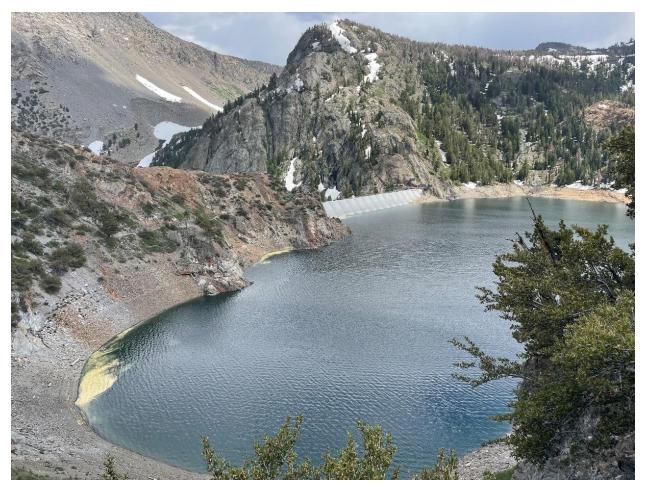
Photo 9. Key Observation Point 8, Gem Dam—View from Upstream (looking east)

Note: July 19, 2023 (37.7546, -119.144)

- GPS Coordinates: 37.7546, -119.144
- Location Description: Rush Creek Trail along the north side of Gem Dam just west of the dam itself.
- Viewshed Description: Facing west along the trail Gem Dam's white geomembrane
 is a dominant element of the foreground and middleground spanning the narrow
 mouth of the lake basin. Gem Lake is an obvious reservoir with a defined "bathtub
 ring" even with the water at high elevation. There is no access to the lake itself
 as steep rocky slopes and cliffs scarce of vegetation separate the trail from
 the shoreline.

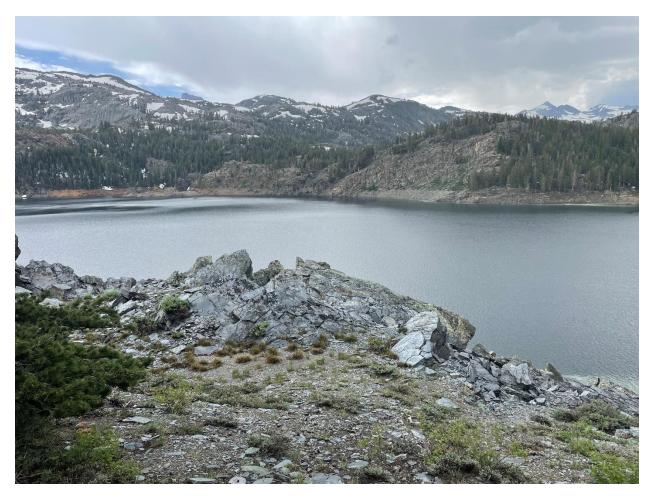
Photo 10. Key Observation Point 9, Gem Lake (looking south)

Note: July 17, 2023 (37.7535, -119.148)

- GPS Coordinates: 37.7535, -119.148
- Location Description: View across Gem Lake from a mid-point of the trail along the northern shoreline.
- Viewshed Description: Viewpoint of a large portion of Gem Lake to the east, south and west. The Sierra crest is visible to the west and the mountains that constitute the basin of Gem Lake visible in all directions. No Project facilities are visible, however, the "bathtub ring" around the lake indicates the viewshed is not of a natural lake basin.

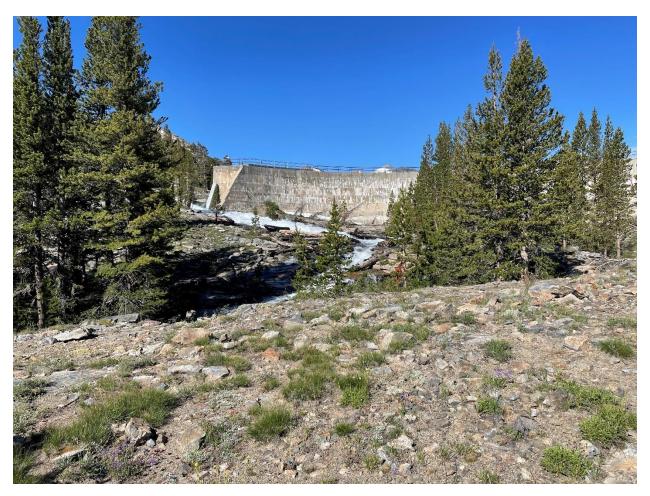
Photo 11. Key Observation Point 10, Rush Meadows Dam—View from Downstream

Note: July 18, 2023 (37.7512, -119.181)

initial view of dam.
- Viewshed Description: Foreground is dominated by the face of the dam which
 obstructs views of the mountains to the west beyond the dam. The dam and its
 notch are visible as is Rush Creek as it passes through the notch. The surrounding
 environment is rocky high Sierra with vegetation consisting of various conifers and
 some low grasses and shrubs. The color of the dam is consistent with surrounding
 colors: gray, tan and weathered.

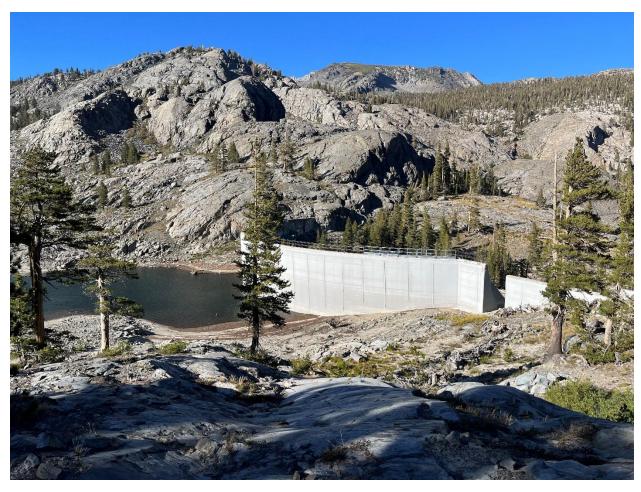
Photo 12. Key Observation Point 11, Rush Meadows Dam—View from Weber Lake Trail

Note: September 26, 2023 (37.7501, -119.182)

Viewshed Description: The entire length of the upstream face of Rush Meadows Dam dominates the view. The upstream face of the dam, covered by the geomembrane is starkly white against a rocky gray backdrop. The notch in the dam is clearly visible as is the railing across the dam's crest.

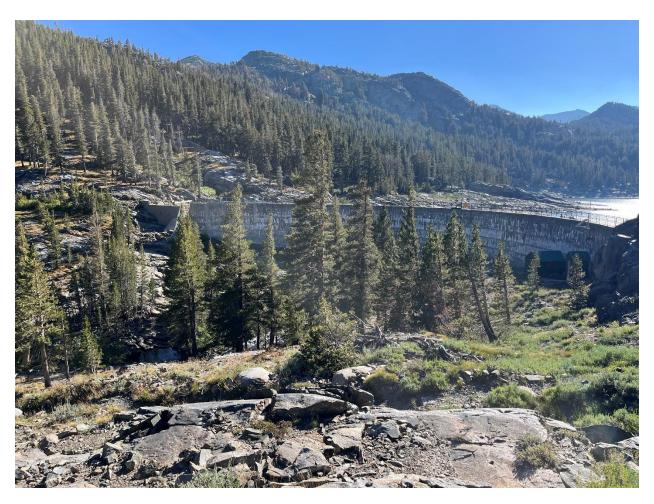
Photo 13. Key Observation Point 12, Rush Meadows Dam

Note: September 26, 2023 (37.7517, -119.181)

- GPS Coordinates: 37.7517, -119.181
- Location Description: Rush Creek Trail adjacent and across from Rush Meadows Dam as the trail climbs from the dam base to Waugh Lake.
- Viewshed Description: The whole of the downstream face of the dam (including the notch) is the dominant visible element in the foreground. Ancillary infrastructure including the gage house, equipment shed, and valve house are also visible. Some of the lake and most of the Sierra crest (Mount Dana, Rodgers Peak and Mount Lyle) are the visible backdrop behind the dam. The dam itself, though an obvious visual intrusion, matches the weathered colors of the landscape. The yellow slide gates at the crest of the dam contrast with the colors of the landscape.

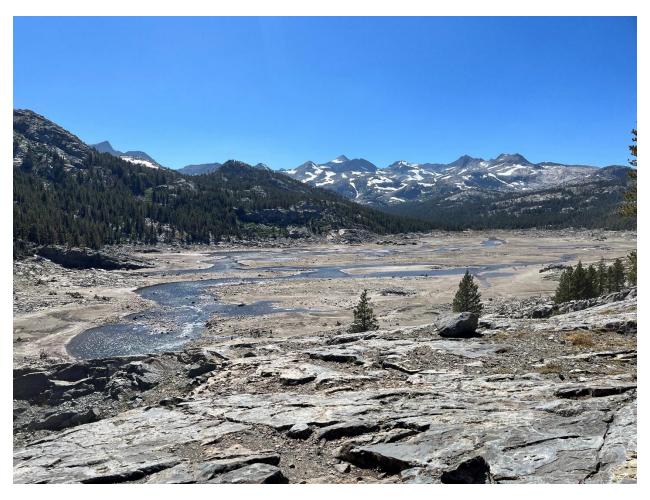
Photo 14. Key Observation Point 13, Waugh Lake—View from Rush Creek Trail Near Dam (looking upstream)

Note: August 31, 2023 (37.7519, -119.182)

- GPS Coordinates: 37.7519, -119.182
- Location Description: View from the shoreline area of Waugh Lake just beyond Rush Meadows Dam – looking west towards the Sierra crest.
- Viewshed Description: The view is expansive across the Waugh lakebed which
 comprises the foreground and middleground of the view while the high peaks of
 the Sierra crest dominate the backdrop. The lakebed itself appears as a drained
 reservoir with silty mud and meandering creek conditions visible across to the far
 side of the lake. Close to the location of the KOP, shallow riffles indicate the current
 of Rush Creek as it travels toward the notch in Rush Meadows Dam.

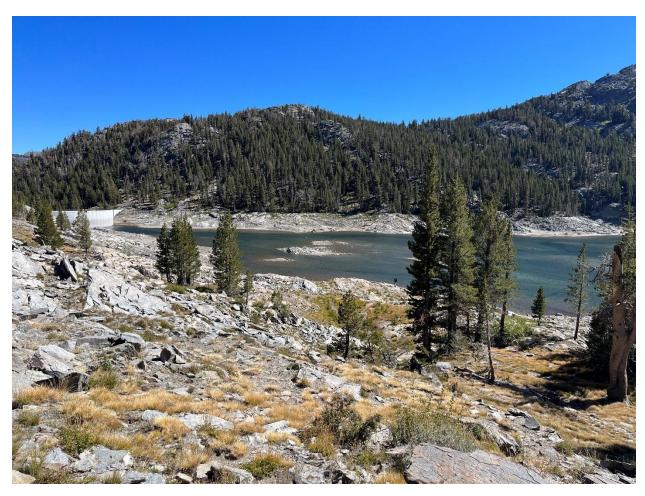
Photo 15. Key Observation Point 14, Rush Meadows Dam—View from Upstream Toward Dam

Note: September 26, 2023 (37.7528, -119.185)

- GPS Coordinates: 37.7528, -119.185
- Location Description: Rush Creek Trail upstream of Rush Meadows Dam
- Viewshed Description: Dam is visible to the west heading down the trail. The white
 of the geomembrane is lighter in color than the surrounding rocks. The lake is low
 compared to the top of the dam and at lower water levels, the lake appears dry
 and a "bathtub ring" is visible. Sparse vegetation along the northern shoreline
 (south facing shoreline) allows for mostly unobstructed views.

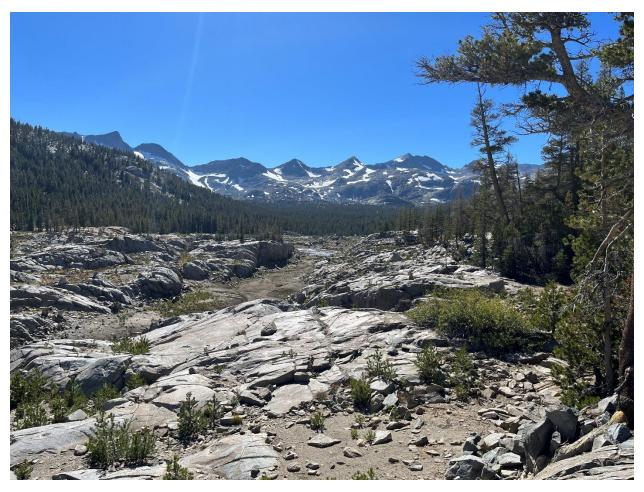
Photo 16. Key Observation Point 15, Waugh Lake—Northern Shoreline (looking upstream)

Note: September 26, 2023 (37.7529, -119.195)

- Viewshed Description: Looking upstream, the silty lakebed of Waugh Lake is replaced by granite slabs of rock and a defined creek channel (mostly dry in September 2023). The high peaks of the Sierra crest dominate the upstream backdrop. Vegetation at the shoreline consists of scattered conifers (mostly lodgepole pine). Downstream the view during early summer (peak runoff) varies dramatically compared to later in the season after most of the snow has melted. During the early season, the lake appears nearly full with no lakebed visible and the crest of the dam just visible as a linear flat feature, distinctive compared to the rounded mountainous terrain on either side of the drainage. Later in the season the brown silt of the lakebed dominates the foreground and the whole of Rush Meadows Dam is visible at the eastern end, its white geomembrane contrasting starkly with the blue and brown of the lakebed and the rocky gray mountains beyond.

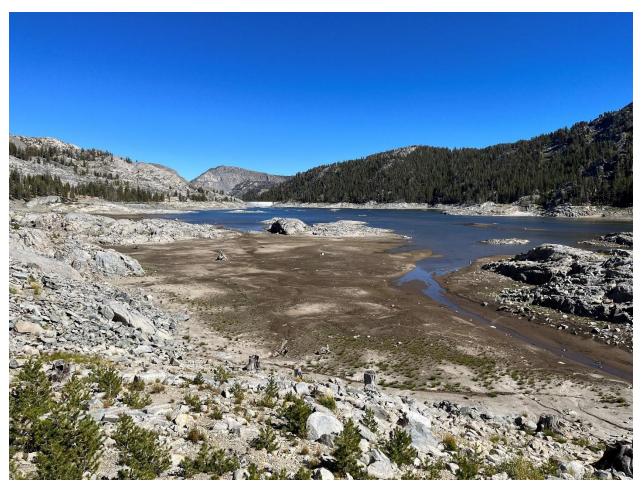
Photo 17. Key Observation Point 15, Waugh Lake—Northern Shoreline (looking downstream)

Note: September 26, 2023 (37.7529, -119.195)

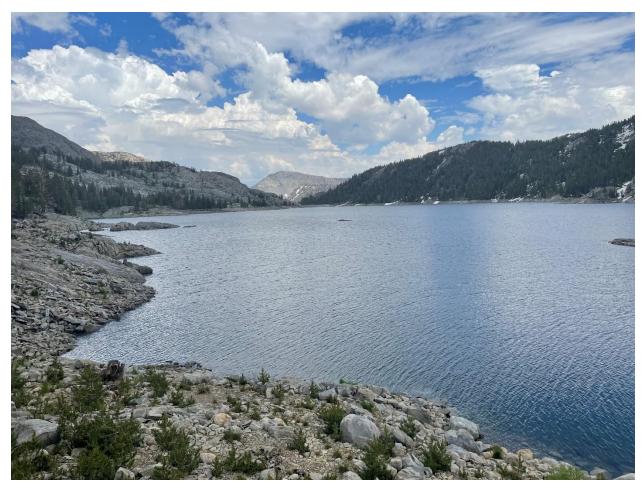
Photo 18. Key Observation Point 15, Waugh Lake—Northern Shoreline (looking downstream)

Note: July 18, 2023 (37.7529, -119.195)

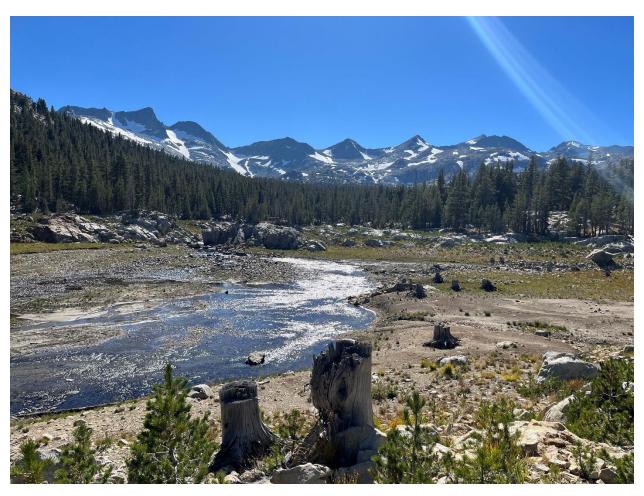
Photo 19. Key Observation Point 16, Waugh Lake—Western End (looking upstream)

Note: September 26, 2023 (37.7499, -119.201)

- GPS Coordinates: 37.7499, -119.201
- Location Description: Western end of Waugh Lake, just downstream from the inlet of Rush Creek to the lakebed.
- Viewshed Description: The upstream view is of the Rush Creek inlet to the lake.
 Coniferous forests ring the lakebed to the west and on either side of the inlet. The
 Sierra crest remains the prominent backdrop. Where the water has receded,
 stumps are visible scatted around the shoreline. Stranded rocky outcroppings
 create varied topography across the lakebed at lower water elevations. In areas of
 permanently exposed sediment uniform stands of young lodgepole pines are
 well established.

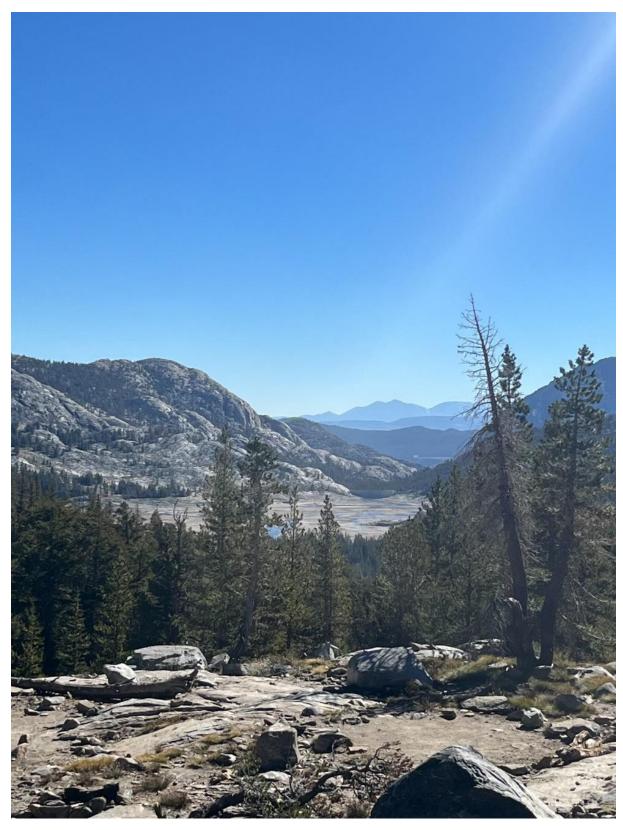
Photo 20. Key Observation Point 17, Waugh Lake from the Pacific Crest Trail

Note: September 26, 2023 (37.7468, -119.215)

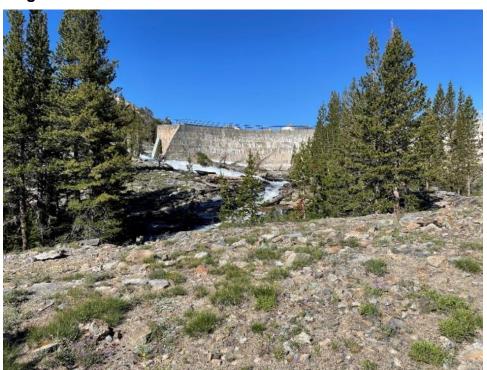
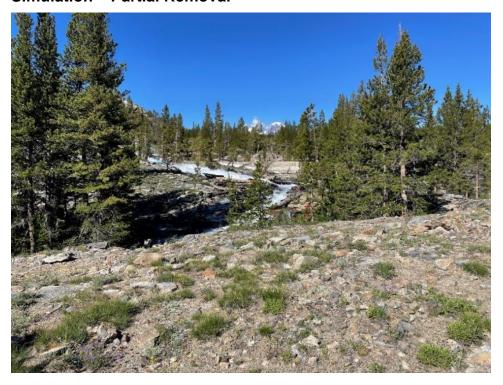
RUSH MEADOWS DAM - KOP 10

Simulation - Partial Removal

Simulation - Full Removal

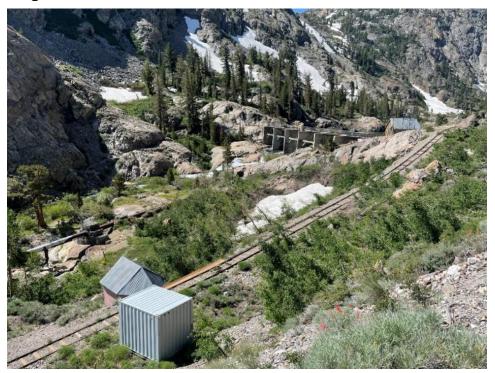
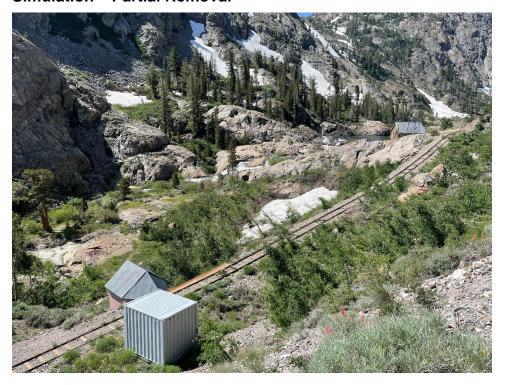
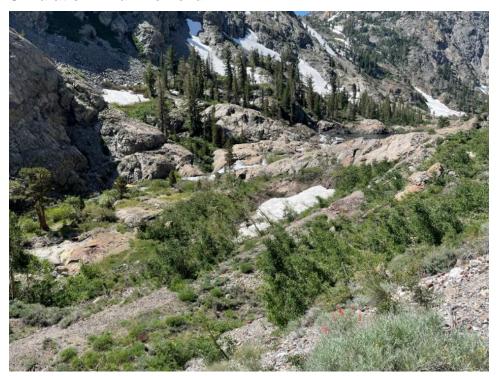
AGNEW DAM - KOP 3

Simulation - Partial Removal

Simulation - Full Removal

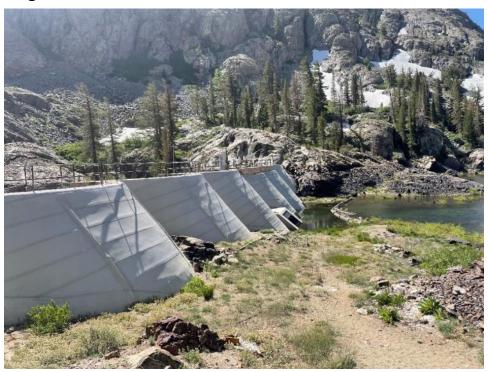
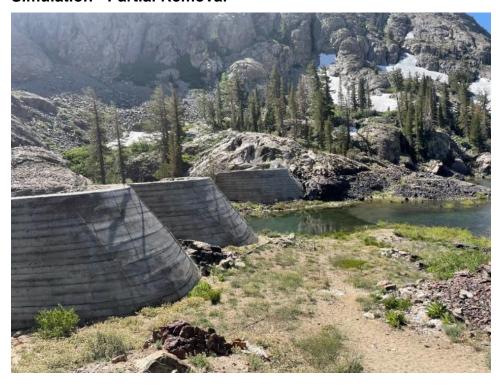
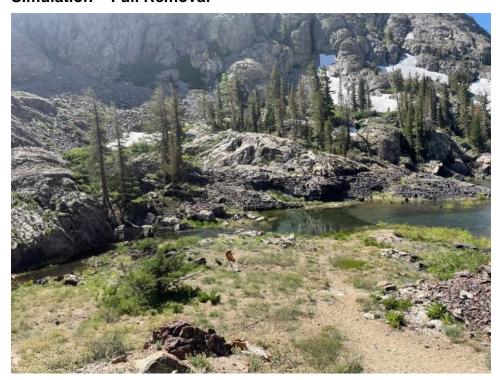
AGNEW DAM - KOP 4

Simulation - Partial Removal

Simulation - Full Removal

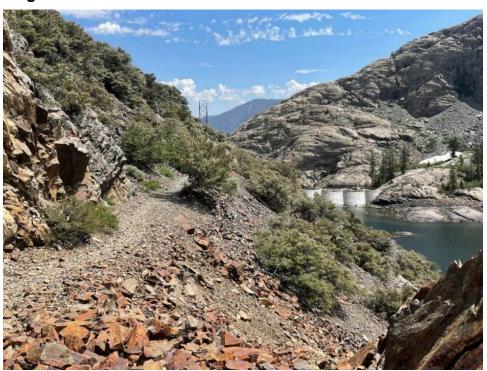
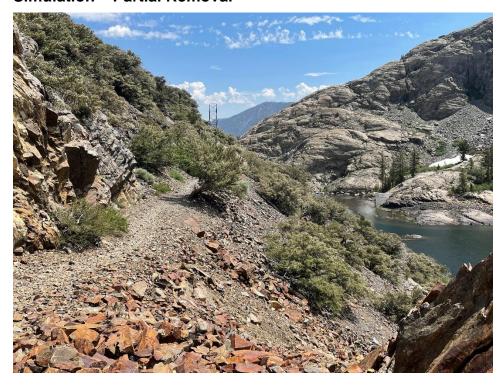
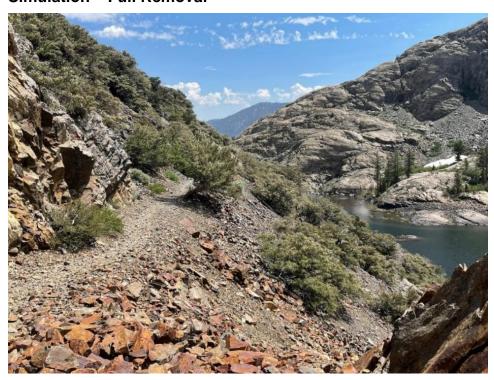
AGNEW DAM - KOP 5

Simulation - Partial Removal

Simulation - Full Removal

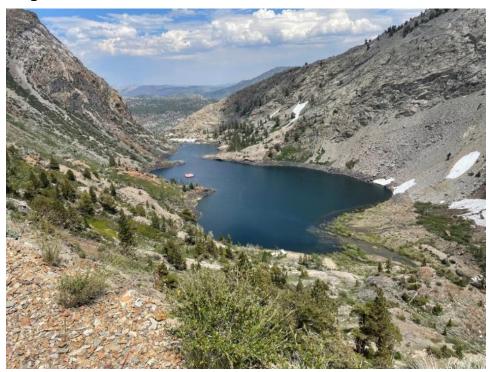
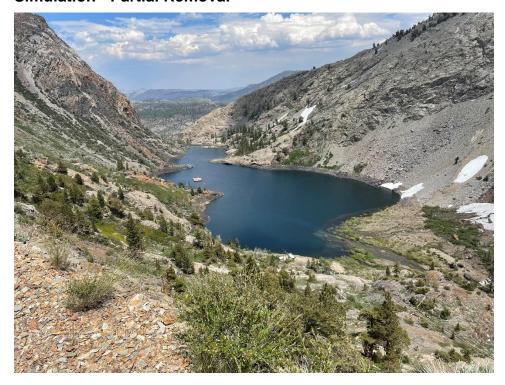
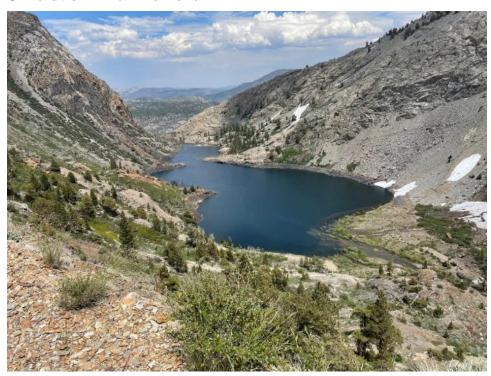
AGNEW DAM - KOP 6

Simulation - Partial Removal

Simulation - Full Removal
