Rush Creek Project, FERC Project No. 1389

TERR 2 – Wildlife Resources Technical Study Report

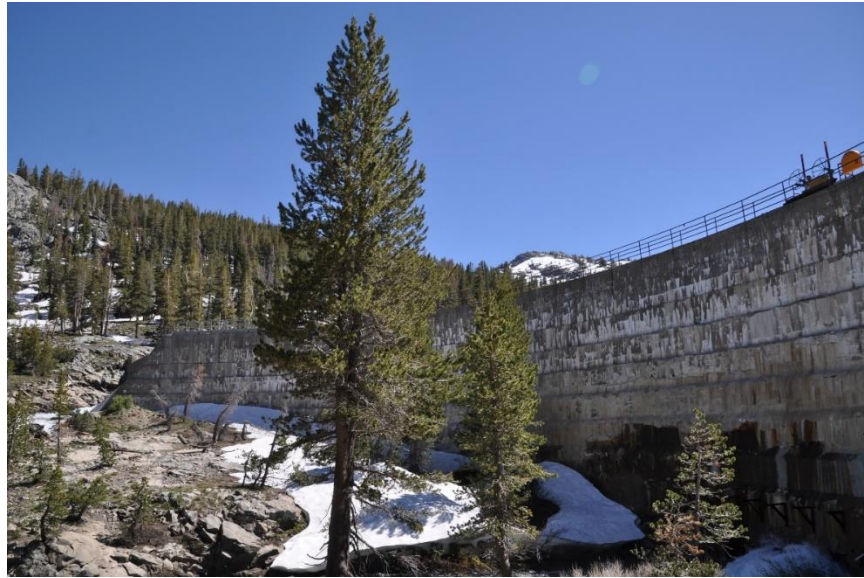
Photo 1. Rush Meadows Dam. The 2024 bat roost surveys determined the dam has an active day roost and night roost present. The dam structure has cracks and crevices that bats utilize for roosting habitat and appropriate thermal conditions (high solar exposure).

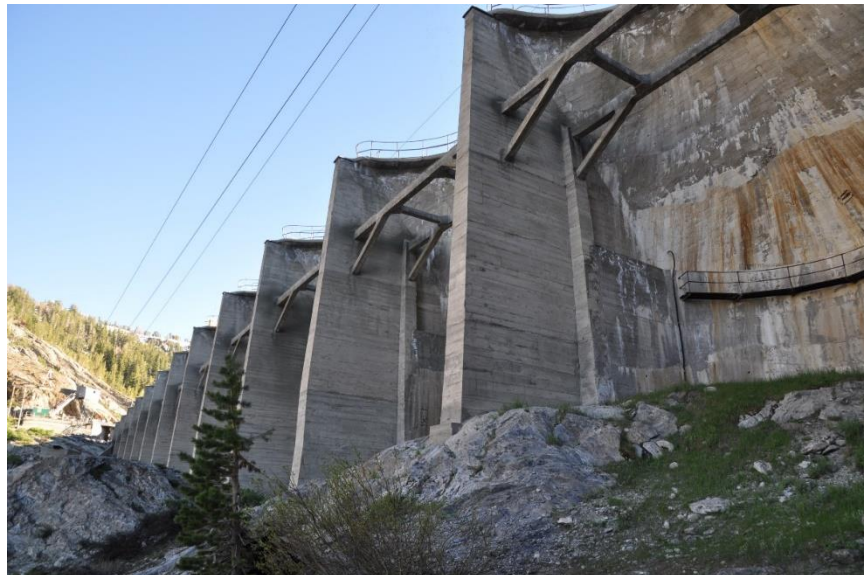
Photo 2. Gem Dam. The 2024 bat roost surveys determined the dam does not currently have a roost present. No guano was observed. This facility was determined to be suitable bat roosting habitat. The dam contains cracks in concrete overhangs and has appropriate thermal conditions (high solar exposure).

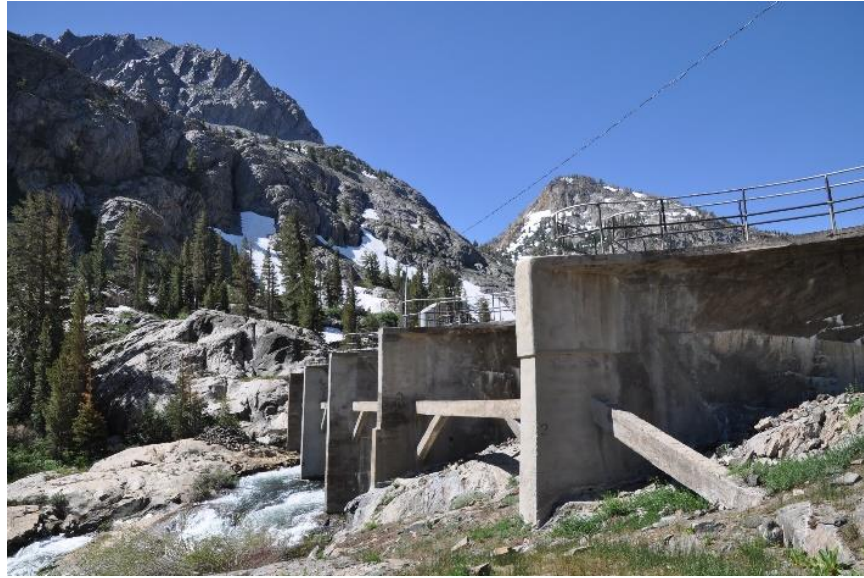
Photo 3. Agnew Dam. The 2024 bat roost surveys determined the dam does not currently have a roost present. No guano was observed. This facility was determined to be suitable bat roosting habitat. The dam has concrete overhangs and crevices and appropriate thermal conditions (high solar exposure).

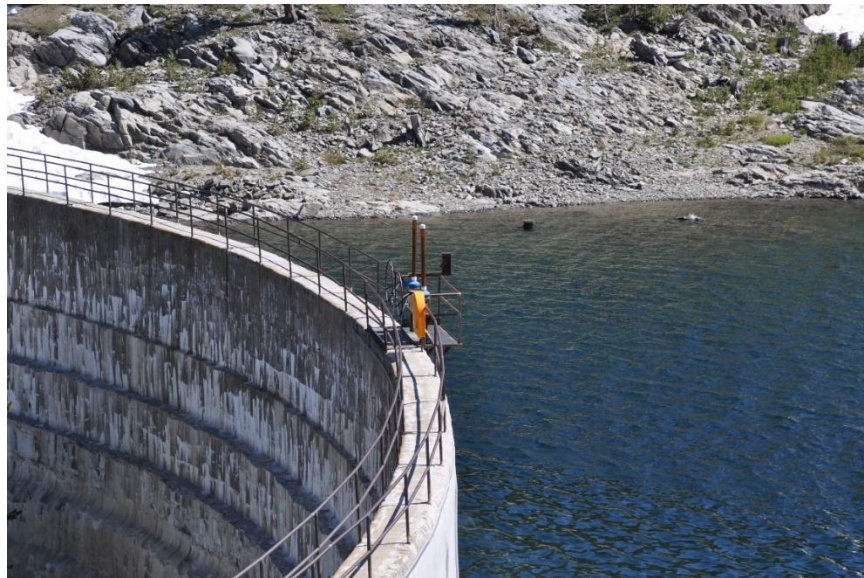
Photo 4. Rush Meadows Dam Valve House. This facility is unsuitable for bat roosting. The valve house does not have overhangs or crevices suitable for bat roosting. Valve house is partially inundated with water and does not have appropriate thermal conditions.

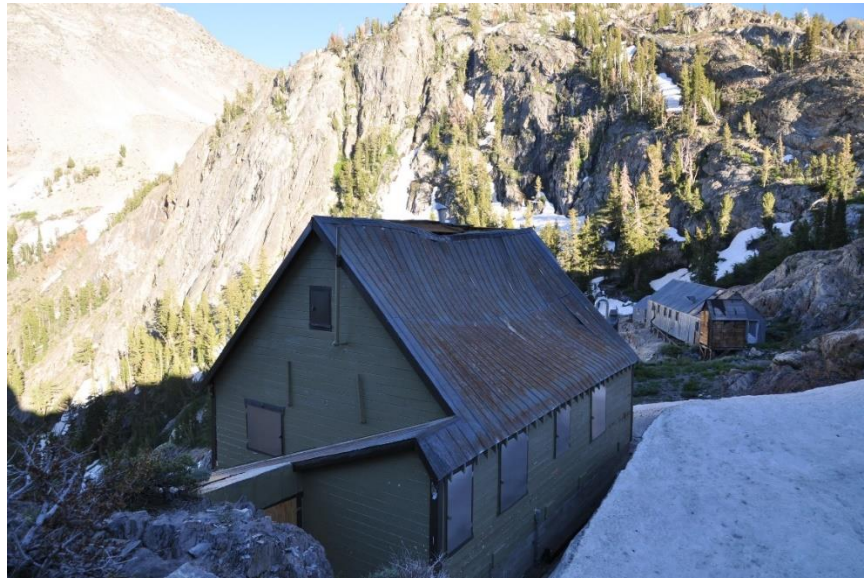
Photo 5. Gem Valve House and Cabin. The 2024 bat roost surveys determined the building does not currently have a roost present. No guano was observed but the interior could not be accessed. This facility was determined to be suitable bat roosting habitat. This wooden building has openings along the tin roof and cracks around windows where bats could enter. Building receives appropriate solar exposure.

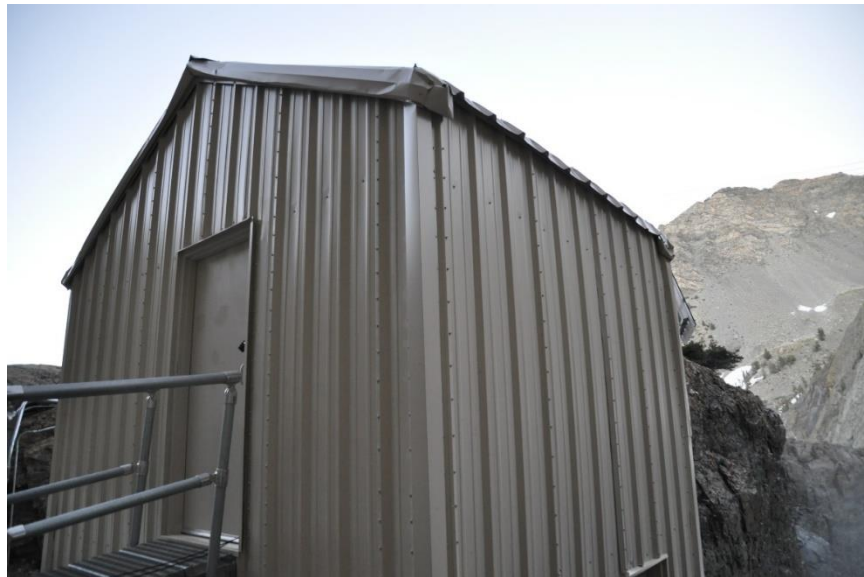
Photo 6. Gem Dam Arch 8 Valve House. This facility is unsuitable for bat roosting. This metal building has no cracks, crevices, or entry points for bats. Roofed elements are made of metal, which do not provide a suitable gripping surface for roosting.

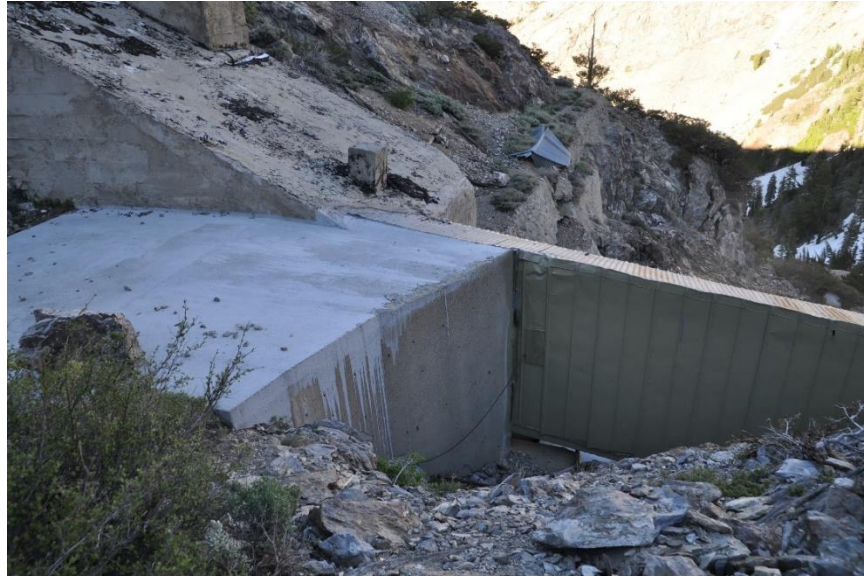
Photo 7. Gem Flowline Valve House. This facility is unsuitable for bat roosting. Metal structure does not provide overhangs or cracks and crevices suitable for roosting. Position over the emergency spillway creates cold thermal conditions unsuitable for maternity roosting.

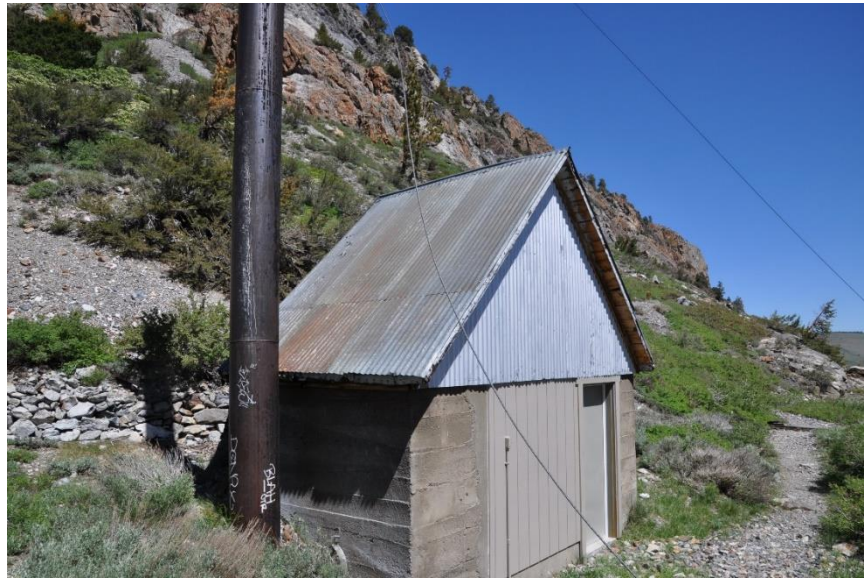
Photo 8. Agnew Junction (Valve House and Stand Pipe). The 2024 bat roost surveys determined the building does not currently have a roost present. No guano was observed. This facility was determined to be suitable bat roosting habitat. Building contains overhangs with cracks along the corrugated metal roof that could provide access to interior.

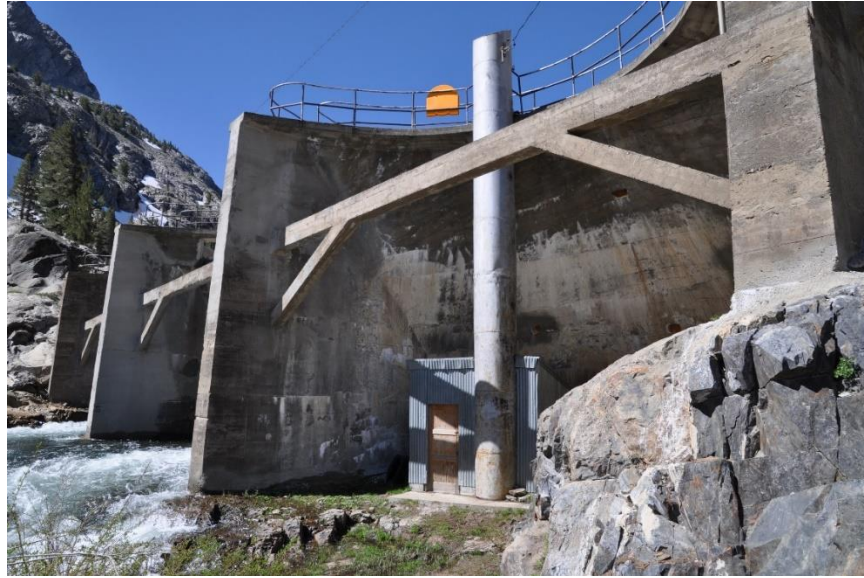
Photo 9. Agnew Dam Valve House. The 2024 bat roost surveys determined the building does not currently have a roost present. No guano was observed but the interior could not be accessed. This facility was determined to be suitable bat roosting habitat. Crack above door provides access; corrugated metal roof provides suitable roofed element. Because of the proximity to dam outlet pipes and shady position, building is likely colder than surrounding conditions. Cold buildings are not preferred for maternity roosting, but could be used for hibernation.

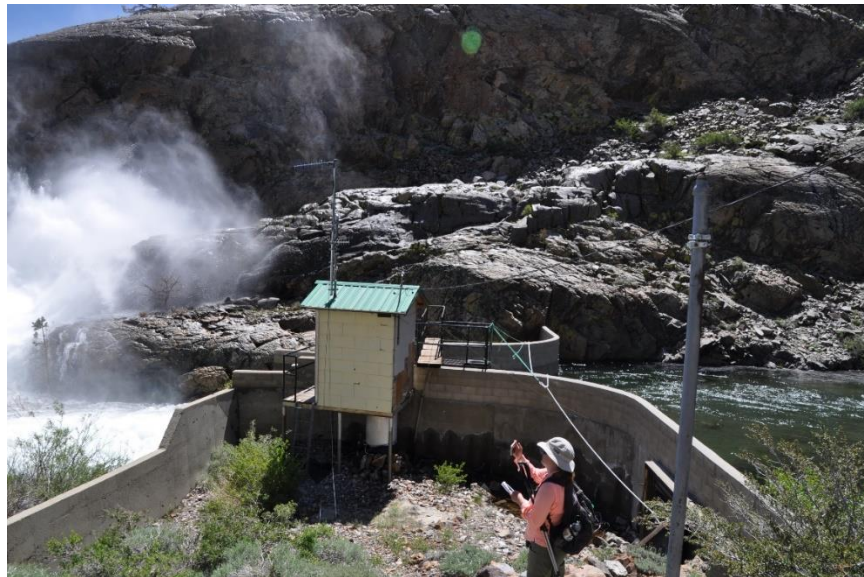
Photo 10. Rush Creek below Agnew Lake (USGS No. 10287289; SCE No. 357). The 2024 bat roost surveys determined the building does not currently have a roost present. No guano was observed. This facility was determined to be suitable bat roosting habitat. The gage building contains suitable cracks and crevices. Underneath the gage is a roofed overhang. Building receives appropriate solar exposure.

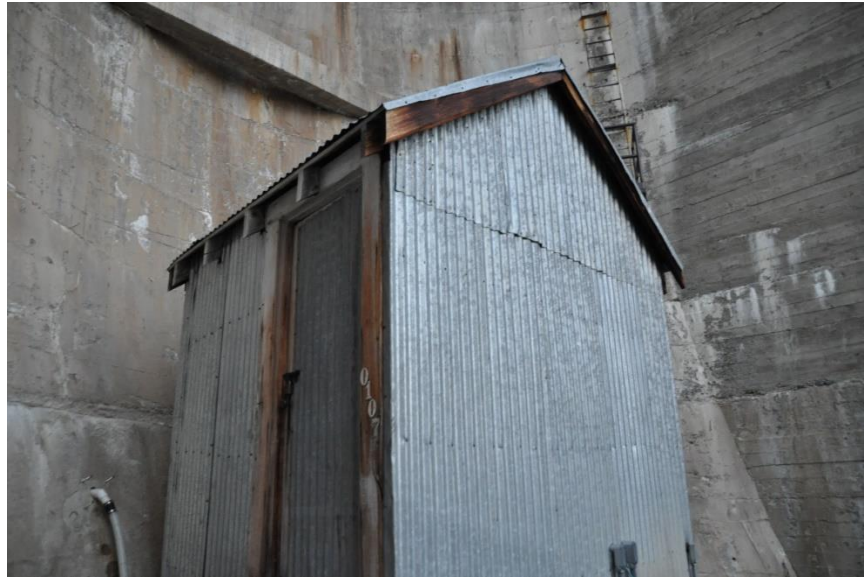
Photo 11. Gem Lake (USGS No. 10287280; SCE No. 352). The 2024 bat roost surveys determined the building does not currently have a roost present. No guano was observed but the interior could not be accessed. This facility was determined to be suitable bat roosting habitat. This gage building is metal with wooden roofed elements and a crack in the door for bats to access. However, it is located in the dam arch and is cold and shaded. Cold buildings are not preferred for maternity roosting, but could be used for hibernation.

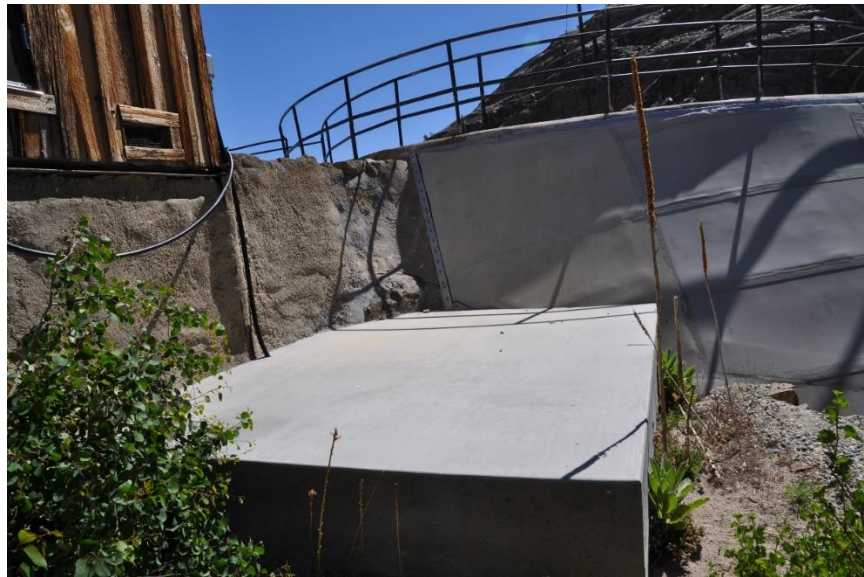
Photo 12. Agnew Lake (USGS no. 10287285; SCE No. 351). This facility is unsuitable for bat roosting. This gage is a concrete slab with no overhangs, cracks, or crevices and is too low to the ground.

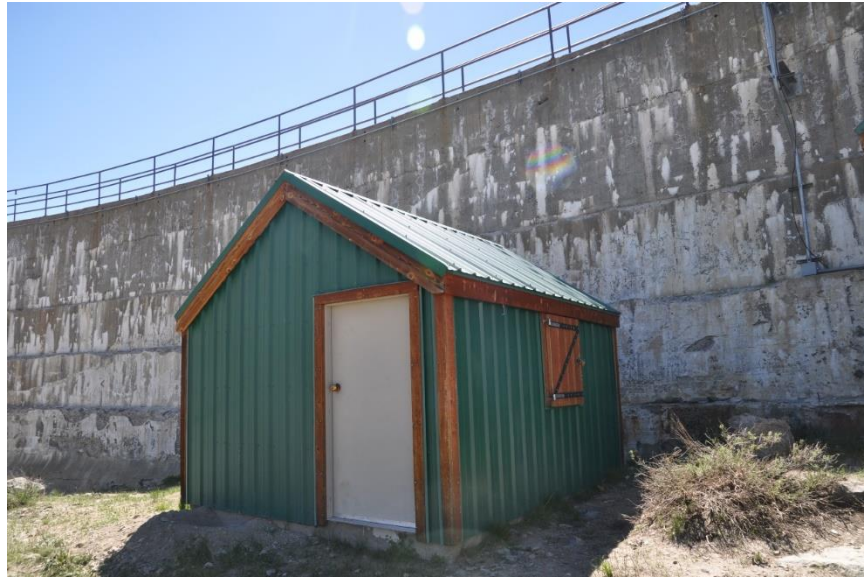
Photo 13. Rush Meadows Equipment Shed. The 2024 bat roost surveys determined the building does not currently have a roost present. Old guano was observed. This facility was determined to be suitable bat roosting habitat. This building contains a wooden overhang on the exterior under which bats could roost, but lacks cracks and crevices around doors or windows for access to the interior.

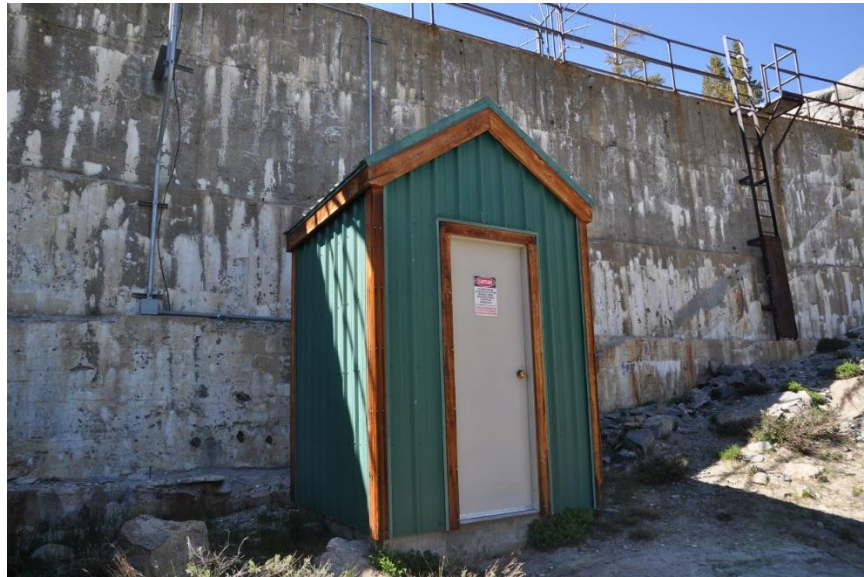
Photo 14. Rush Meadows Dam Gage House. The 2024 bat roost surveys determined the building does not currently have a roost present. No guano was observed but the interior could not be accessed. This facility was determined to be suitable bat roosting habitat. Building contains wooden overhangs under which bats could roosts, but lacks cracks and crevices allowing access to the interior.

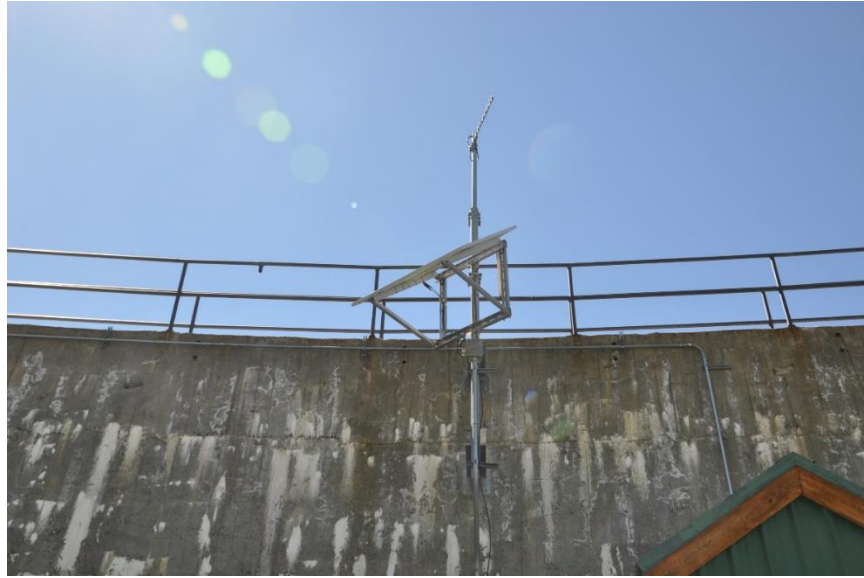
Photo 15. Rush Meadows Dam Solar Facility. This facility is unsuitable for bat roosting. Metal structure does not contain suitable overhangs or crevices for bat roosting.

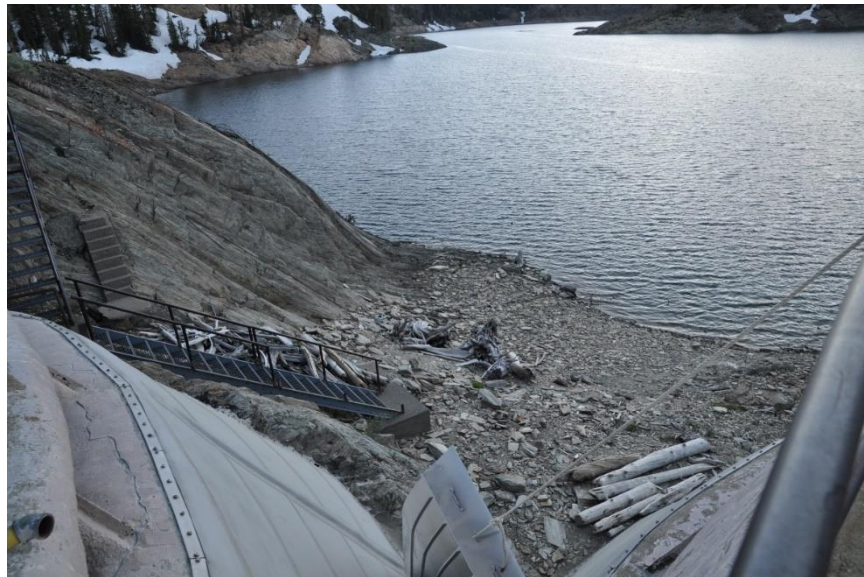
Photo 16. Gem Lake Dock. This facility is unsuitable for bat roosting. This is a concrete slab close to the ground and water. There is no overhangs or cracks and crevices for roosting.

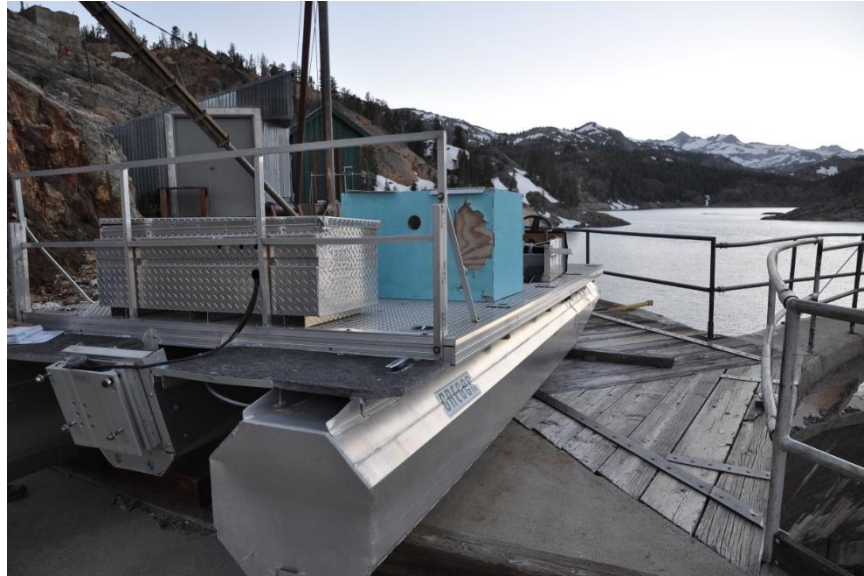
Photo 17. Gem Lake Motor Barge. This facility is unsuitable for bat roosting. Watercraft does not represent appropriate bat roosting habitat.

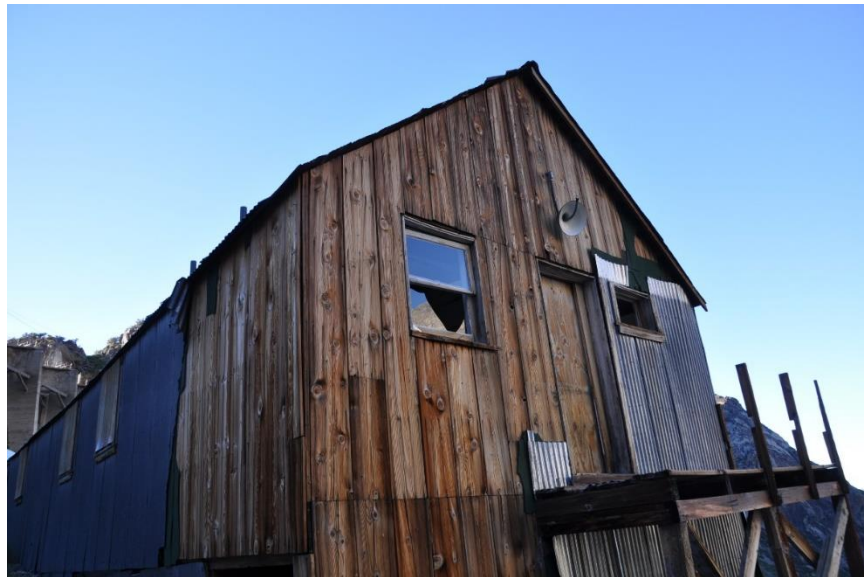
Photo 18. Gem Bunkhouse. The 2024 bat roost surveys determined the building does not currently have a roost present. No guano was observed. This facility was determined to be suitable bat roosting habitat. This building provides suitable roofed elements, cracks, crevices, and open window entrance points for bats. Building is positioned in an area with high solar exposure for maternity roosting.

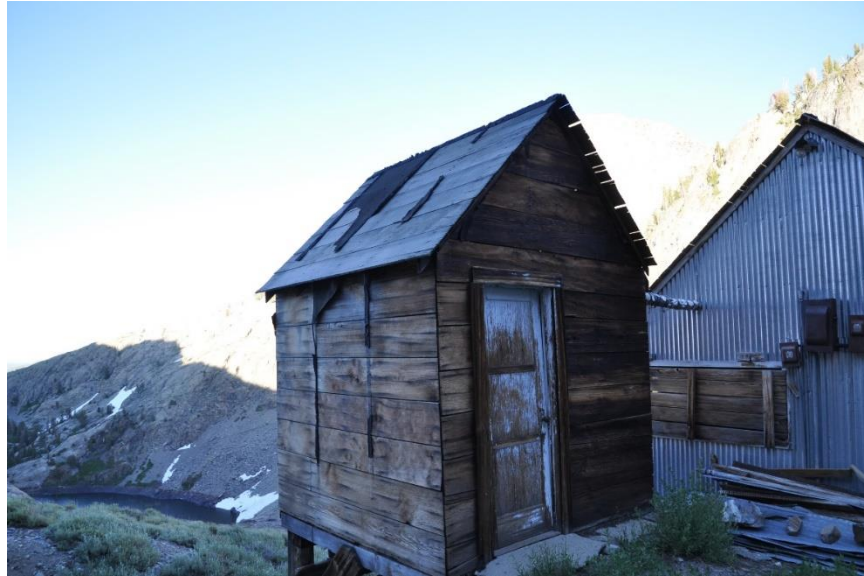
Photo 19. Gem Outhouse. The 2024 bat roost surveys determined the building does not currently have a roost present. No guano was observed. This facility was determined to be suitable bat roosting habitat. This wooden building contains suitable roofed elements, cracks and crevices for bat entry, and is in an area that has appropriate thermal conditions for maternity roosting (high solar exposure).

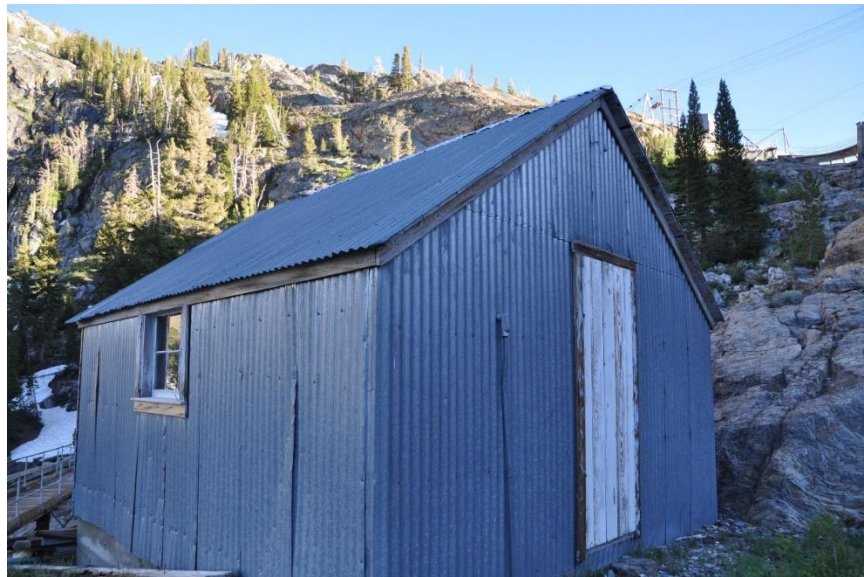
Photo 20. Gem Cookhouse. The 2024 bat roost surveys determined the building does not currently have a roost present. No guano was observed but the interior could not be accessed. This facility was determined to be suitable bat roosting habitat. This building contains suitable roofed elements for bat roosting, and has a broken window and gaps in the metal siding for bats to enter. The roof is a corrugated metal sheet with enough spacing for bats to roost under the eaves. Building is located in an area that has appropriate thermal conditions for maternity roosting (high solar exposure).

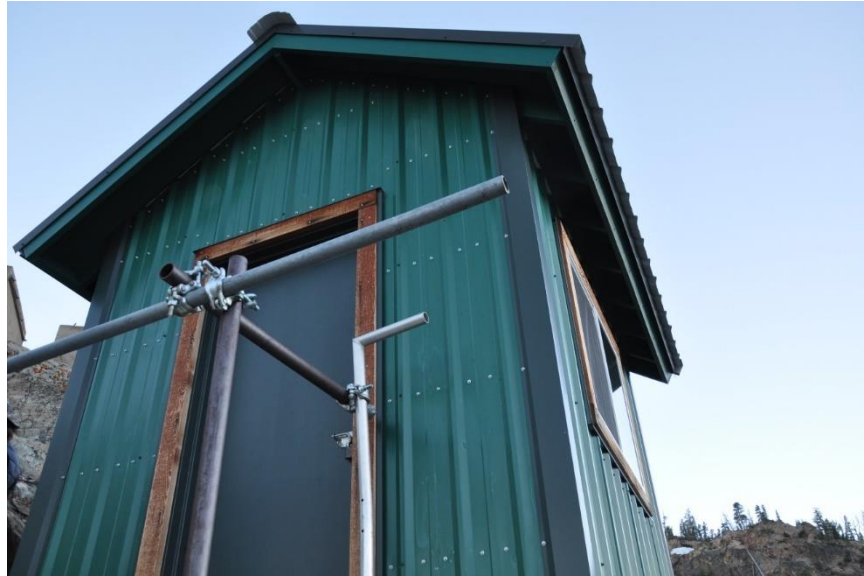
Photo 21. Gem Dam Compressor Shed. This facility is unsuitable for bat roosting. New metal building with no gaps in door or along roofline. There are metal eaves do not provide a suitable gripping surface for bat roosting (i.e., lacks cracks and crevices for bats to grip).

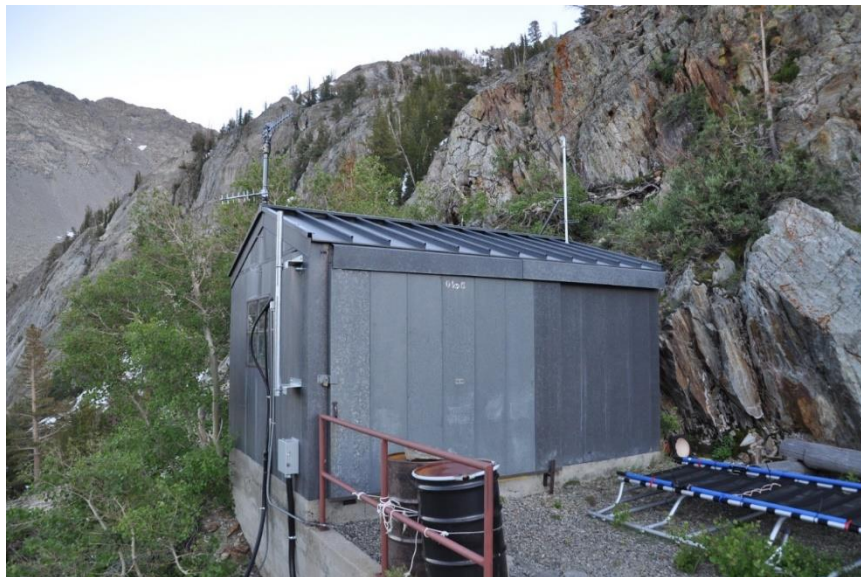
Photo 22. Gem Dam Storage Shed. The 2024 bat roost surveys determined the building does not currently have a roost present. No guano was observed. This facility was determined to be suitable bat roosting habitat. Metal building does not provide suitable bat roosting habitat, but the pipe opening provides a large enough crevice for some smaller bat species to roost. The building has appropriate thermal conditions for maternity roosting (high solar exposure).

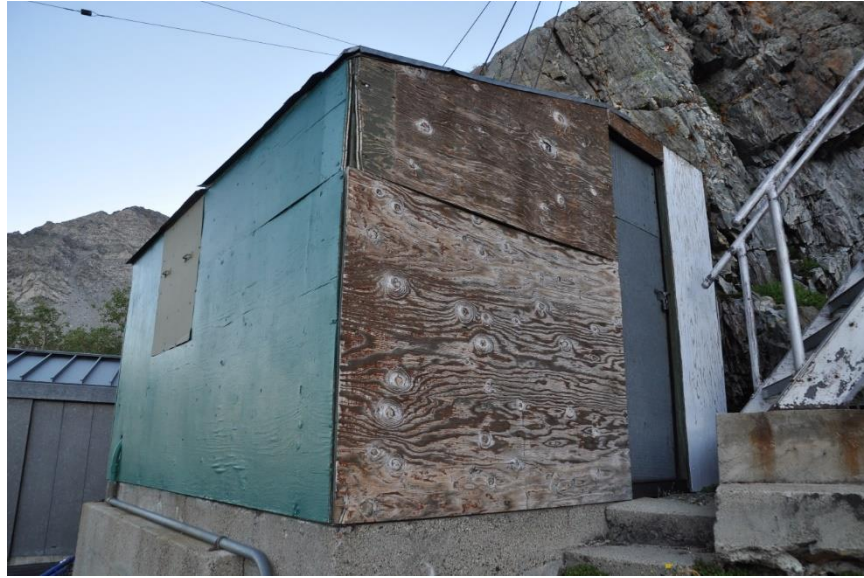
Photo 23. Gem Dam Overhead Hoist House for Dam Length. The 2024 bat roost surveys determined the building does not currently have a roost present. No guano was observed. This facility was determined to be suitable bat roosting habitat. Wooden building with holes that bat could potentially access suitable roosting habitat.

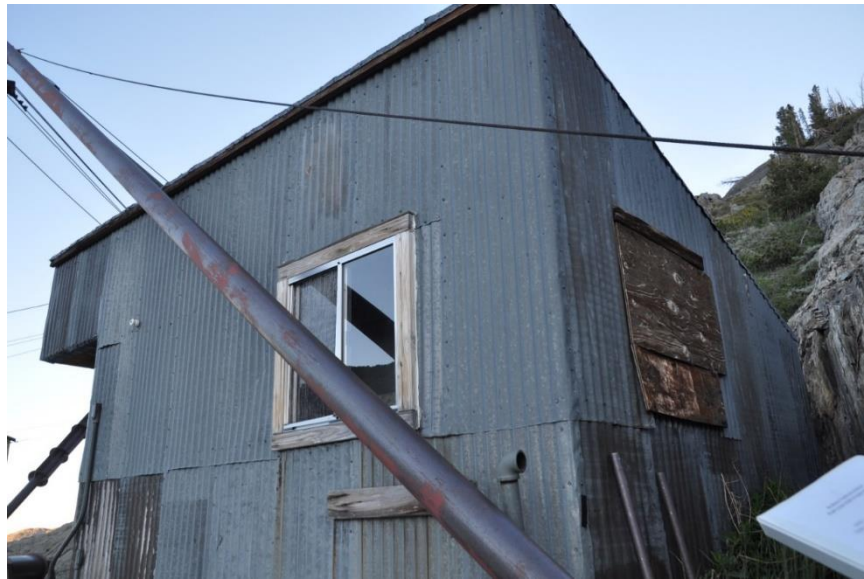
Photo 24. Gem Dam Overhead Hoist House. The 2024 bat roost surveys determined the building has a potential night roost present. Guano was observed and collected but the interior could not be accessed. This facility is suitable bat roosting habitat. Corrugated metal building with wooden roofed elements on exterior and contains cracks and crevices allow for access to suitable interior roosting habitat. The building has appropriate thermal conditions for maternity roosting (high solar exposure).

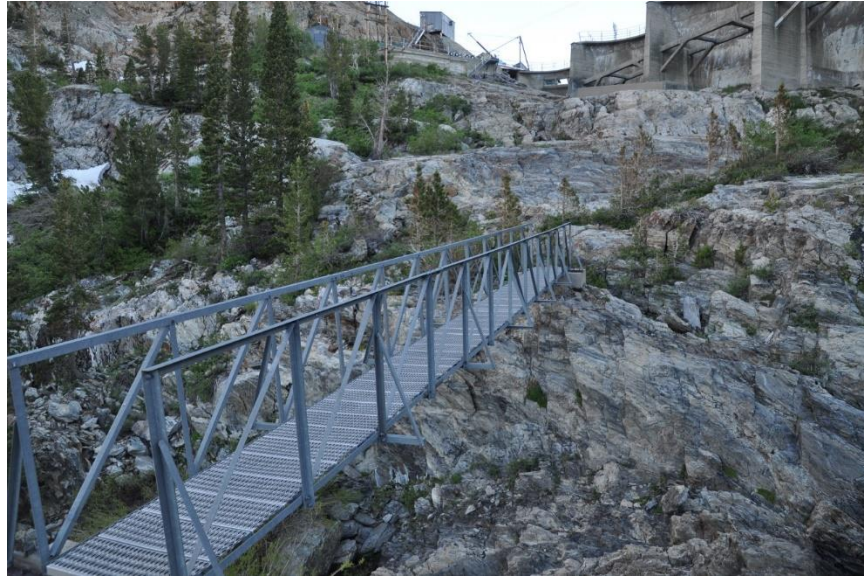
Photo 25. Gem Fish Release Footbridge. This facility is unsuitable for bat roosting. Metal grating bridge that stretches over Rush Creek does not provide roofed elements or cracks and crevices suitable for roosting. Metal material does not provide a suitable gripping surface.

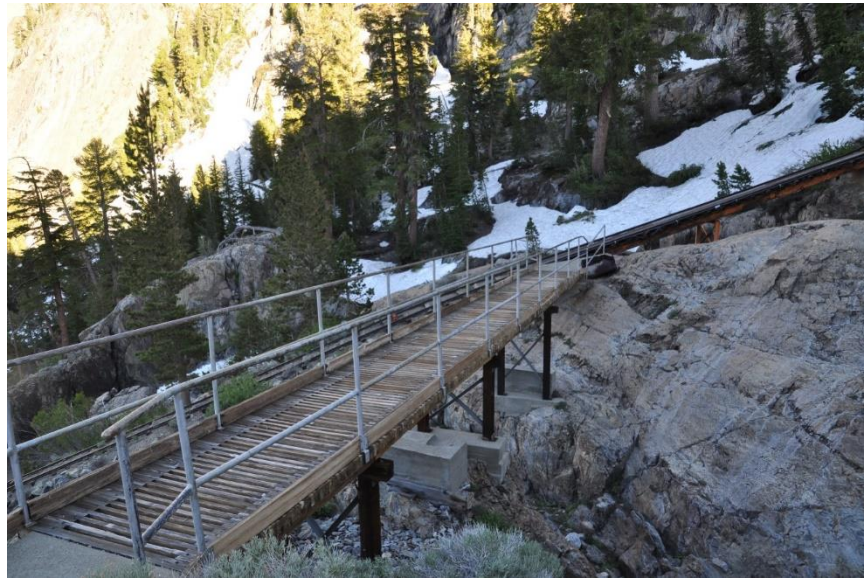
Photo 26. Gem Tram Landing Footbridge. The 2024 bat roost surveys determined the bridge is not suitable roosting habitat. Gaps on the underside of the footbridge are wide and the facility is in an exposed windy location.

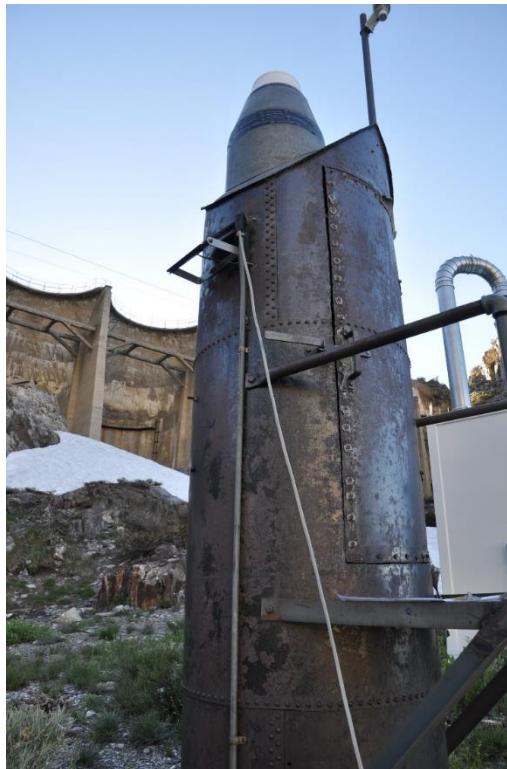
Photo 28. Gem Weather Station. The 2024 bat roost surveys determined the building does not currently have a roost present. No guano was observed but the interior could not be accessed. This facility was determined to be suitable bat roosting habitat. There are cracks in the metal door with an overhanging wooden shelf inside that could provide suitable roosting habitat. Building has appropriate thermal conditions for maternity roosting (high solar exposure).

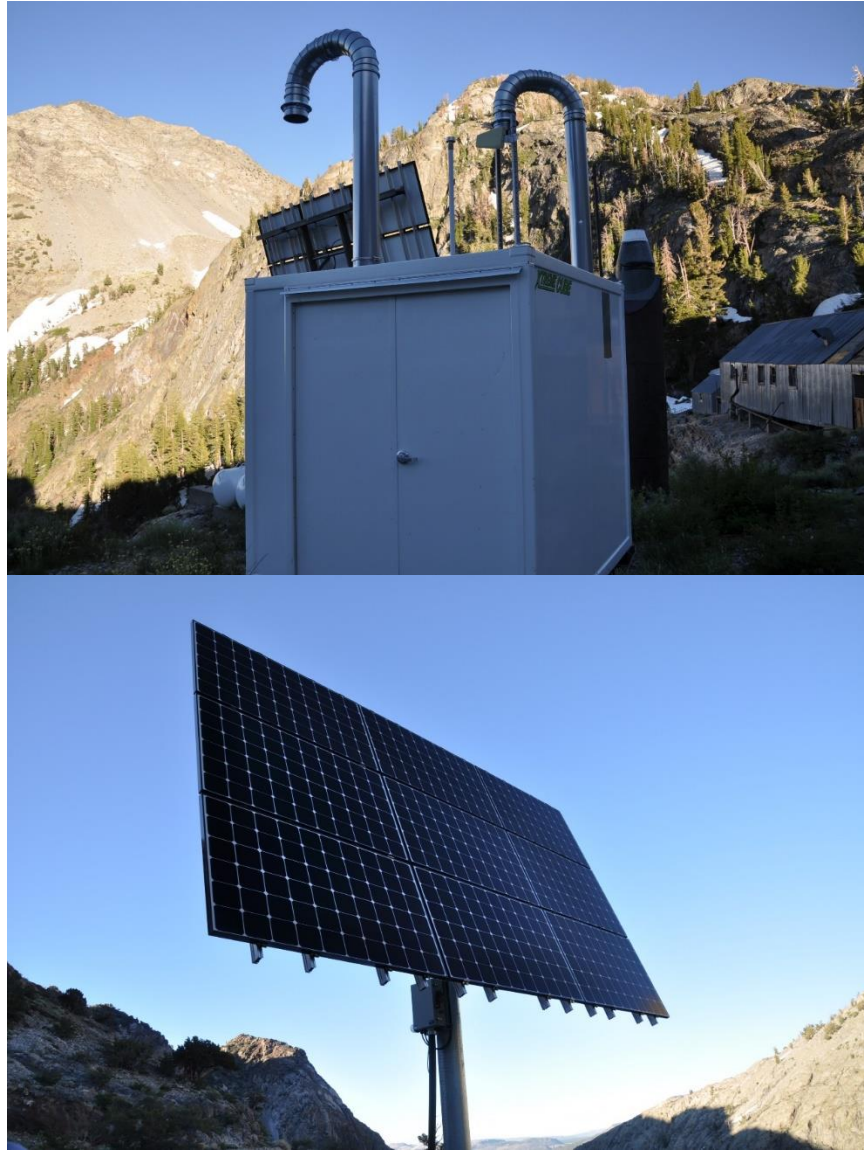
Photo 29. Gem Satellite Dish/ Gem Solar Facility. This facility is unsuitable for bat roosting. The satellite dish and solar facility do not provide roofed elements or cracks and crevices suitable roosting habitat. The building that is connected to the satellite dish/solar facility has no openings for bats to enter.

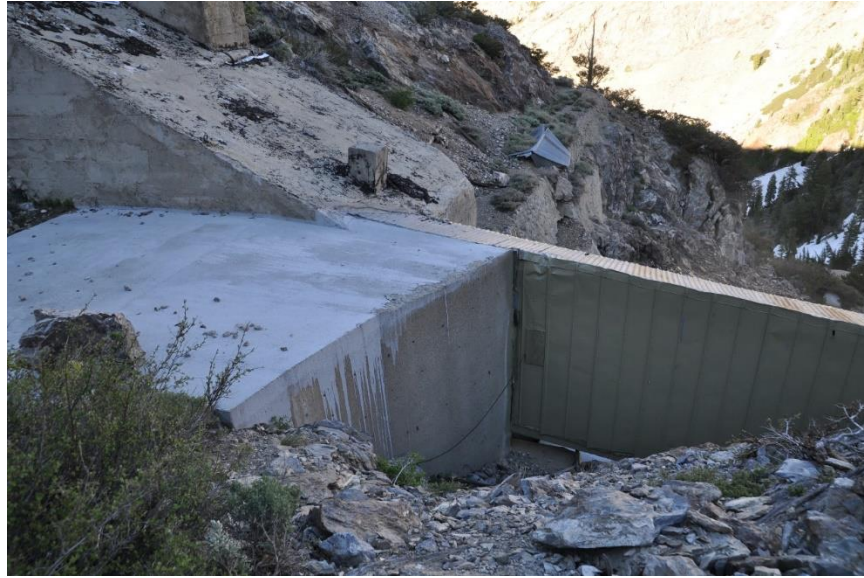
Photo 30. Gem Valve House Tunnel. This facility is unsuitable for bat roosting. The tunnel is used as a spillway during high flows. The concrete pad does not contain roofed elements or cracks and crevices suitable for roosting and the conveyance of water makes this structure unsuitable.

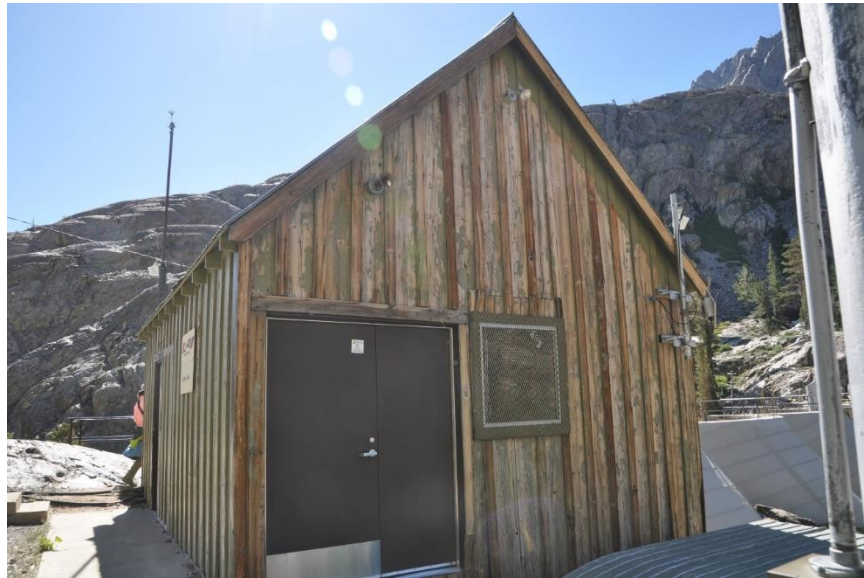
Photo 31. Lower Agnew Lake Boathouse/Dock. The 2024 bat roost surveys determined the building does not currently have a roost present. Old guano was observed, likely from incidental use. This facility was determined to be suitable bat roosting habitat. The building contains holes for bats to enter and suitable solar exposure. The cracks in the corrugated metal roof could also provide suitable entrance points for roosting.

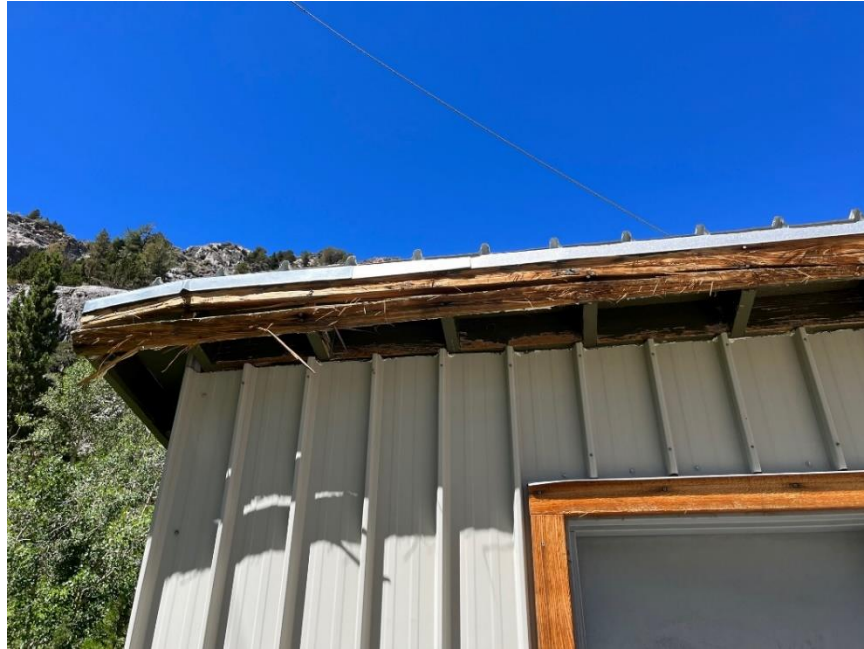
Photo 32a. Upper Agnew Lake Boathouse. The 2024 bat roost surveys determined the building does not currently have a roost present. No guano was observed but the interior could not be accessed. This facility was determined to be suitable bat roosting habitat. The building contains suitable wooden roofed elements with corrugated metal sheeting that provides cracks and crevices for bats to access the interior. The concrete pad where the building sits also has a wooden edge that also provide roofed elements. The building has appropriate thermal conditions for maternity roosting (high solar exposure).

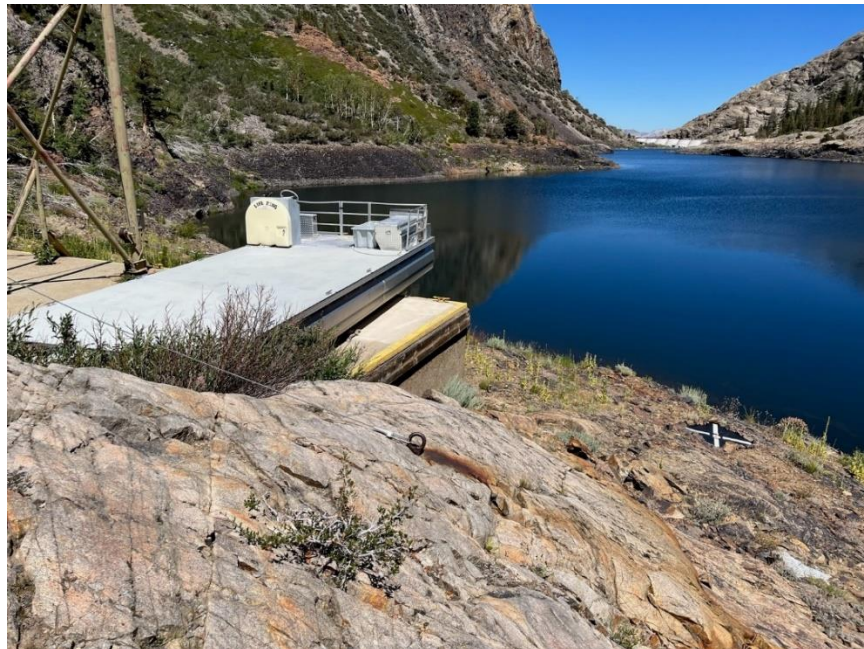
Photo 32b. Upper Agnew Lake Dock. The 2024 bat roost surveys determined the facility does not currently have a roost present. No guano was observed. This facility was determined to be suitable bat roosting habitat. The dock contains suitable wooden roofed elements with corrugated metal sheeting

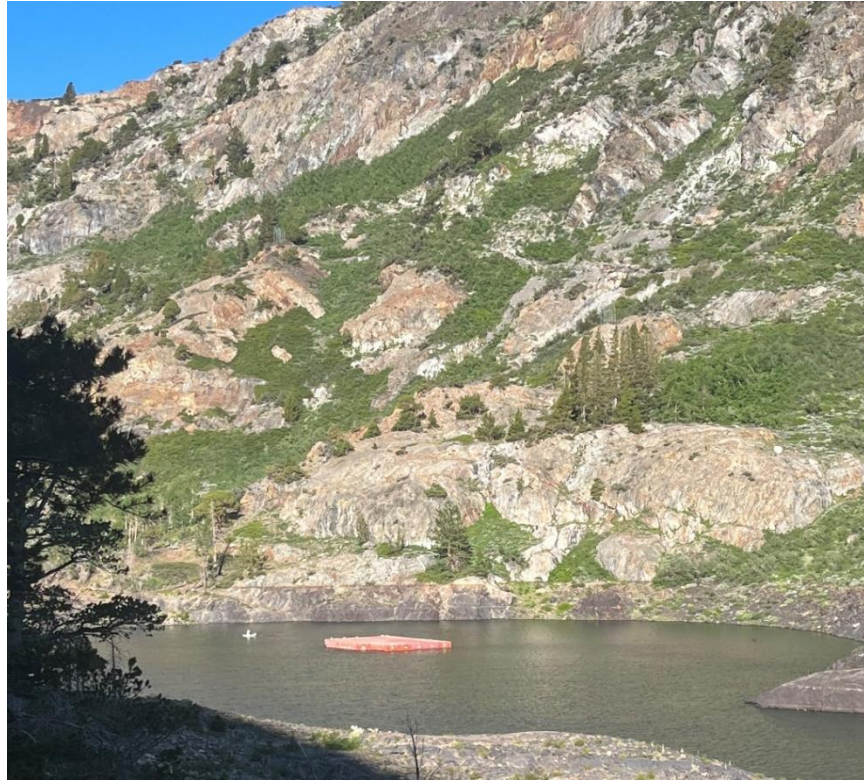
Photo 33. Agnew Lake Motor Barge. This facility is unsuitable for bat roosting. Motor barge is a flat surface located within Agnew that does not provide suitable roofed elements or cracks and crevices for roosting.

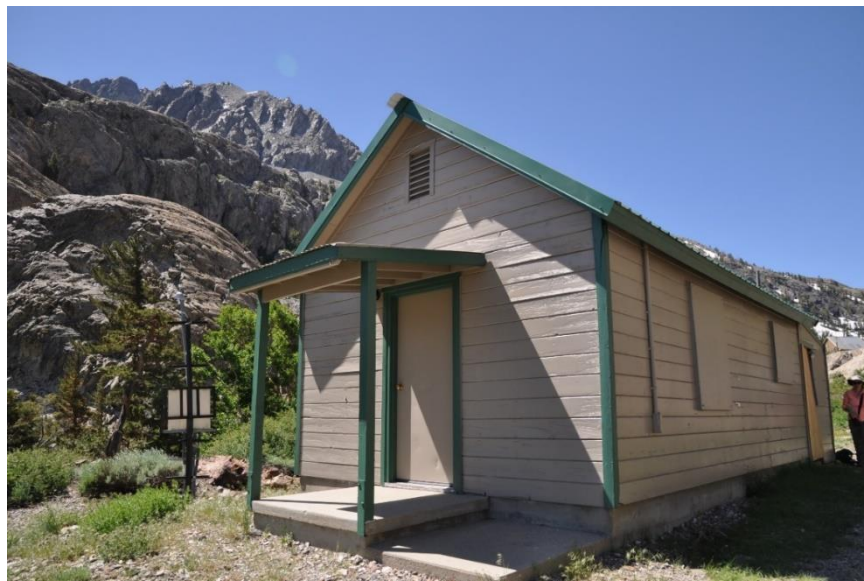
Photo 34. Agnew Cabin. The 2024 bat roost surveys determined the building does not currently have a roost present. No guano was observed. This facility was determined to be suitable bat roosting habitat. Building provides vertical and roofed components that could potentially support roosting bats. The

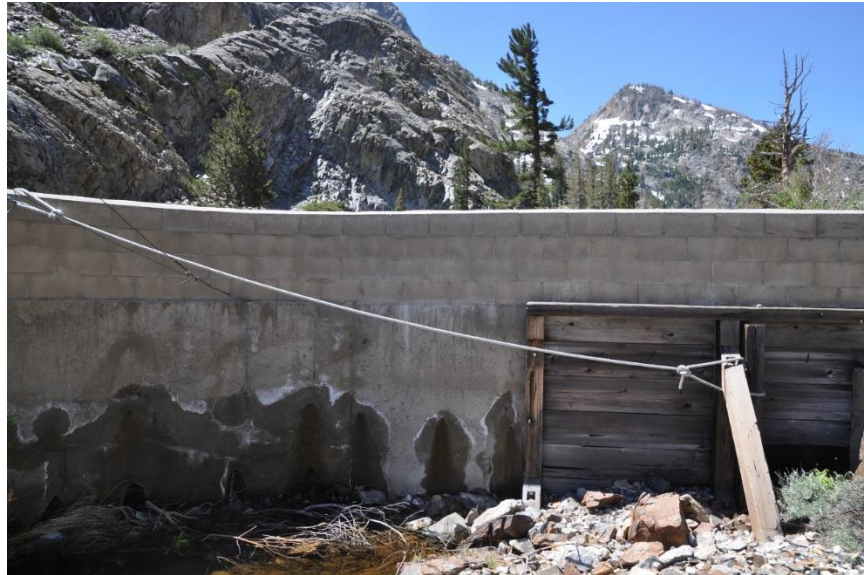
Photo 35. Agnew Flume (downstream of Agnew Dam). This facility is unsuitable for bat roosting. The flume is made of relatively new concrete that does not have cracks and crevices for bats to enter and lacks roofed elements. The flume conveys Rush Creek which makes the walls of the structure too cold for day roosting.

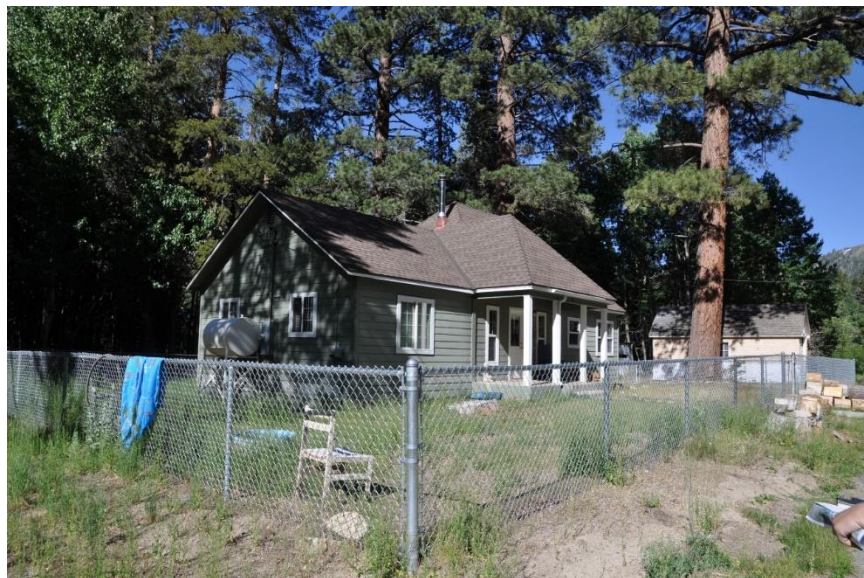
Photo 36. Rush Creek Powerhouse Cottage No. 1. The 2024 bat roost surveys determined the building has a potential night roost present. Guano was observed and collected. This facility is suitable bat roosting habitat. Signs indicated that bats were roosting under roof eaves on the building. Resident noted that there were no bats in the interior. Building receives solar exposure.

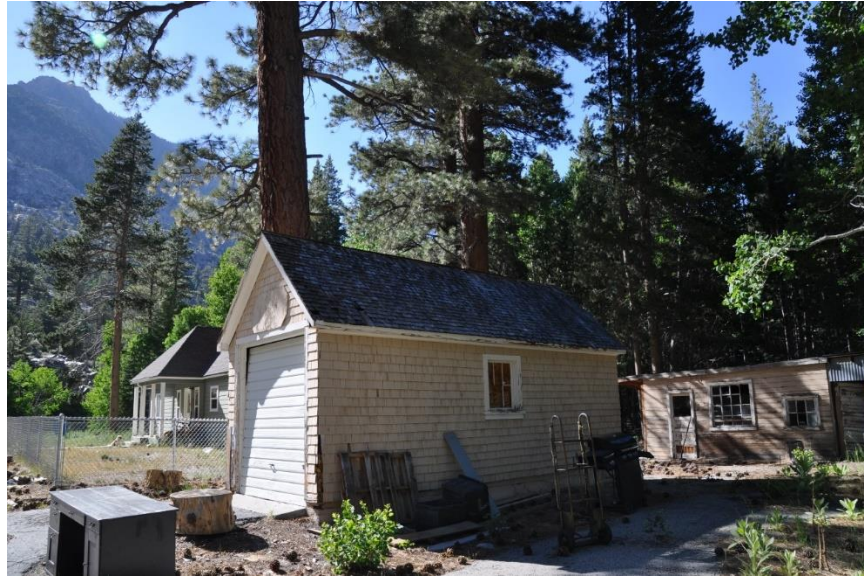
Photo 37. Rush Creek Powerhouse Garage No. 1. The 2024 bat roost surveys determined the building does not currently have a roost present. Old guano was observed, likely from incidental use. This facility was determined to be suitable bat roosting habitat. Structure contains vertical and roofed components and cracks and crevices suitable for bat roosting. Building has appropriate thermal conditions (high solar exposure).
