Rush Creek Project, FERC Project No. 1389

TERR 2 – Wildlife Resources Technical Study Report

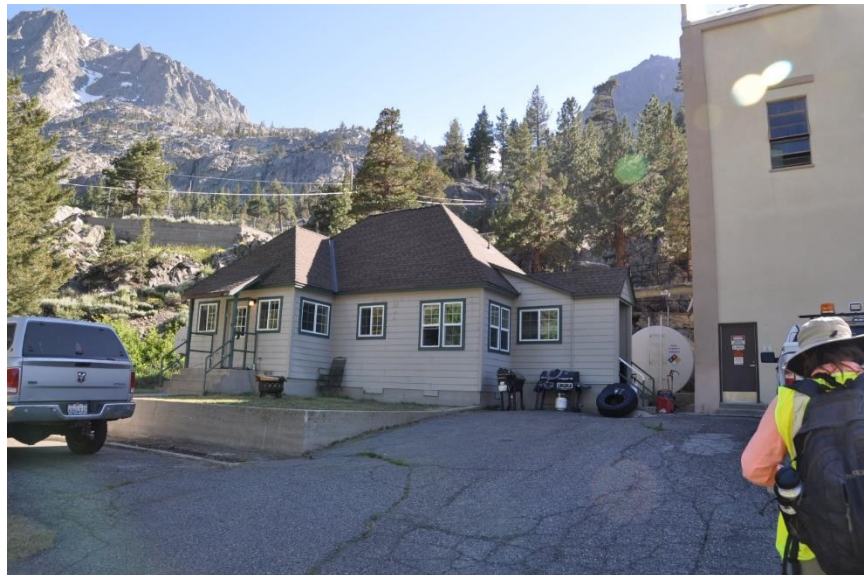
Photo 38. Rush Creek Powerhouse Cottage No. 2. The 2024 bat roost surveys determined the building does not currently have a roost present. No guano was observed. This facility was determined to be suitable bat roosting habitat. There are eaves located on the building that provide roofed elements. The building is mostly sealed around edges and does not display cracks or crevices. Building has appropriate thermal conditions (high solar exposure).

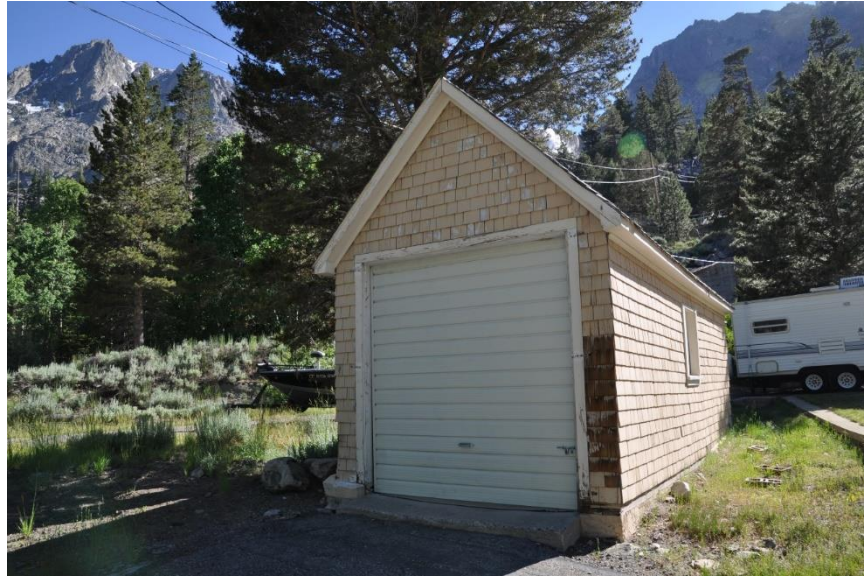
Photo 39. Rush Creek Powerhouse Garage No. 2. The 2024 bat roost surveys determined the building does not currently have a roost present. Old guano was observed, likely from incidental use. This facility was determined to be suitable bat roosting habitat. Building provides vertical and roofed components that could potentially support roosting bats. The building has cracks and crevices that bats could enter and the building has appropriate thermal conditions (high solar exposure).

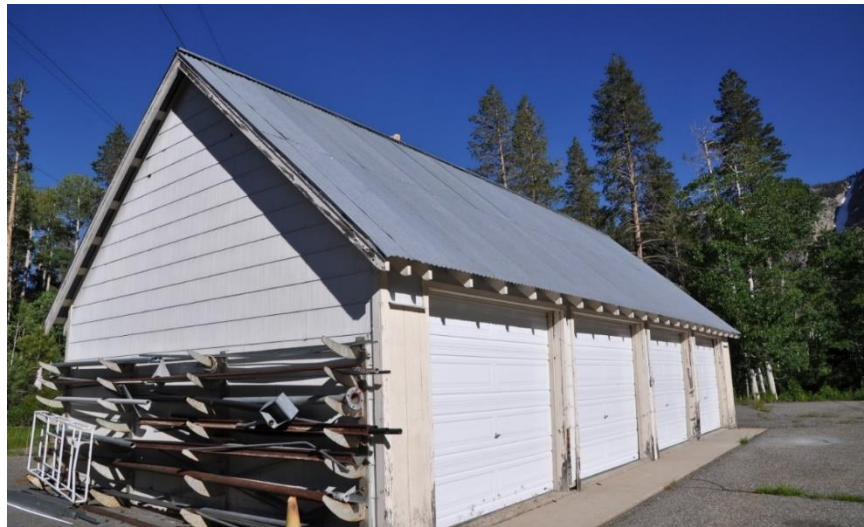
Photo 40. Rush Creek Powerhouse Garage No. 3. The 2024 bat roost surveys determined the building does not currently have a roost present. Old guano was observed, likely from incidental use. This facility was determined to be suitable bat roosting habitat. Building provides vertical and roofed components that could potentially support roosting bats. The building has cracks and crevices that bats could enter and the building has appropriate thermal conditions (high solar exposure).

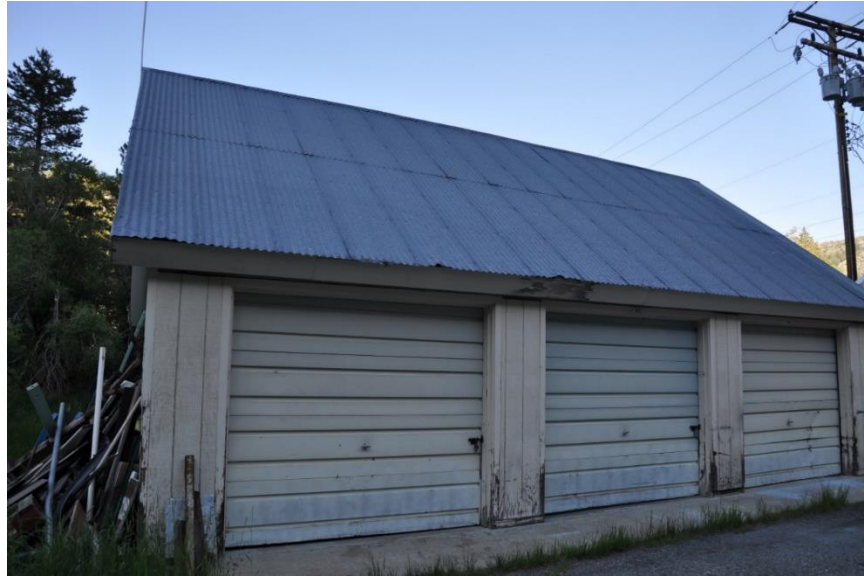
Photo 41. Rush Creek Powerhouse Garage No. 4. The 2024 bat roost surveys determined the building does not currently have a roost present. No guano was observed. This facility was determined to be suitable bat roosting habitat. Building provides vertical and roofed components that could potentially support roosting bats. The building has cracks and crevices where bats could enter the building has appropriate thermal conditions (high solar exposure).

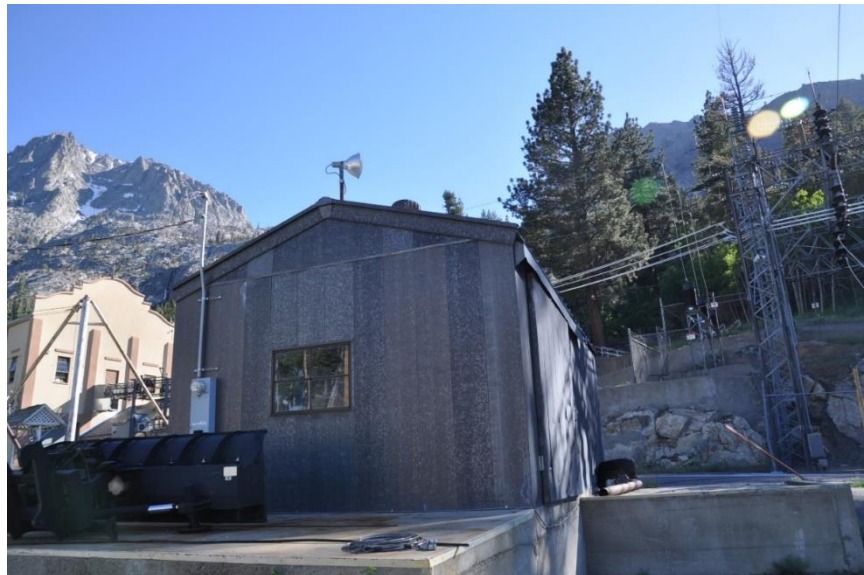
Photo 42. Rush Creek Powerhouse Warehouse and Dock. The 2024 bat roost surveys determined the building is not suitable for roosting. Metal structure gets very hot during the day and cold at night and has no suitable places on the exterior for roosting and lacks cracks and crevices for bats to enter interior.

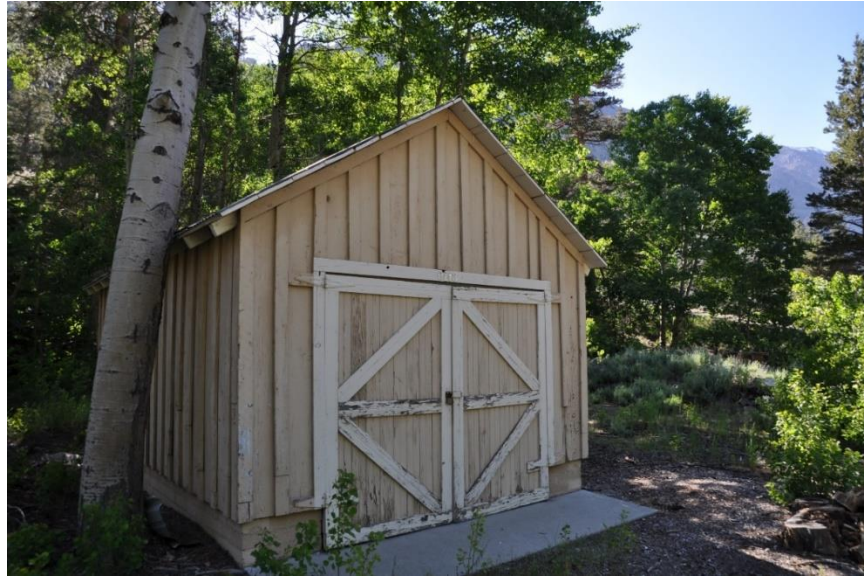
Photo 43. Rush Creek Powerhouse Building 0113. The 2024 bat roost surveys determined the building does not currently have a roost present. No guano was observed. This facility was determined to be suitable bat roosting habitat. Building provides vertical and roofed components that could potentially support roosting bats. The building has cracks and crevices that bats could enter, and the building has appropriate thermal conditions (high solar exposure).

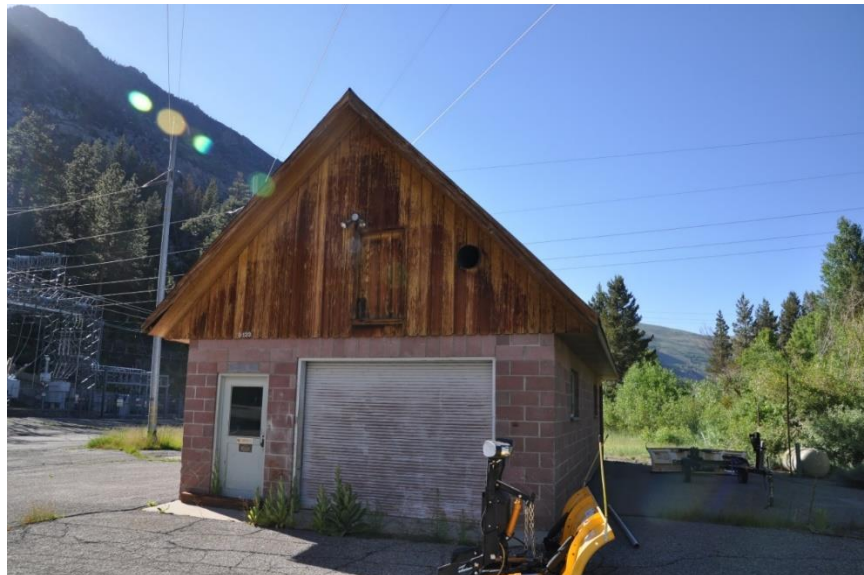
Photo 44. Rush Creek Powerhouse Machine Shop. The 2024 bat roost surveys determined the building has a potential night roost present. Guano was observed and collected. This facility is suitable bat roosting habitat. Building provides vertical and roofed components that could potentially support roosting bats. The building has cracks and crevices that bats could enter. The building also provides warm thermal conditions for potential roosting bats.

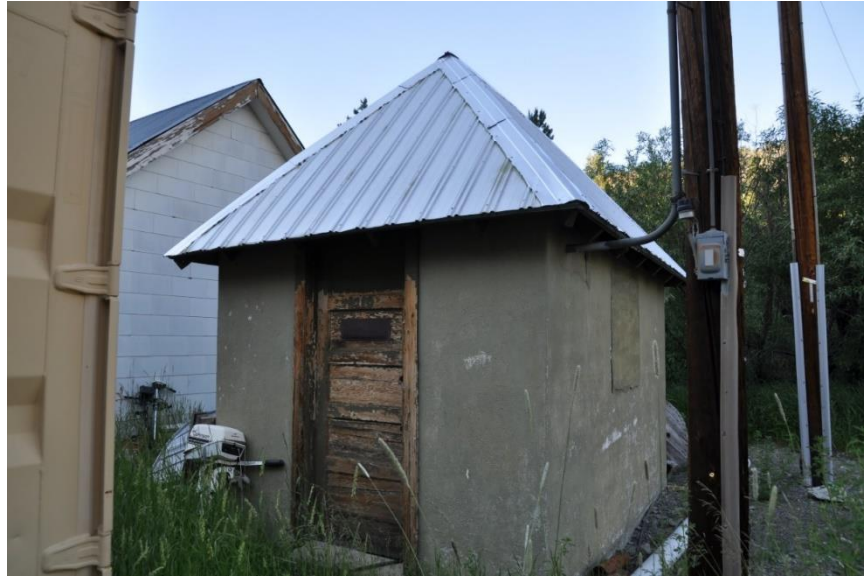
Photo 45. Rush Creek Powerhouse Pump House. The 2024 bat roost surveys determined the building has a potential night roost present. Guano was observed and collected. This facility is suitable bat roosting habitat. Building provides vertical and roofed components that could potentially support roosting bats. The building has cracks and crevices that bats could enter and has appropriate thermal conditions (high solar exposure).

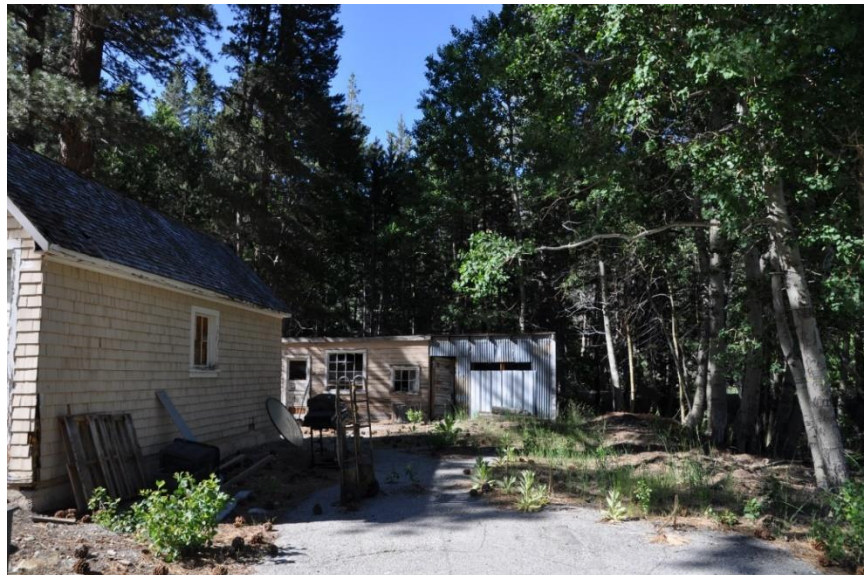
Photo 46. Rush Creek Powerhouse Woodshed No. 1. The 2024 bat roost surveys determined the building does not currently have a roost present. Old guano was observed, likely from incidental use. This facility was determined to be suitable bat roosting habitat. Building provides vertical and roofed components that could potentially support roosting bats. The building has abundant cracks and crevices that bats could enter, and the building has appropriate thermal conditions (high solar exposure).

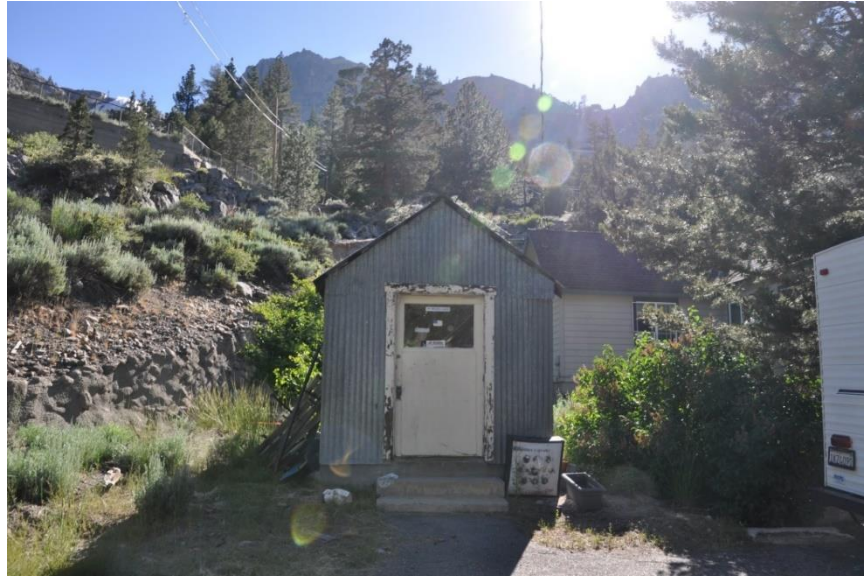
Photo 47. Rush Creek Powerhouse Woodshed No. 2. The 2024 bat roost surveys determined the building does not currently have a roost present. No guano was observed. This facility was determined to be suitable bat roosting habitat. Building provides vertical and roofed components that could potentially support roosting bats on the exterior. The building does not contain cracks and crevices to enter the interior, but it receives appropriate solar exposure.

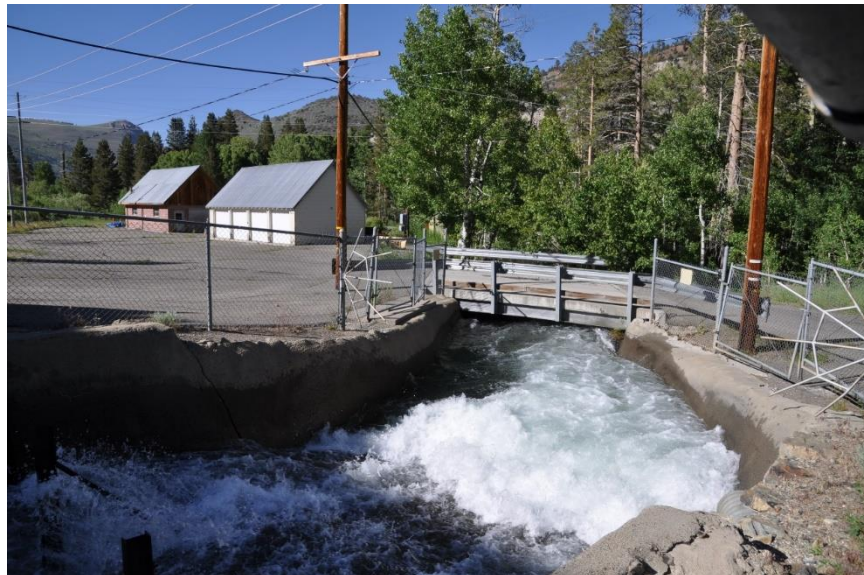
Photo 48. Bridge over Rush Creek Powerhouse Tailrace. This facility is unsuitable for bat roosting. Tailrace water levels are routinely high (to bottom of bridge), which would prevent bat roosting.

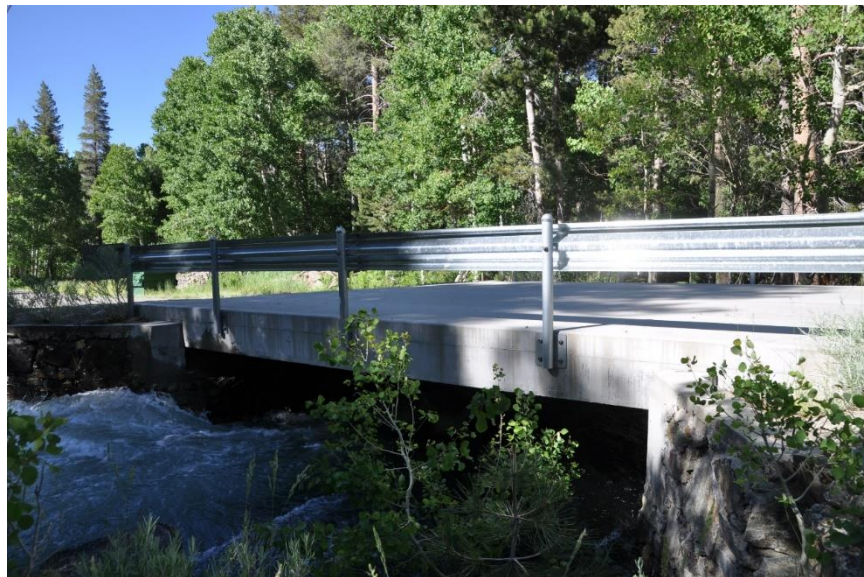
Photo 50. Bridge over Rush Creek. This facility is unsuitable for bat roosting. Bridge provides roofed component that could potentially support roosting bats during low flow conditions.

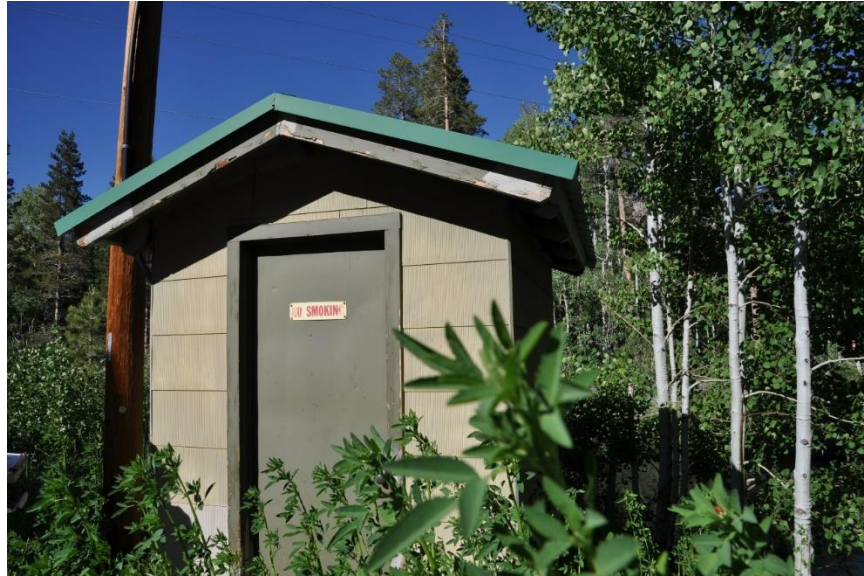
Photo 51. Unnamed Shed near Rush Creek Powerhouse. The 2024 bat roost surveys determined the building does not currently have a roost present. No guano was observed. This facility was determined to be suitable bat roosting habitat. Building provides vertical and roofed components that could potentially support roosting bats. Cracks and crevices on the shingle siding may provide openings for small bats. Building has appropriate thermal conditions for maternity roosting (high solar exposure).

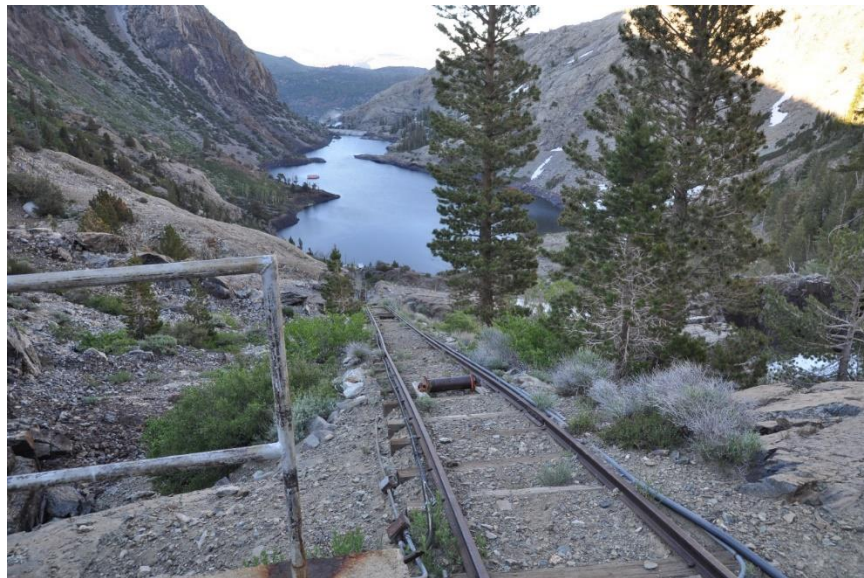
Photo 53. Gem Tram. This facility is unsuitable for bat roosting. Tram line does not provide vertical or roofed components that provide appropriate bat roosting habitat and lies against the ground.

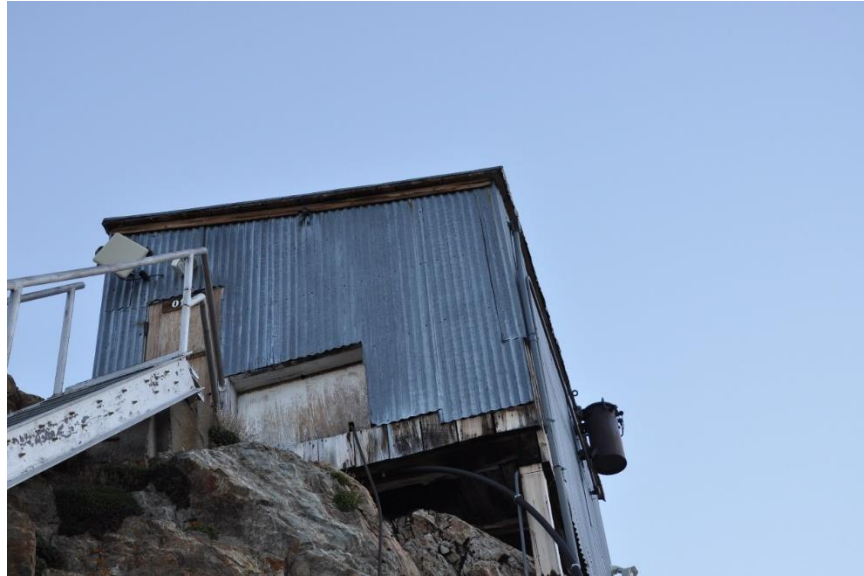
Photo 54. Gem Tram Hoist House. The 2024 bat roost surveys determined the building does not currently have a roost present. No guano was observed. This facility was determined to be suitable bat roosting habitat. Building provides vertical and roofed components that could potentially support roosting bats. The building has cracks and crevices that bats could enter and has appropriate thermal conditions for maternity roosting (high solar exposure).

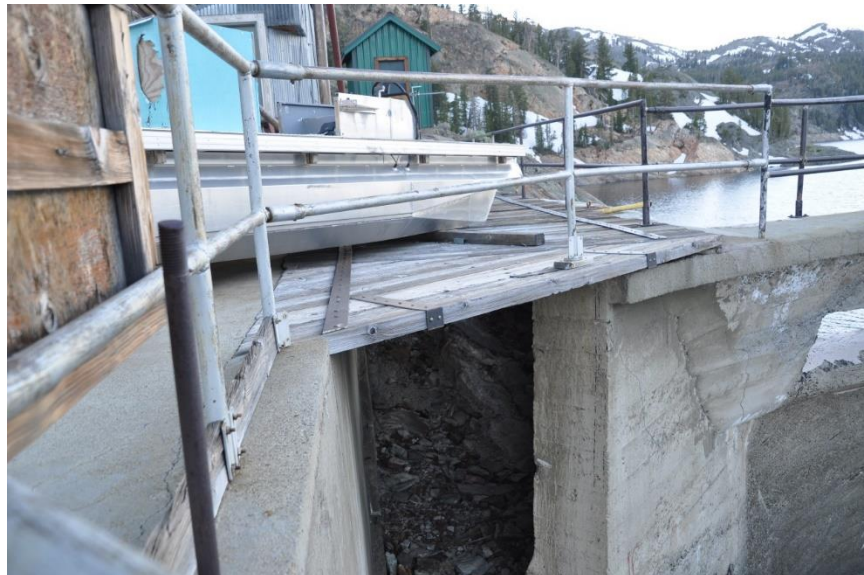
Photo 55. Gem Tram Upper Landing. The 2024 bat roost surveys determined the building does not currently have a roost present. No guano was observed. This facility does not contain suitable bat roosting habitat. Concrete generally lacks cracks and crevices large enough for roosting though the structure has appropriate thermal conditions for maternity roosting (high solar exposure).

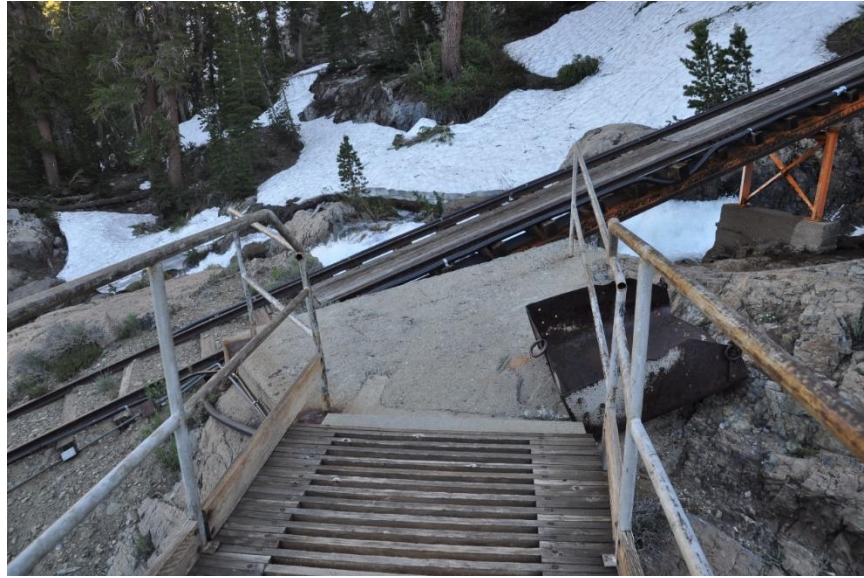
Photo 56. Gem Tram Lower Landing. This facility is unsuitable for bat roosting. Lower landing is a concrete slab on the ground that does not provide vertical or roofed components or cracks/crevices for roosting bats.

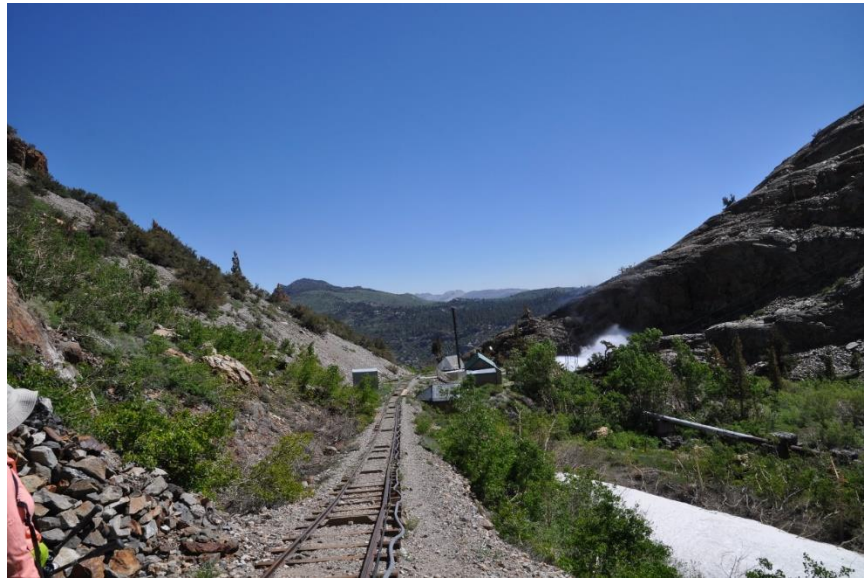
Photo 57. Agnew Tram. This facility is unsuitable for bat roosting. Tram line does not provide vertical or roofed components that provide appropriate bat roosting habitat. Tram line lies against the ground.

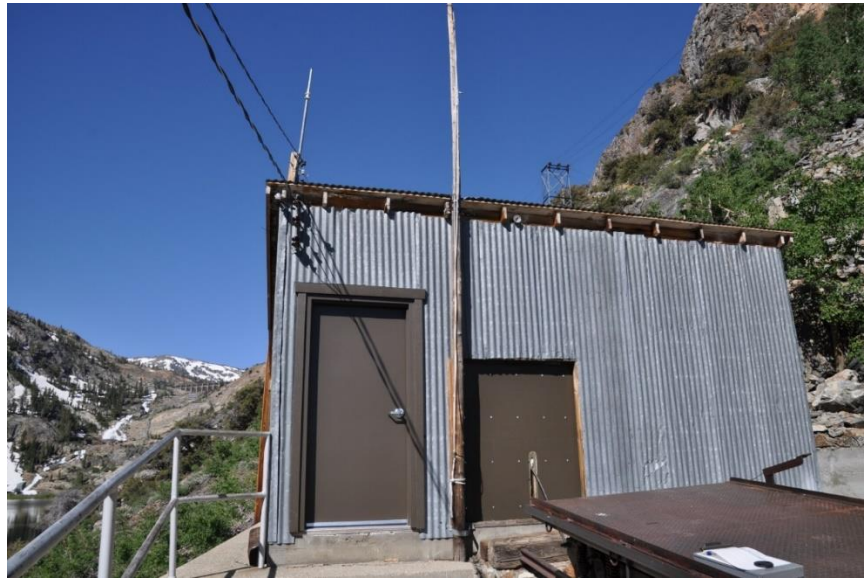
Photo 58. Agnew Tram Hoist House. The 2024 bat roost surveys determined the building does not currently have a roost present. No guano was observed. This facility was determined to be suitable bat roosting habitat. Building provides vertical and roofed components and has cracks and crevices that could potentially support roosting bats. Building has appropriate thermal conditions for maternity roosting (high solar exposure).

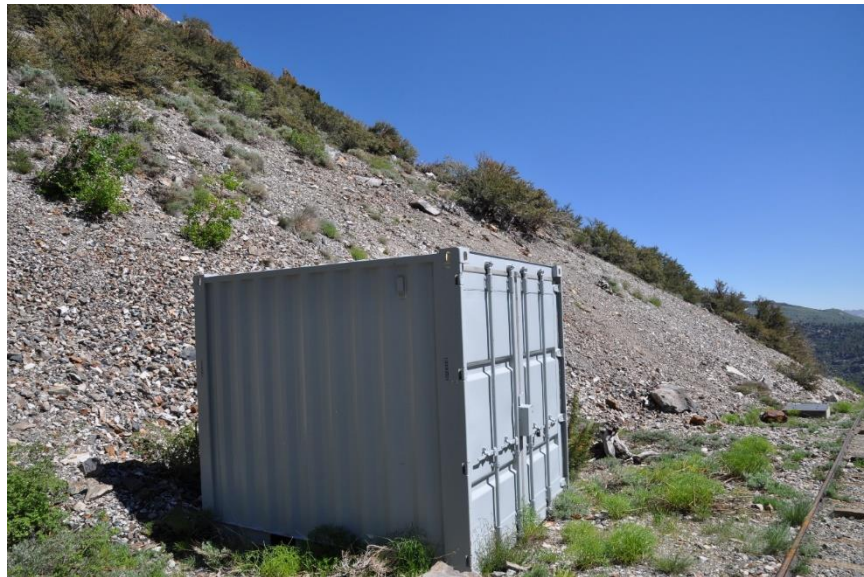
Photo 59. Agnew Tram Landing (metal storage building not identified on facility list or on the maps). This facility is unsuitable for bat roosting. Metal storage container does not provide roofed components or cracks and crevices that could potentially support roosting bats.

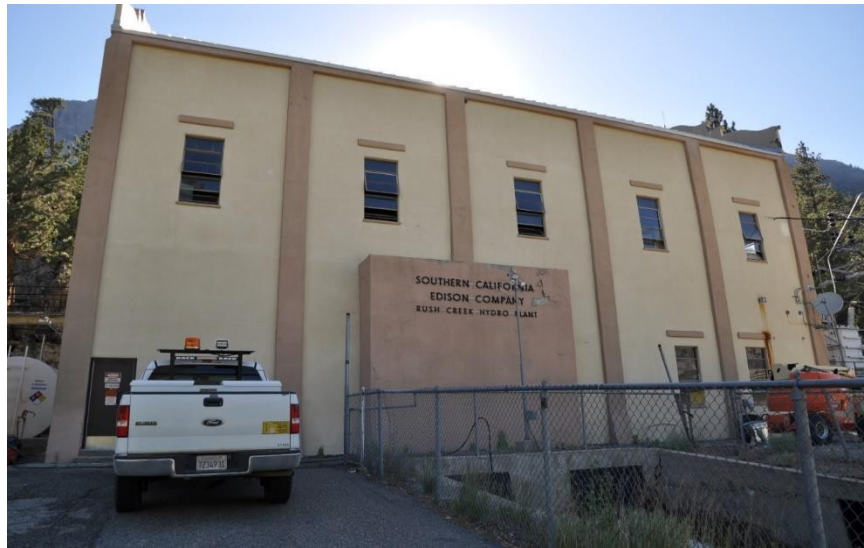
Photo 60. Rush Creek Powerhouse. The 2024 bat roost surveys determined the building does not currently have a roost present. One piece of was observed near the corner where Cottage No. 2 has a light. Guano is likely a result of a fly-by and is incidental. This facility was determined to be suitable bat roosting habitat. Building provides vertical and roofed components that could potentially support roosting bats. The building has cracks and crevices where bats could enter the facility. The building has appropriate thermal conditions for maternity roosting (high solar exposure).
