REC 1 – RECREATION FACILITY CONDITION ASSESSMENT TECHNICAL MEMORANDUM

**KERN RIVER NO. 1 HYDROELECTRIC PROJECT
*FERC PROJECT No. 1930***

December 2025

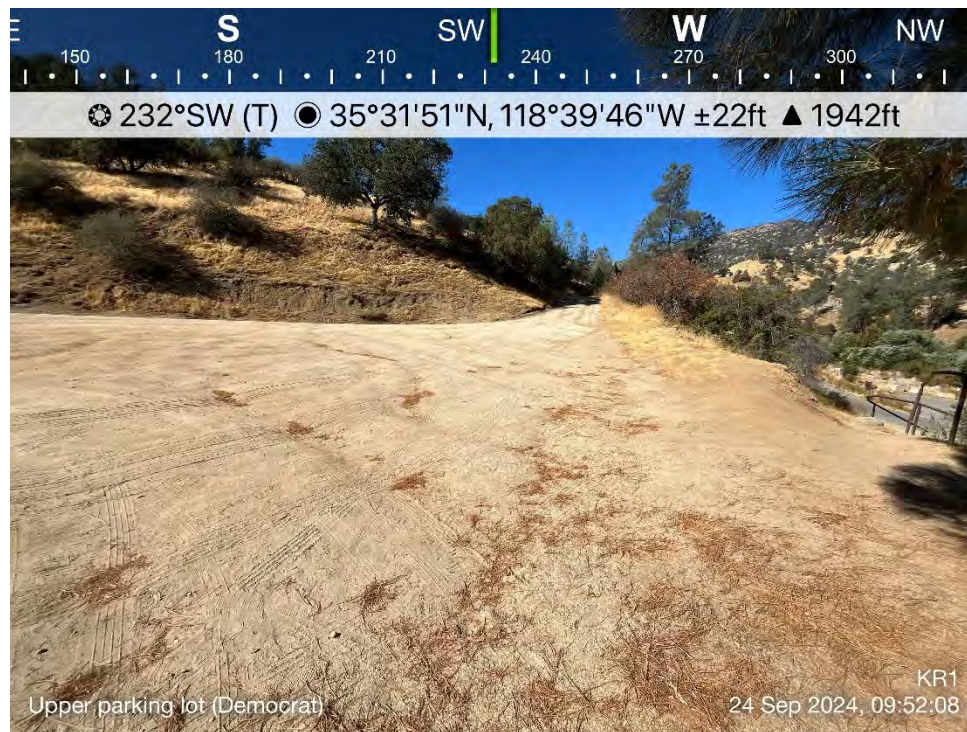
Site Condition: Field staff observed areas of erosion along the upper unpaved access road as well as within the unpaved parking lot. There is some evidence of vegetation disturbance due to extended footpath use and creation of informal trails. There is evidence of erosion near the informal overlook, at the covered picnic area, and at the stairs down to the lower boat ramp area. Overgrown vegetation is present on the paved access paths. There was no graffiti or litter throughout the site.

Amenity	Description	Condition ¹	FSORAG Compliance	Photo (Appendix B)
Boat Ramp	Two-lane, carry-in boat launch	G	NA	B-23
Upper Parking Area	Unpaved; approximately 20 parking spots	M	NA	B-3, B-4, B-6
Paved Whitewater Access Area	Paved; no parking allowed	G	NA	B-20, B-21
ADA Parking Spots	Two spots in the upper unpaved parking area	G	Yes	B-10
Covered Picnic Area	One table; covered	M	No: lack of adequate space (48 inch minimum) (FSORAG Section 4.1.4)	B-14, B-15, B-16, B-17
Informal Overlook	At picnic area overlooking lower paved whitewater access area	R	No: uneven surface (FSORAG Section 3.4.6) and lack of adequate space around picnic shelter (48 inch minimum) (FSORAG Section 4.1.4)	B-13
Pit Toilet	At upper unpaved parking area; two stalls	G	Yes	B-6, B-7, B-8, B-9, B-10

Photo B-3. Democrat Raft Take-out Boating Site – Upper Parking Lot

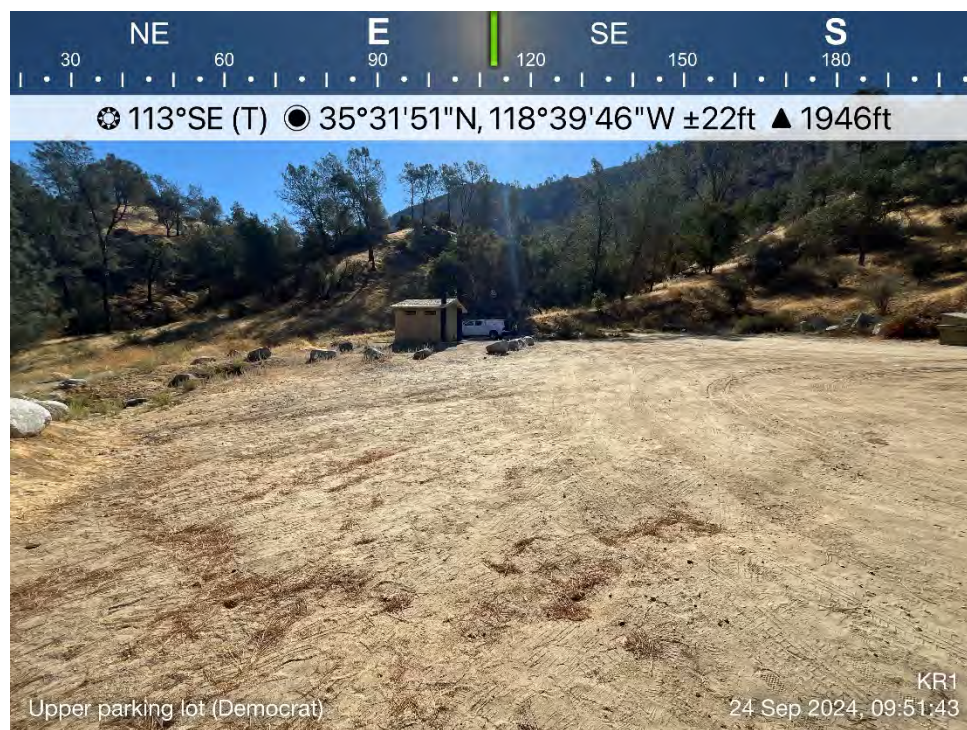
Photo B-4. Democrat Raft Take-out Boating Site – Upper Parking Lot

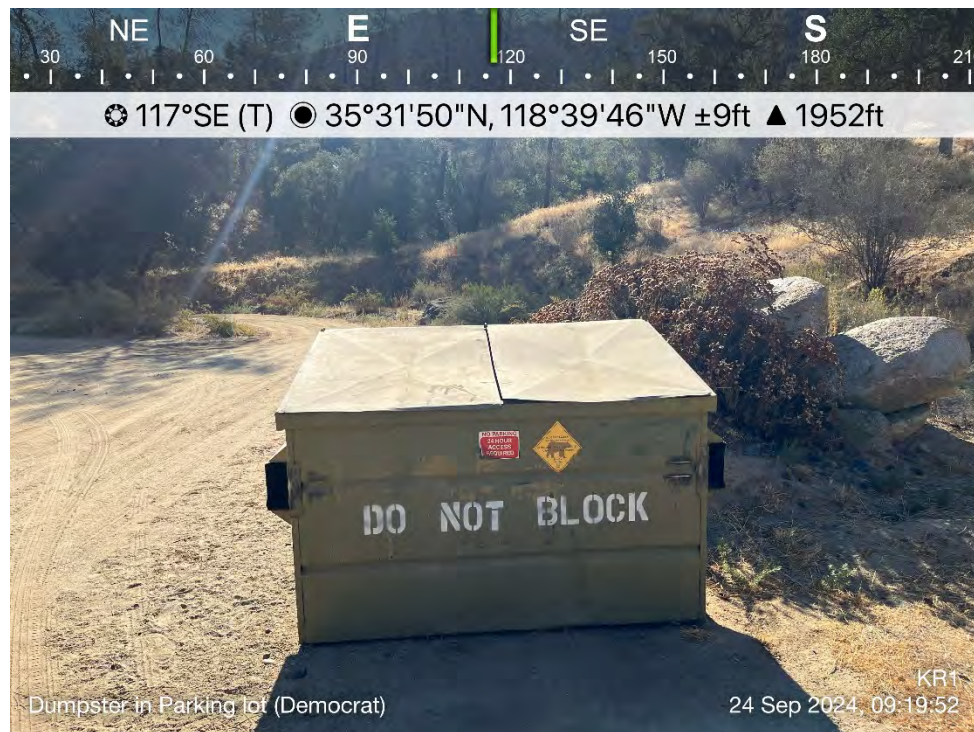
Amenity	Description	Condition ¹	FSORAG Compliance	Photo (Appendix B)
Trash Receptacle	At upper unpaved parking area	G	No: reach ranges are not within specifications (FSORAG 4.5.5 and ABAAS section 308)	B-5
Access Roads	Paved and unpaved	Paved: G Unpaved: M	NA	B-3
Paved Access Path	From pit toilet structure to covered picnic table area	M	No: overgrown vegetation, missing handrails and eroded, uneven, and incomplete sections (ABAAS Section 505.1 and FSORAG Sections 2.2 and 2.7)	B-11, B-12, B-13
Entry Sign	Off SR-178	G	NA	B-1
Directional Sign Along Access Road	Along paved access road	G	NA	B-2
Informational Signboard 1 (Fire Information)	English; glass and fire information	G	Yes	B-16
Informational Signboard 2 (General Information)	English; hours of operation, fire, fishing, dog and glass information	G	Yes	B-22

Photo B-5. Democrat Raft Take-out Boating Site – Dumpster in Upper Parking Lot

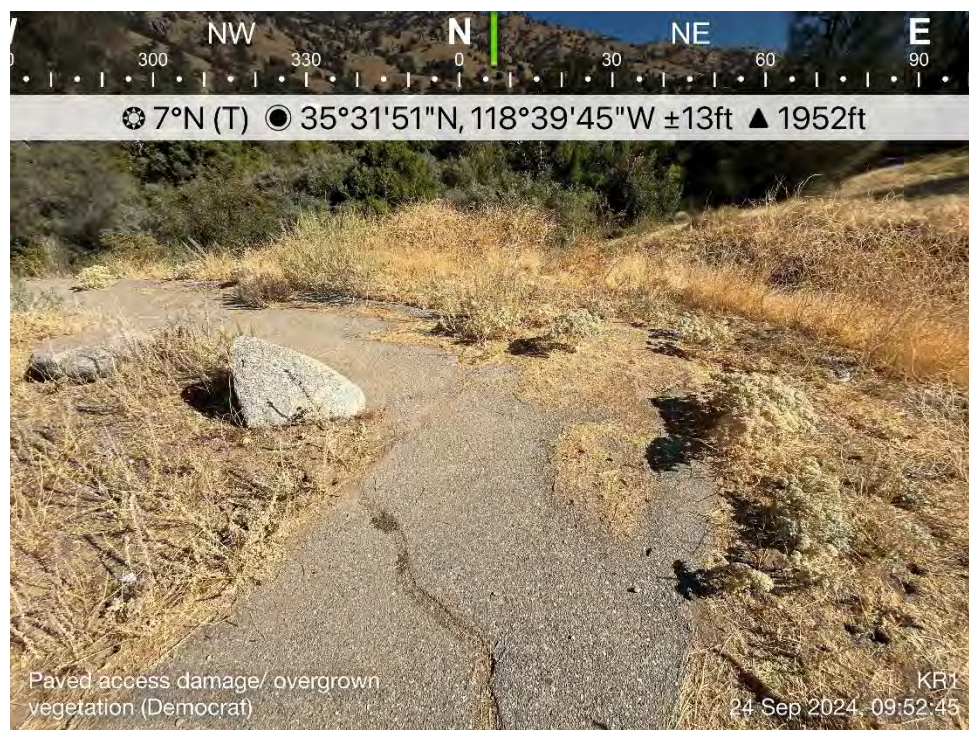
- The paved access paths are not compliant due to overgrown vegetation, missing handrails, and eroded, uneven and incomplete sections of pavement.
- The informal overlook is not compliant due to inadequate clearance around the picnic shelter for viewing and maneuvering.

Photo B-11. Democrat Raft Take-out Boating Site – Paved Access Path and Overgrown Vegetation

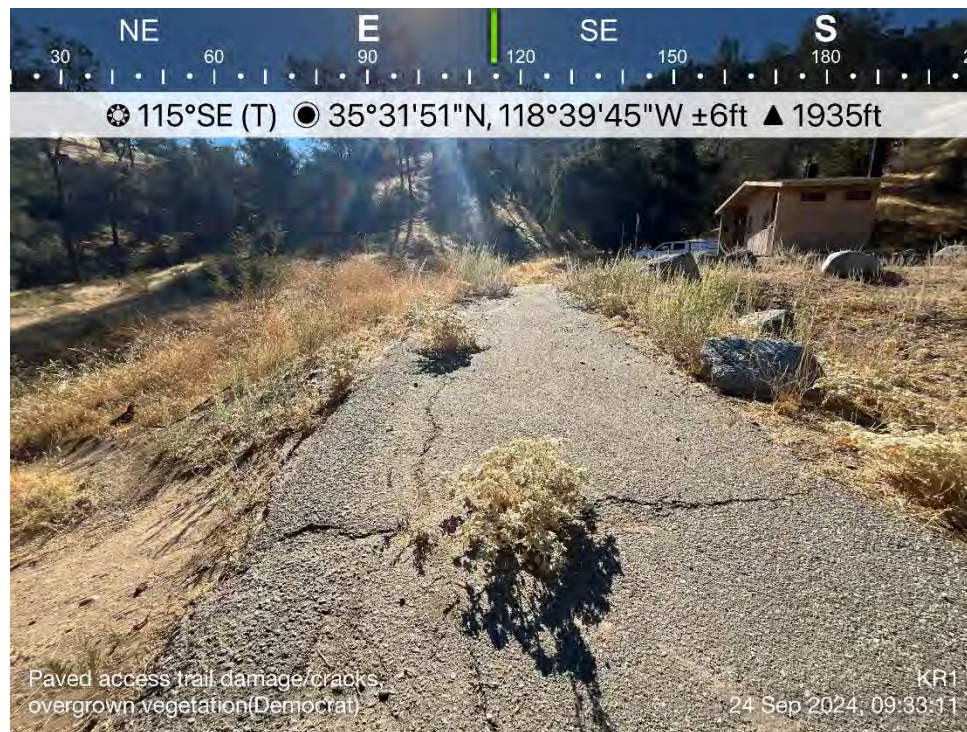
Photo B-12. Democrat Raft Take-out Boating Site – Paved Access Path and Overgrown Vegetation

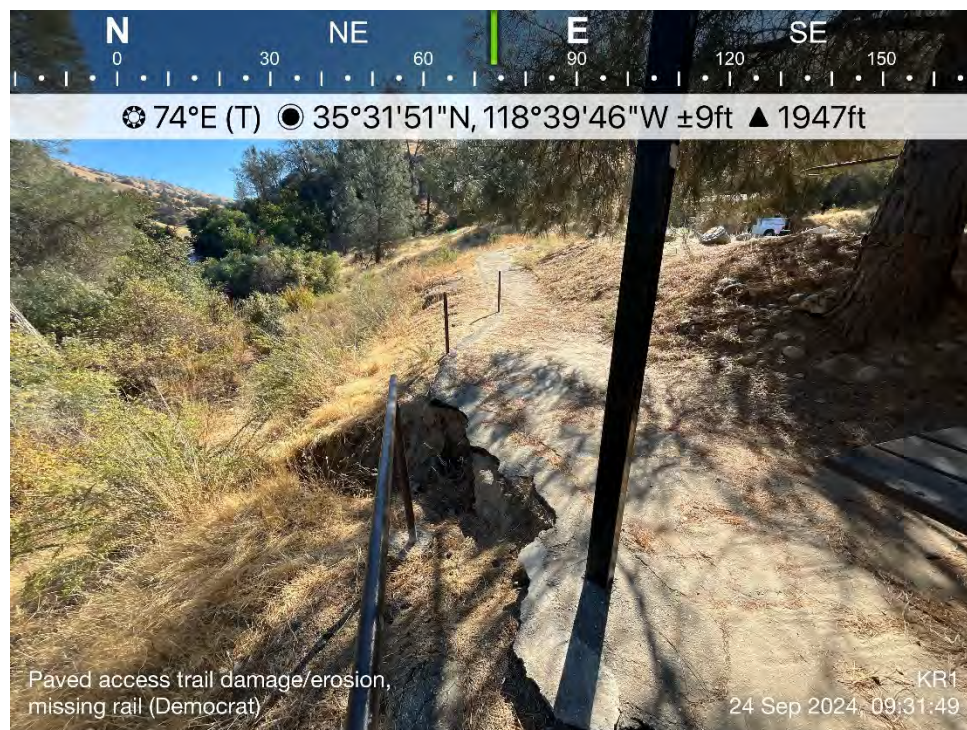
Photo B-13. Democrat Raft Take-out Boating Site – Paved Access Trail with Missing Handrails, Erosion and Wash Out

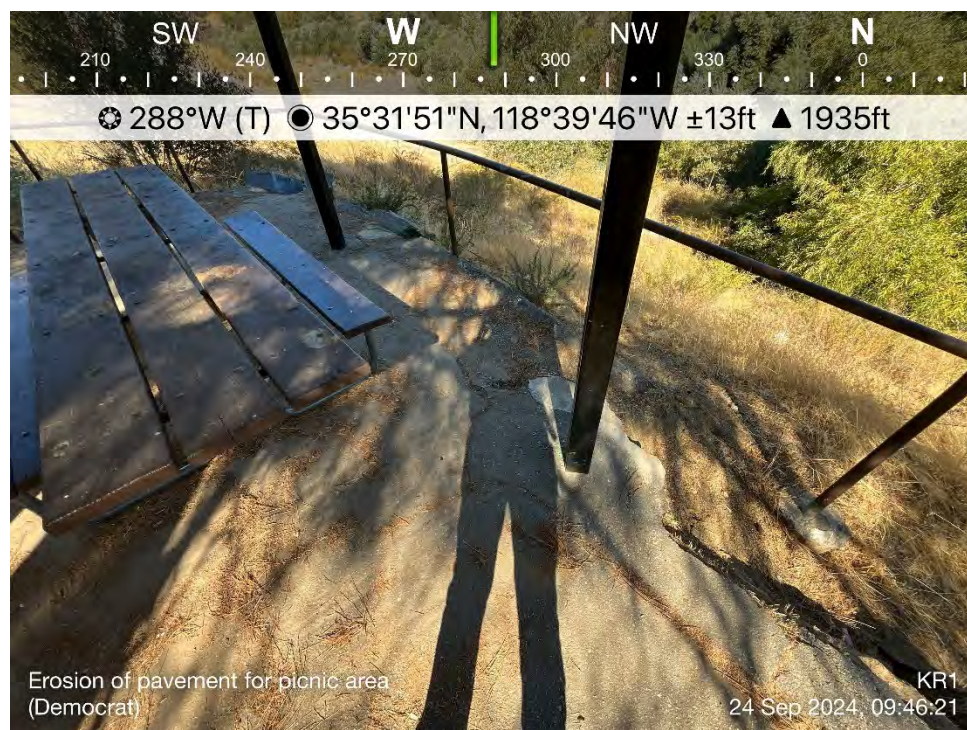
- The trash receptacle is not compliant due to reach ranges outside of the required specifications.
- The covered picnic area is not compliant due to inadequate clearance around the picnic table and noncompliant access paths.

Photo B-15. Democrat Raft Take-out Boating Site – Covered Picnic Table and Erosion

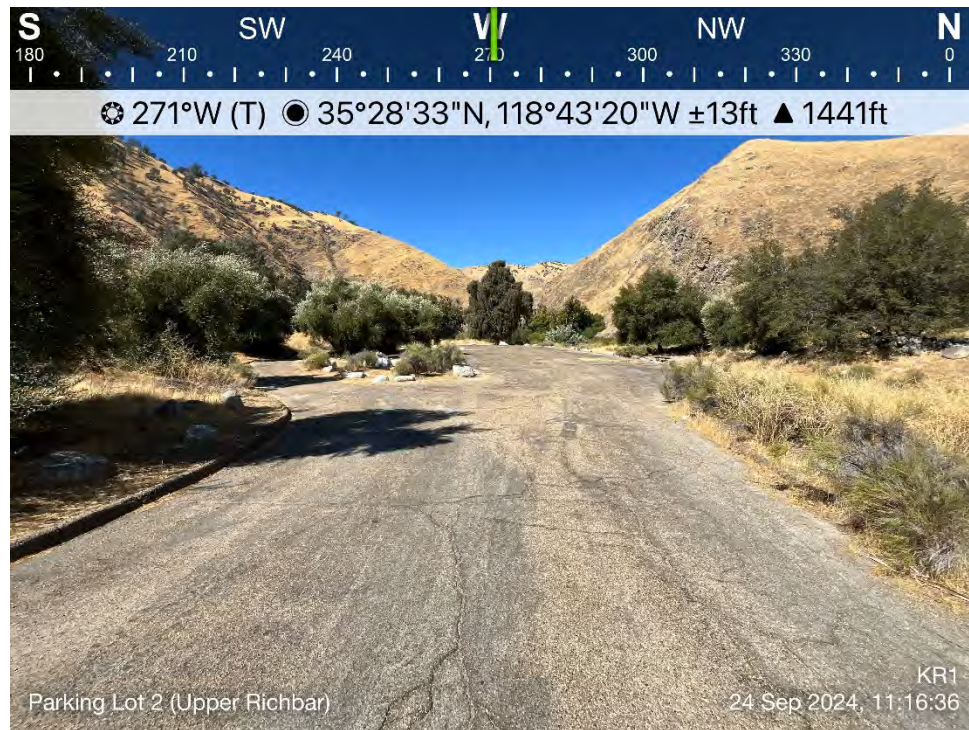
Amenity	Description	Condition¹	FSORAG Compliance	Photo (Appendix B)
Entry Sign	Off SR-178	G	NA	B-24
West Parking Lot	Paved; 18 parking spots	M	Yes	B-26
Dirt Road	Closed off with a chain in the middle of site	G	NA	B-31
East Parking Lot	Paved; 22 parking spots	M	Yes	B-27, B-28
ADA Parking Spots	Two spots in the east paved parking lot	M	Yes	B-27, B-28
Picnic Tables	Uncovered; 14 tables	M/R	No: picnic tables are not accessible via the paved access path (FSORAG Section 3.3.2)	B-39, B-42, B-43, B-44, B-45, B-46, B-47, B-48, B-49, B-50
Paved Access Paths	Paths from parking lot lead to beach access area, picnic area with missing table, and pit toilets	M/G	No: the surface is uneven due to cracks caused by erosion and the path is not sufficiently wide (FSORAG Section 2.3 and 2.7)	B-34, B-35, B-36, B-37, B-38
Trash Receptacles	Metal trash cans outside pit toilet	G	Yes	B-30, B-32, B-33
Grills	10 grills, some rusted	M	No: grills are not accessible via the paved access path. (FSORAG Section 4.2.6 and 4.2.7)	B-42, B-43, B-44, B-46, B-47, B-48, B-49, B-50

Photo B-26. Upper Richbar Day Use Area – West Parking Lot

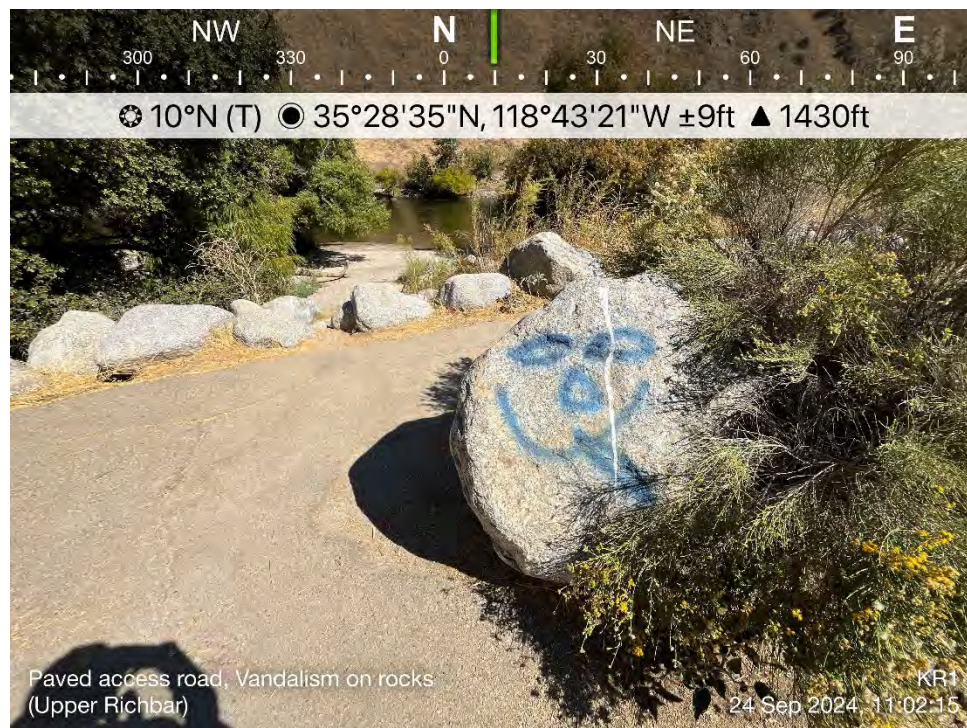
Site Condition: There is some evidence of vegetation disturbance due to extended footpath use and creation of informal trails west of the west parking lot. Graffiti is present on rocks, trees, and various structures throughout the site (refer to Appendix B, Photos B-37 and B-51). Litter was present throughout the site and at the beach below the site (refer to Appendix B, Photo B-41). Parking space delineation is faded and hard to see.

Photo B-37. Upper Richbar Day Use Area – Paved Access Path and Graffiti

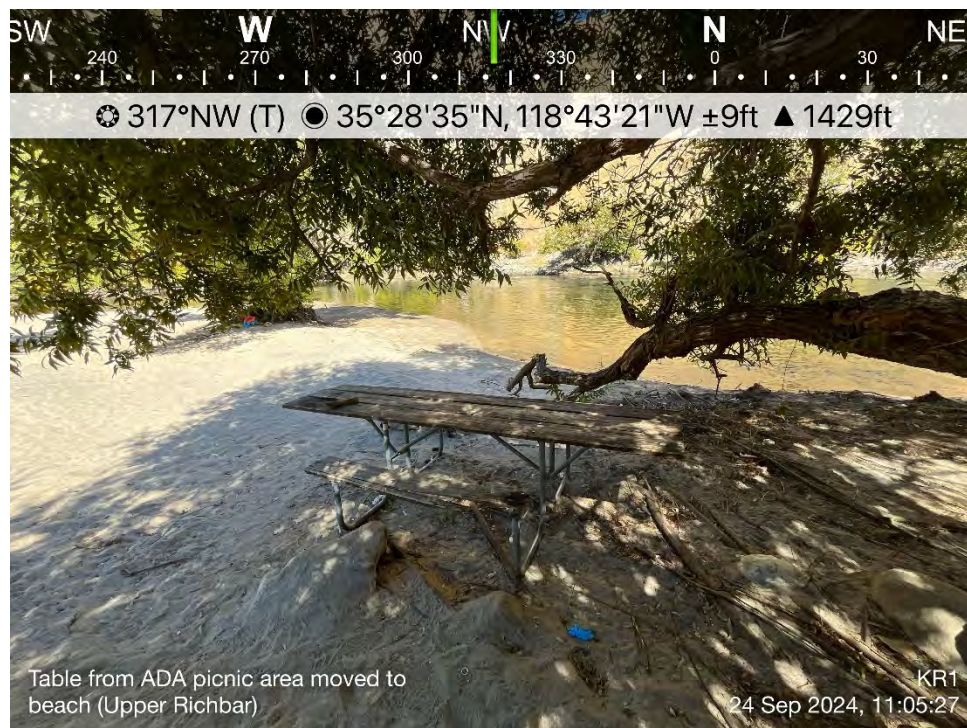
Photo B-39. Upper Richbar Day Use Area – Moved and Damaged FSORAG Compliant Picnic Table

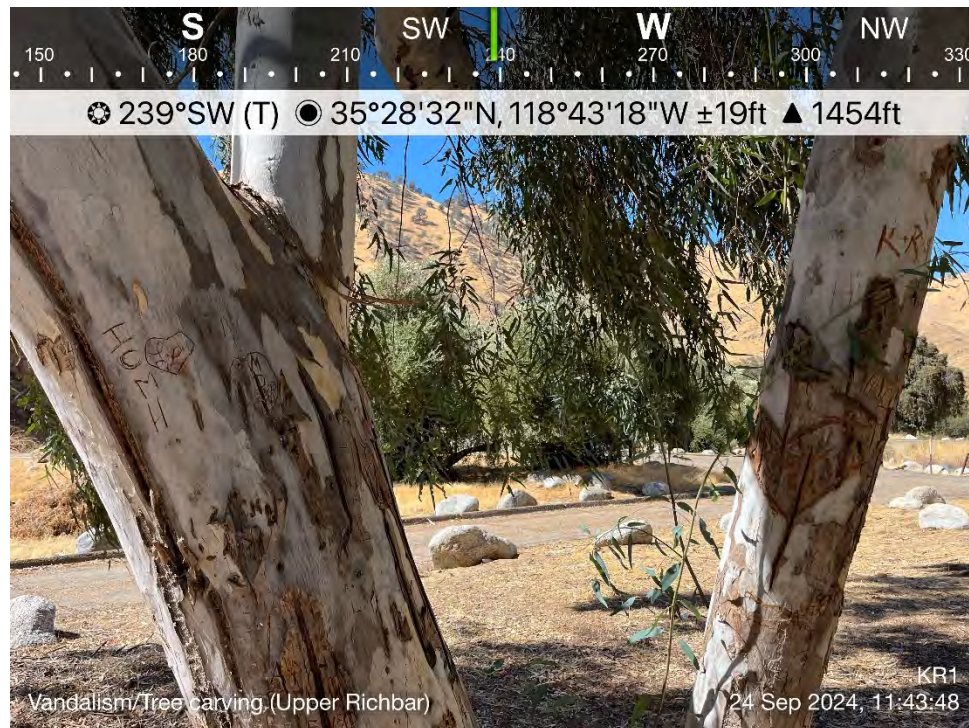
Photo B-51. Upper Richbar Day Use Area – Graffiti on Trees

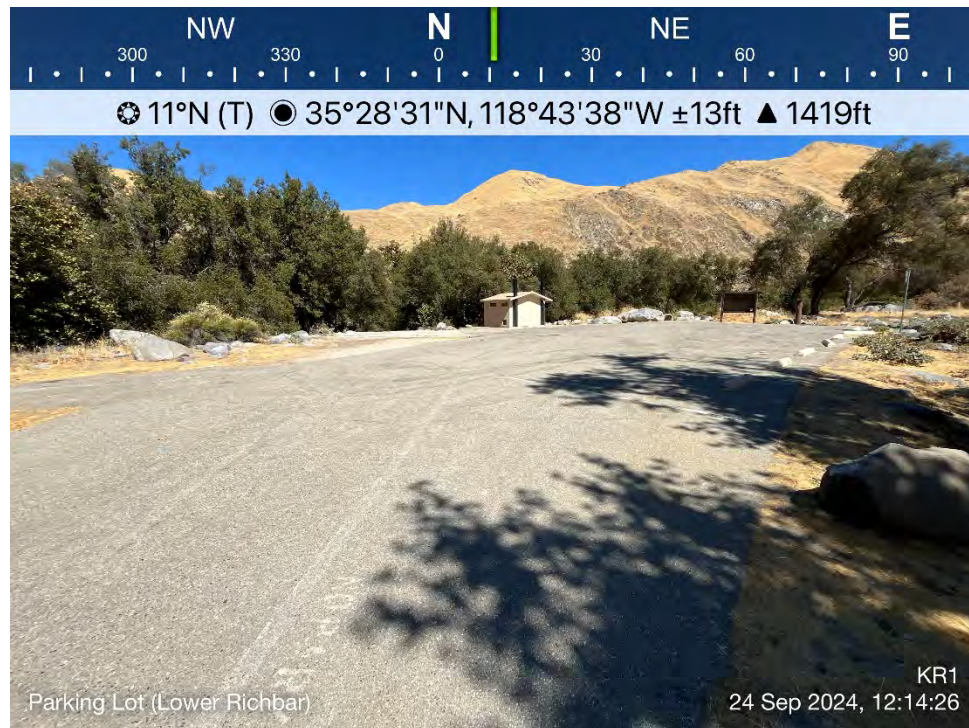
Site Condition: There is some evidence of vegetation disturbance due to extended footpath use and creation of informal trails. Picnic tables were in generally good condition. Graffiti is present on rocks and trees throughout the site (refer to Appendix B, Photo B-57, B-58, and B-64). Litter was present throughout the site and at the beach below the site. Parking space delineation is faded and hard to see.

Amenity	Description	Condition ¹	FSORAG Compliance	Photo (Appendix B)
Picnic Tables	Uncovered; 11 tables - including one picnic table designed for universal access.	G	Yes	B-61, B-62, B-63
Parking Lot	Paved; 10 spots	M	Yes	B-53, B-54
ADA Parking Spaces	One spot	M	Yes	B-54, B-55
Paved Access Paths	One paved trail from parking lot to paved picnic area. The surface is uneven but determined to remain accessible for a wheelchair.	M	Yes	B-60
Trash Receptacles	None on site due to site closed for season	Unknown ²	Unknown ²	NA
Grills	Five grills, some rusted	M	Yes	B-61, B-62
Pit Toilets	One structure; two stalls total. Pit toilets were locked during time of assessment	Unknown ²	Unknown ²	B-55, B-59
Informational Signboard and Fee Post	Site closed for season; void of postings	Unknown ²	No: lack of adequate clearance surrounding fee post (FSORAG Section 3.5.3)	B-56
Gate	Locked gate just past entry sign	G	NA	NA

Photo B-53. Lower Richbar Day Use Area – Parking Lot

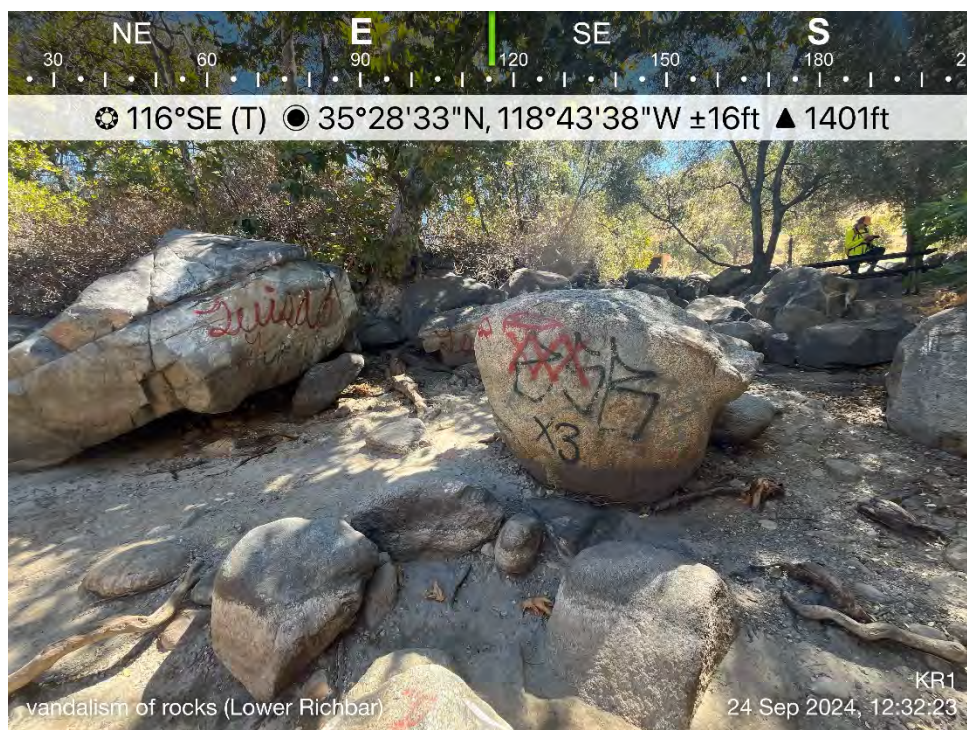
Photo B-64. Lower Richbar Day Use Area – Graffiti on Rocks

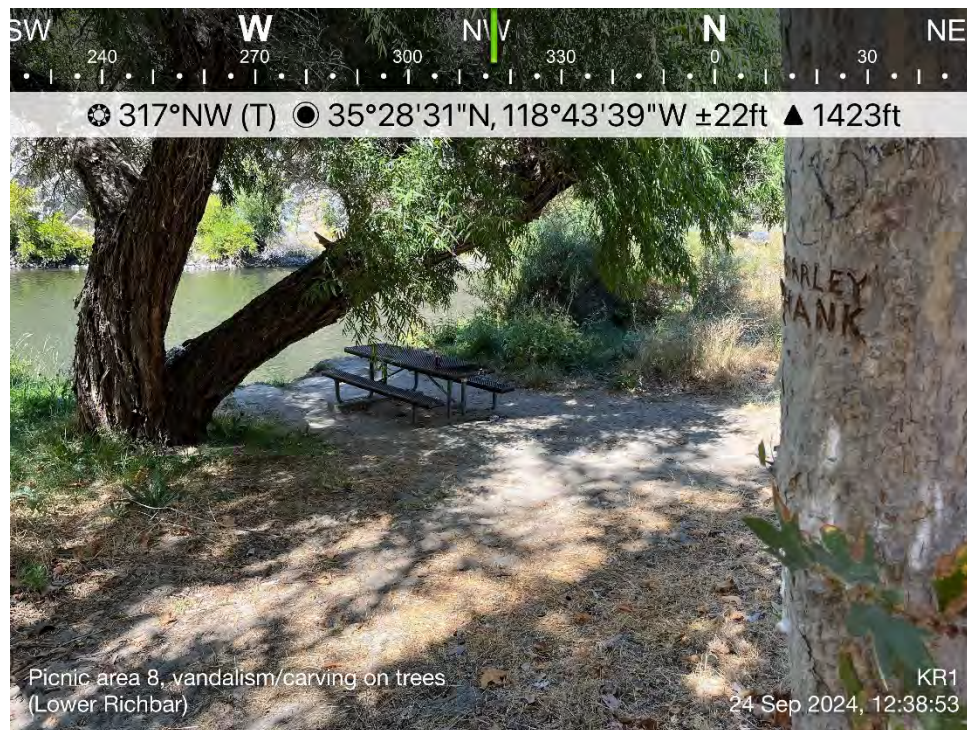
Photo B-65. Lower Richbar Day Use Area – Graffiti on Rocks

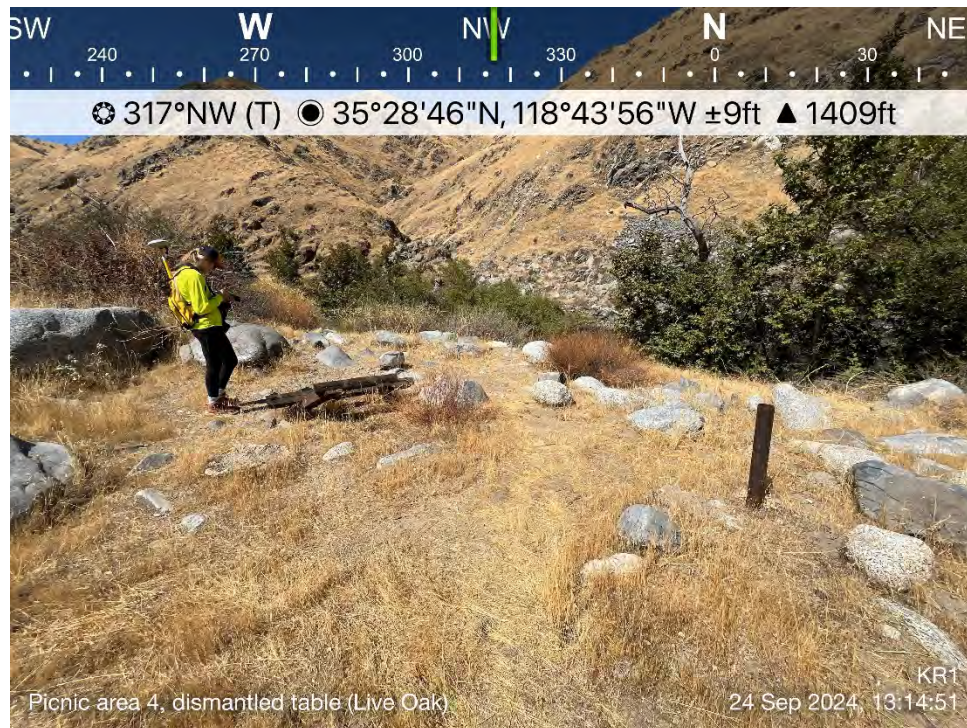
Site Condition: There is some evidence of vegetation disturbance due to extended footpath use and creation of informal trails (refer to Appendix B, Photo B-75 and B-77). Parking space delineation is faded and hard to see. Many of the picnic tables are in poor condition, require maintenance, or are missing. Some areas had posts for grills, but the grills themselves were absent (appeared to have been removed by force). Graffiti is present on rocks, pit toilets, and tables throughout the site (refer to Appendix B, Photo B-76).

Photo B-75. Live Oak Day Use Area – Picnic Area (broken picnic table)

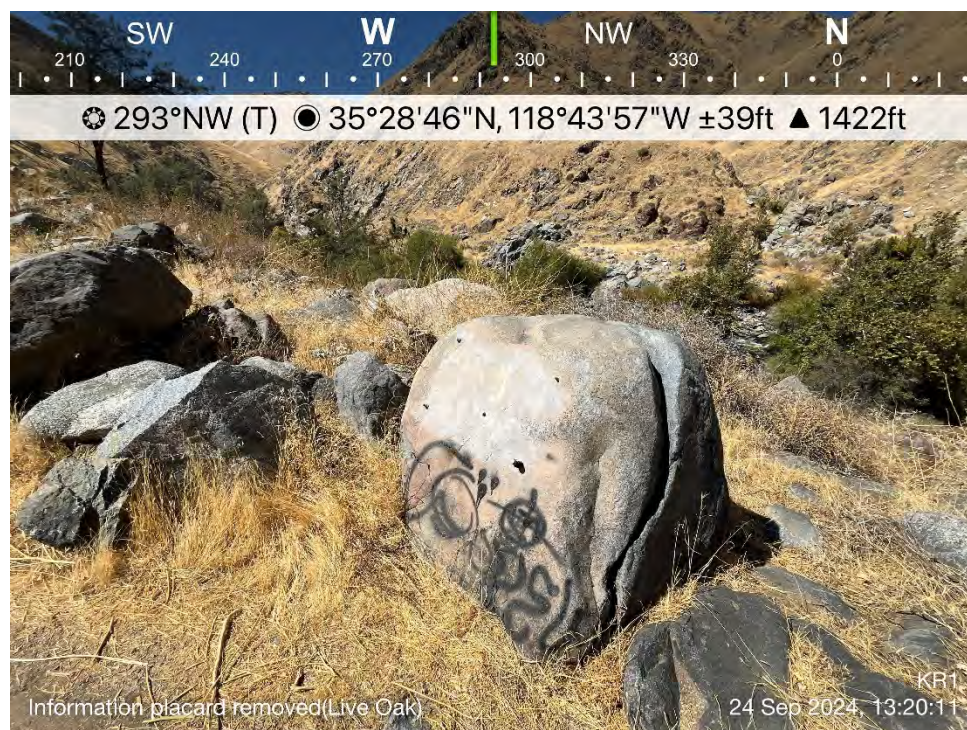
Photo B-76. Live Oak Day Use Area – Graffiti on Rocks
