TERR 2 – WILDLIFE RESOURCES TECHNICAL MEMORANDUM

**KERN RIVER NO. 1 HYDROELECTRIC PROJECT
*FERC PROJECT No. 1930***

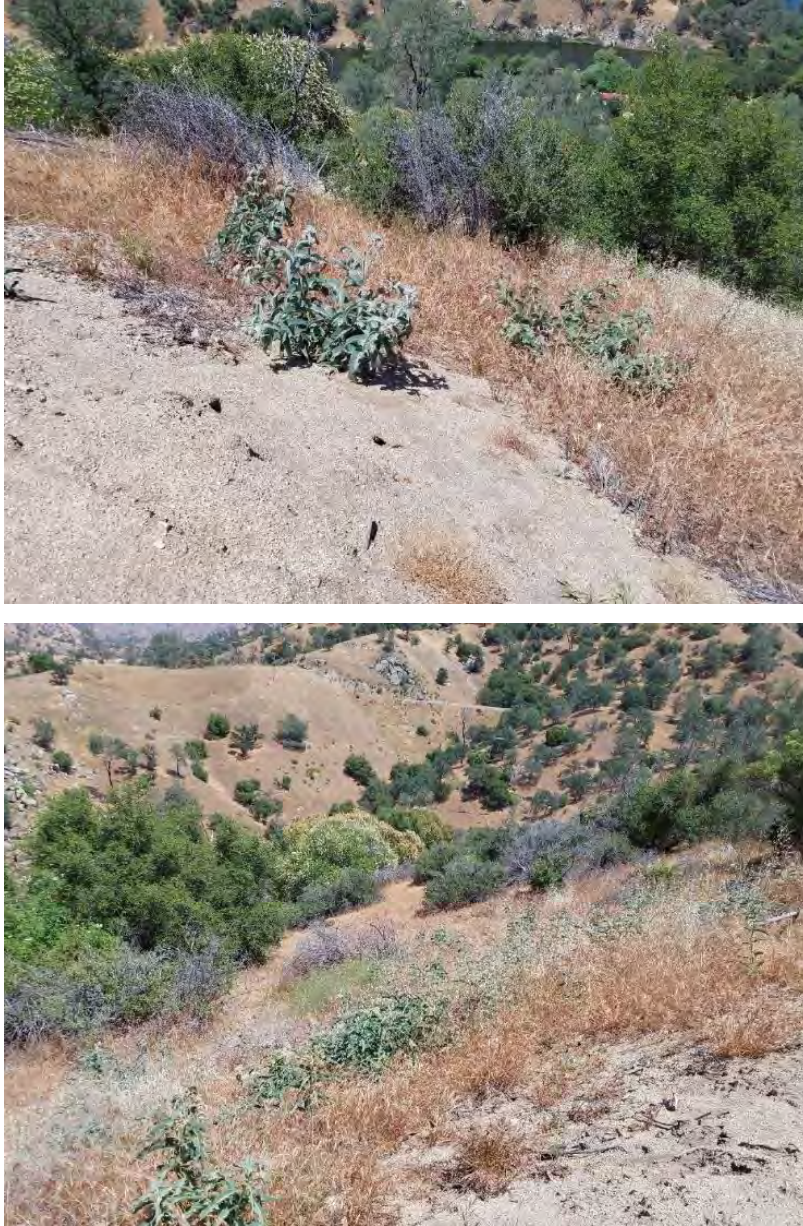
Photo A-1a, b. A large population of California milkweed (*Asclepias californica*) (Map ID ASC-1) found along Democrat Dam Road. This population is estimated to contain at least 70 individuals within approximately 6,500 square feet.

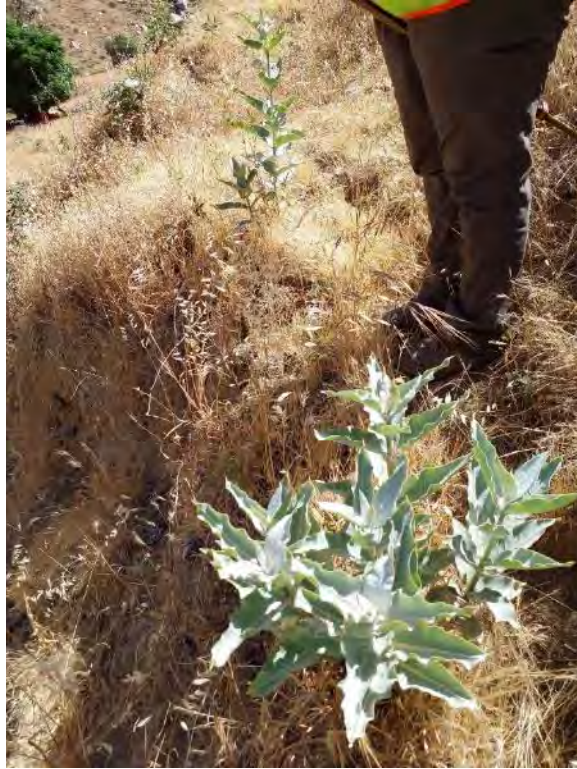
Photo A-2. A California milkweed identified along the Overflow Spillway Trail (Map ID ASC-3). This small population consists of two individuals within approximately 4 square feet.

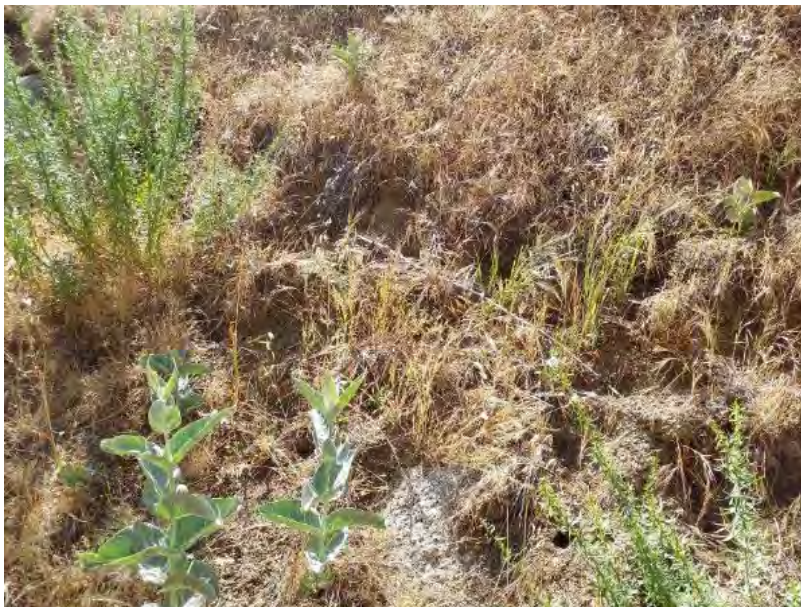
Photo A-3. A small population of California milkweed individuals found along the Overflow Spillway Trail (Map ID ASC-4). This population consists of seven individuals within approximately 40 square feet.

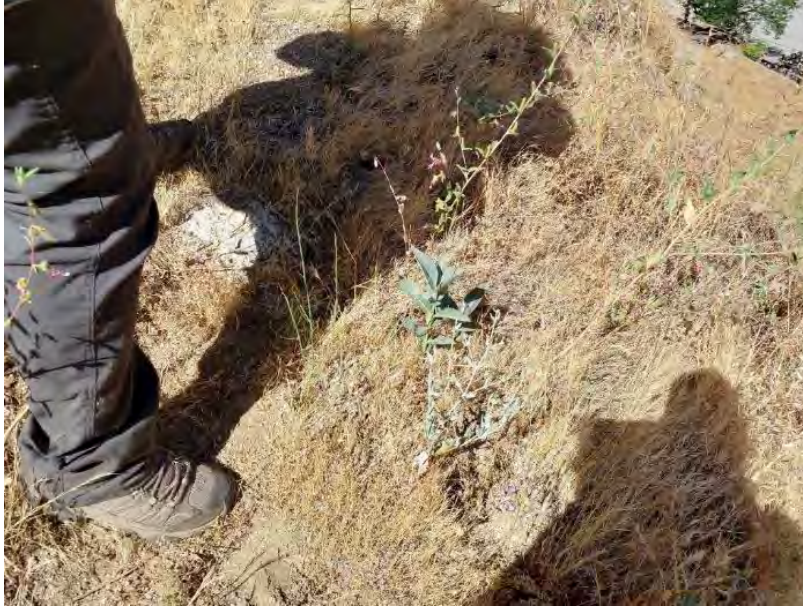
Photo A-4. A California milkweed plant observed along the Overflow Spillway Trail (Map ID ASC-6). This population consists of only one individual and is approximately 1 square foot.

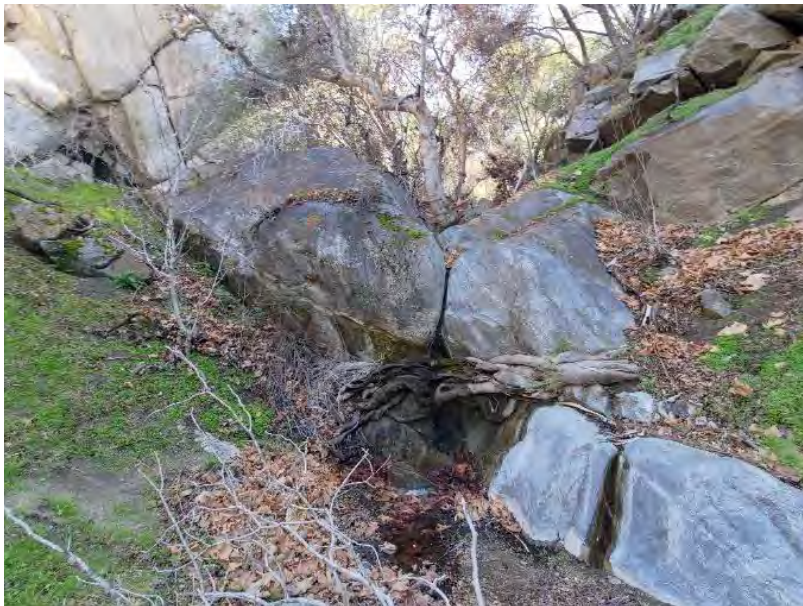
Photo A-5. Unnamed Seep along Willow Spring Creek Road: This location potentially meets the life history requirements for western spadefoot toad. Aquatic breeding habitat was present at the time of the survey and there is suitable upland habitat for adults.

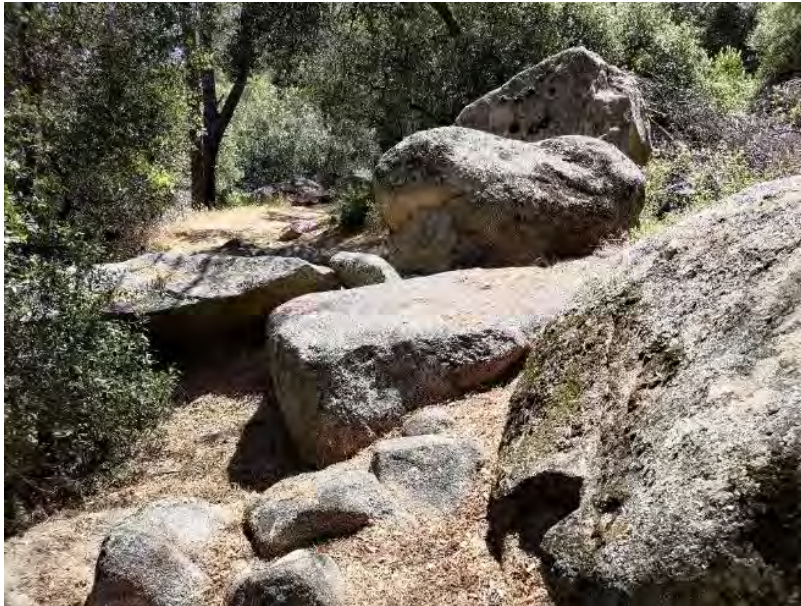
Photo A-8. Habitat for terrestrial reptiles was found throughout the Project area. Reptiles were most often seen on or along roads and trails where rock or vegetative cover was nearby. Both snakes and lizards were observed in areas with features similar to this photo (i.e. warm sunny areas, cracks in/between rocks, burrows, and vegetative cover).

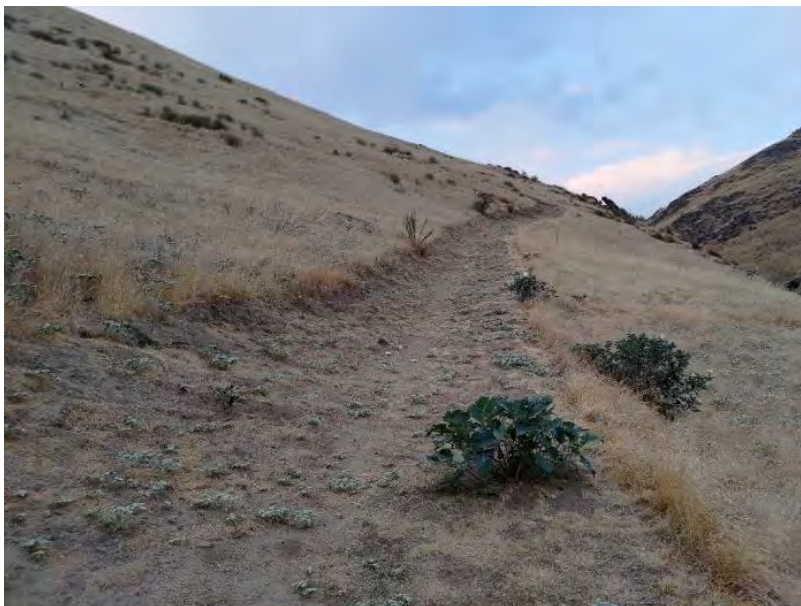
Photo A-9. This photograph of Lucas Creek Trail shows another typical trail and the surrounding terrestrial reptile habitat within the Project area. This photo was taken after SCE mowing maintenance in July 2024. Burrows of varying size were found along the length of the trail.

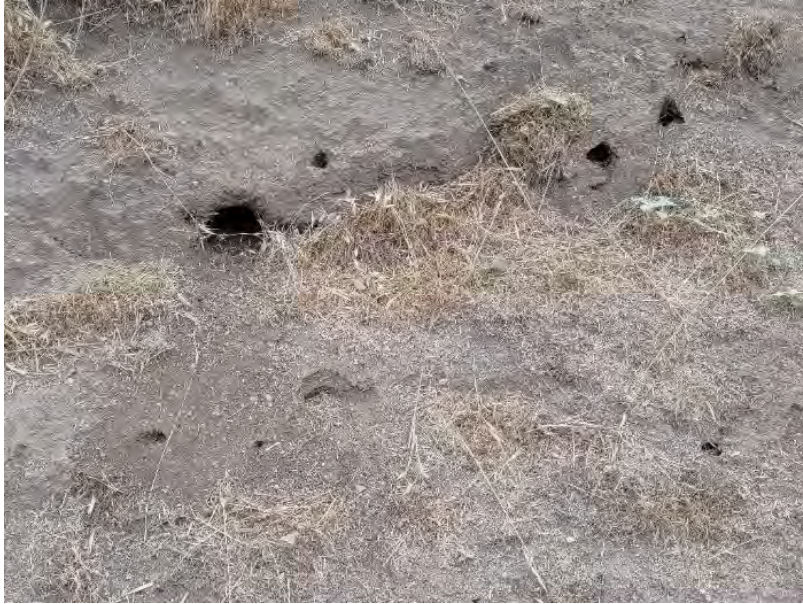
Photo A-10. Example of a typical variety of burrow sizes seen throughout the Project area. These burrows were observed along Lucas Creek Trail and provide habitat for terrestrial reptiles.

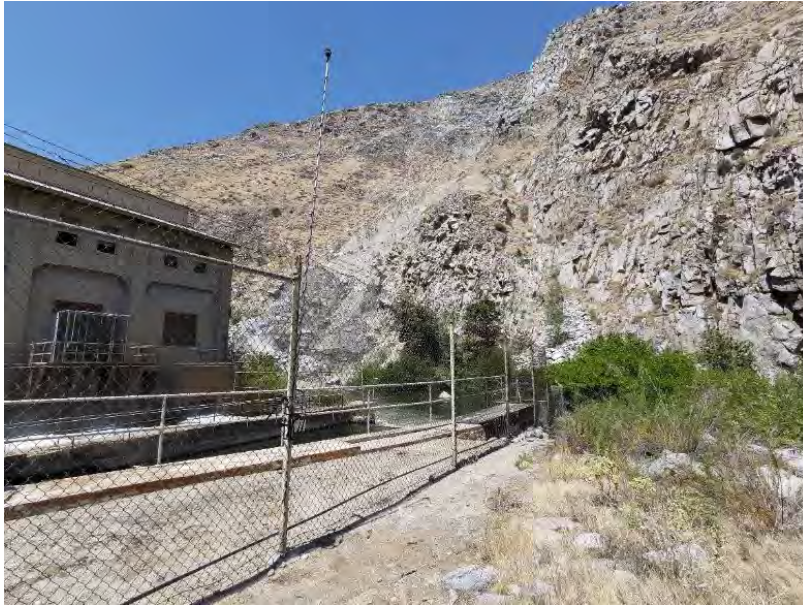
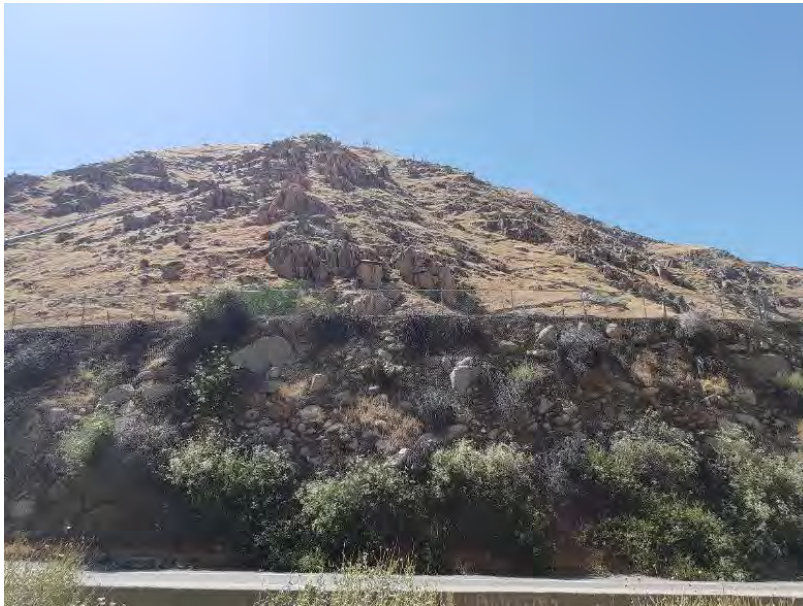
Photo A-11a, b. Examples of cliff habitat in the study area (near the Kern River Powerhouse and Skip Hoist/Forebay Trail, respectively).

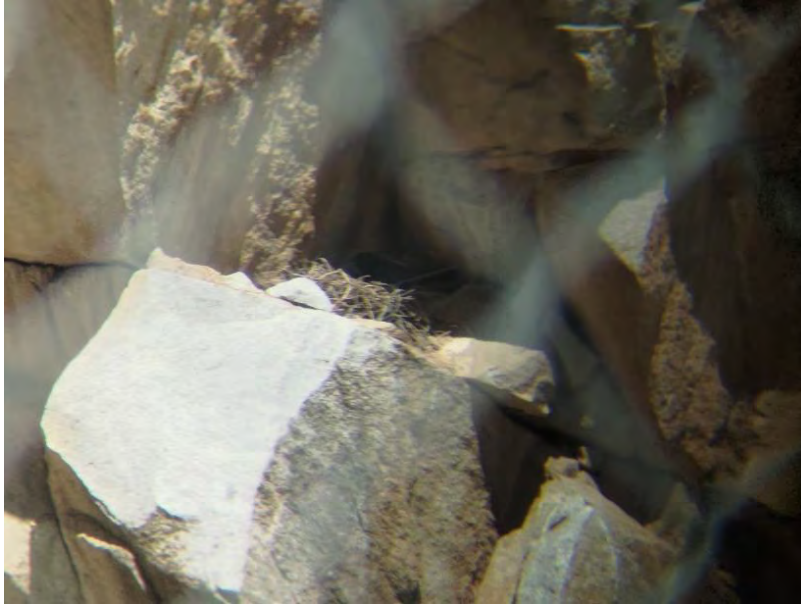
Photo A-12. The common raven nest is located to the west of Upper Powerhouse Road on the cliff bordering the Kern River outside the FERC boundary. Two adults were observed feeding two young within the nest.

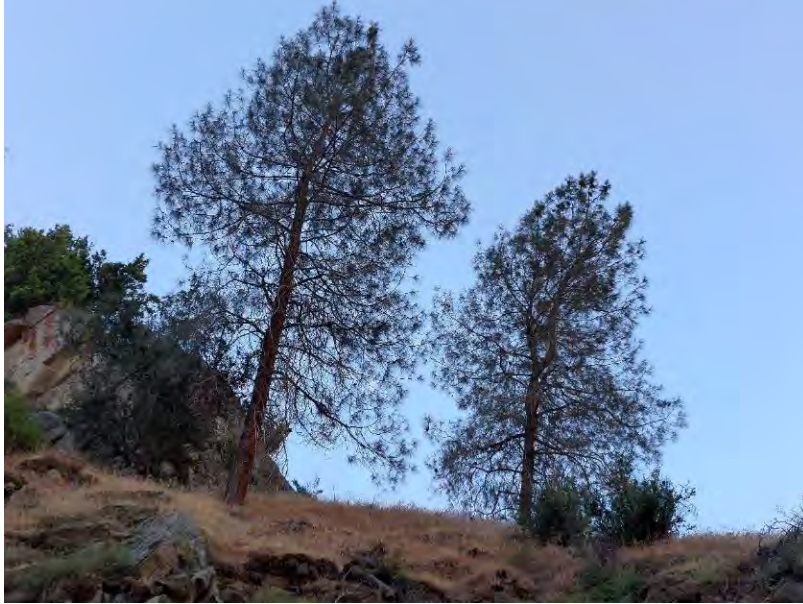
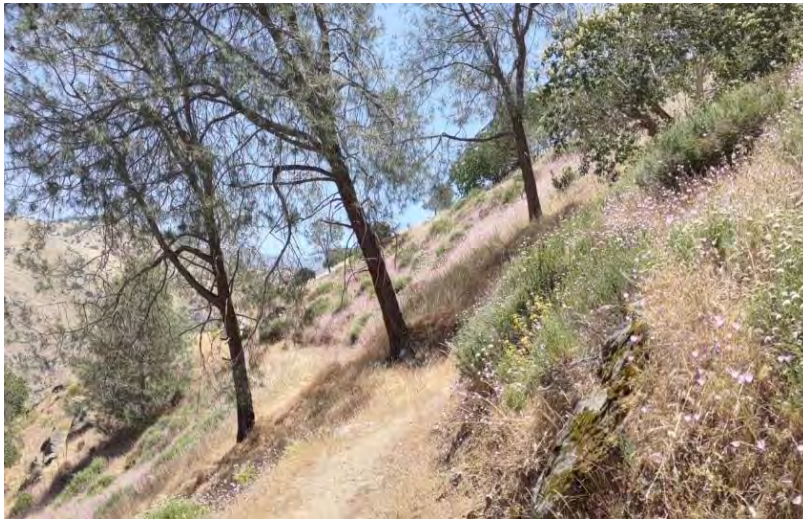
Photo A-13a, b. Photographs of typical Blue Oak–Foothill Pine CWHR habitat in the study area.

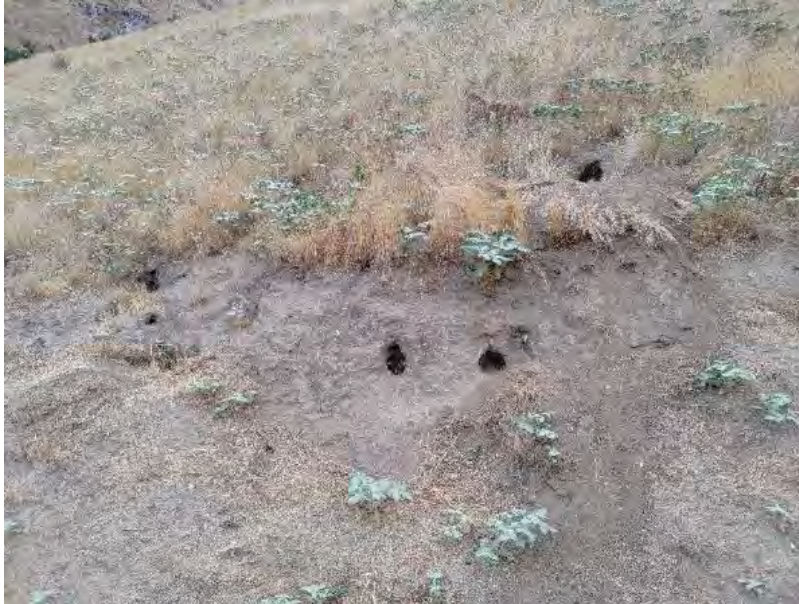
Photo A-17. This burrow complex (Map ID BUR-1, BUR-2, BUR-3) was found on Lucas Creek Trail. All the burrow entrances are approximately the same size ranging from three and a half to four inches tall and three to four inches wide. BUR-2 is collapsed and is only three inches deep. BUR-1 goes back approximately seven inches before turning while BUR-3 goes down approximately nine inches before turning. BUR-3 had some soil disturbance leading from the burrow and grass that was flattened around it indicating it may be active. No signs of kit fox habitation were observed.

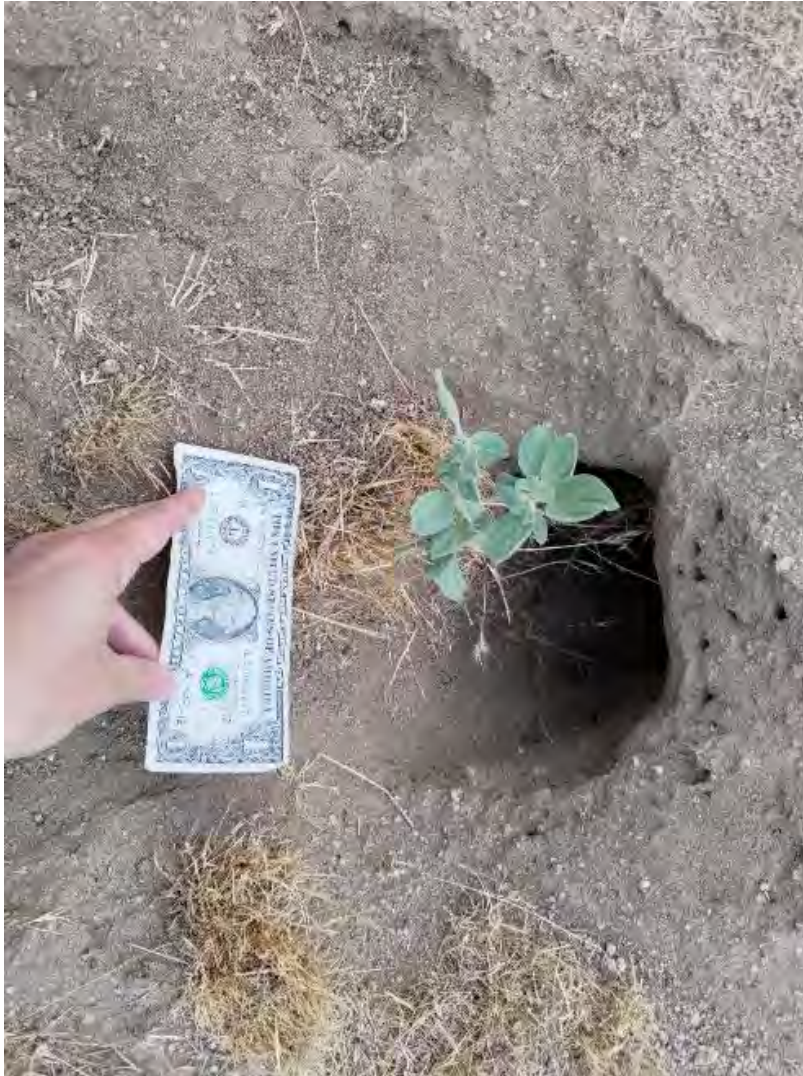
Photo A-18. This burrow (Map ID Bur-4) was found along Lucas Creek Trail. The entrance is five and a half inches tall and six inches wide. The burrow goes back approximately two feet before turning and no chamber was visible. There were no indications the burrow is active.

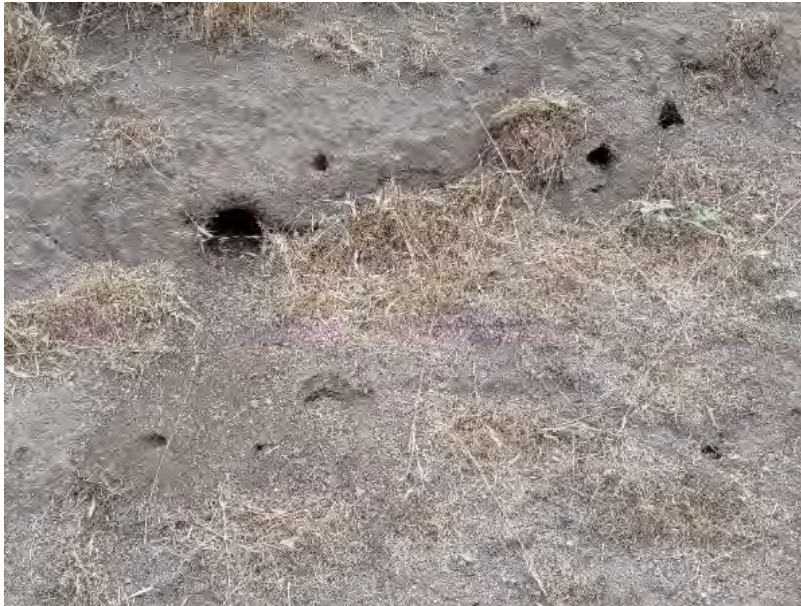
Photo A-19. This burrow (Map ID BUR-5) was found on Lucas Creek Trail. The entrance is four and a half inches tall and four and a half inches wide. The burrow goes back approximately one and a half feet before turning so the den chamber size could not be determined. The soil disturbance may be from unstable soils and not excavations. There are no other signs of occupancy.

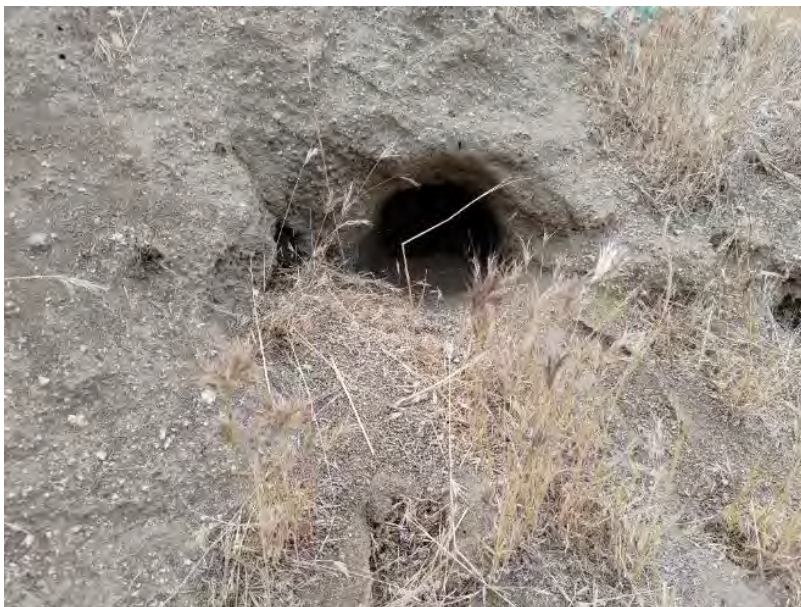
Photo A-20. This burrow (Map ID BUR-7) was found along Lucas Creek trail. The entrance is six and a half inches wide and five and a half inches tall. It is three to four feet deep with a visible chamber of approximately one foot by one foot. The burrow seems to have a second chamber that goes further and is part of a turn. There were no signs of occupation but the burrow is suitable size for kit fox. It is likely overgrown with grasses in the spring/summer.

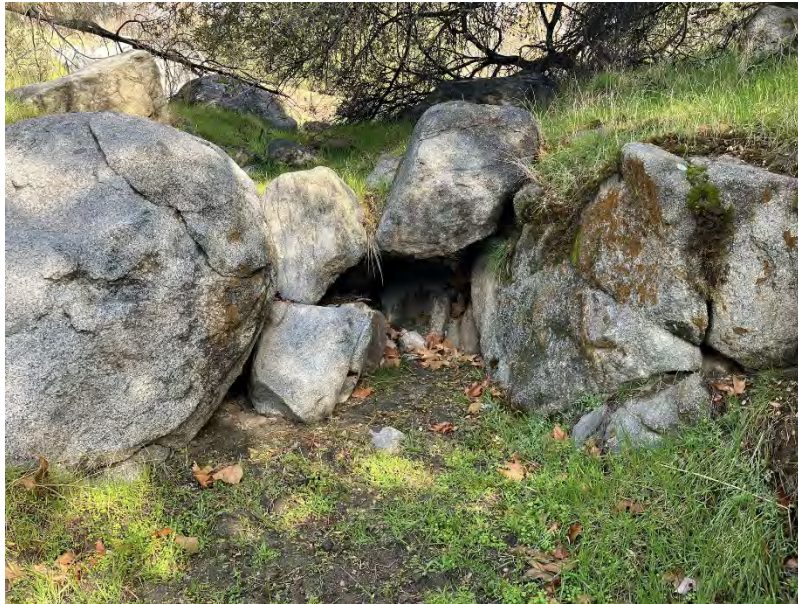
Photo E-1. An example of potential relictual slender salamander (*Batrachoseps relictus*) (FPE, CSC) habitat, dry during the assessment, observed within the Democrat Dam Impoundment area on January 27, 2025. This habitat was wet with slow flowing water and small pools at the time of the visual encounter survey. This photo shows that potential habitat can be dry during non-breeding periods.

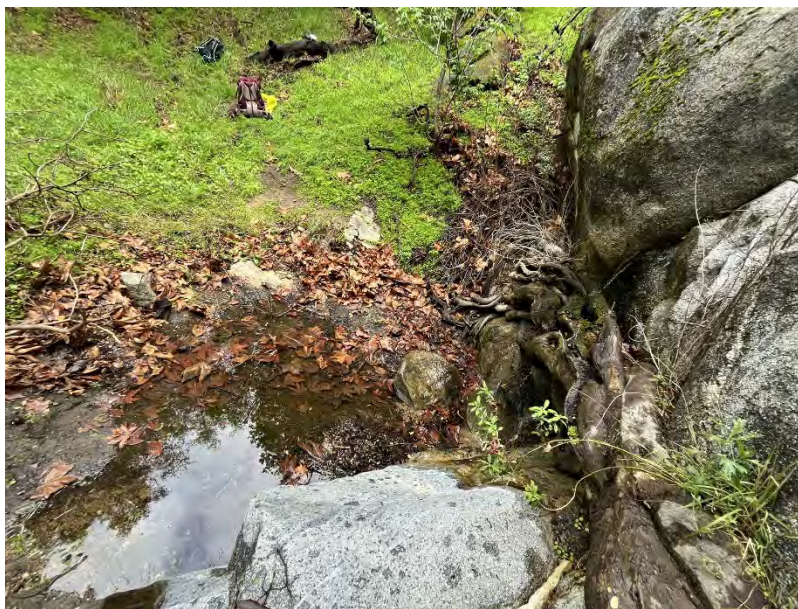
Photo E-2. An example of potential relictual slender salamander habitat with water present observed along Willow Spring Creek Road during the visual encounter survey on March 3, 2025.

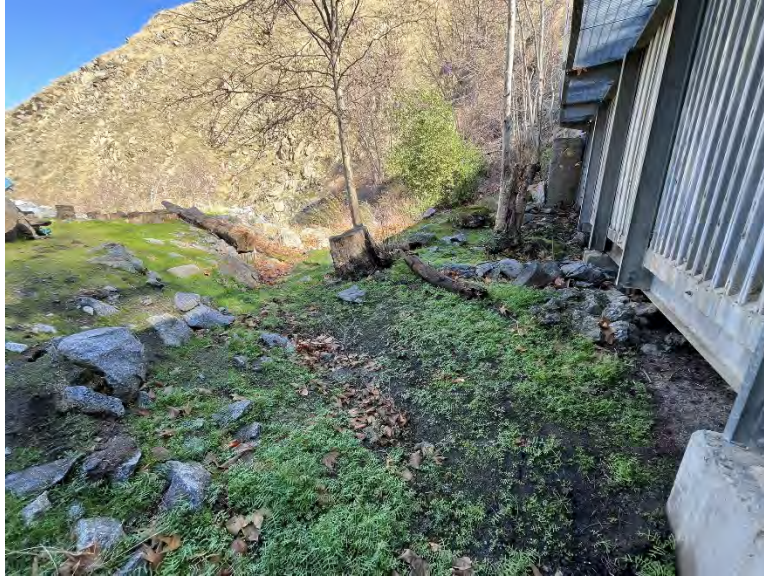
Photo E-3. An example of potential relictual slender salamander habitat observed at Flume No. 5 intersecting with Dougherty Creek observed during the habitat assessment on January 28, 2025.

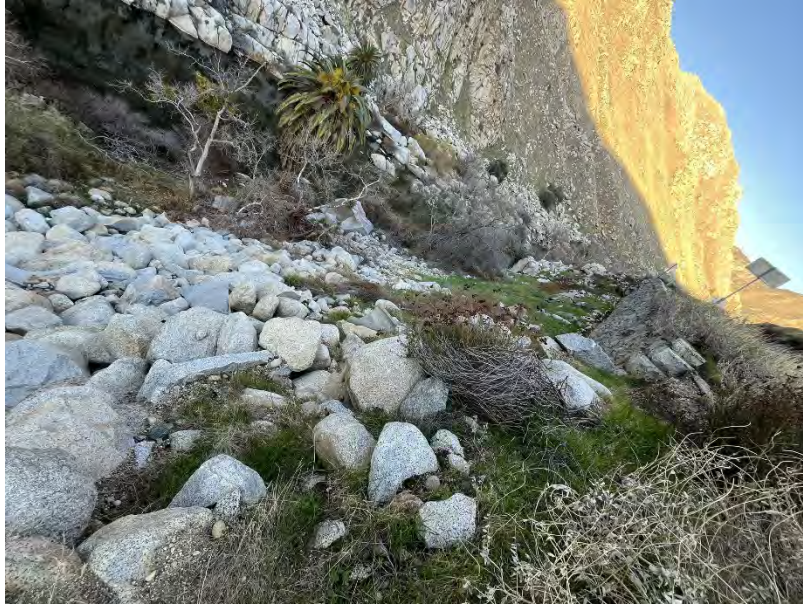
Photo E-5. An example of Kern Canyon slender salamander (*Batrachoseps simatus*) (FPT, CT) habitat observed east of the Kern River Powerhouse during the habitat assessment conducted on January 29, 2025.

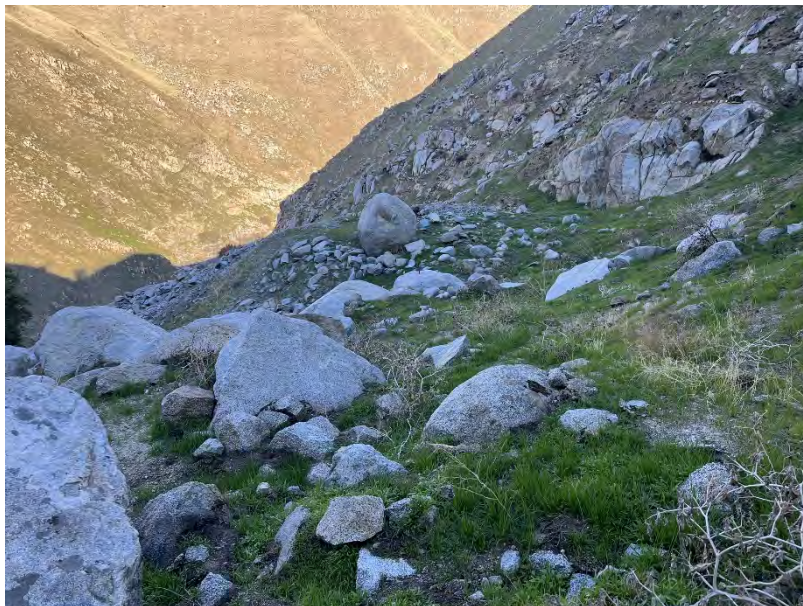
Photo E-6. An example of potential Kern Canyon slender salamander habitat observed at Adit 14 & 15 during the habitat assessment on January 30, 2025.

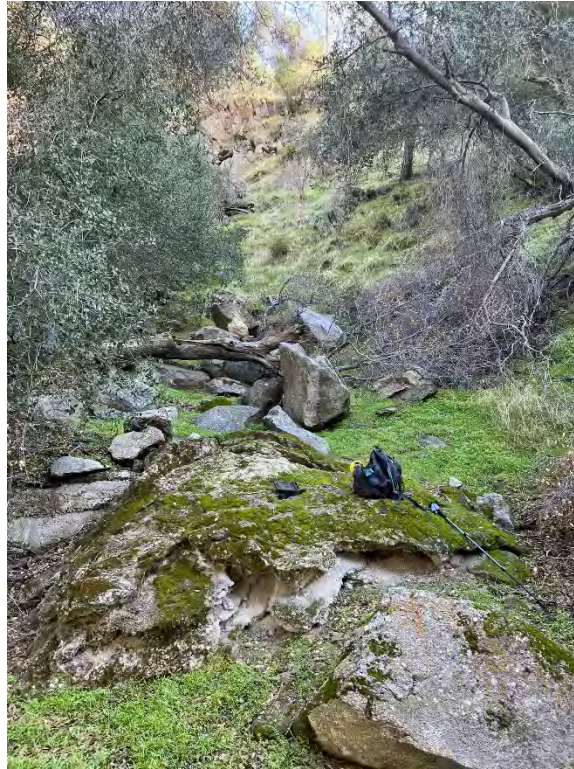
Photo E-7. An example of potential Kern Canyon slender salamander habitat observed at Conduit No. 6 during the habitat assessment on January 29, 2025.

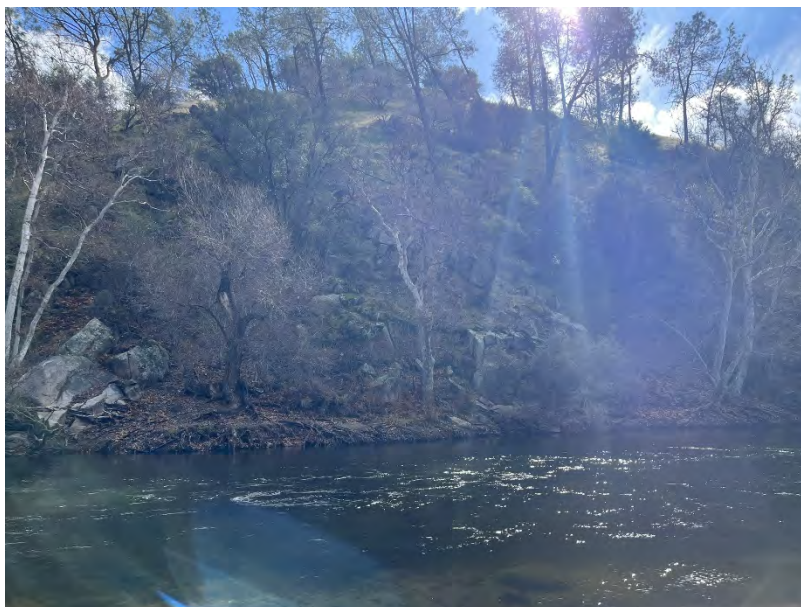
Photo E-8. An example of potential Kern Canyon slender salamander habitat observed along the Democrat Impoundment during the habitat assessment on January 27, 2025.

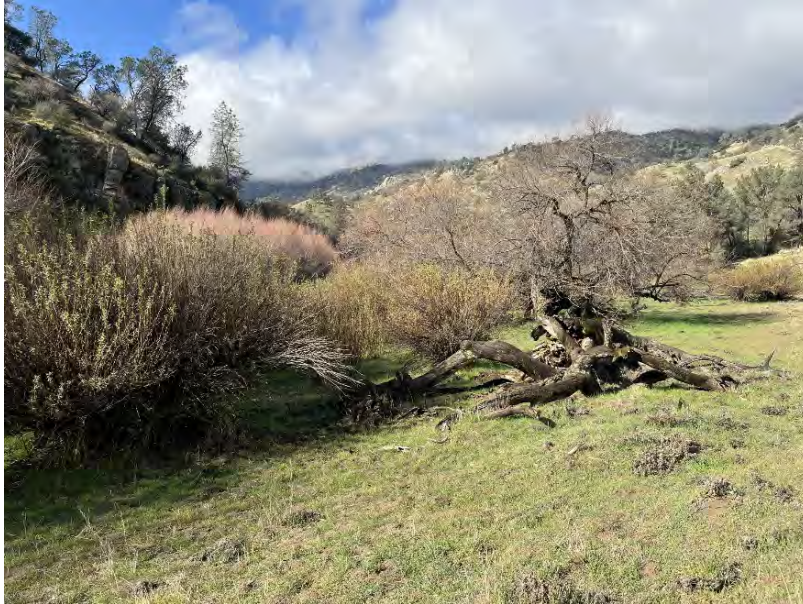
Photo E-9. An example of potential yellow-blotched salamander (*Ensatina eschscholtzii croceater*) (FSCC, WL) habitat found along the Democrat Dam Impoundment during the habitat assessment on January 27, 2025.

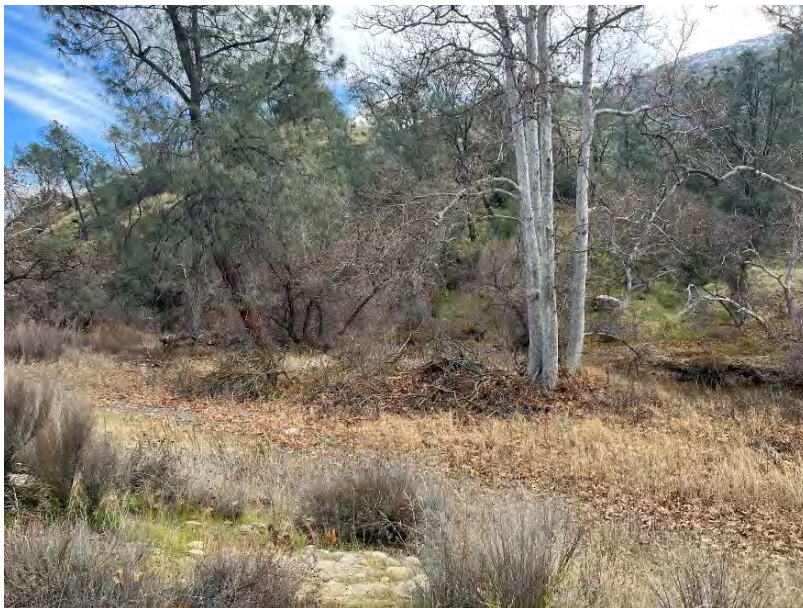
Photo E-10. Another example of potential yellow-blotched salamander habitat, found on the island within the Democrat Dam Impoundment during the habitat assessment on January 27, 2025.

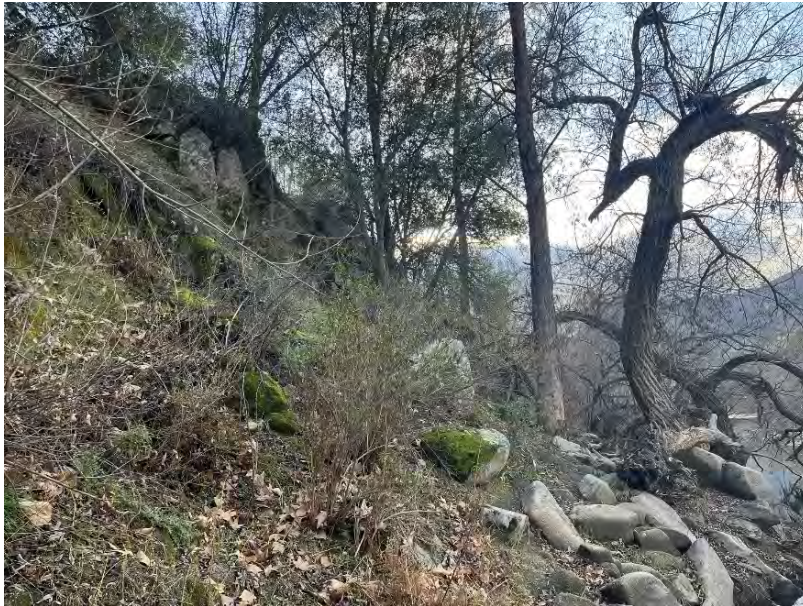
Photo E-11. Potential yellow-blotched salamander habitat found along the Democrat Dam Impoundment during the habitat assessment on January 27, 2025.

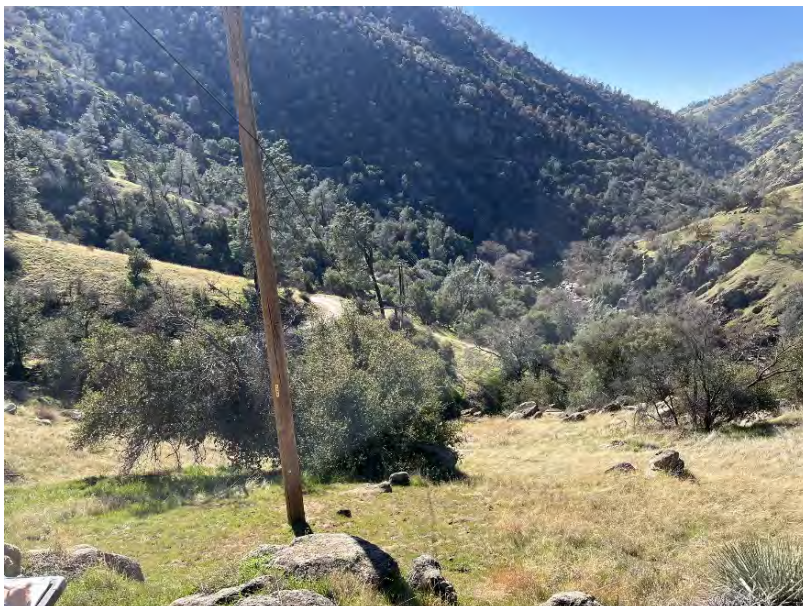
Photo E-12. Potential yellow-blotched salamander habitat found along the Intake Gatehouse to Flume No. 1 Powerline boarding Willow Spring Creek Road, dry during the habitat assessment on January 27, 2025.

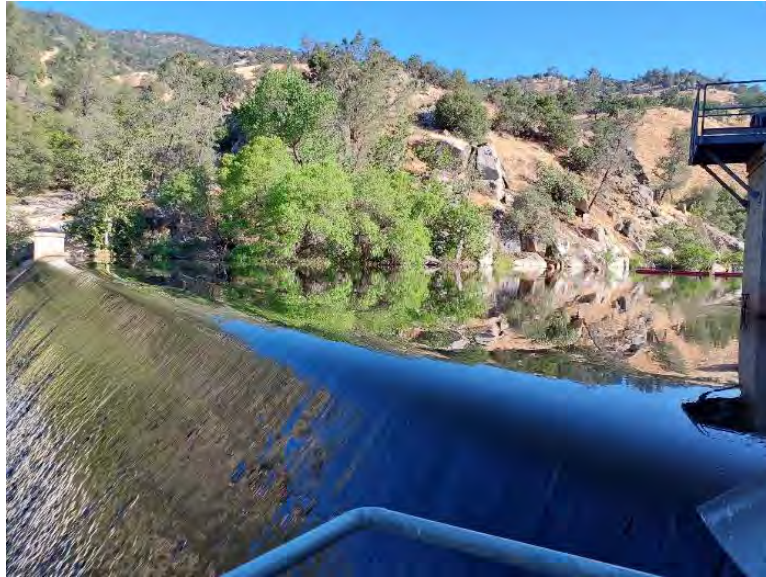
Photo G-1. Democrat Dam: The Democrat Dam is regularly submerged in the water and is not suitable habitat for roosting bats. The support buildings contain roofed elements but the wind exposure is too high for bat roosting and there are limited area bats can grasp for roosting.

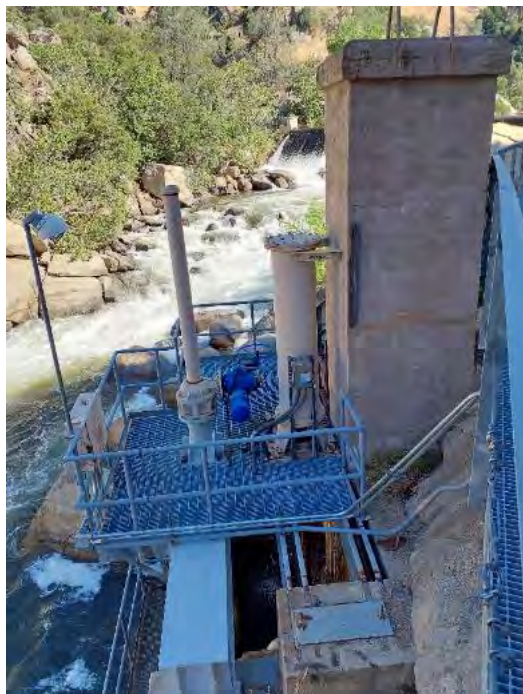
Photo G-4. Drainage Tunnel Outlet: The drainage tunnel outlet is a textured concrete structure with some vertical steel, and roofed elements. This structure could act as a potential night roost. No guano or signs of roosting were observed. This facility is not currently being utilized by bats.

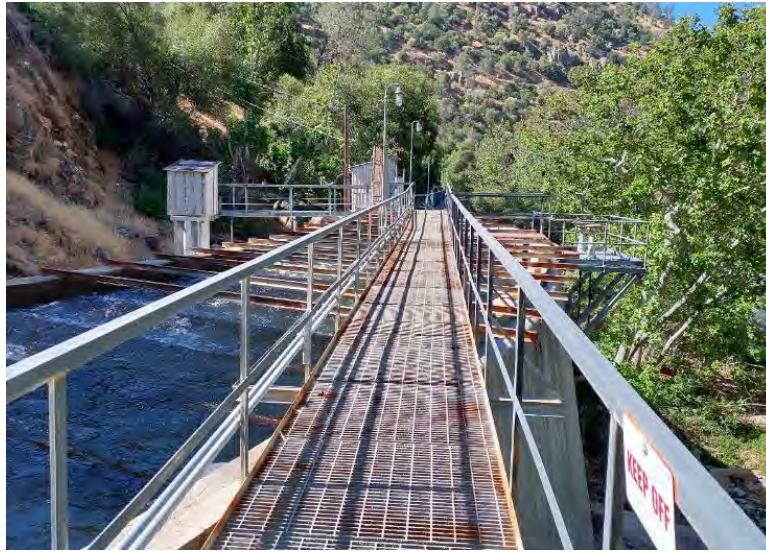
Photo G-5: Democrat Dam Access Walkway: The grated walkway is composed of steel and is exposed. It is not suitable habitat for maternity or day roosting. The roofed elements and vertical structures could potentially support bat roosts at night. The unnamed buildings on the walkway were found to have guano and are suitable night roosting habitat. An active western mastiff bat colony is present adjacent to the walkway on a connected rock crevasse.

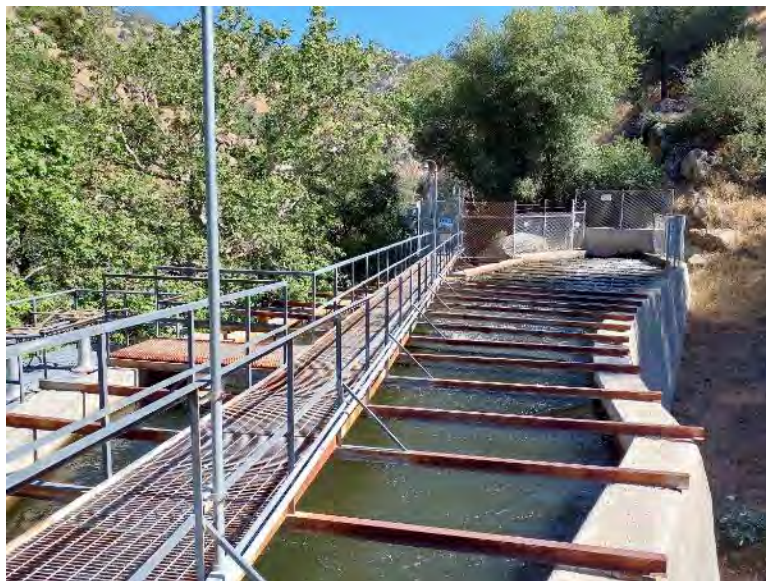
Photo G-6. Sandbox: This Project facility is an open water conveyance system. It is a concrete structure with no cracks or roofed elements that could support bat roosting. This facility is not suitable for roosting.

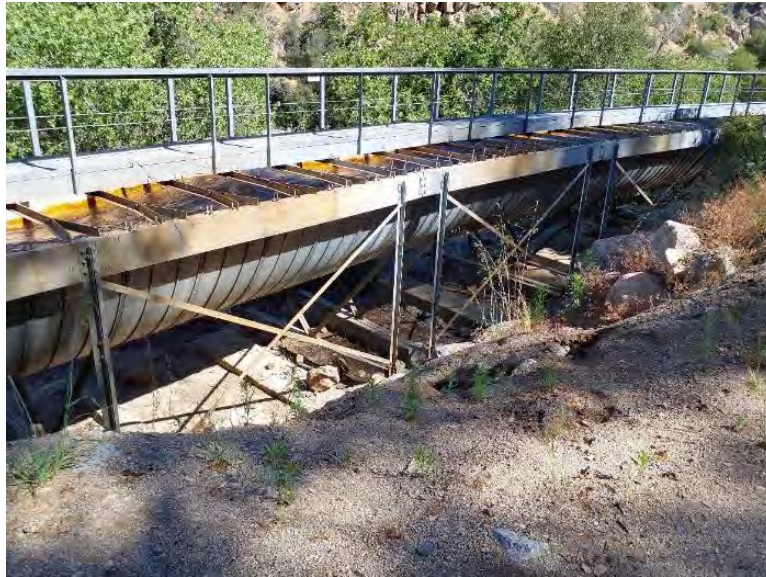
Photo G-7. Flume No. 1: This Project facility supports vertical structures and roofed elements but the vibration from the flow of water and cold metal makes utilization unlikely. This facility is not suitable for roosting.

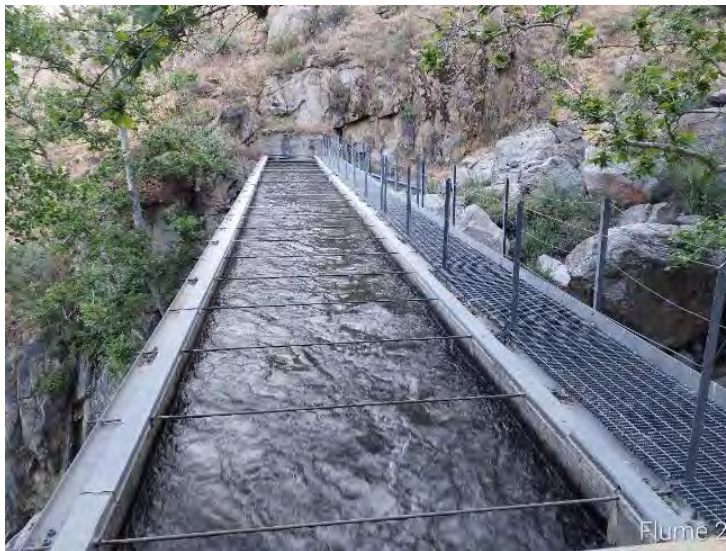
Photo G-12. Flume No. 2 Cow Flat Creek and Gauge 11192000 (SCE 410): The flume consists of metal with no point of attachment for bats and is filled with flowing water. Old guano was present along the walkway between the facility and Stilling Well No. 2. The facility is likely used as a water source but is not currently being used for roosting. The flume could be utilized for roosting if mud nests are present as observed on Flume No. 4 (Lucas Creek).

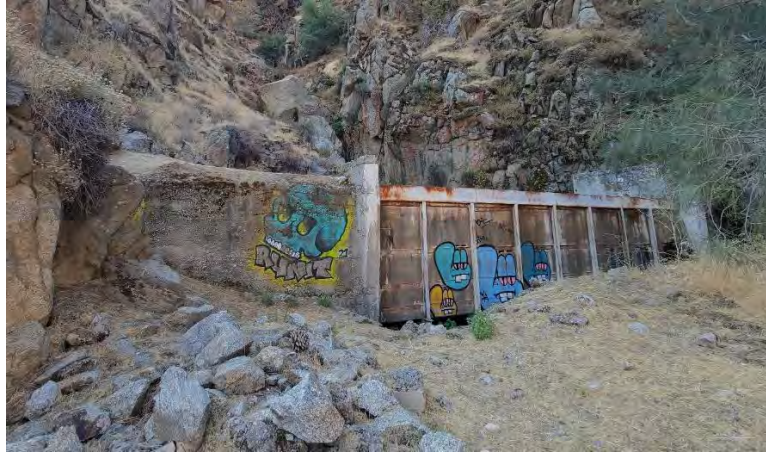
Photo G-13. Conduit No. 4/Conduit No. 5: The conduits are directly up and downstream of the flume have vertical structures but lack roofed elements or entry points for cover during roosting. These facilities are not suitable for roosting.

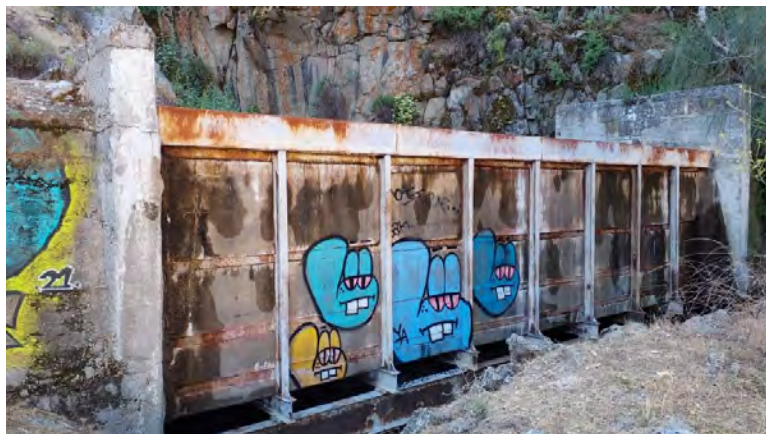
Photo G-14. Flume No. 3: The facility is an exposed steel structure with rapidly flowing water. This facility is not currently being used for roosting but is a potential water source. The flume could be utilized for roosting if swallow mud nests are present as was observed on Flume No. 4 (Lucas Creek). Bats are not currently utilizing this facility.

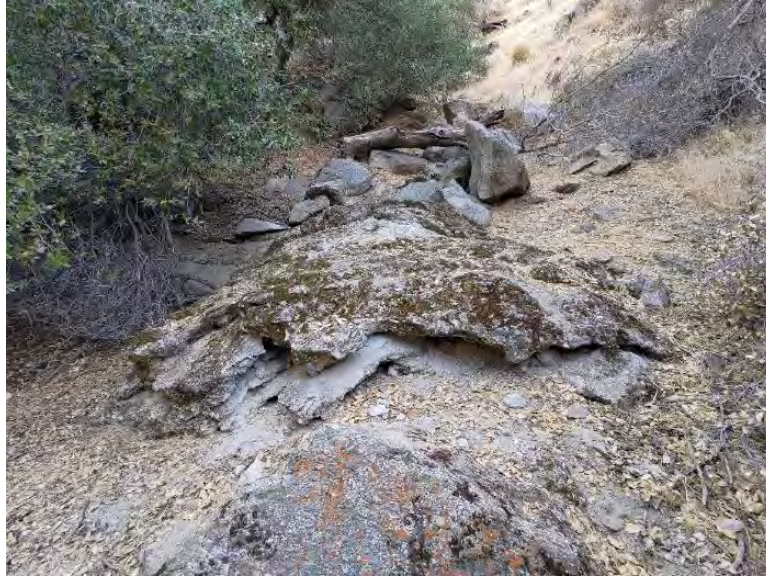
Photo G-15. Conduit No. 6: The conduit is entirely enclosed with concrete and eroded granite. The conduit has some crevices bats could utilize. However, the conduit is too close to the ground and potential predators. This facility is not suitable for roosting.

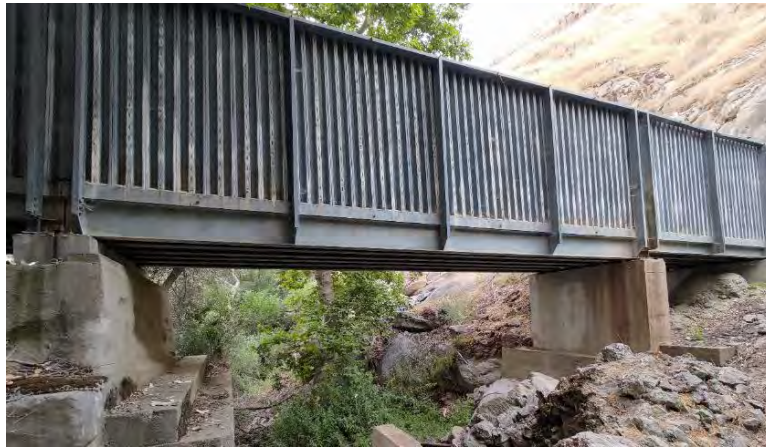
Photo G-16. Flume No. 4 Lucas Creek: The flume is made of metal and has steel roofed elements that bats could utilize for roosting under appropriate conditions. Large amounts of guano were found on the flume under old/failed swallow mud nests. Bats are likely utilizing the mud areas, where they can grip, to roost at night while foraging. This facility supports a night roost.

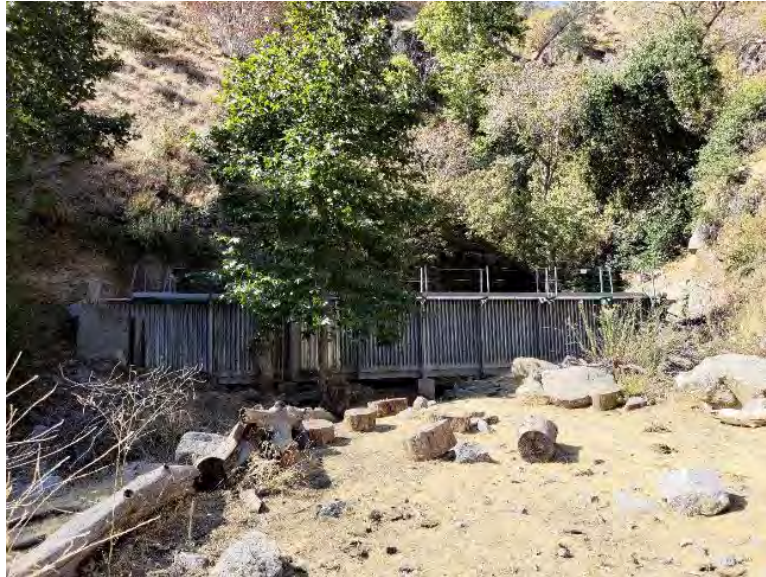
Photo G-17. Flume No. 5 Dougherty Creek/Conduit No. 7: The flume is made of metal and has steel roofed elements that bats could utilize for roosting under appropriate conditions. It also has concrete in some areas which could be used for roosting. The flume could be utilized for roosting if swallow mud nests are present as was observed on Flume No. 4 (Lucas Creek). Bats are not currently utilizing this facility.

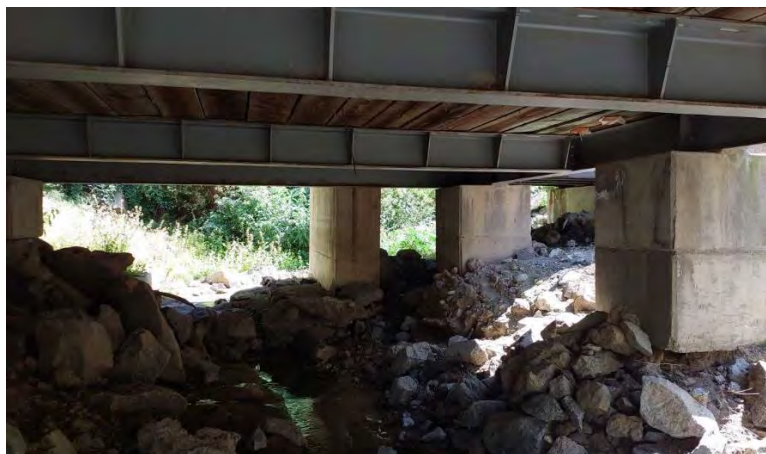
Photo G-18. Access Platform: The underside of the platform is very open with no good roosting locations on metal girders and wooden planks where bats could be sheltered. Cattle also often disturb this area passing under this location. This facility is not suitable for roosting.

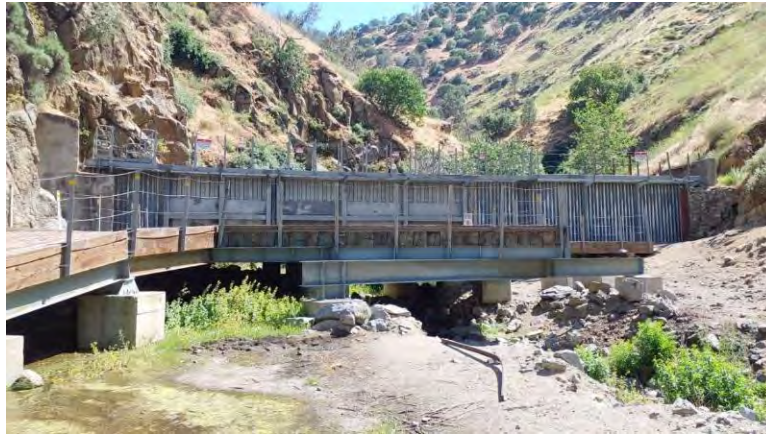
Photo G-19. Flume No. 6 Stark Creek/Conduit No. 8: The flume is made of metal and largely not suitable habitat for roosting bats. The conduit is made of concrete with no cracks or areas that bats could utilize. The flume could be utilized for roosting if swallow mud nests are present as was observed on Flume No. 4 (Lucas Creek).

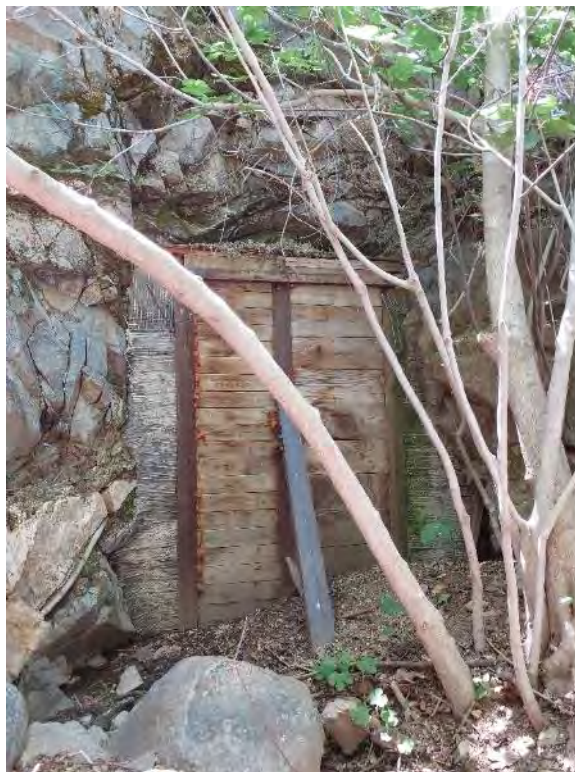
Photo G-20. Adit 12 & 13: The adit has a wooden door/covering and a small roofed element. However, it is too exposed to unfavorable weather conditions and does not contain areas with cover suitable for roosting. The riparian area surrounding adit could be suitable for tree roosting bats.
