TERR 2 – WILDLIFE RESOURCES TECHNICAL MEMORANDUM

**KERN RIVER NO. 1 HYDROELECTRIC PROJECT
*FERC PROJECT No. 1930***

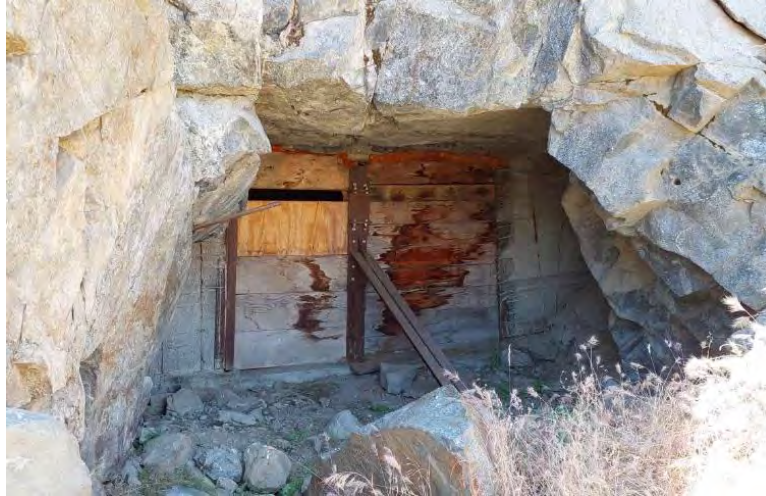
Photo G-21. Adit 13 & 14: The adit has an opening through a door into a cavern which has dark crevices where bats could roost. Guano present on adit door and within the interior. The interior could not be accessed to confirm interior roost status. This facility supports a night roost and a potential day and maternity roost.

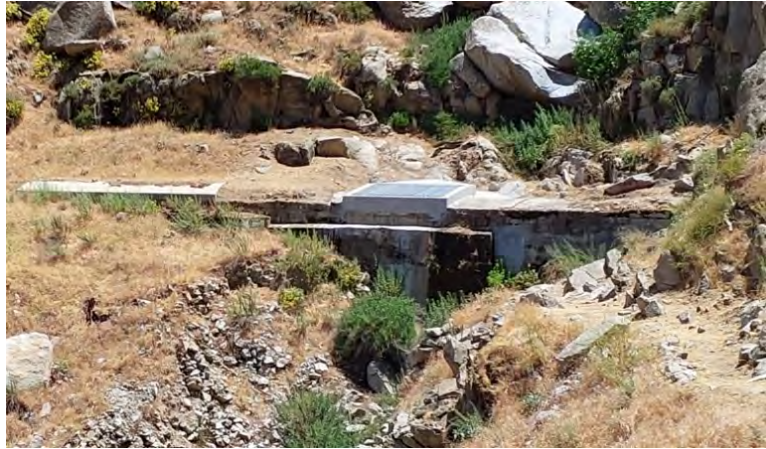
Photo G-23. Conduit No. 9: The concrete structure has a metal covering that bats could enter but it contains flowing water and is not suitable roosting habitat. The exterior has no cracks or crevices. The facility is not suitable for roosting.

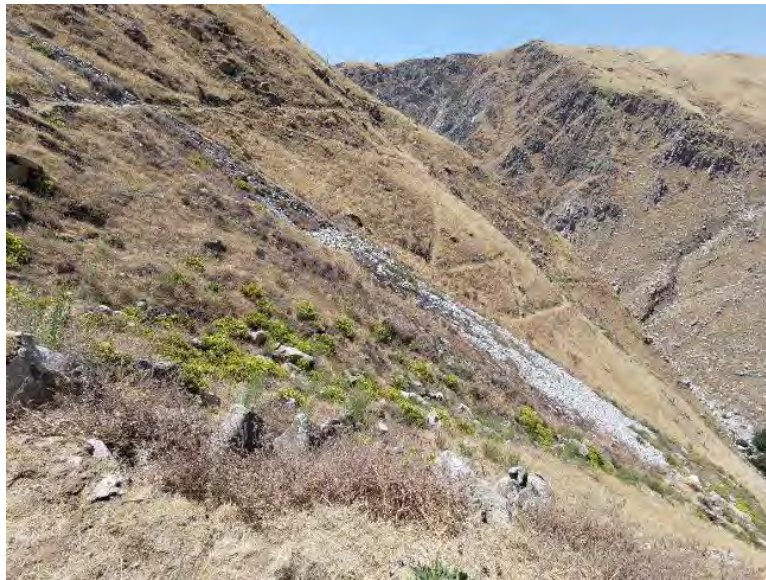
Photo G-24. Adit 18 & 19: This adit is composed of a pile of granite rocks on a steep slope. Rocks too close to the ground and does not have suitable entry points for bats. The facility is not suitable for roosting.

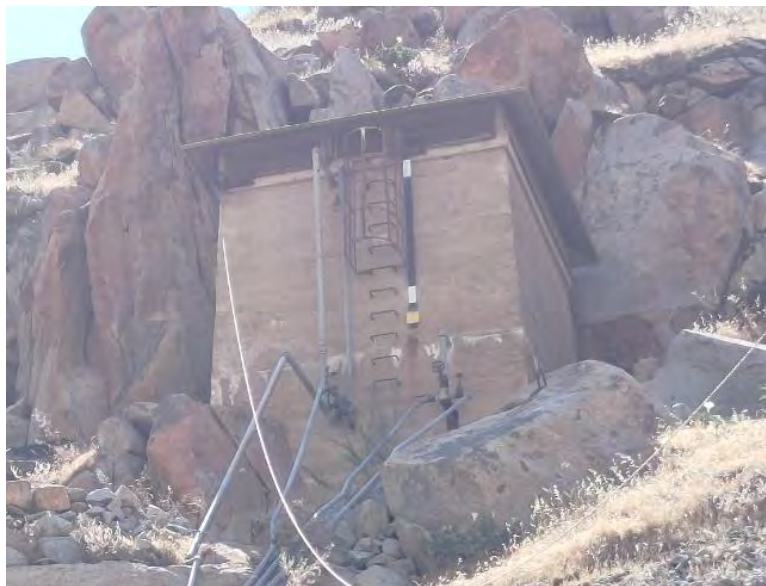
Photo G-28. Water Tank: The water tank has vertical structures, overhangs, and a textured concrete base. The area where the roof joins the wall provides suitable night roosting habitat. A guano pile was found between water tank and rock wall. This facility supports a night roost and a potential day roost.

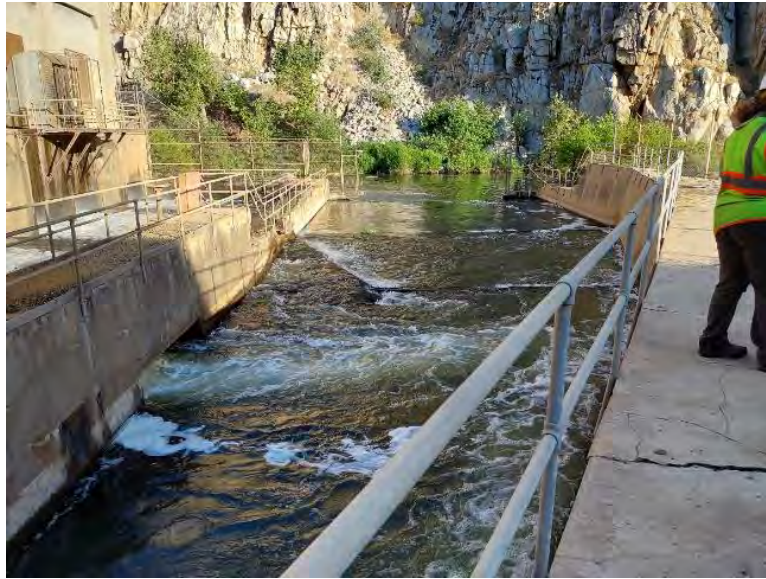
Photo G-29. Trailrace: The tailrace does not support suitable bat roost habitat. It is an open waterway and does not contain roosting elements though bats may drink from it.

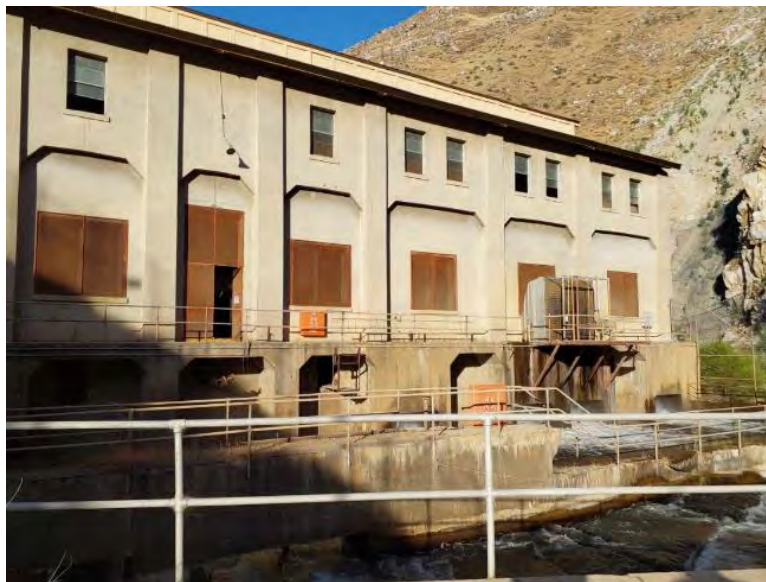
Photo G-30. Kern River No. 1 Powerhouse: Bat roosts are present inside and outside of the building. There are rooms, hallways, stairwells, and corners where bat urine and feces were observed. The operations manager stated that bat activity is seen often. Big brown bat observed (dead). This facility supports an active night roost. It also supports a seasonal day and maternity roost.

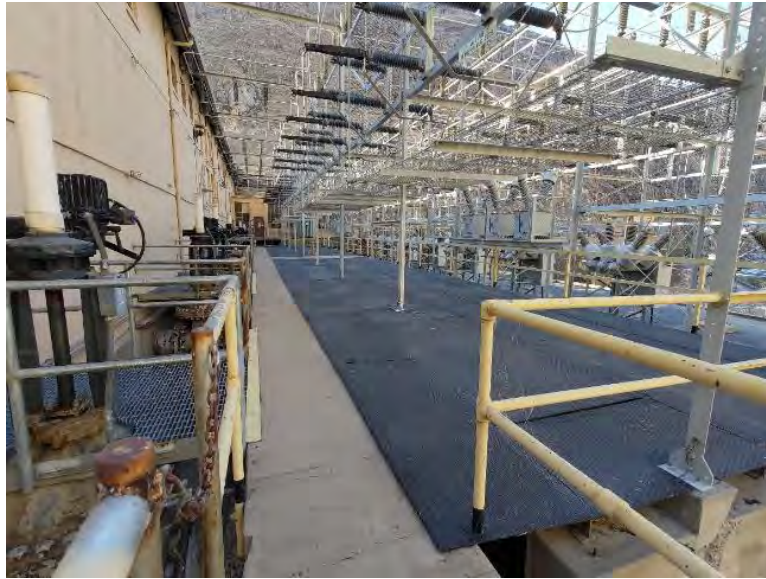
Photo G-31. Kern River No. 1 Switchyard: The facility consists of active electrical equipment and potential roosting areas are highly exposed to the elements or electrical current. Facility is not suitable for roosting but bats may pass through to enter the Powerhouse.
