# Kaweah Project, FERC Project No. 298

## AQ 8 – Fish Passage Draft Technical Study Report

April 2019

Southern California Edison Company  
Regulatory Support Services  
1515 Walnut Grove Avenue, Rosemead, CA 91770

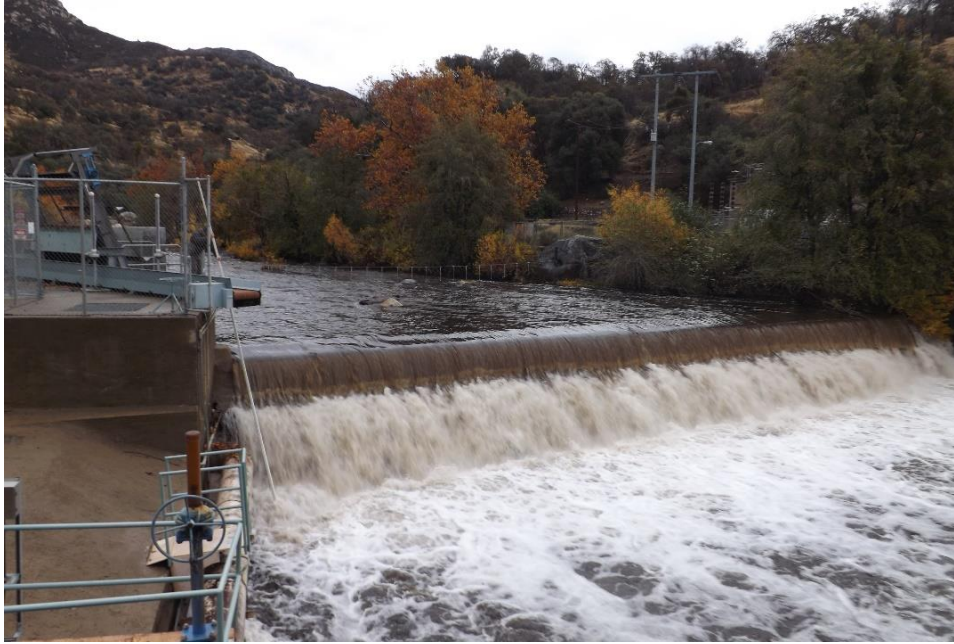
**Figure C-2. Image of project barrier at Kaweah No. 2 Diversion Dam.**  
*Staff holding stadia rod on left side of image for scale.*

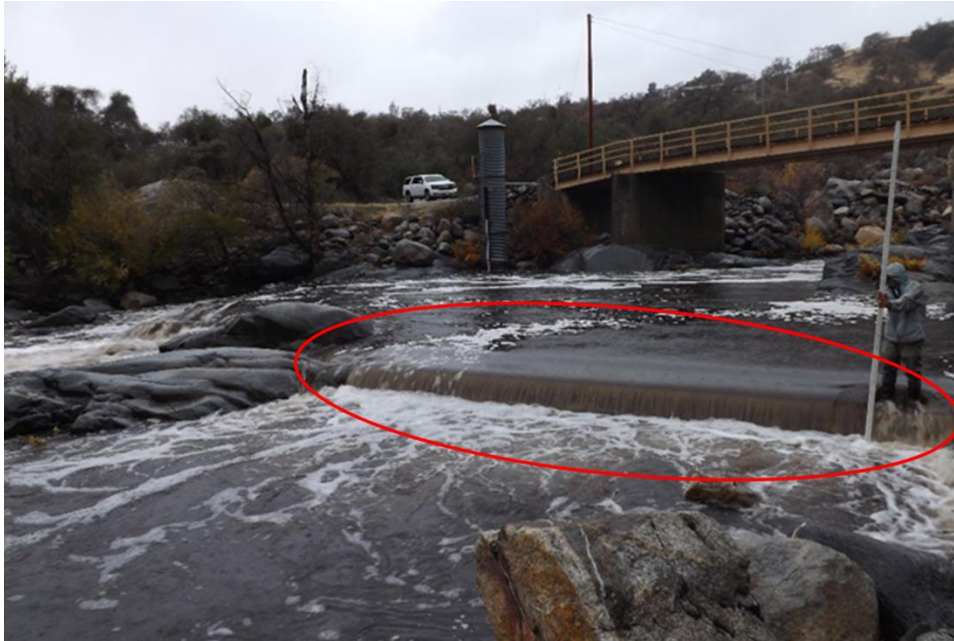
**Figure C-3.** Image across width of stream at entire project barrier at Kaweah No. 2 Diversion Dam Gage Pool Weir.  
 Circled portion identifies location of measurements.

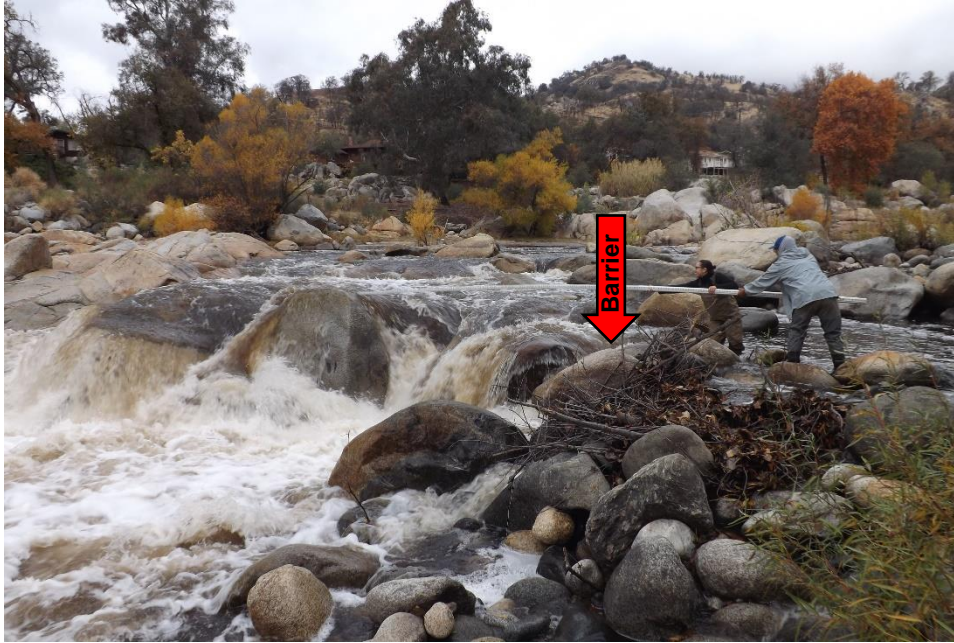
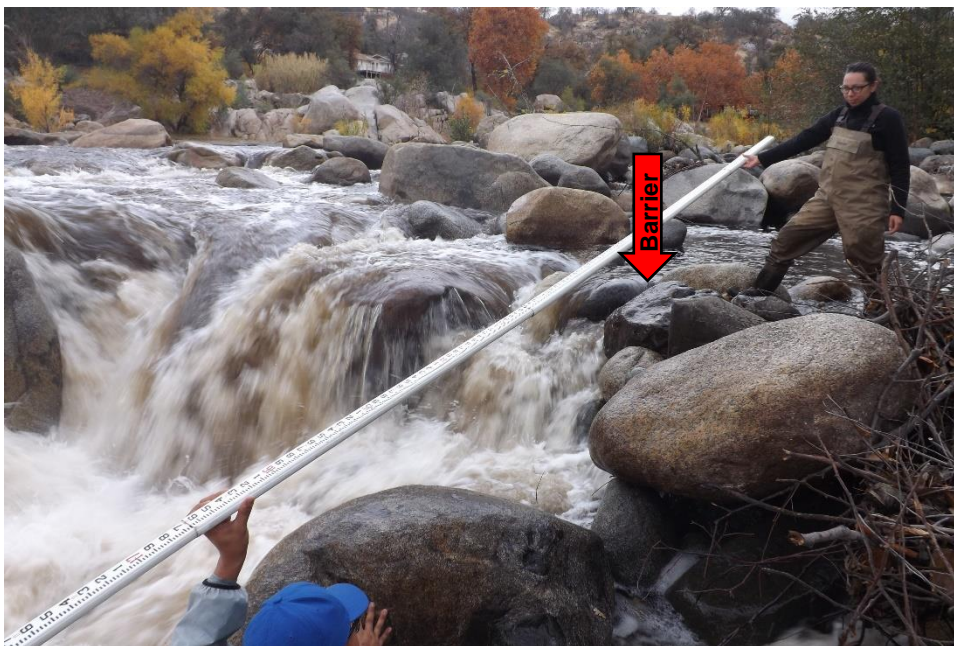
**Figure C-4. TOP: Overview image of natural barrier downstream of Kaweah No. 2 Powerhouse. BOTTOM: Image of natural barrier downstream of Kaweah No. 2 Powerhouse.**

*Barrier site consisted of multiple variable size falls and side channels spanning the width of the river. The measurements in Table C-4 only reflect the falls indicated by the red arrows.*

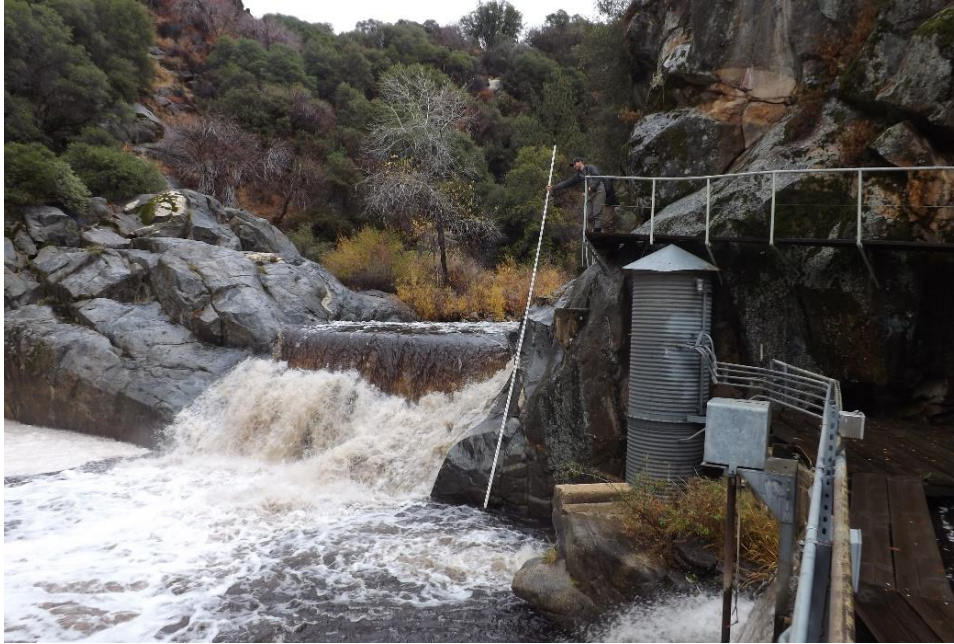
**Figure C-5. Image of project barrier at Kaweah No. 1 Diversion Dam.**  
*Staff with stadia rod on left bank for scale.*

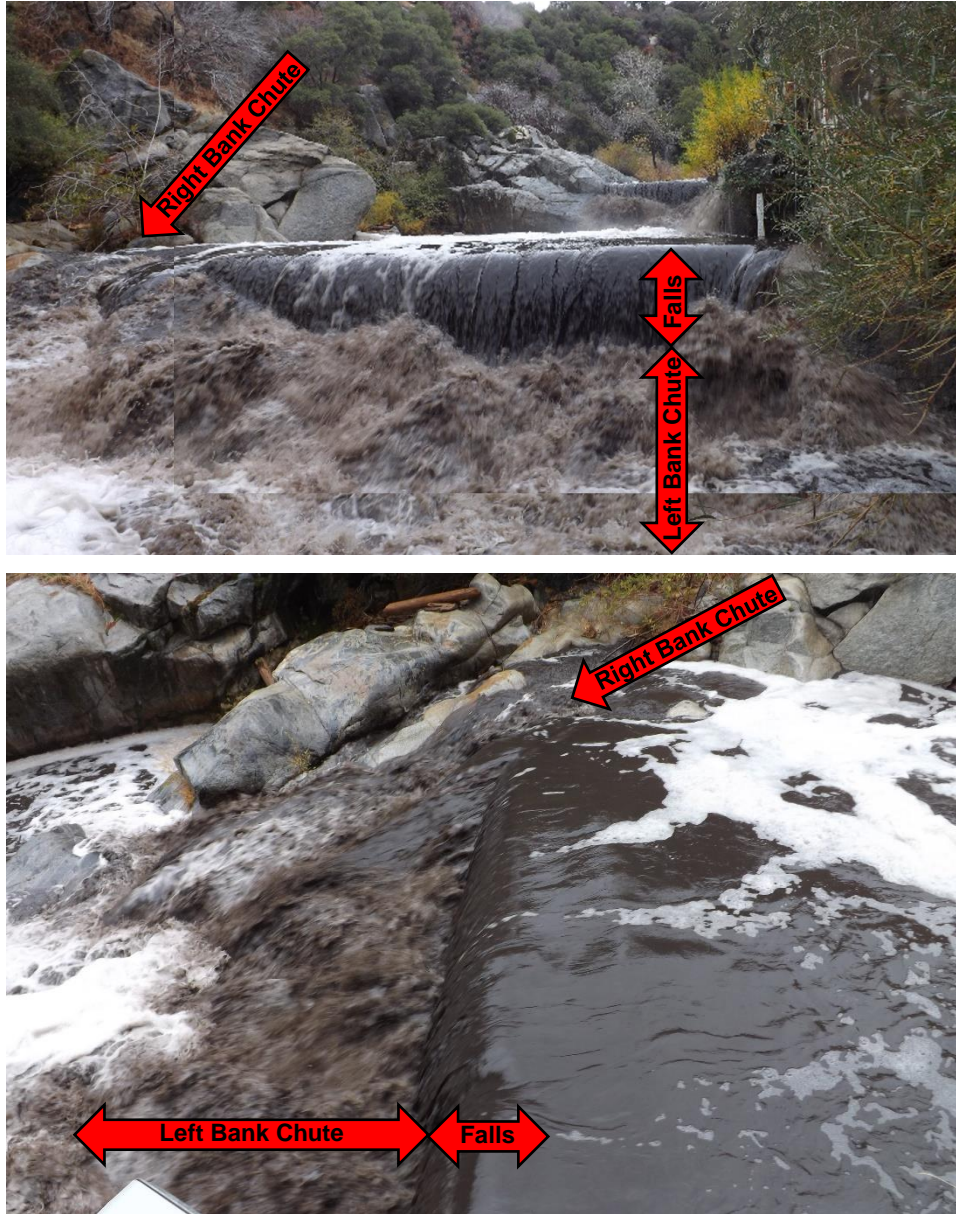
**Figure C-6.** TOP: Image of project barrier at Kaweah No. 1 Diversion Dam Gage Pool Weir. Kaweah No. 1 Diversion Dam project barrier is visible in background. BOTTOM: Image across width of project barrier at Kaweah No. 1 Diversion Dam Gage Pool Weir towards the right bank.

*Image shows above angle with left bank falls into immediate chute and larger right bank chute.*

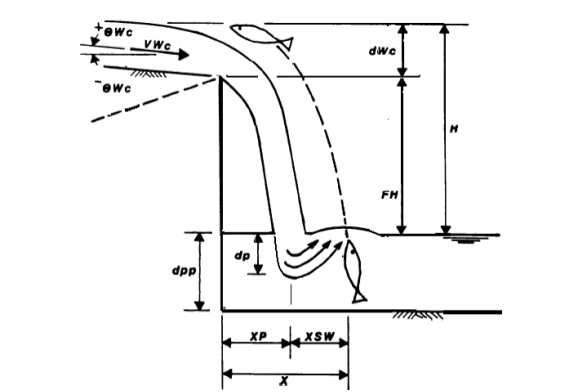
**Table C-6. Kaweah No. 1 Diversion Dam Gage Pool Weir (Project Barrier) fall measurements.**

Water depth at crest in feet (dWc):	0.8	
Water velocity at crest in feet per second (VWc):	3	
Angle of water at crest ( $\pm \theta Wc$ ):	<1	
Fall height in feet (FH):	5.2	
Depth of plunge pool in feet (dpp):	0.5	
Depth of plunging water in feet (dp):	0.5	
Distance from crest to plunge in feet (Xp):	1	
Distance from plunge to standing wave in feet (XSW):	0

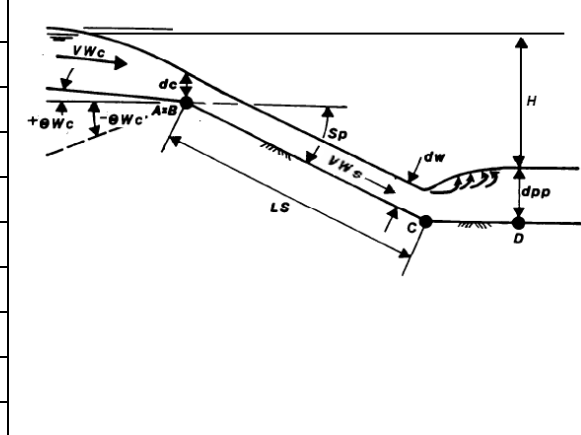
**Table C-7. Kaweah No. 1 Diversion Dam Gage Pool Weir (Project Barrier) left bank chute measurements.**

Water depth at crest in feet (dWc):	0.5	
Water velocity at crest in feet per second (VWc):	-	
Angle of water at crest ( $\pm \theta Wc$ ):	20	
Chute height in feet (H):	2	
Depth of water in chute in feet (dW):	0.5	
Velocity of water in chute in feet per second (VWs)	>12	
Length of chute slope in feet (LS):	10.2	
Slope of chute passage area (Sp):	20	
Depth of plunge pool in feet (dpp):	2.5

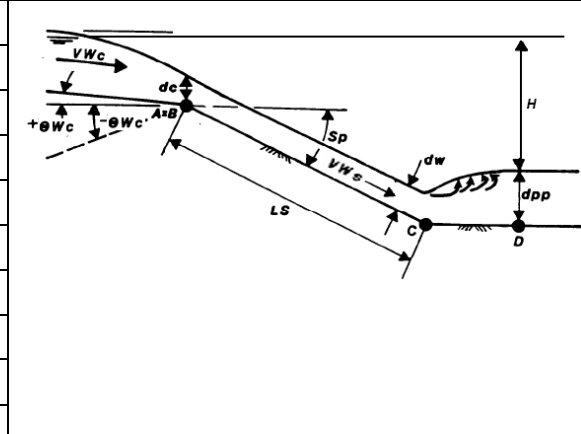
**Table C-8. Kaweah No. 1 Diversion Dam Gage Pool Weir (Project Barrier) right bank chute measurements.**

Water depth at crest in feet (dWc):	0.5	
Water velocity at crest in feet per second (VWc):	>3	
Angle of water at crest ( $\pm \theta Wc$ ):	<1	
Chute height in feet (H):	7.2	
Depth of water in chute in feet (dW):	0.5	
Velocity of water in chute in feet per second (VWs)	>12	
Length of chute slope in feet (LS):	17	
Slope of chute passage area (Sp):	48	
Depth of plunge pool in feet (dpp):	2.5

Measurements estimated while in the field, chute not safely accessible.

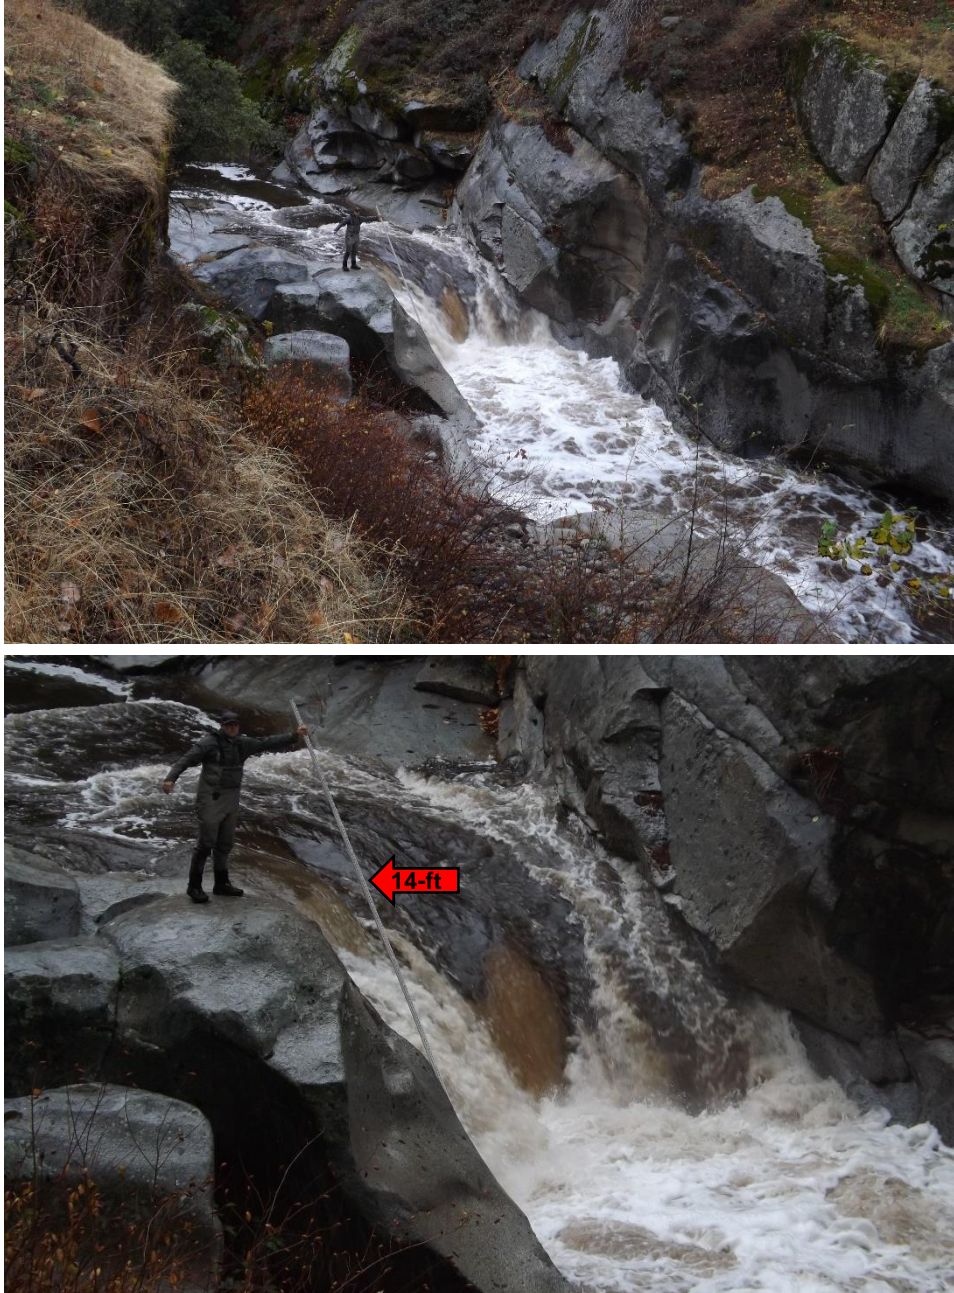
**Figure C-7. TOP: Overview image of natural barrier on East Fork Kaweah downstream of Kaweah River Bridge. BOTTOM: Image of natural barrier on East Fork Kaweah downstream of Kaweah River Bridge.**

*Staff is holding the stadia rod at the base of fall on the surface of the water. The red arrow identifies the 14-foot mark on the stadia rod.*

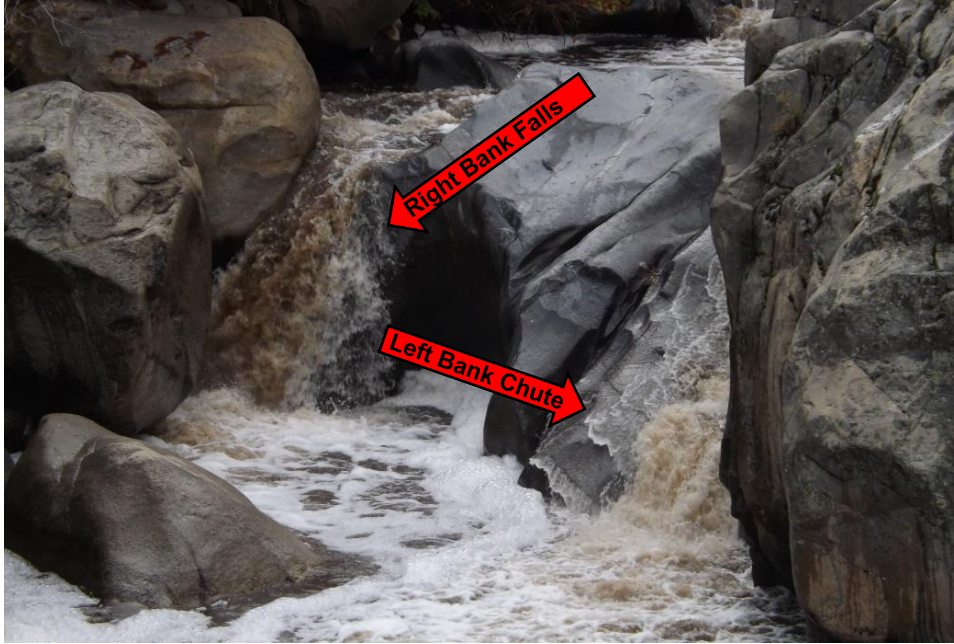
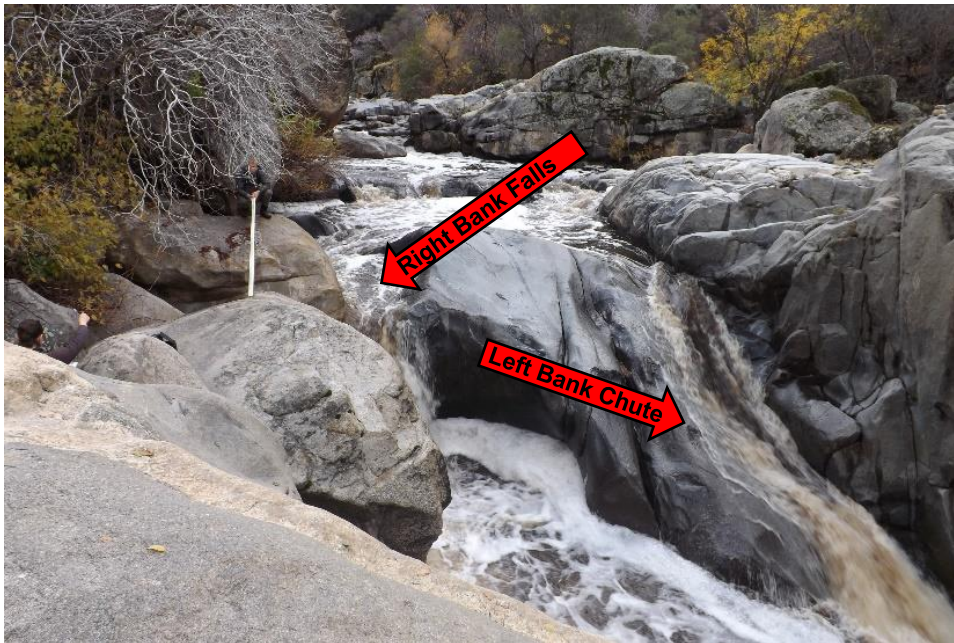
**Figure C-8.** TOP: Image of natural barrier on the East Fork Kaweah above the confluence with Kaweah River. Right bank falls and the bottom of the left bank bedrock chute in view. BOTTOM: Image of the left bank bedrock chute and the upper section of the right bank falls.
