**Subject: Rush Creek Hydroelectric Project, FERC Project No. 1389-059  
Filing of a Revised LAND 1 – Aesthetics Technical Study Report**

Rush Creek Project, FERC Project No. 1389

**Revised** LAND 1 – Aesthetics  
Technical Study Report

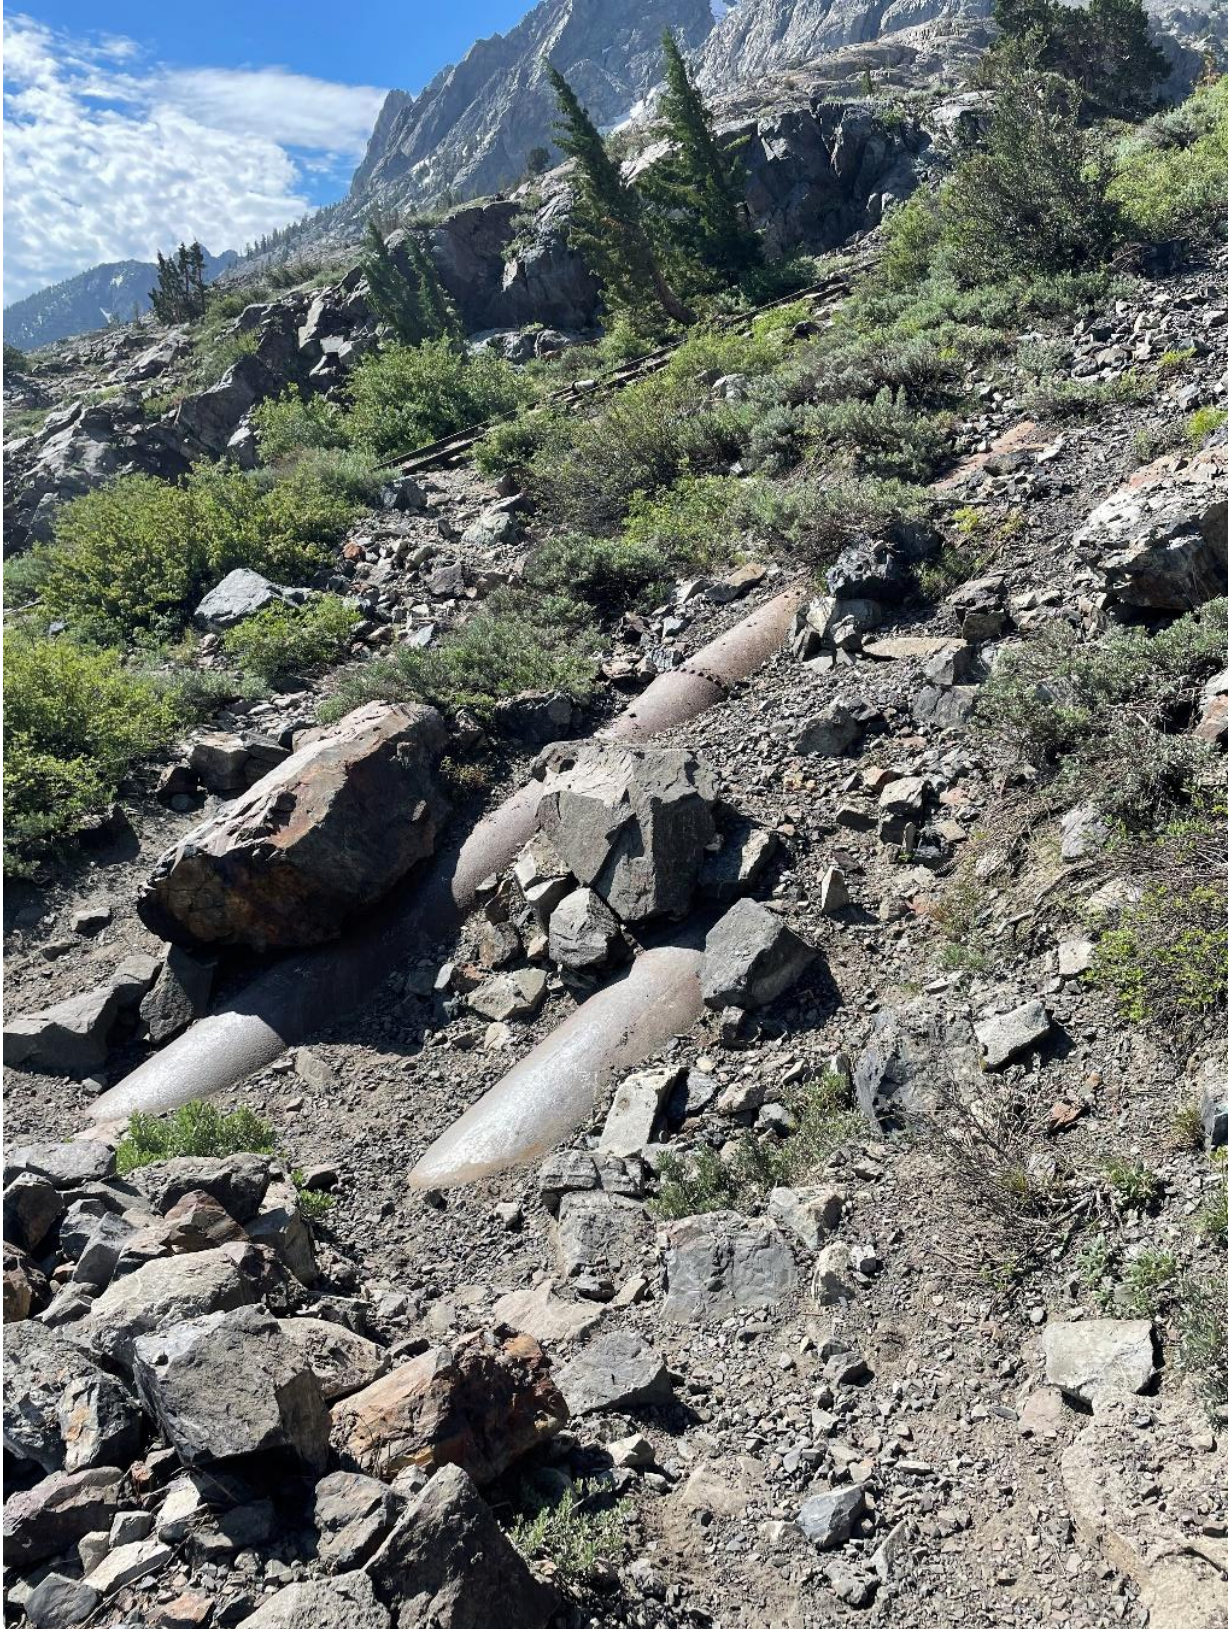
**Photo 1. Key Observation Point 1, Penstock and Tram Tracks**

Note: July 17, 2023 (37.7655, -119.13)

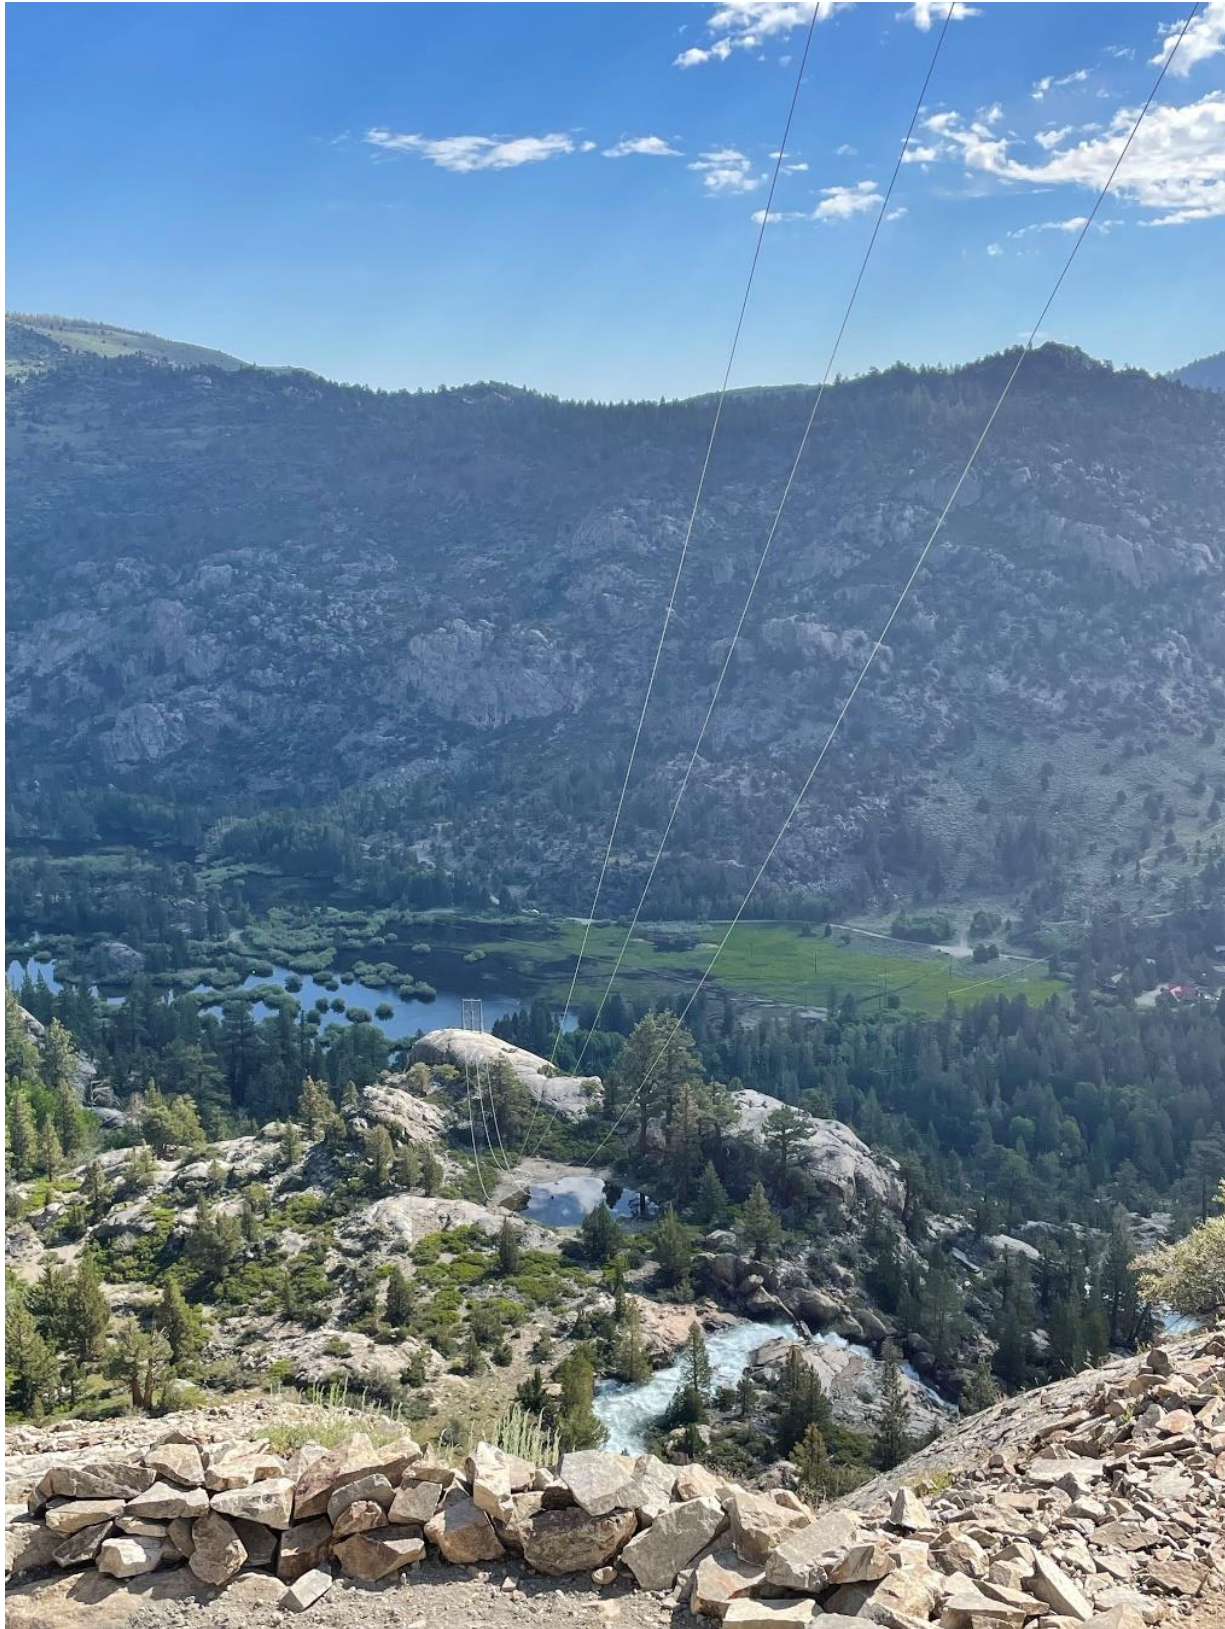
**Photo 2. Key Observation Point 2, Agnew 4-kV Line**

Note: July 17, 2023 (37.7628, -119.129)

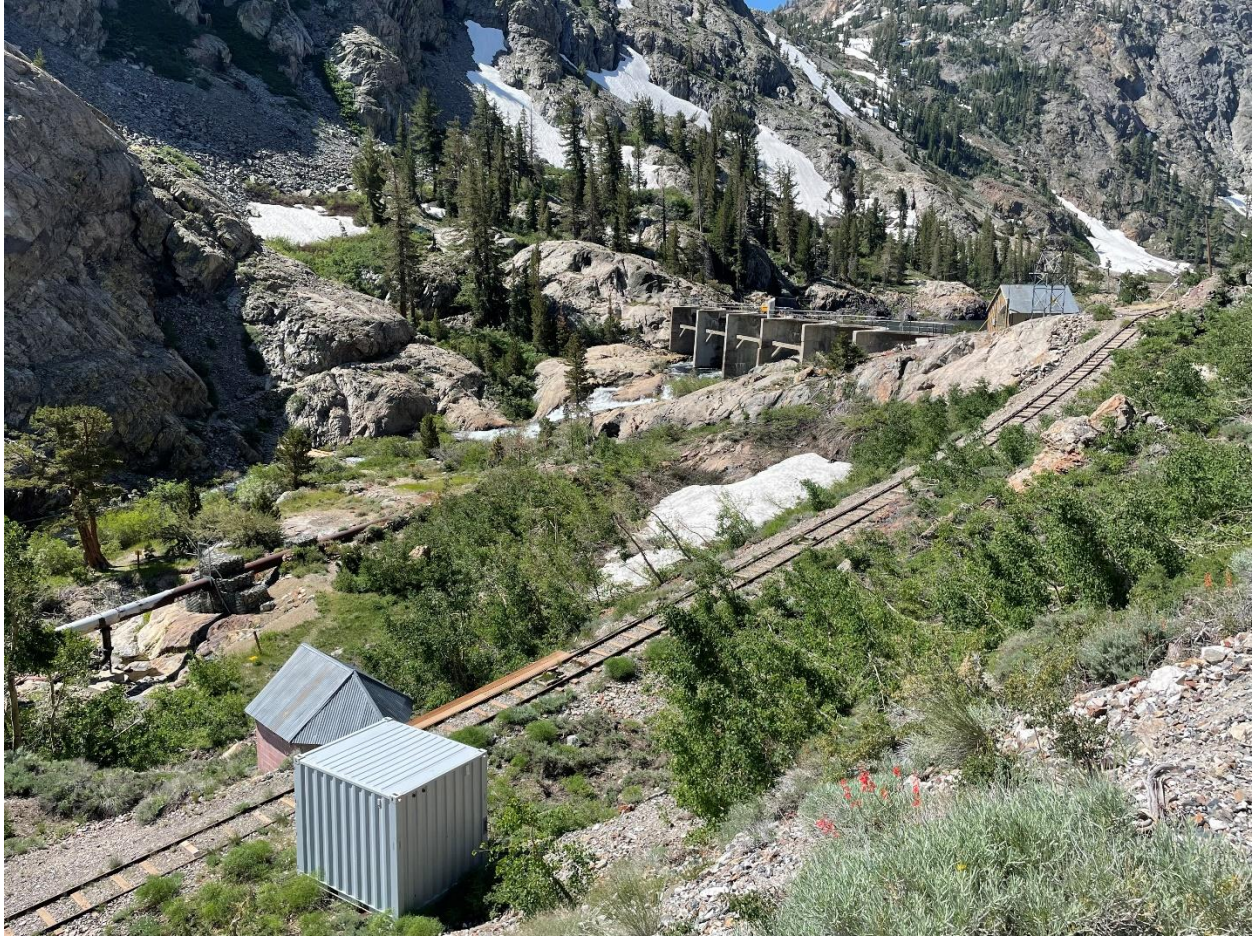
**Photo 3. Key Observation Point 3, Agnew Dam and Ancillary Facilities—View from Downstream**

Note: July 17, 2023. (37.7593, -119.132)

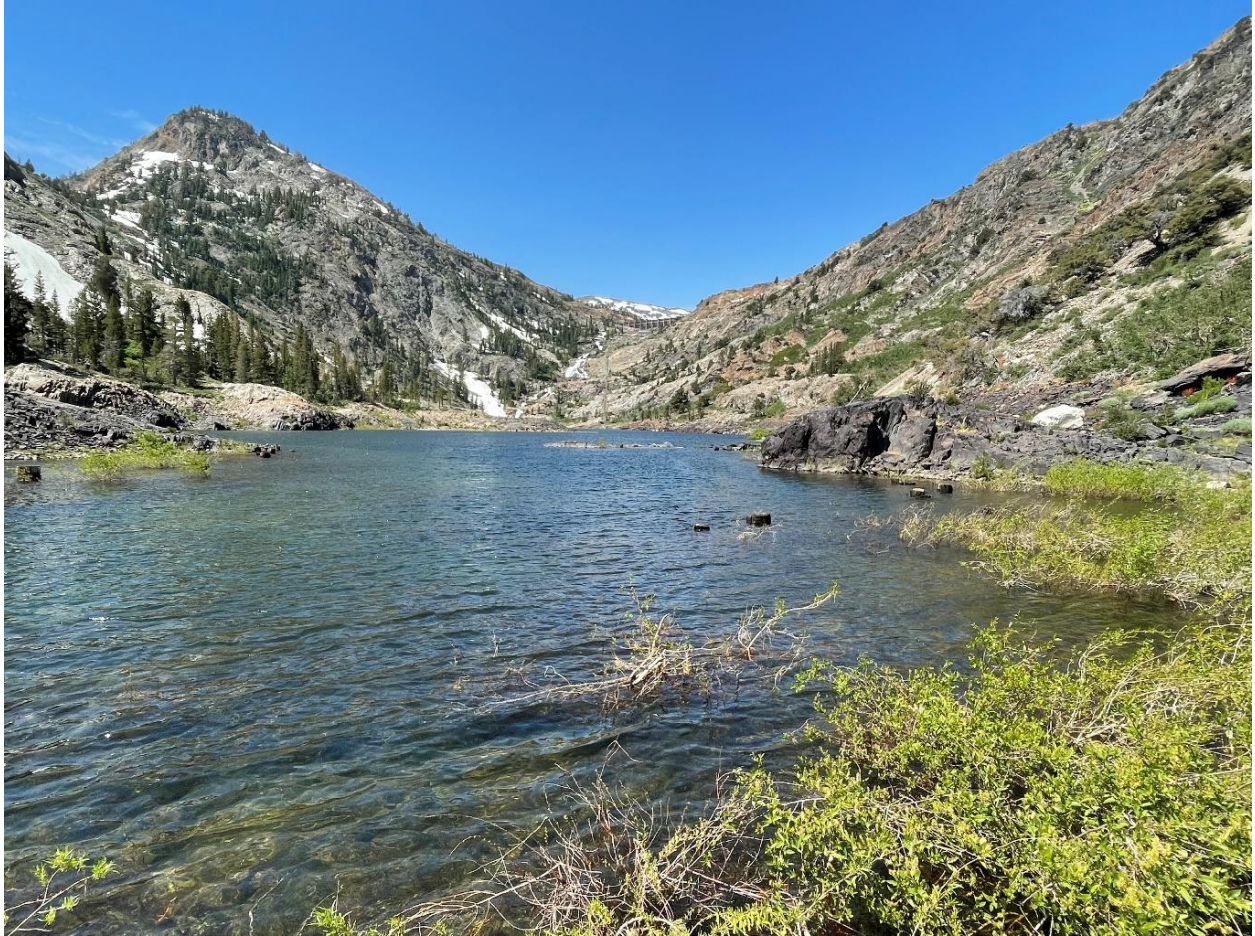
**Photo 4. Key Observation Point 4, Agnew Lake and Dam at Shoreline—(looking upstream toward Gem Dam)**

Note: July 17, 2023 (37.7579, -119.132)

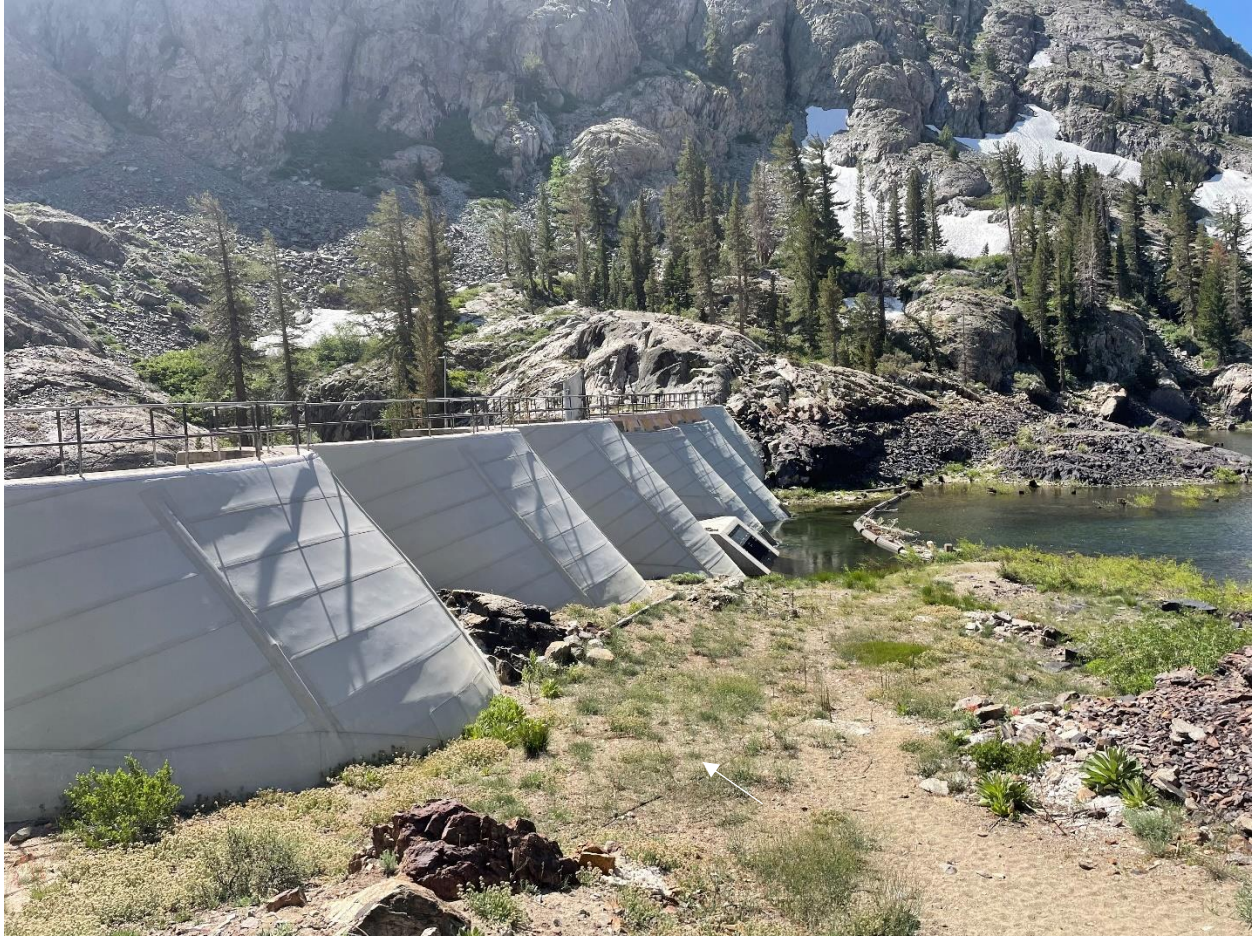
**Photo 5. Key Observation Point 4, Agnew Dam at Shoreline**

Note: July 17, 2023 (37.7579, -119.132)

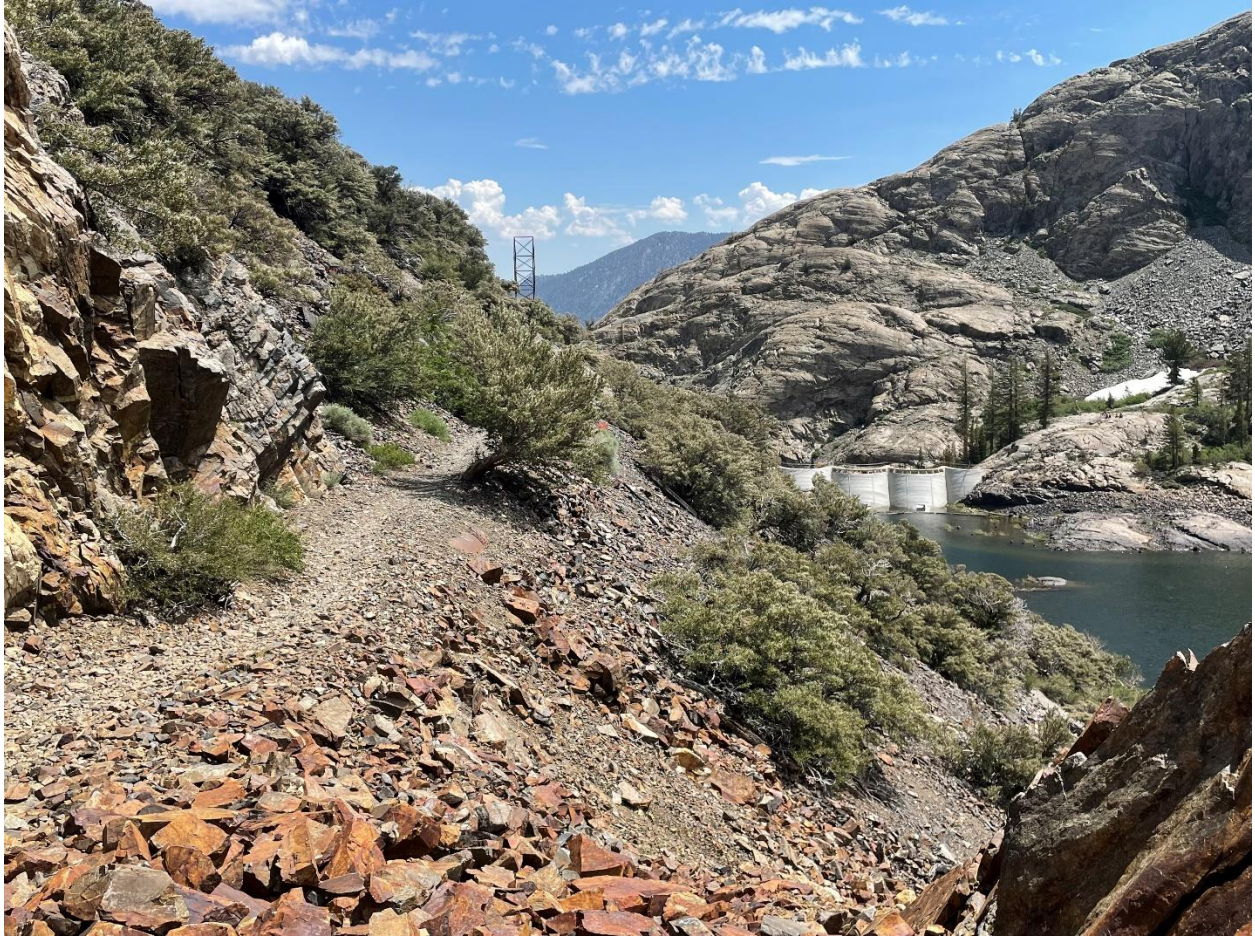
**Photo 6. Key Observation Point 5, Agnew Lake—View from Upstream**

Note: July 17, 2023 (37.7574, -119.135)

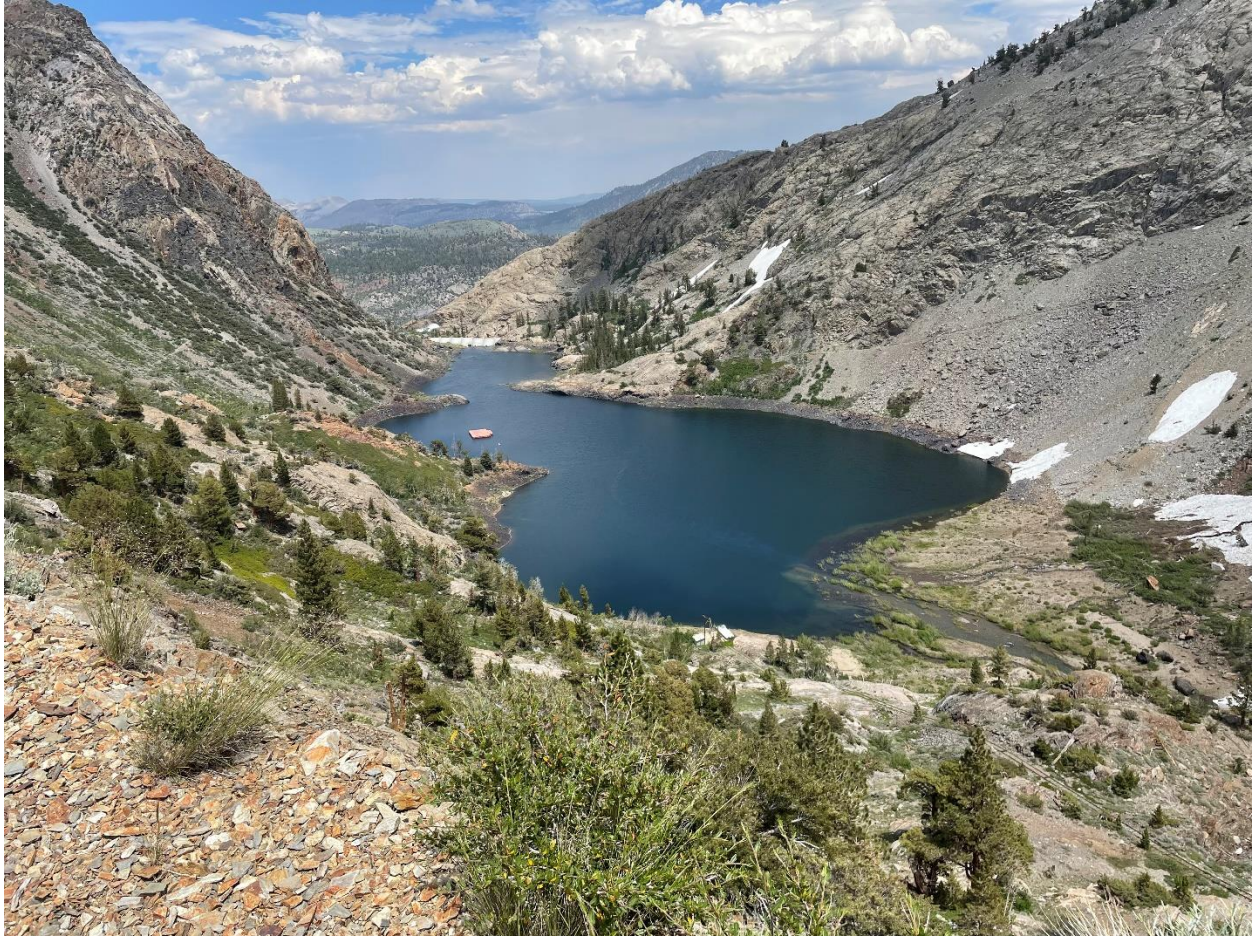
**Photo 7. Key Observation Point 6, Agnew Lake and Dam—View from Above**

Note: July 17, 2023 (37.7528, -119.141)

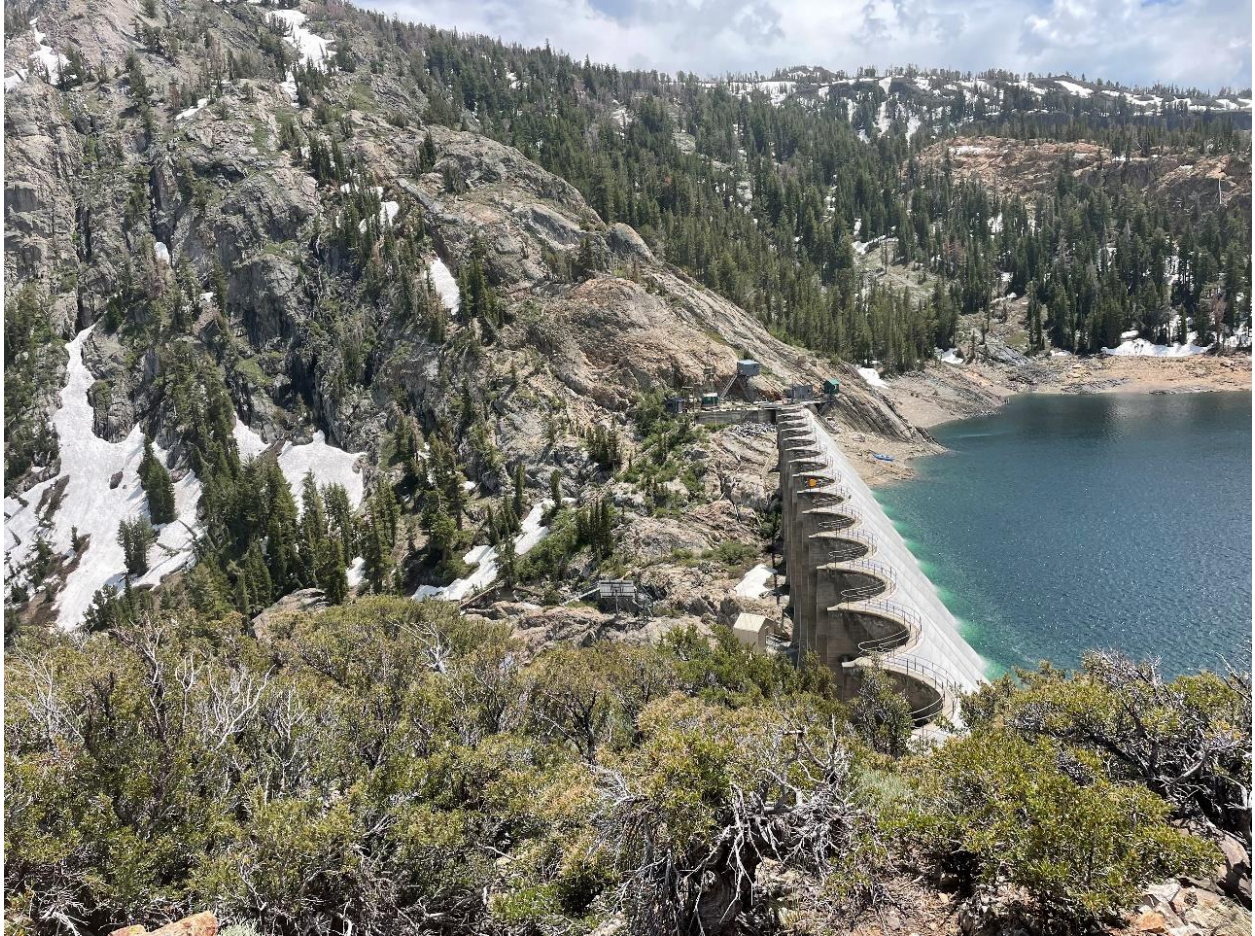
**Photo 8. Key Observation Point 7, Gem Dam**

Note: July 17, 2023 (37.7525, -119.141)

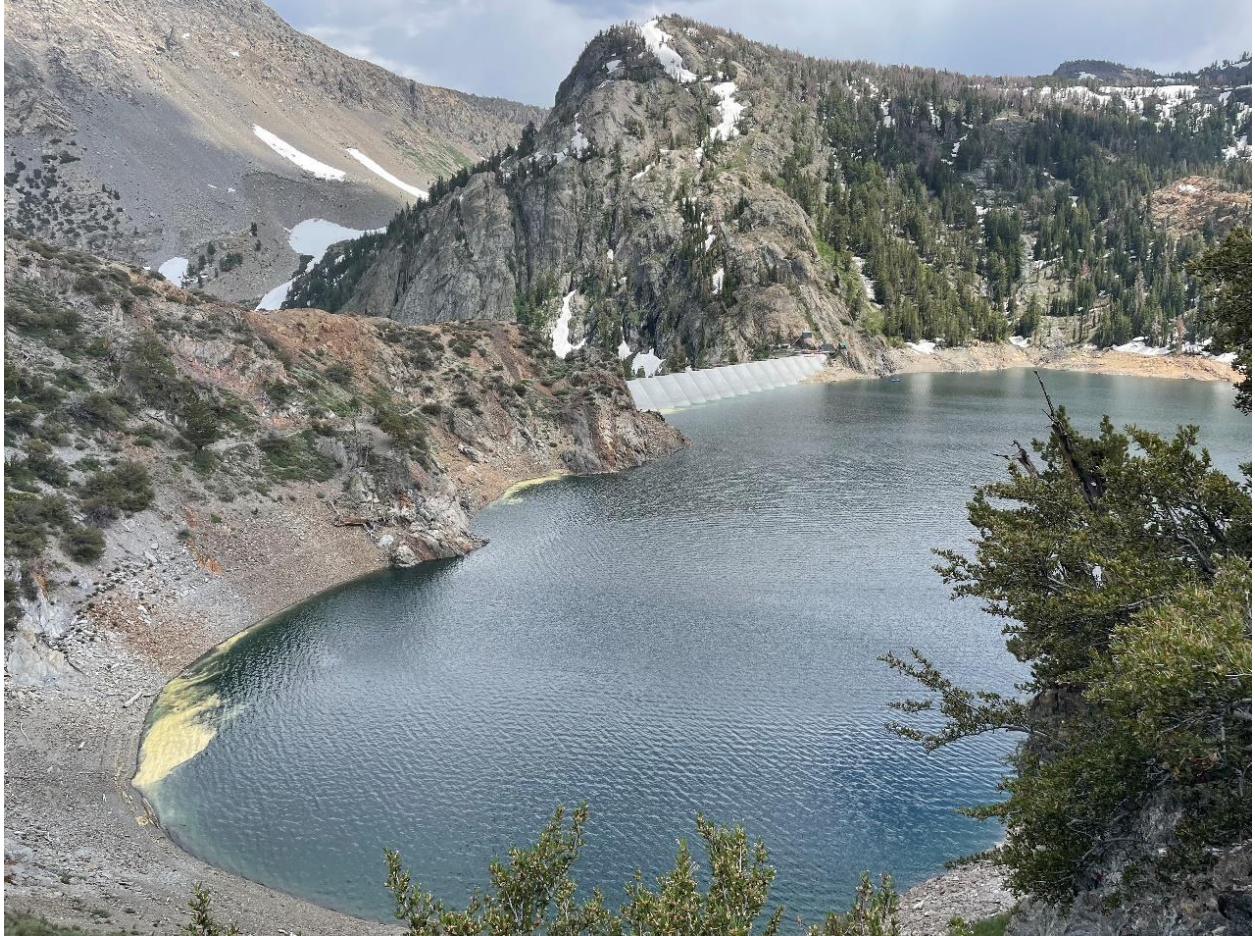
**Photo 9. Key Observation Point 8, Gem Dam—View from Upstream (looking east)**

Note: July 19, 2023 (37.7546, -119.144)

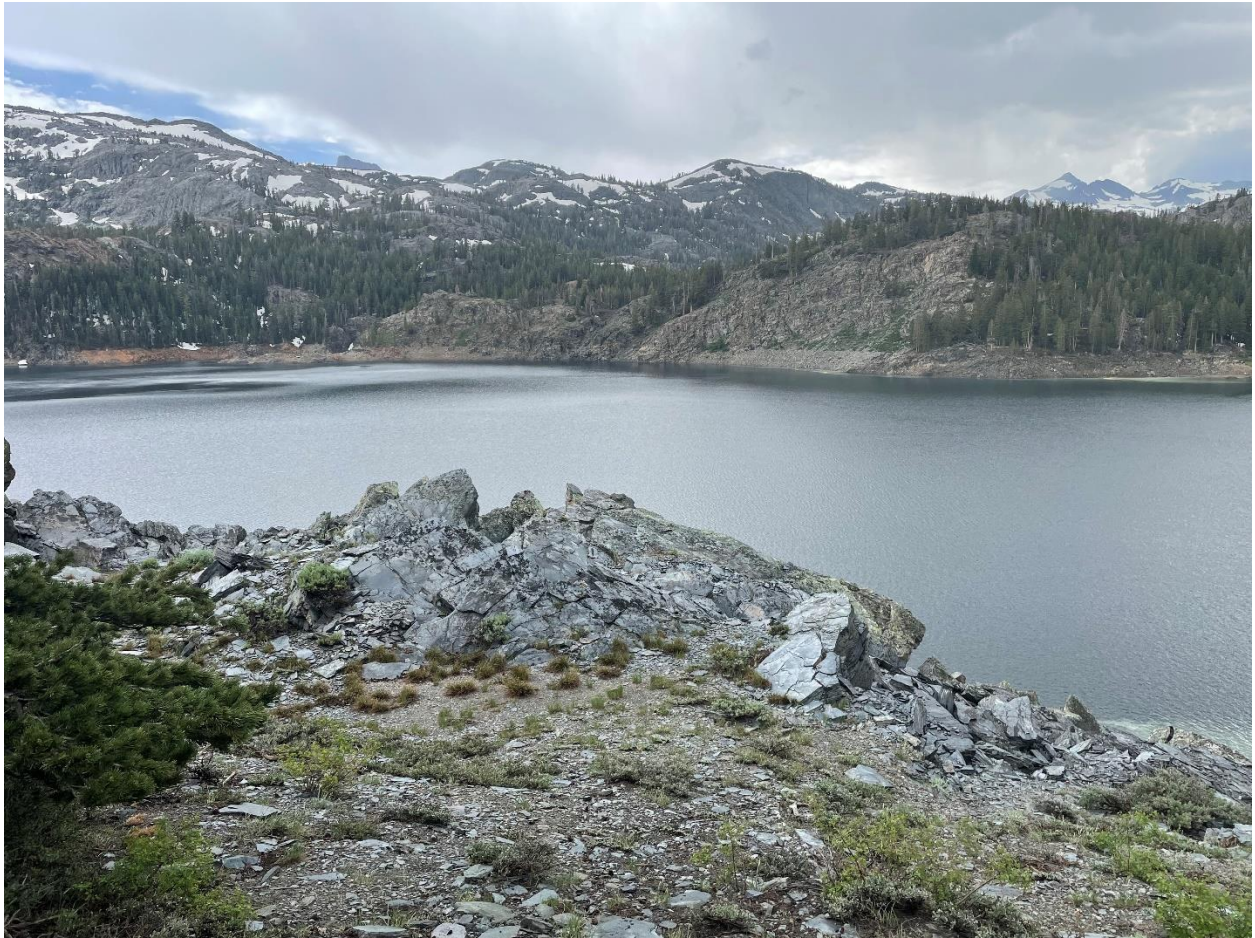
**Photo 10. Key Observation Point 9, Gem Lake (looking south)**

Note: July 17, 2023 (37.7535, -119.148)

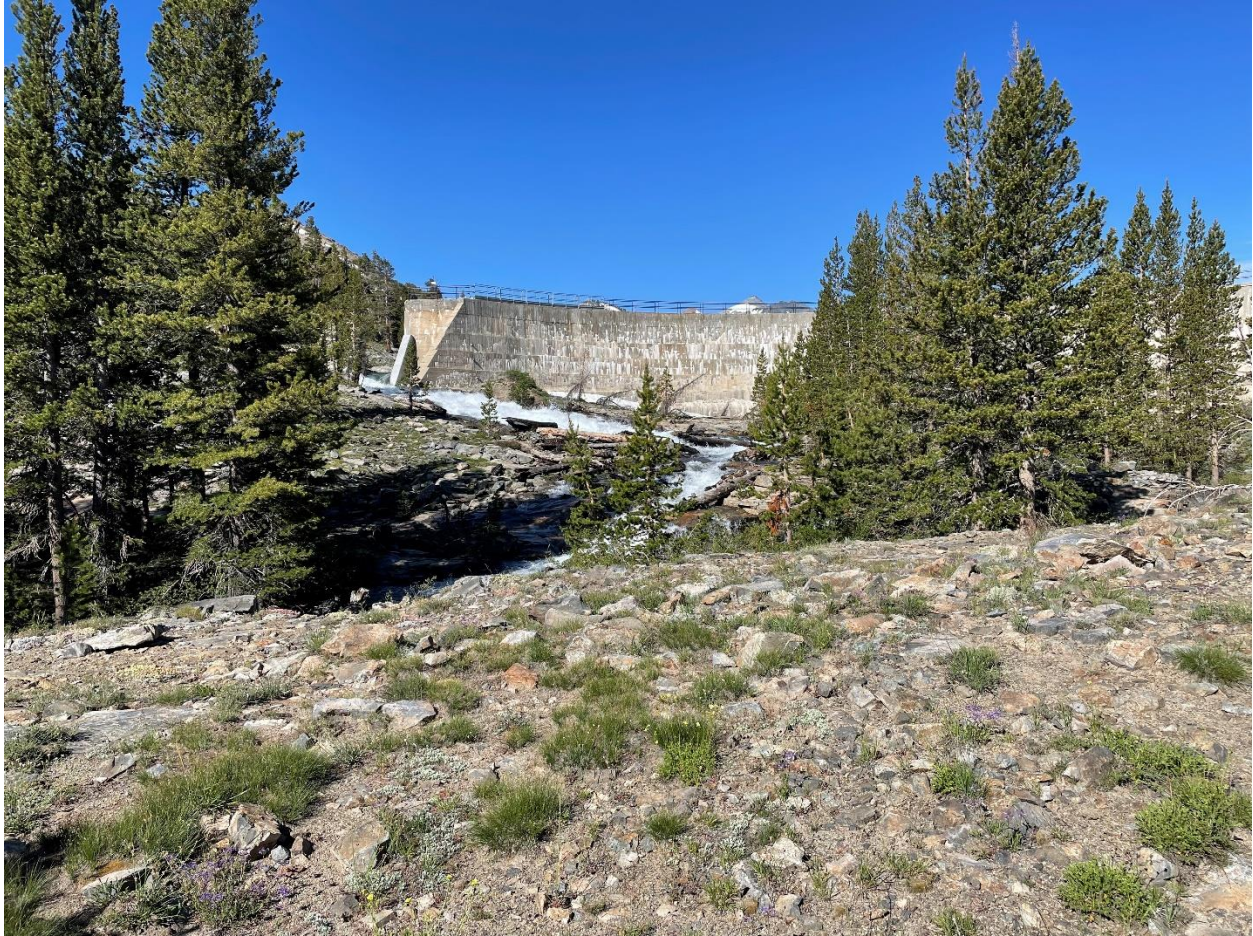
**Photo 11. Key Observation Point 10, Rush Meadows Dam—View from Downstream**

Note: July 18, 2023 (37.7512, -119.181)

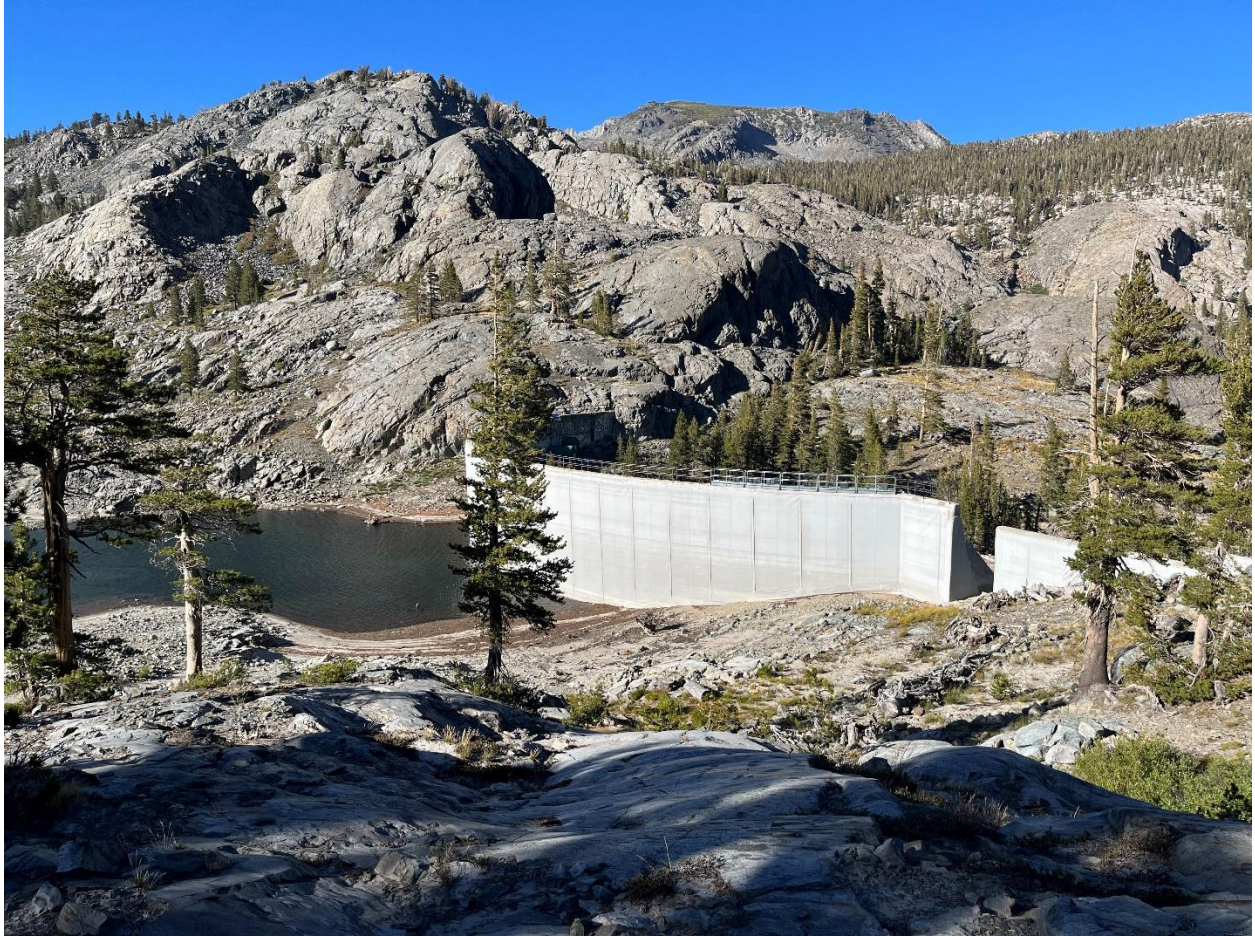
**Photo 12. Key Observation Point 11, Rush Meadows Dam—View from Weber Lake Trail**

Note: September 26, 2023 (37.7501, -119.182)

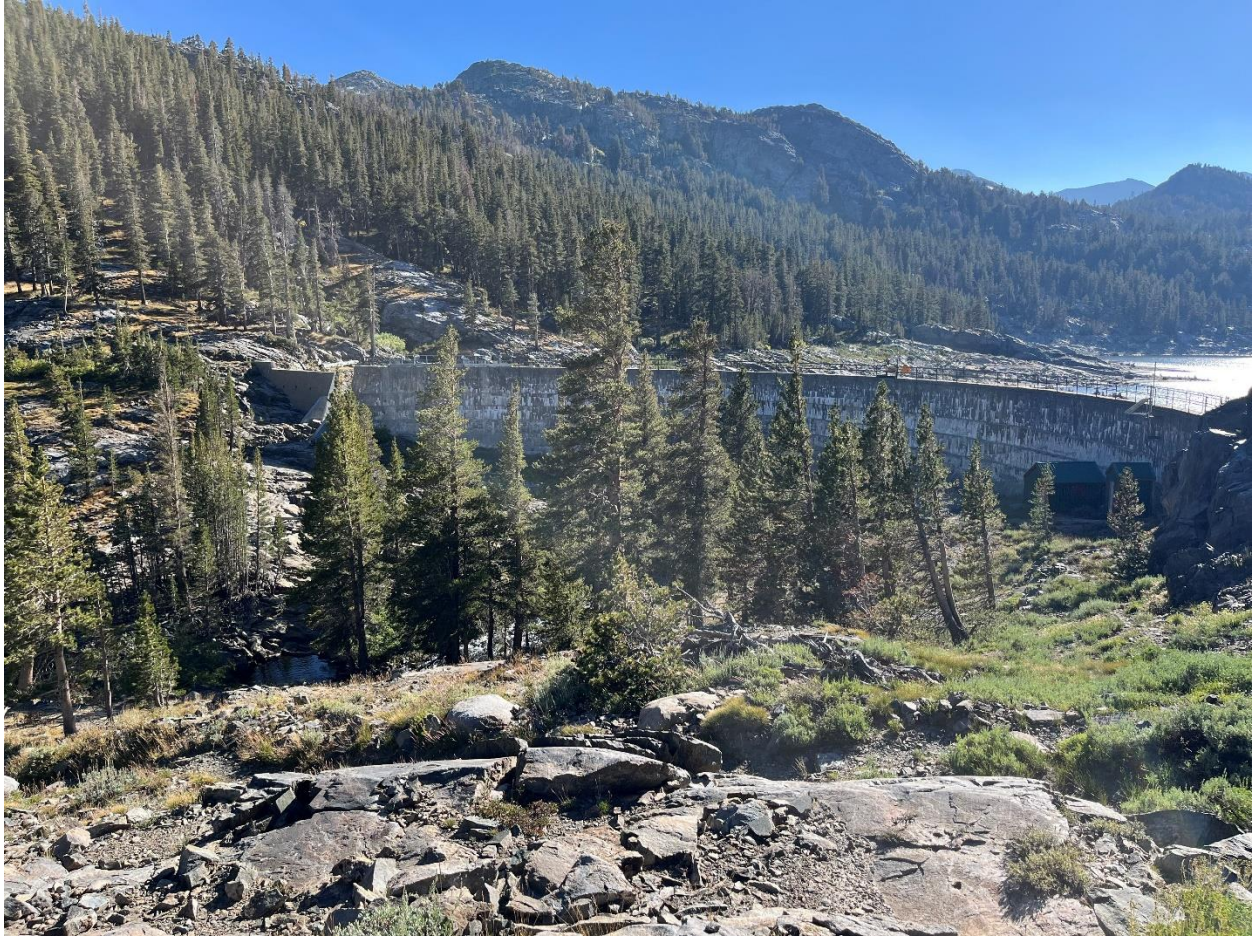
**Photo 13. Key Observation Point 12, Rush Meadows Dam**

Note: September 26, 2023 (37.7517, -119.181)

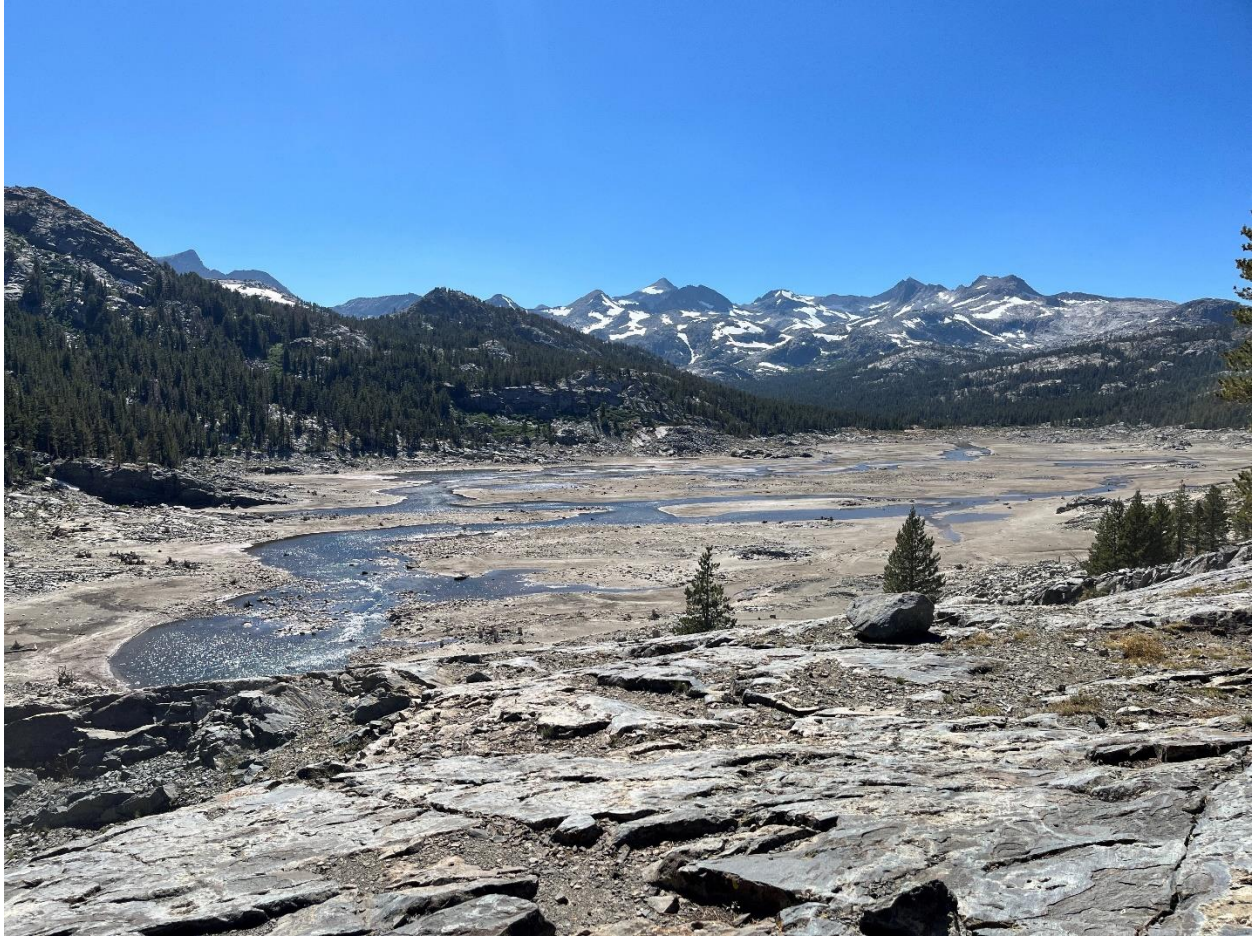
**Photo 14. Key Observation Point 13, Waugh Lake—View from Rush Creek Trail Near Dam (looking upstream)**

Note: August 31, 2023 (37.7519, -119.182)

- GPS Coordinates: 37.7519, -119.182
- Location Description: View from the shoreline area of Waugh Lake just beyond Rush Meadows Dam – looking west towards the Sierra crest.
- Viewshed Description: The view is expansive across the Waugh lakebed which comprises the foreground and middleground of the view while the high peaks of the Sierra crest dominate the backdrop. The lakebed itself appears as a drained reservoir with silty mud and meandering creek conditions visible across to the far side of the lake. Close to the location of the KOP, shallow riffles indicate the current of Rush Creek as it travels toward the notch in Rush Meadows Dam.

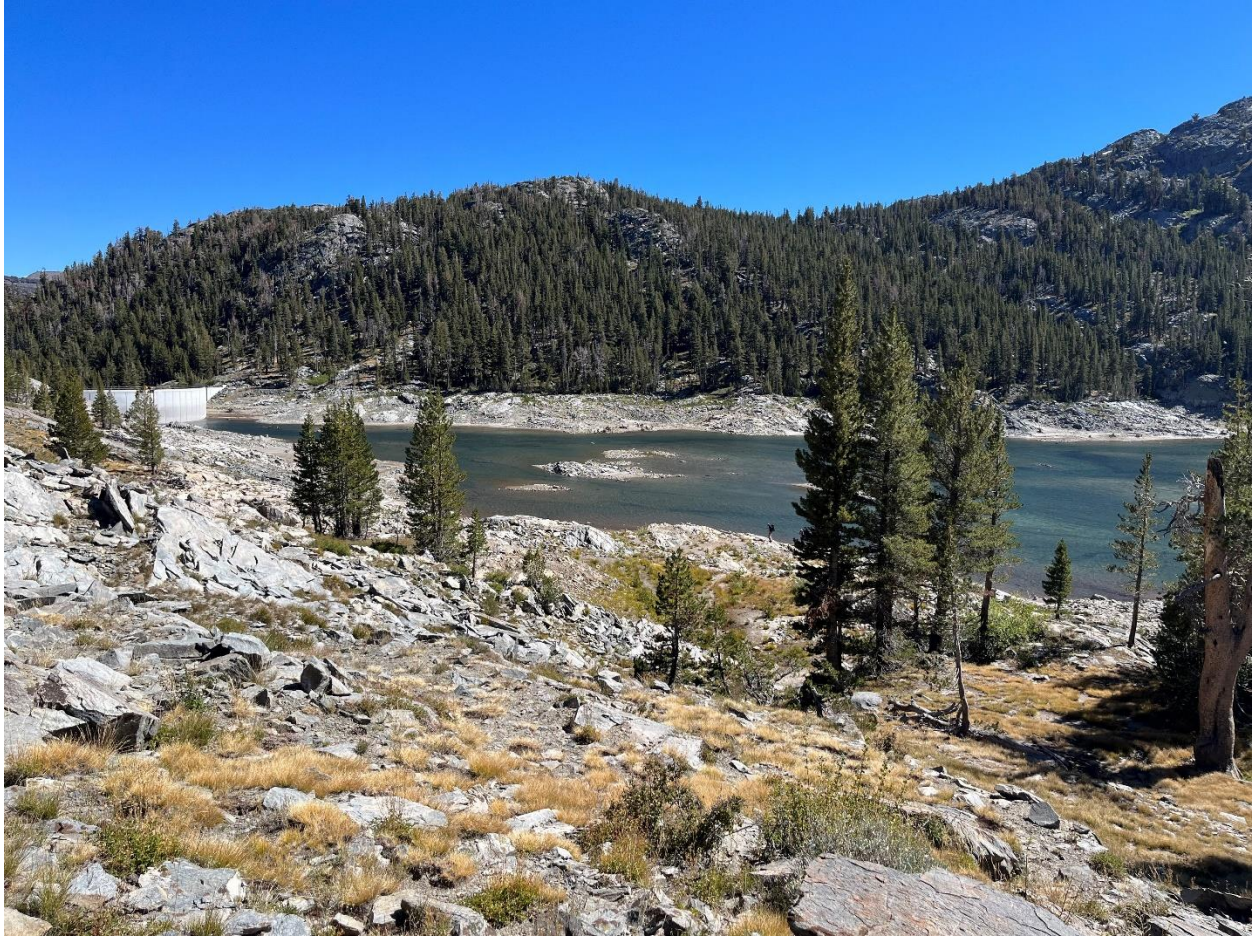
**Photo 15. Key Observation Point 14, Rush Meadows Dam—View from Upstream Toward Dam**

Note: September 26, 2023 (37.7528, -119.185)

- Viewshed Description: Looking upstream, the silty lakebed of Waugh Lake is replaced by granite slabs of rock and a defined creek channel (mostly dry in September 2023). The high peaks of the Sierra crest dominate the upstream backdrop. Vegetation at the shoreline consists of scattered conifers (mostly lodgepole pine). Downstream the view during early summer (peak runoff) varies dramatically compared to later in the season after most of the snow has melted. During the early season, the lake appears nearly full with no lakebed visible and the crest of the dam just visible as a linear flat feature, distinctive compared to the rounded mountainous terrain on either side of the drainage. Later in the season the brown silt of the lakebed dominates the foreground and the whole of Rush Meadows Dam is visible at the eastern end, its white geomembrane contrasting starkly with the blue and brown of the lakebed and the rocky gray mountains beyond.

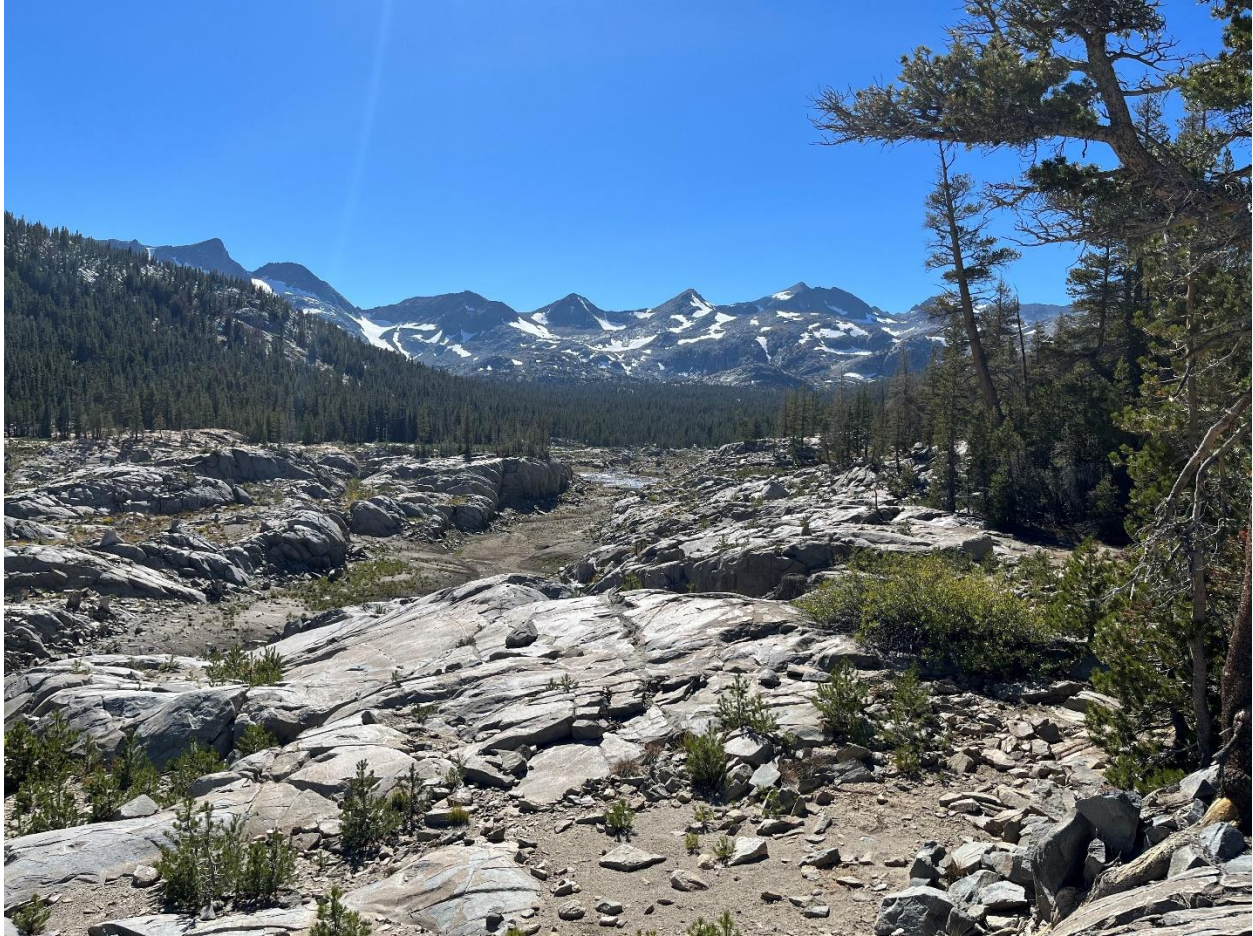
**Photo 16. Key Observation Point 15, Waugh Lake—Northern Shoreline (looking upstream)**

Note: September 26, 2023 (37.7529, -119.195)

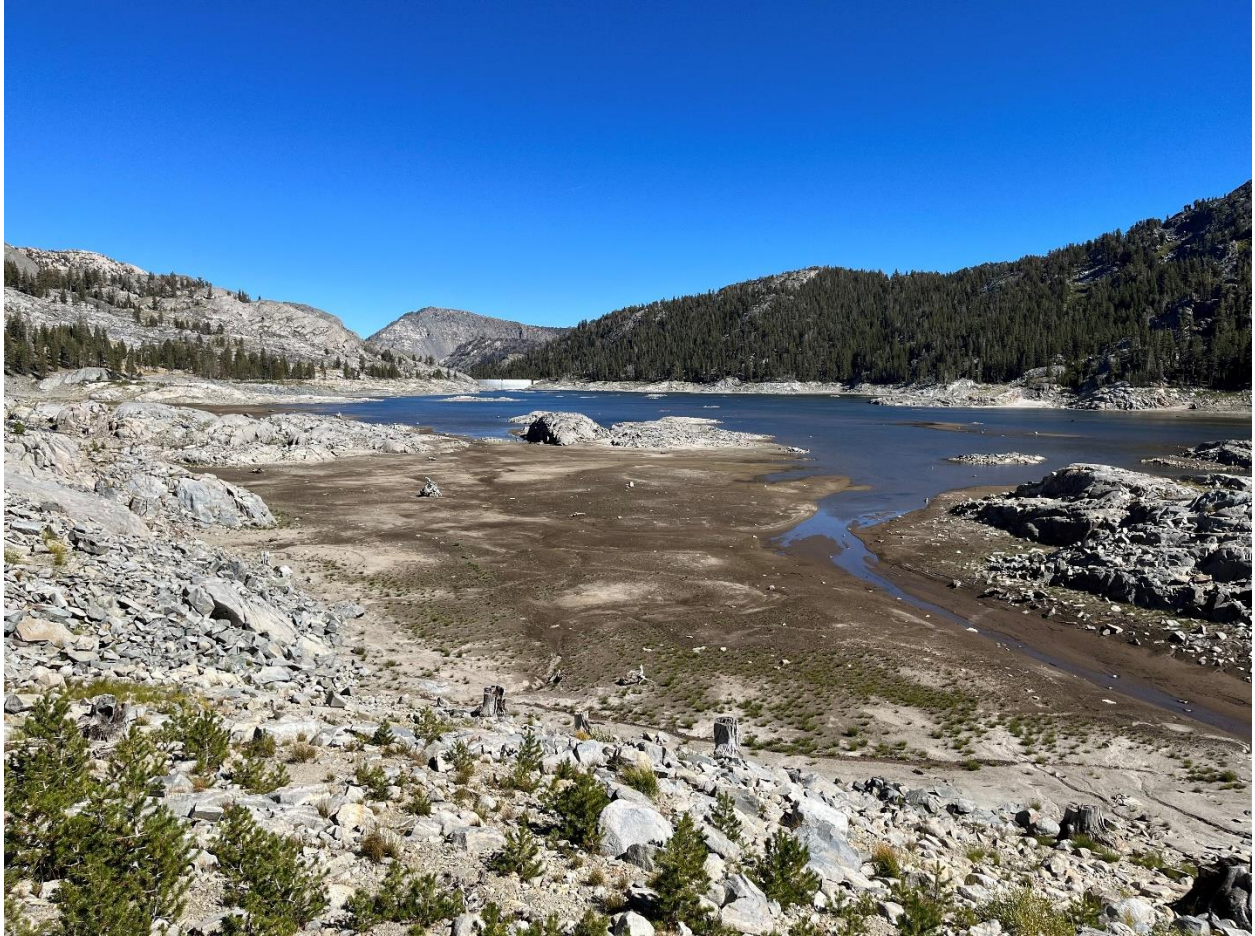
**Photo 17. Key Observation Point 15, Waugh Lake—Northern Shoreline (looking downstream)**

Note: September 26, 2023 (37.7529, -119.195)
