**Subject: Rush Creek Hydroelectric Project, FERC Project No. 1389-059  
Filing of a Revised LAND 1 – Aesthetics Technical Study Report**

Rush Creek Project, FERC Project No. 1389

**Revised** LAND 1 – Aesthetics  
Technical Study Report

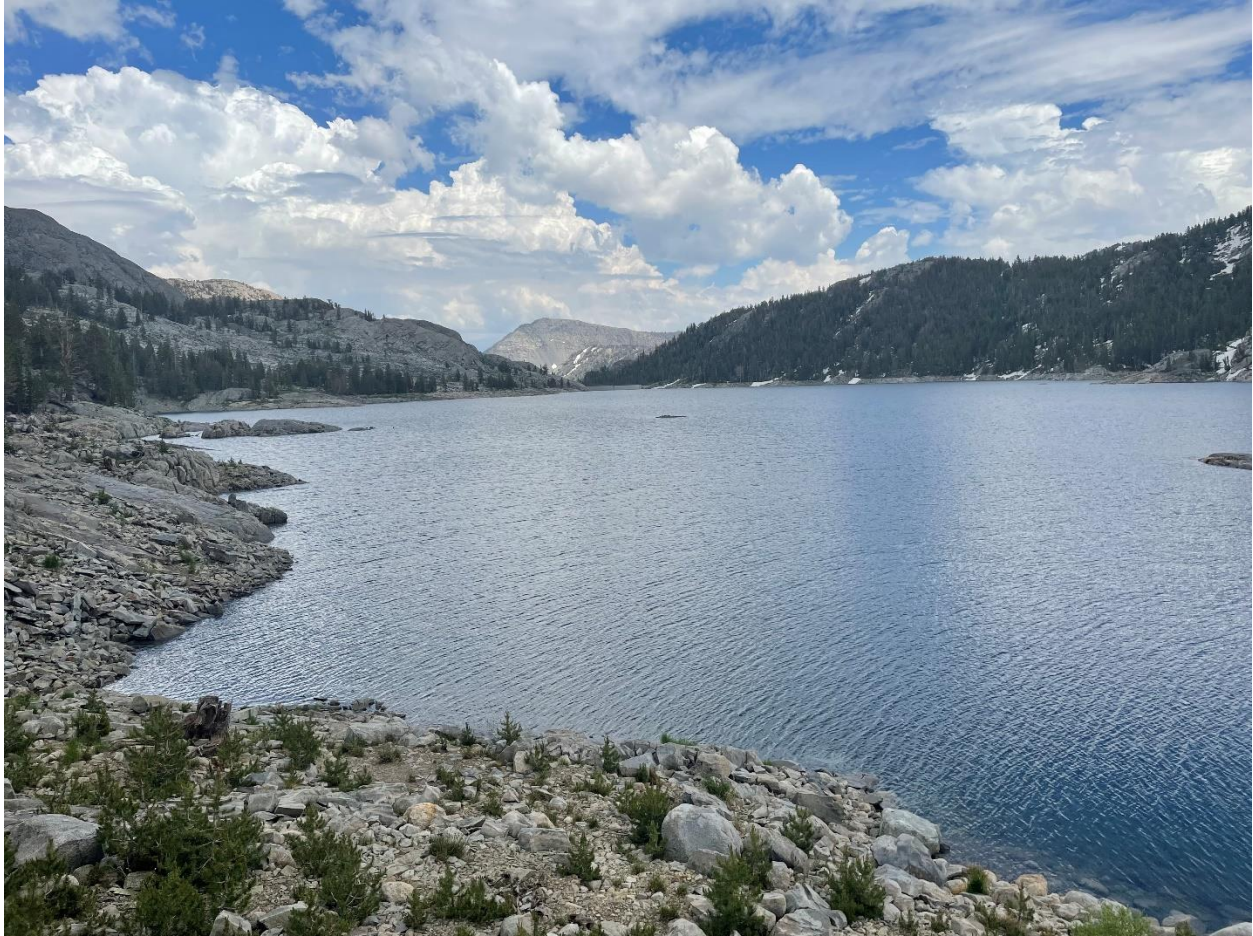
**Photo 18. Key Observation Point 15, Waugh Lake—Northern Shoreline (looking downstream)**

Note: July 18, 2023 (37.7529, -119.195)

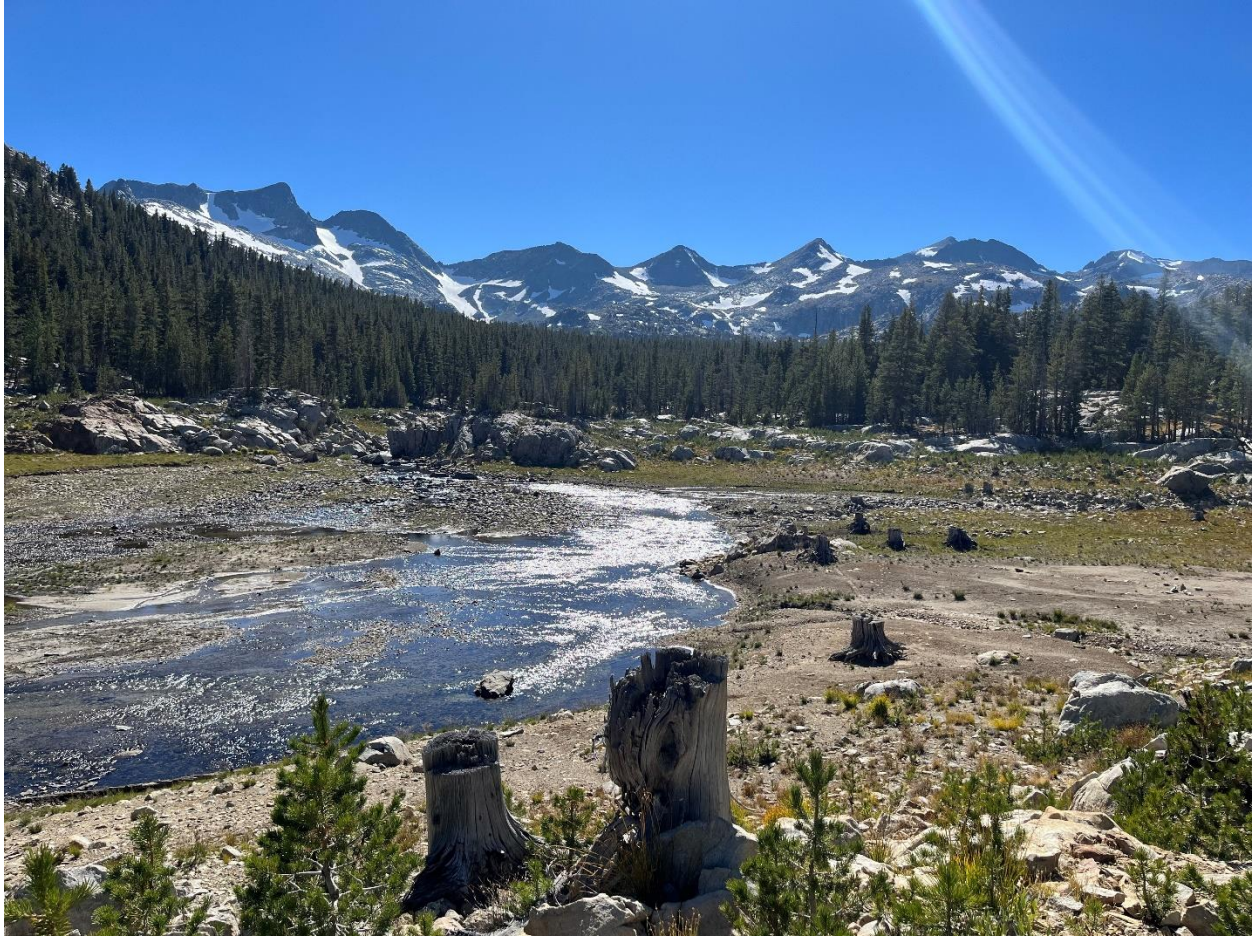
**Photo 19. Key Observation Point 16, Waugh Lake—Western End (looking upstream)**

Note: September 26, 2023 (37.7499, -119.201)

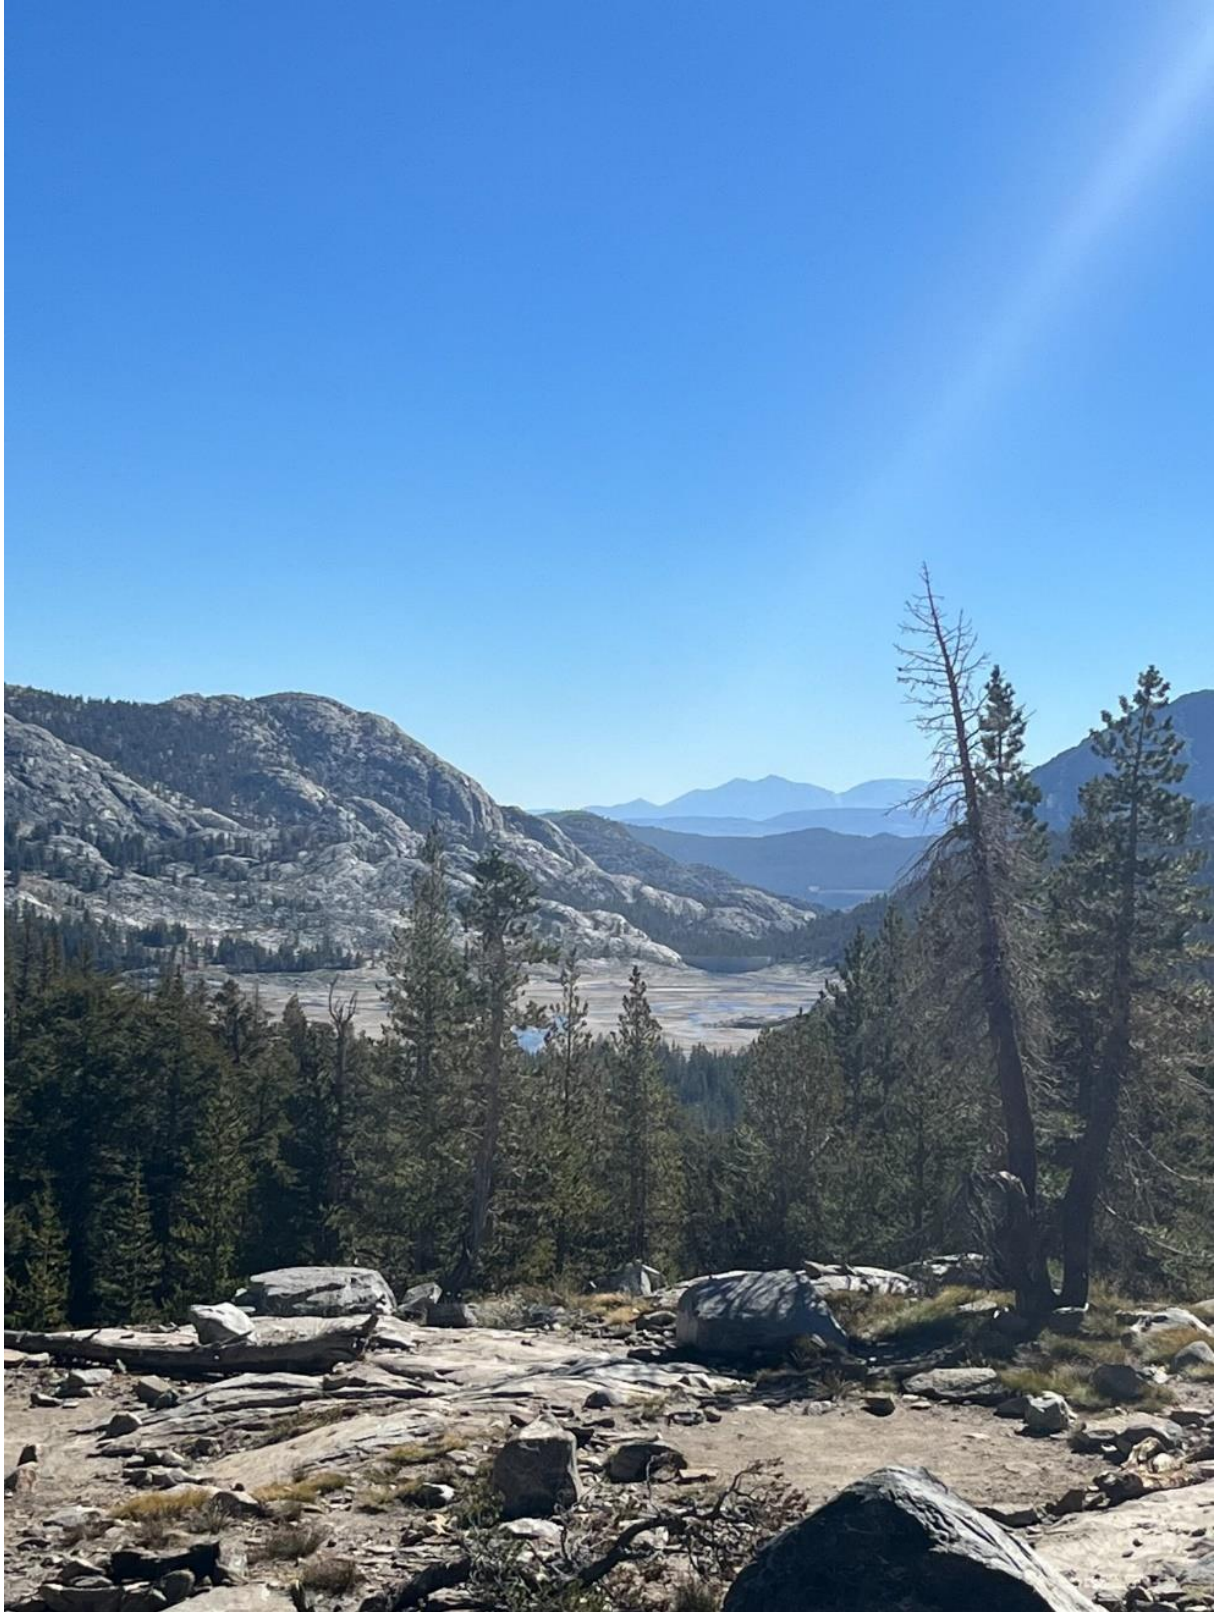
**Photo 20. Key Observation Point 17, Waugh Lake from the Pacific Crest Trail**

Note: September 26, 2023 (37.7468, -119.215)

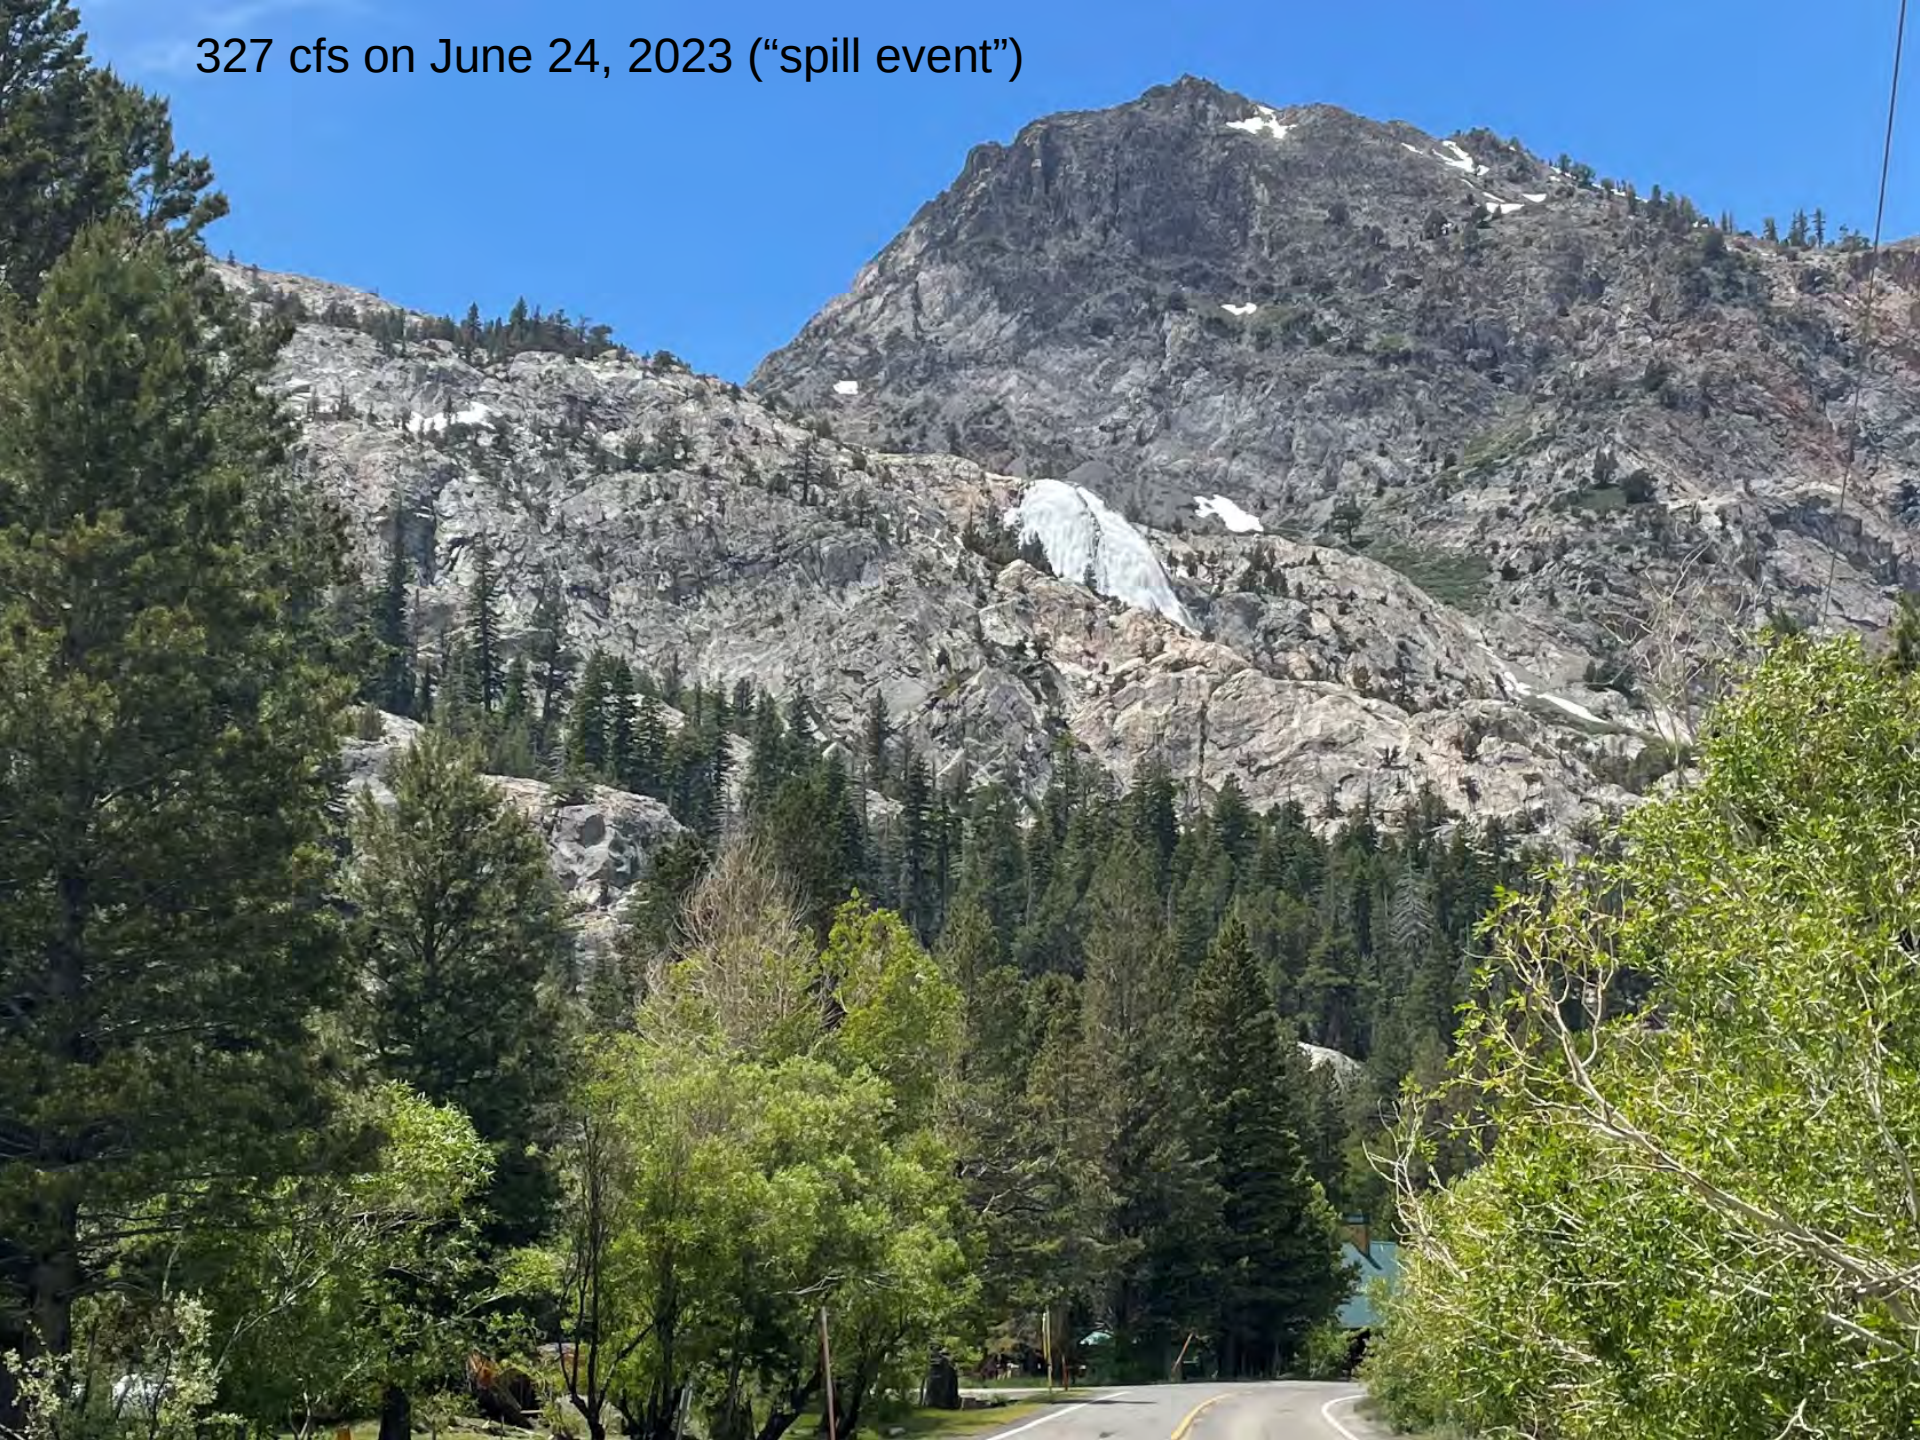
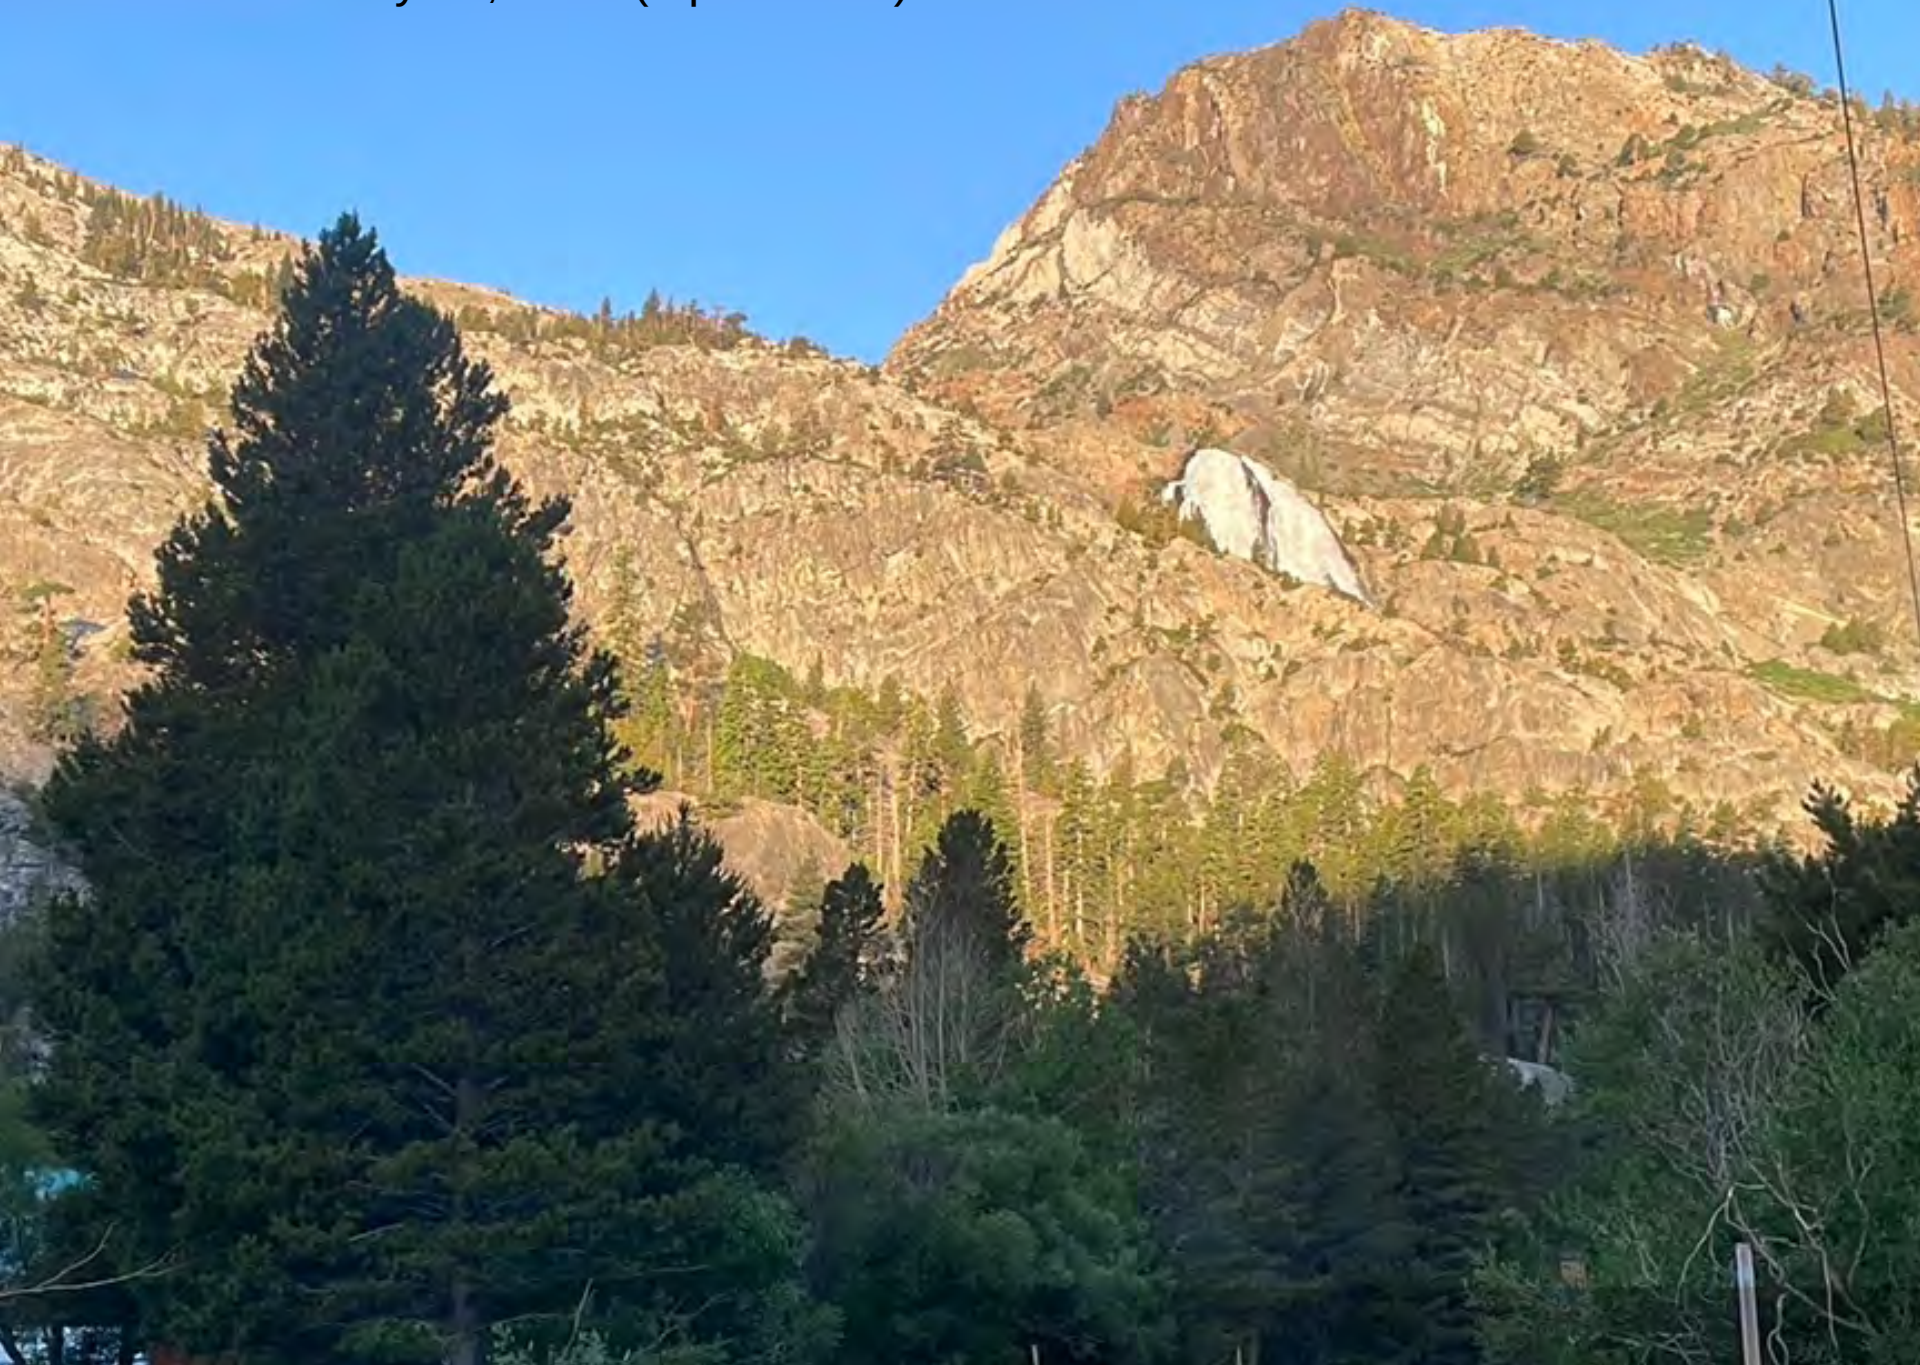
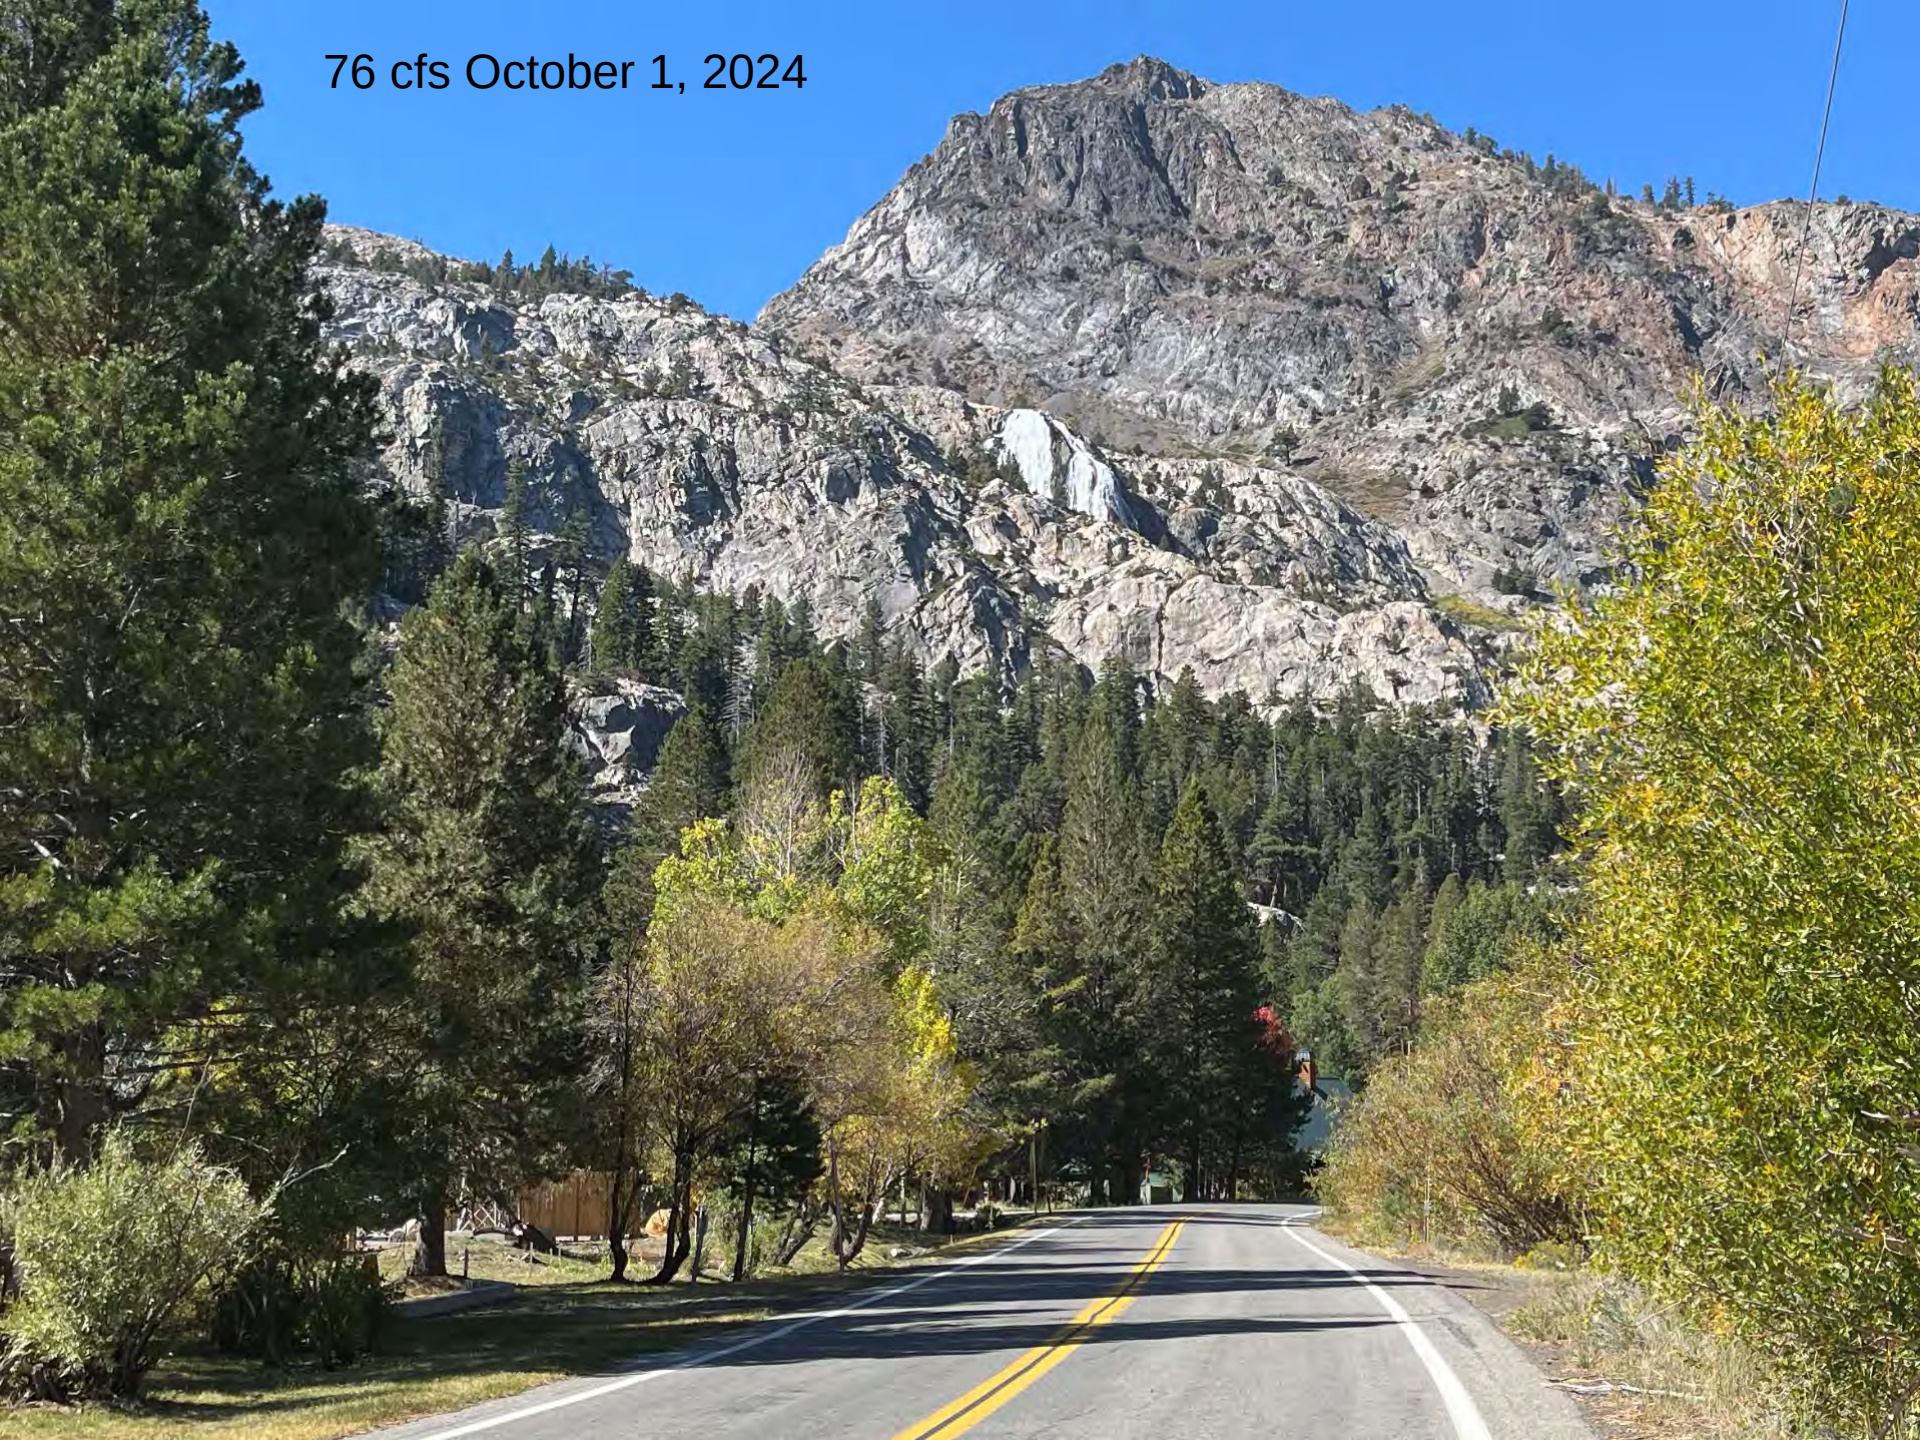
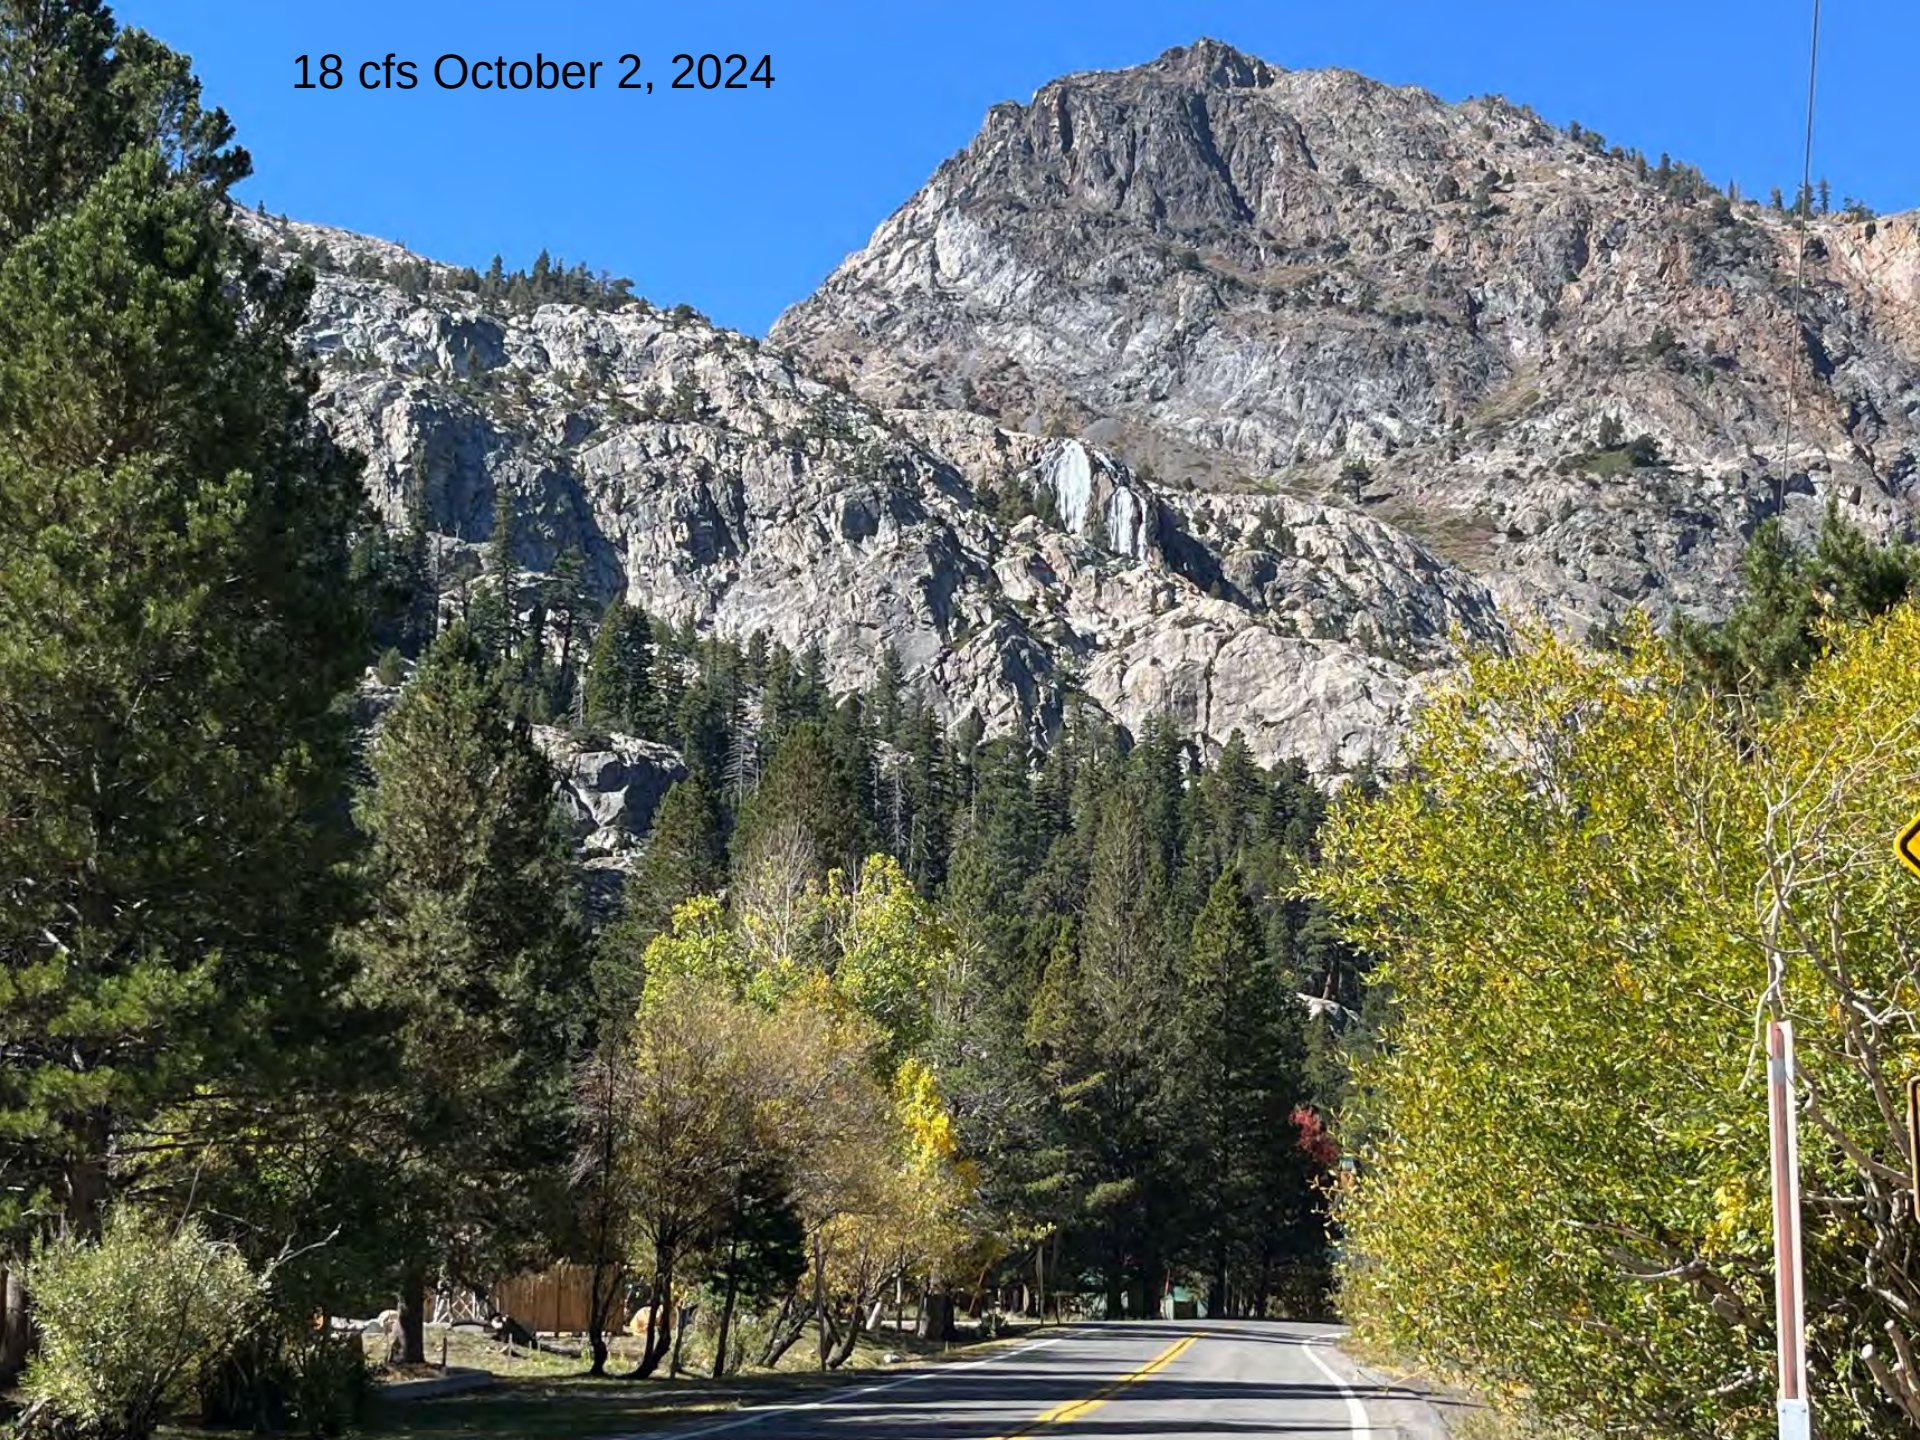
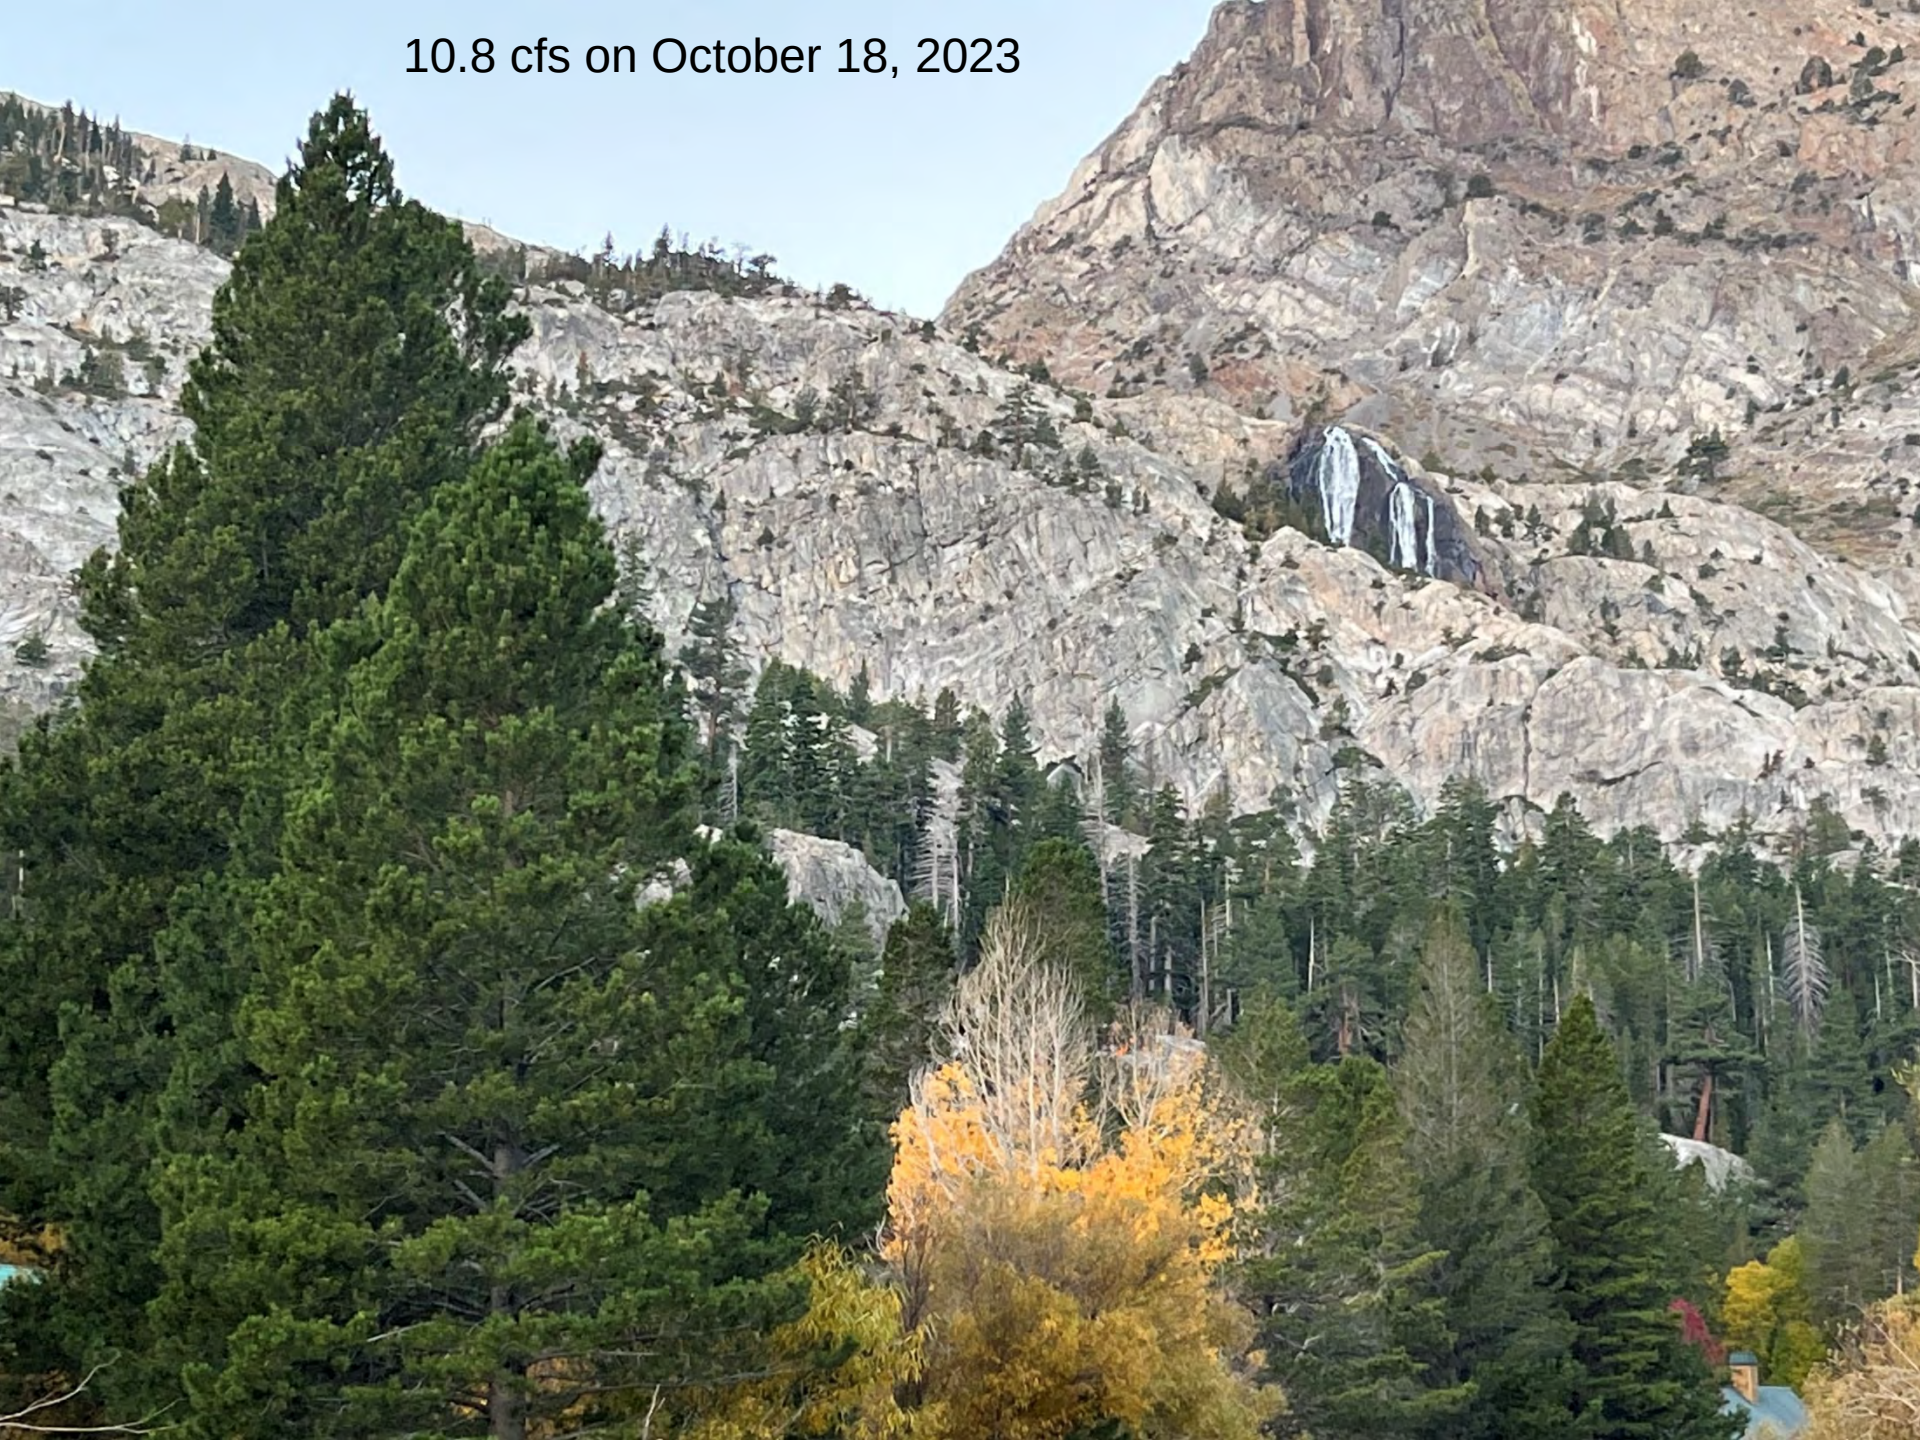
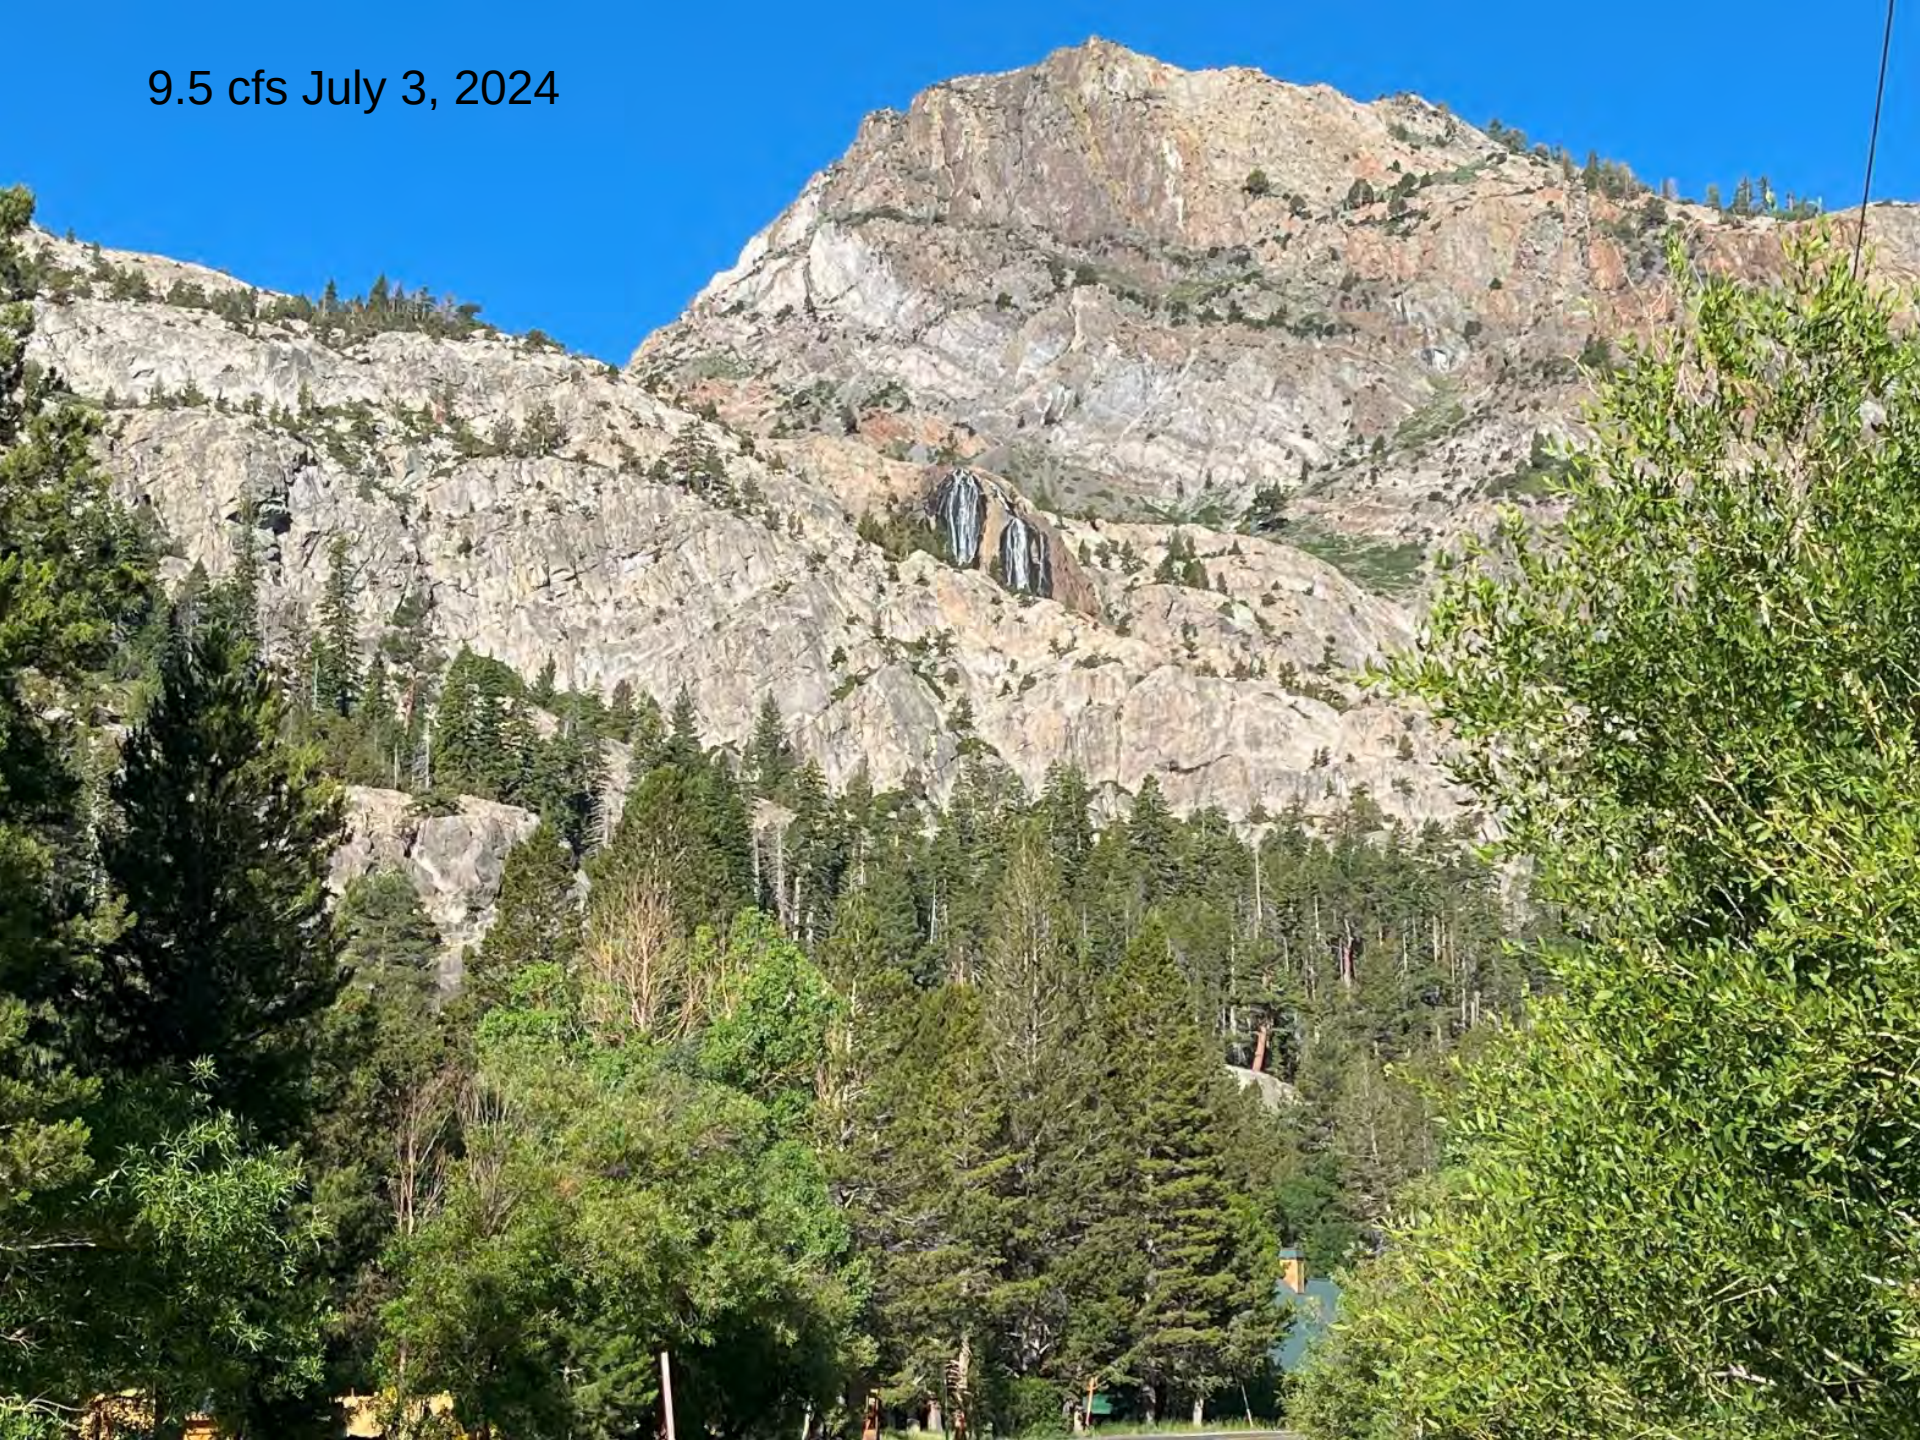
**KEY OBSERVATION POINT 1**

327 cfs on June 24, 2023 ("spill event")

284 cfs on July 17, 2023 ("spill event")

76 cfs October 1, 2024

18 cfs October 2, 2024

10.8 cfs on October 18, 2023

9.5 cfs July 3, 2024

2.6 cfs on September 9, 2023

2.10 cfs on September 16, 2023

Horsetail Falls is a water feature along Rush Creek downstream of Agnew Dam where the creek falls and cascades approximately 500 vertical feet. Horsetail Falls is a dramatic and eye-catching component of the middleground view from SR 158 at high flows and an eye-catching, though less dramatic, visual phenomena at lower flows. At lower flows, time-of-day, and weather conditions (e.g., overcast or clear) may reduce or enhance the view of the falls from the highway. From the Rush Creek Trail, the falls are a larger component of the overall viewshed. While spectacular at high flows, they are an outstanding feature of the landscape from the trail even at 2 cfs.

Over the course of the 2023 and 2024 field season field staff visited the KOPs to photo document Horsetail Falls under different flow conditions. In some cases, coordination with SCE operations was necessary to organize releases commensurate with the desired flow condition because the flow condition was otherwise not present or only present for a short time period. For example, flows in the 13-to 20-cfs range occurred on just 2 days during the 2023 field season—October 11 and October 19—while flows in the 70-to 85-cfs range over the falls occurred on just 1 day—August 2, 2023. Because of the short period during which these flows occurred, field staff were not able to mobilize quickly enough to document flows under these two conditions during the 2023 season. Instead, field staff coordinated with SCE operations to arrange for these two flow conditions in October of
