**Subject: Rush Creek Hydroelectric Project, FERC Project No. 1389-059  
Filing of a Revised LAND 1 – Aesthetics Technical Study Report**

Rush Creek Project, FERC Project No. 1389

**Revised** LAND 1 – Aesthetics  
Technical Study Report

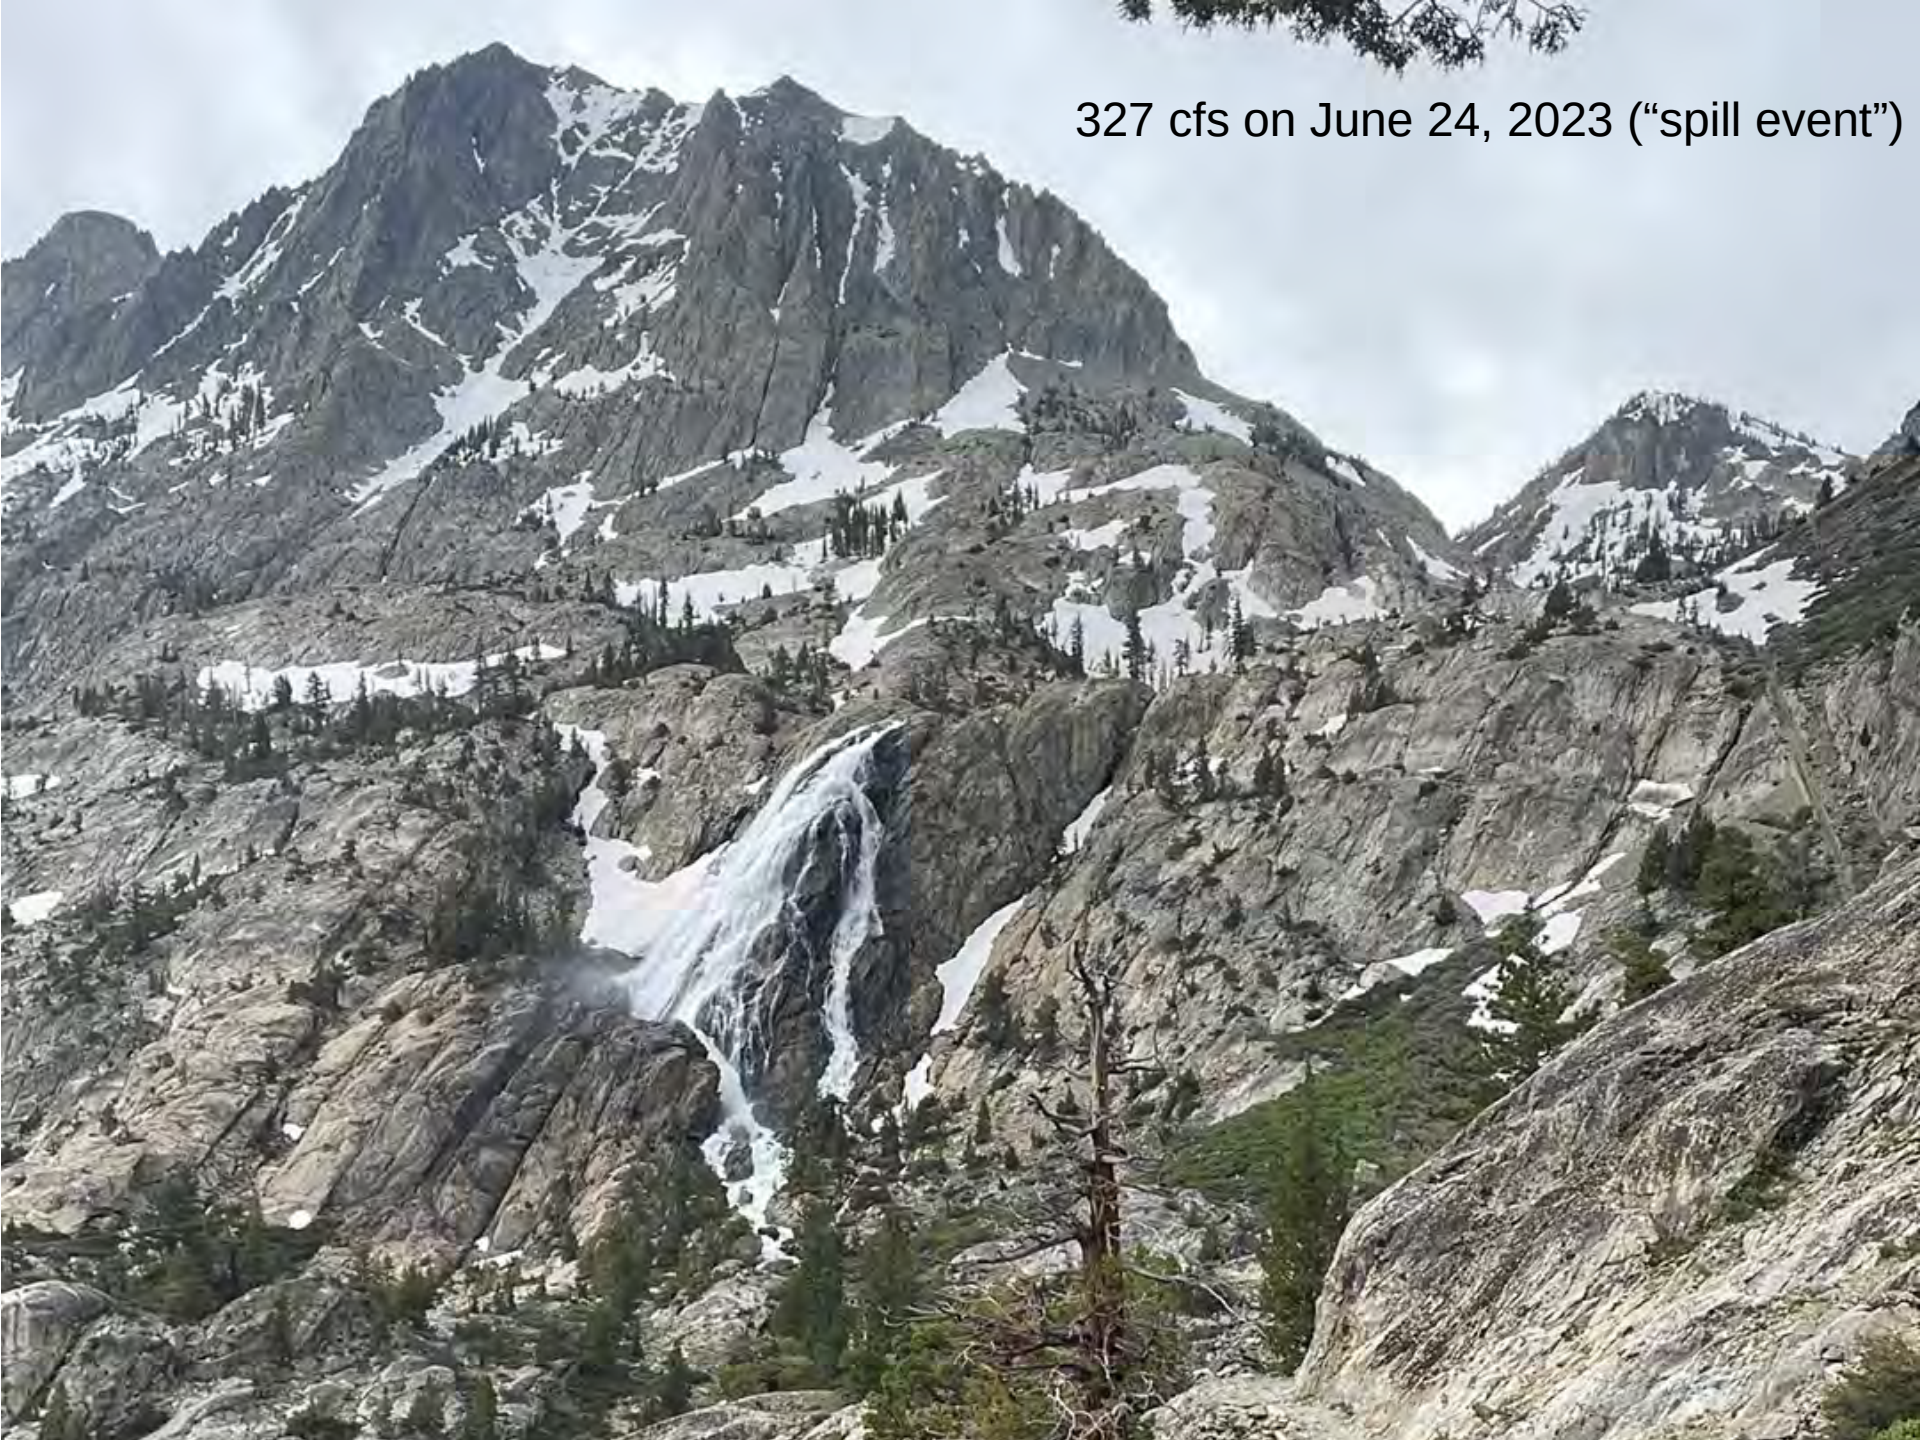
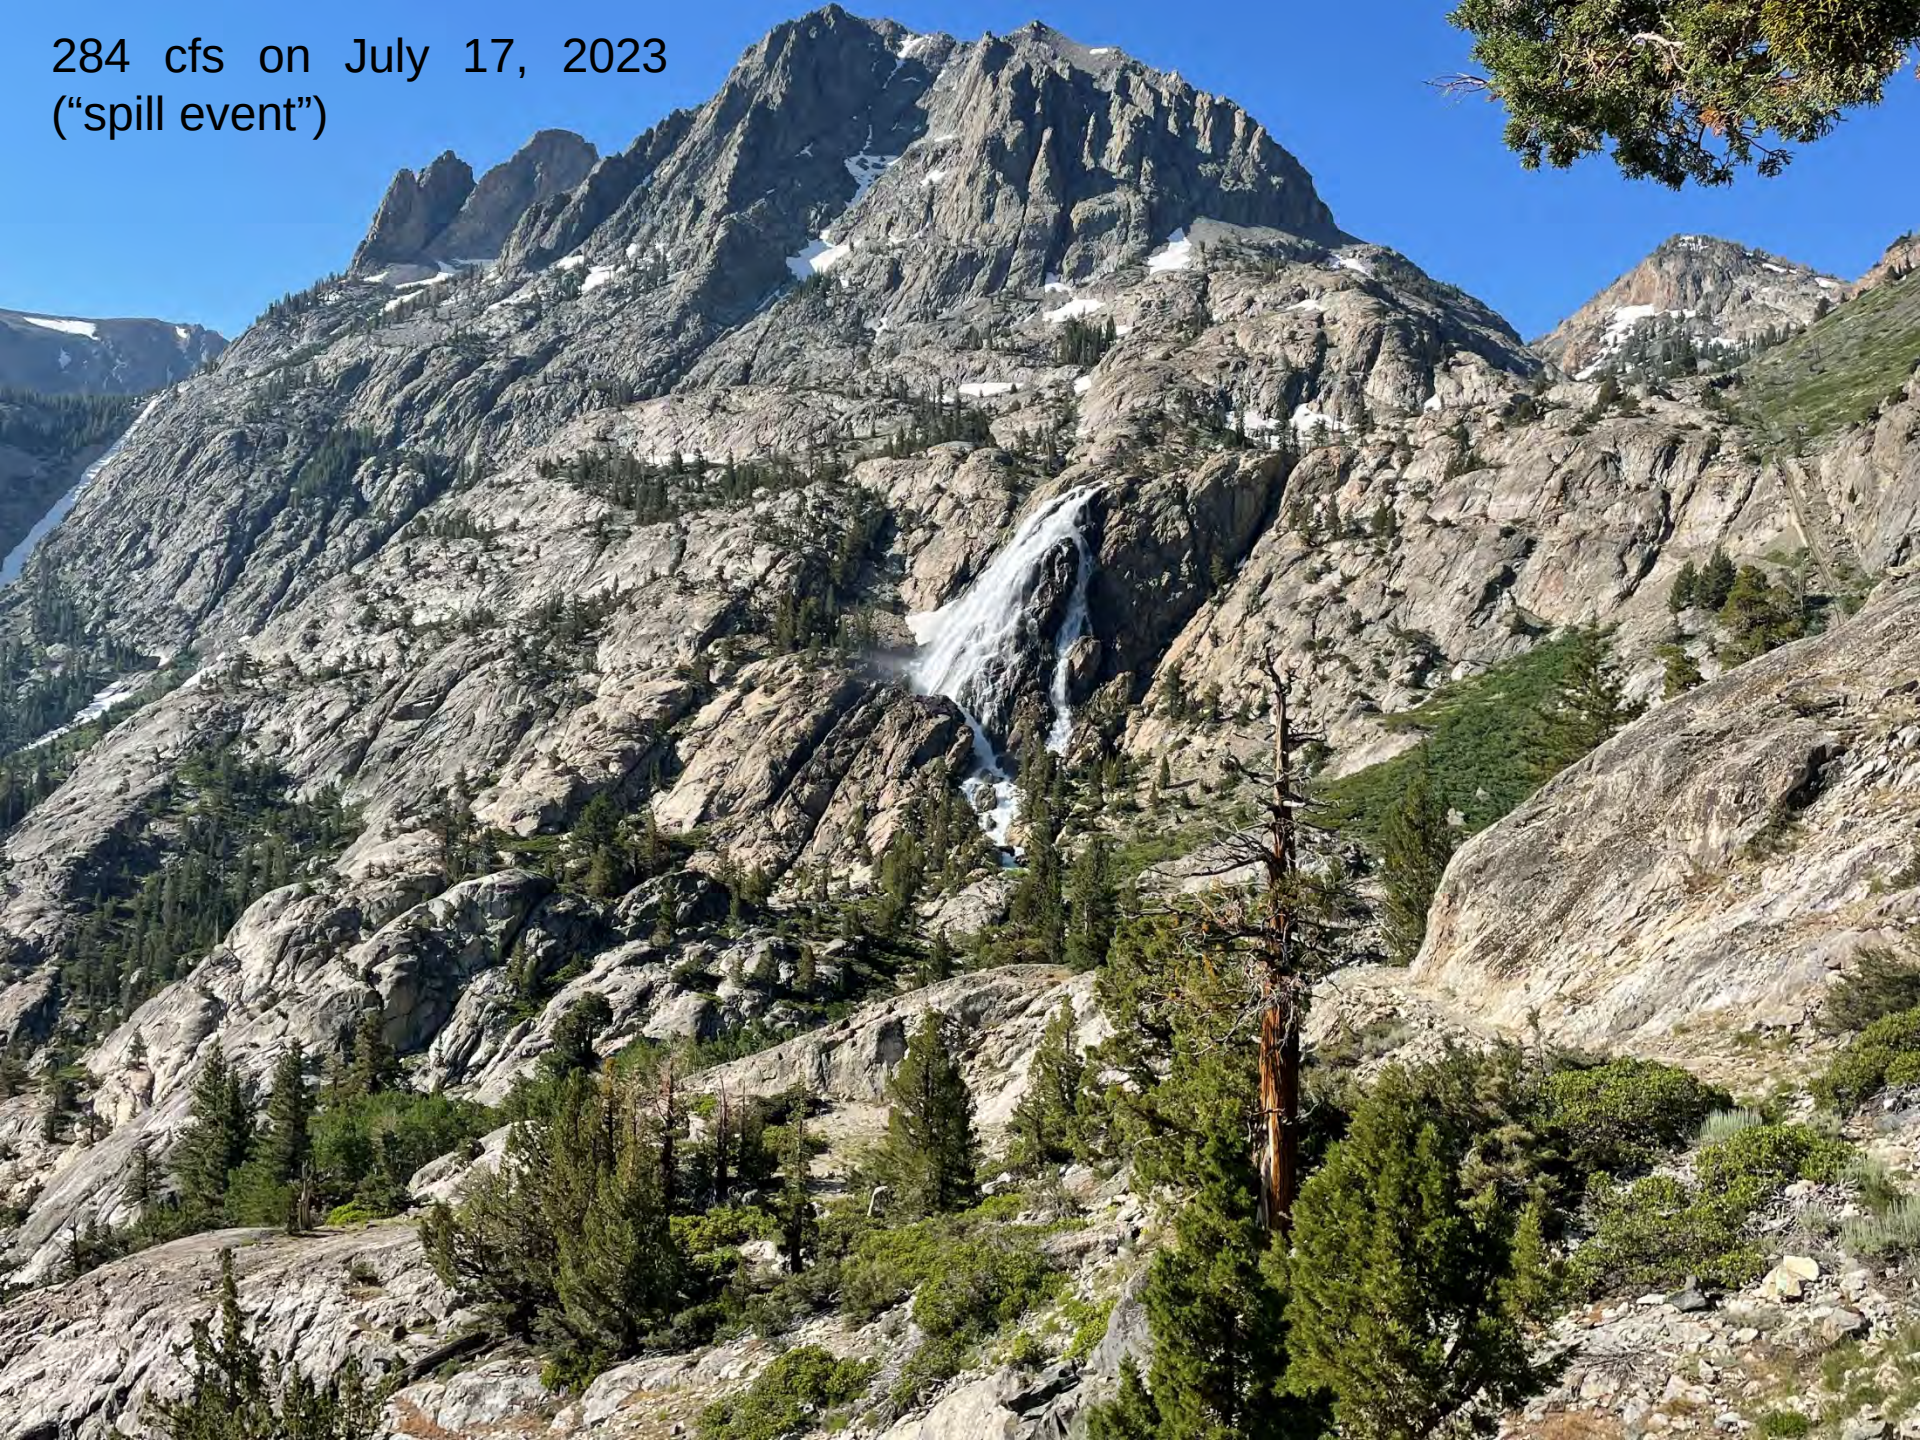
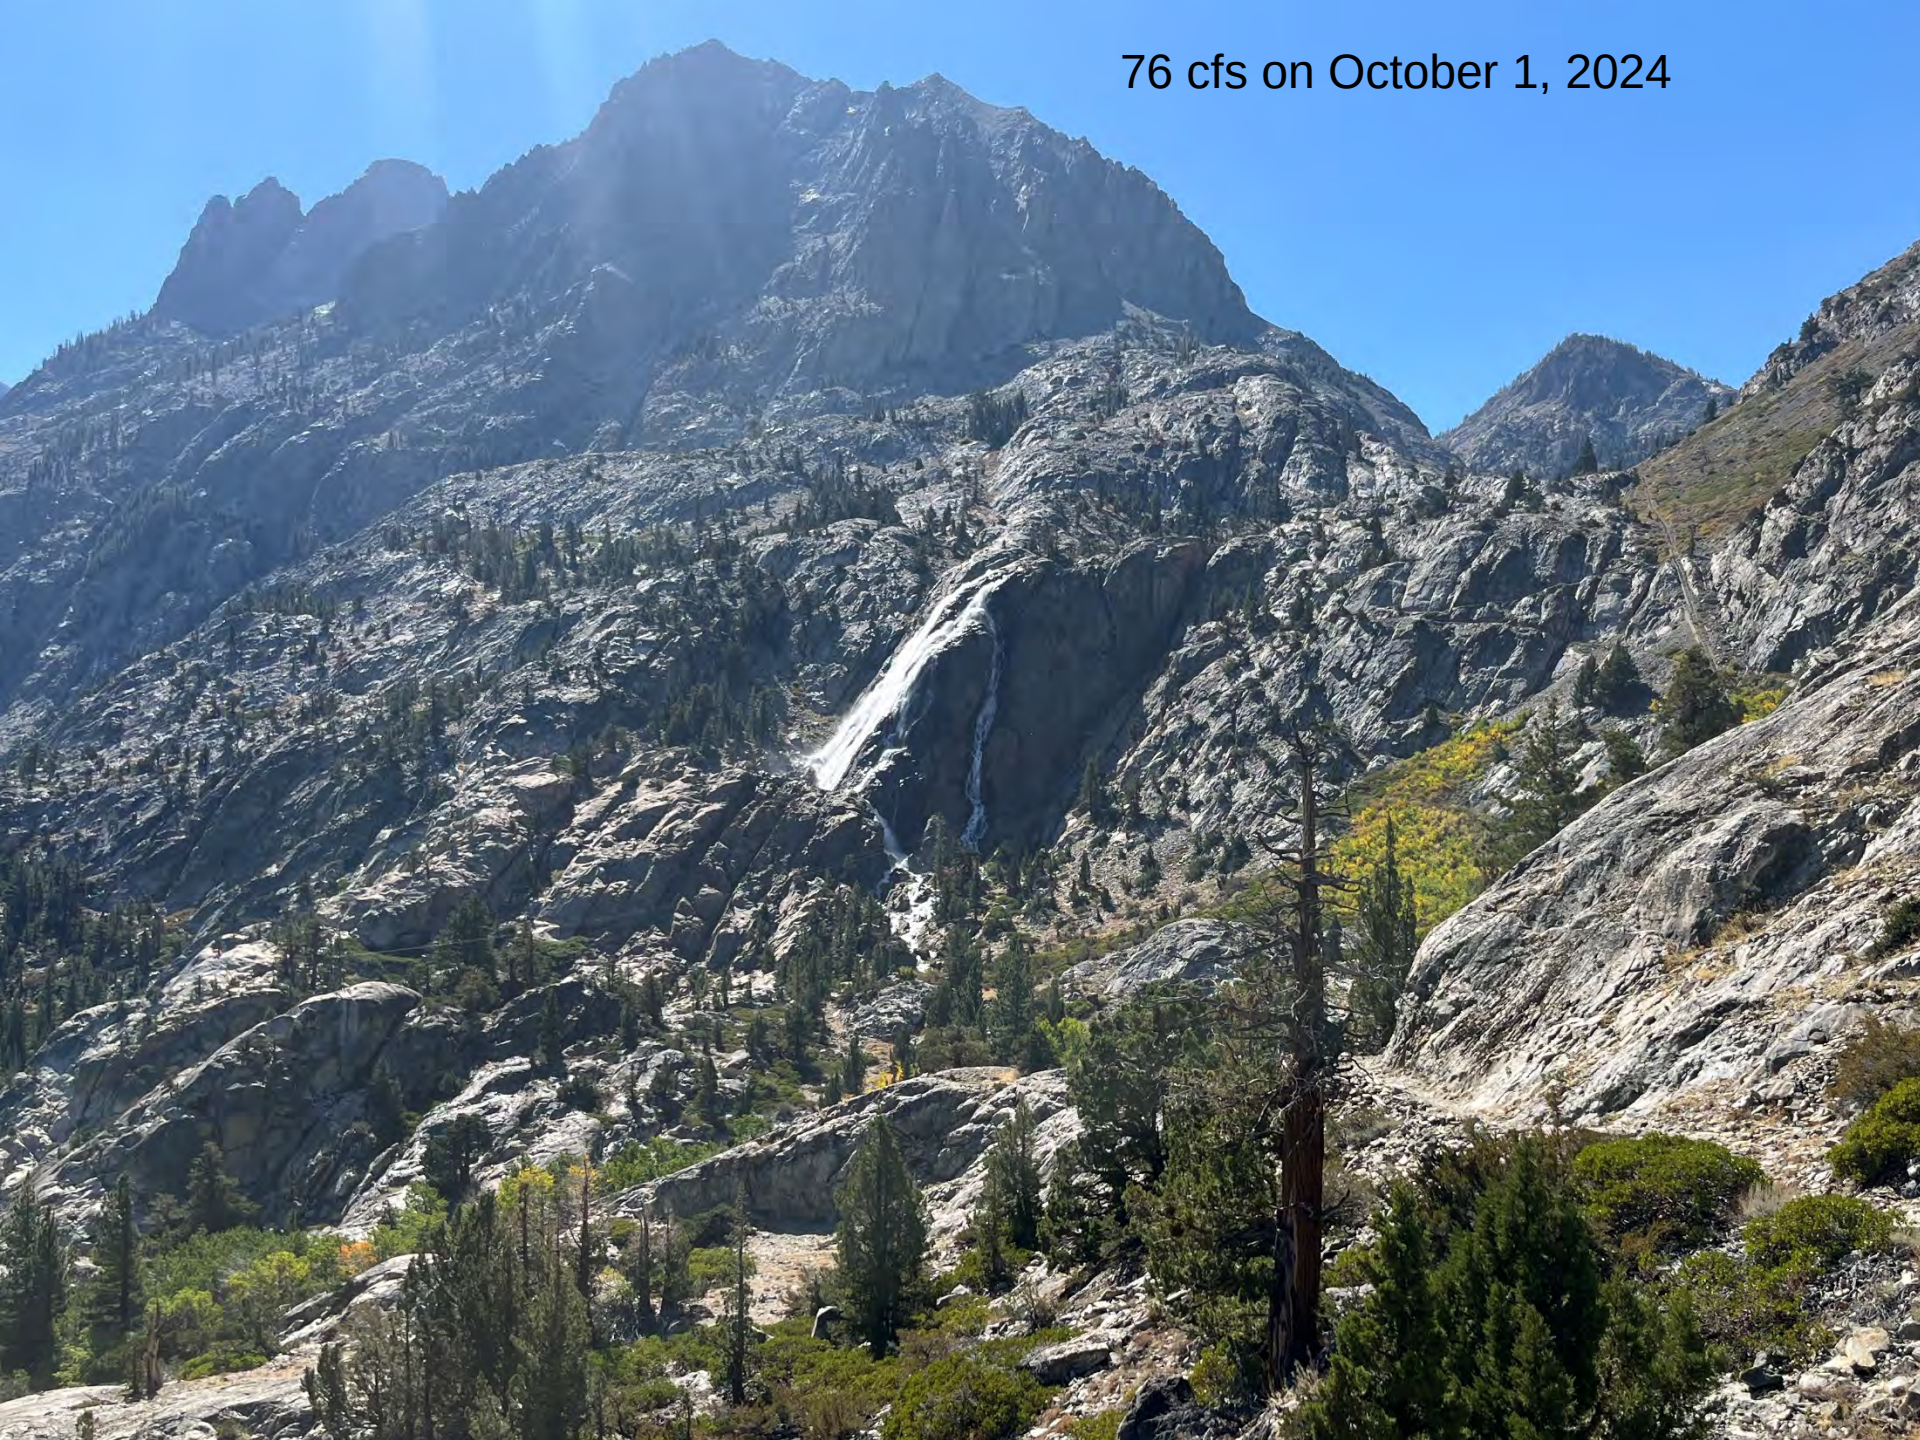
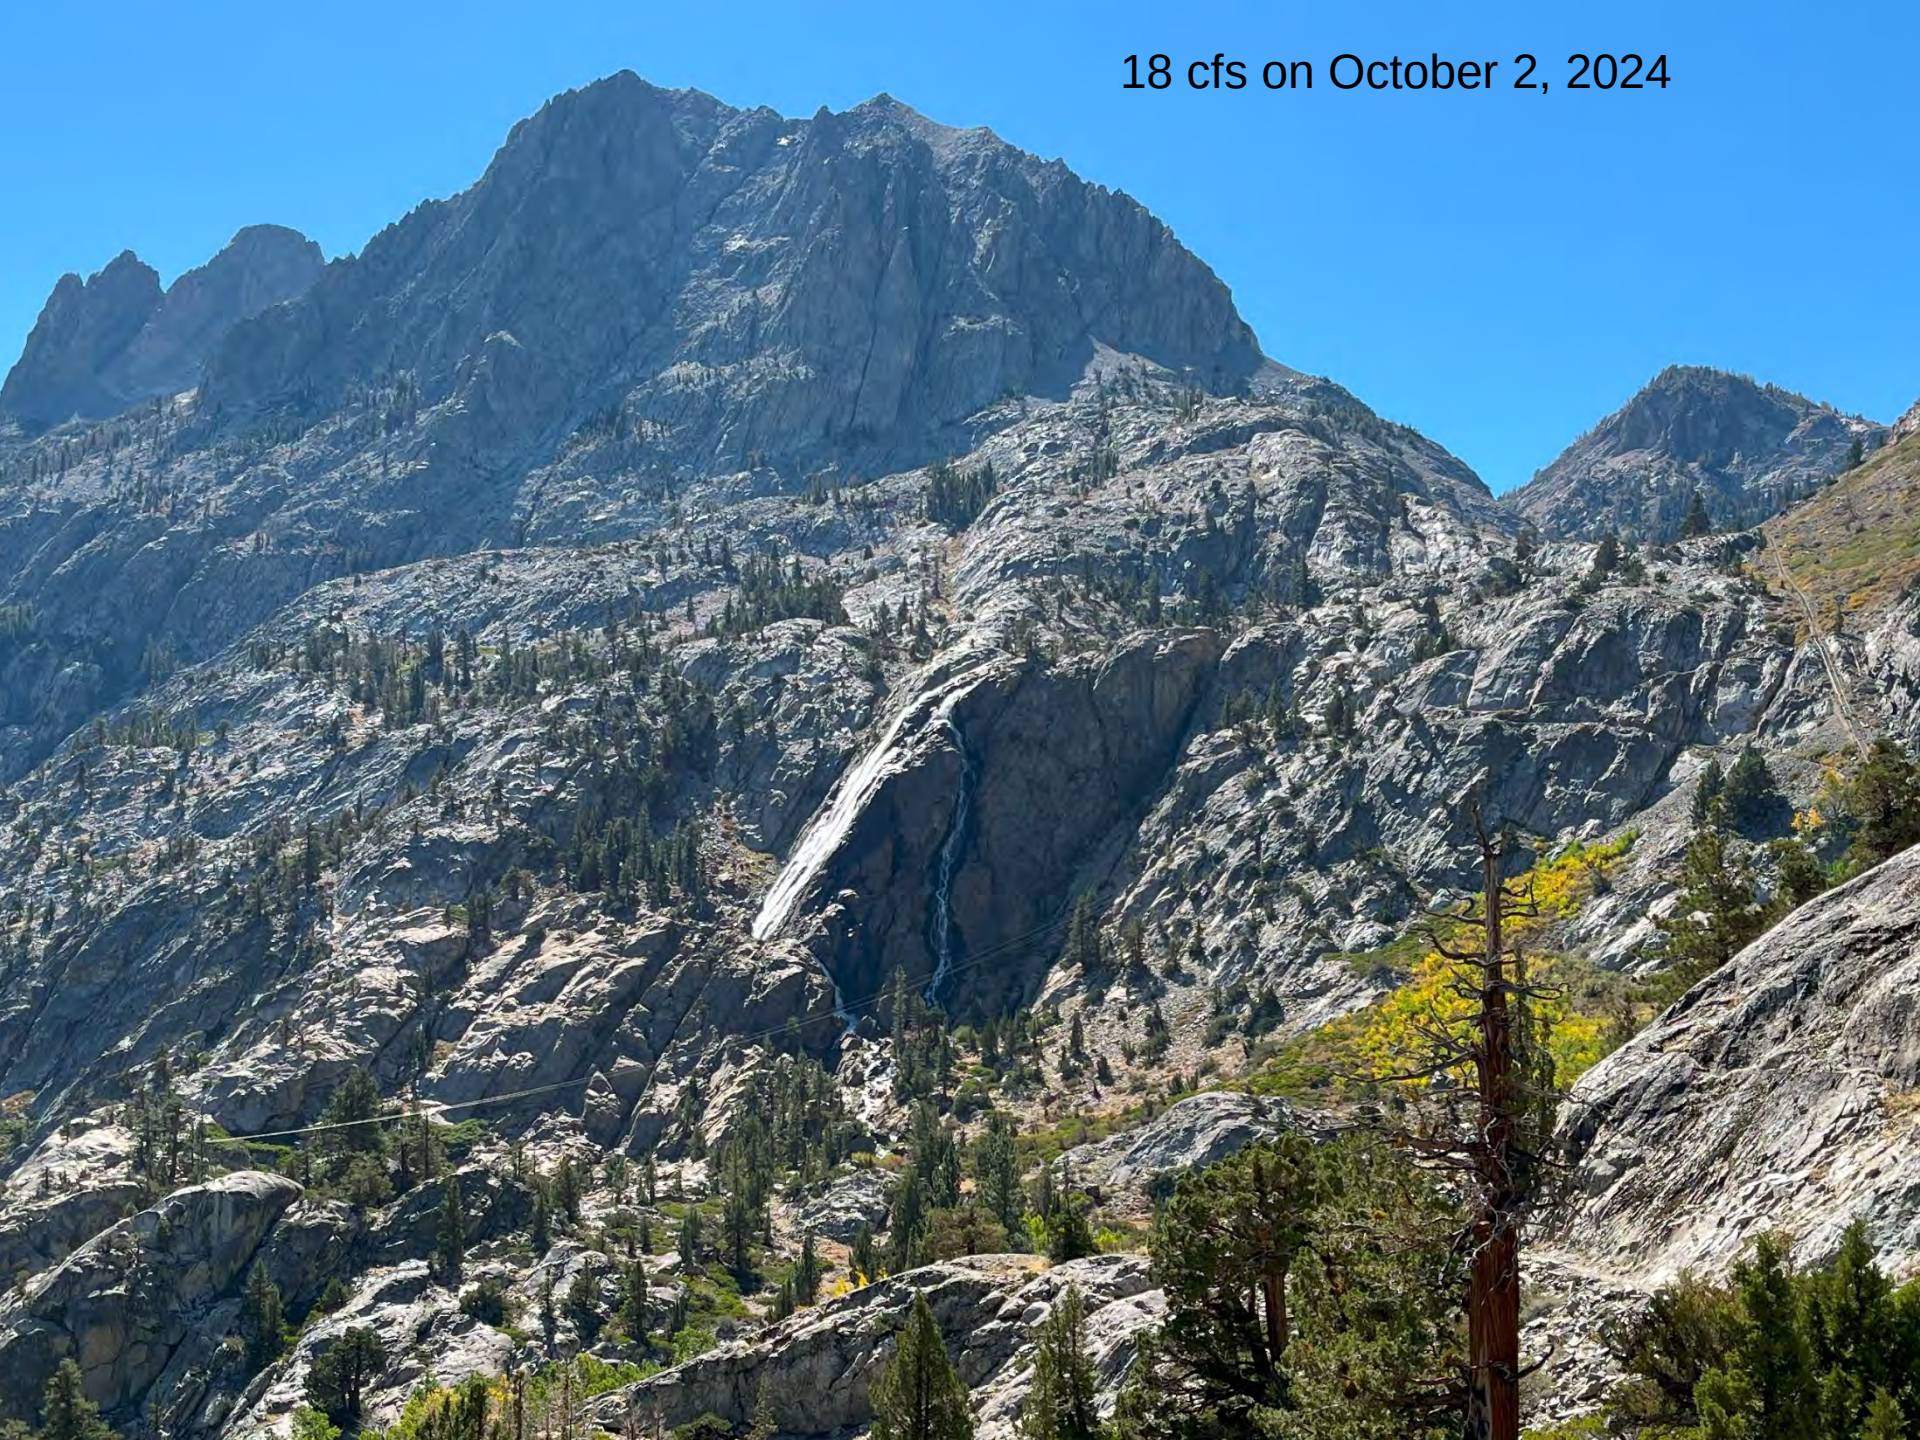
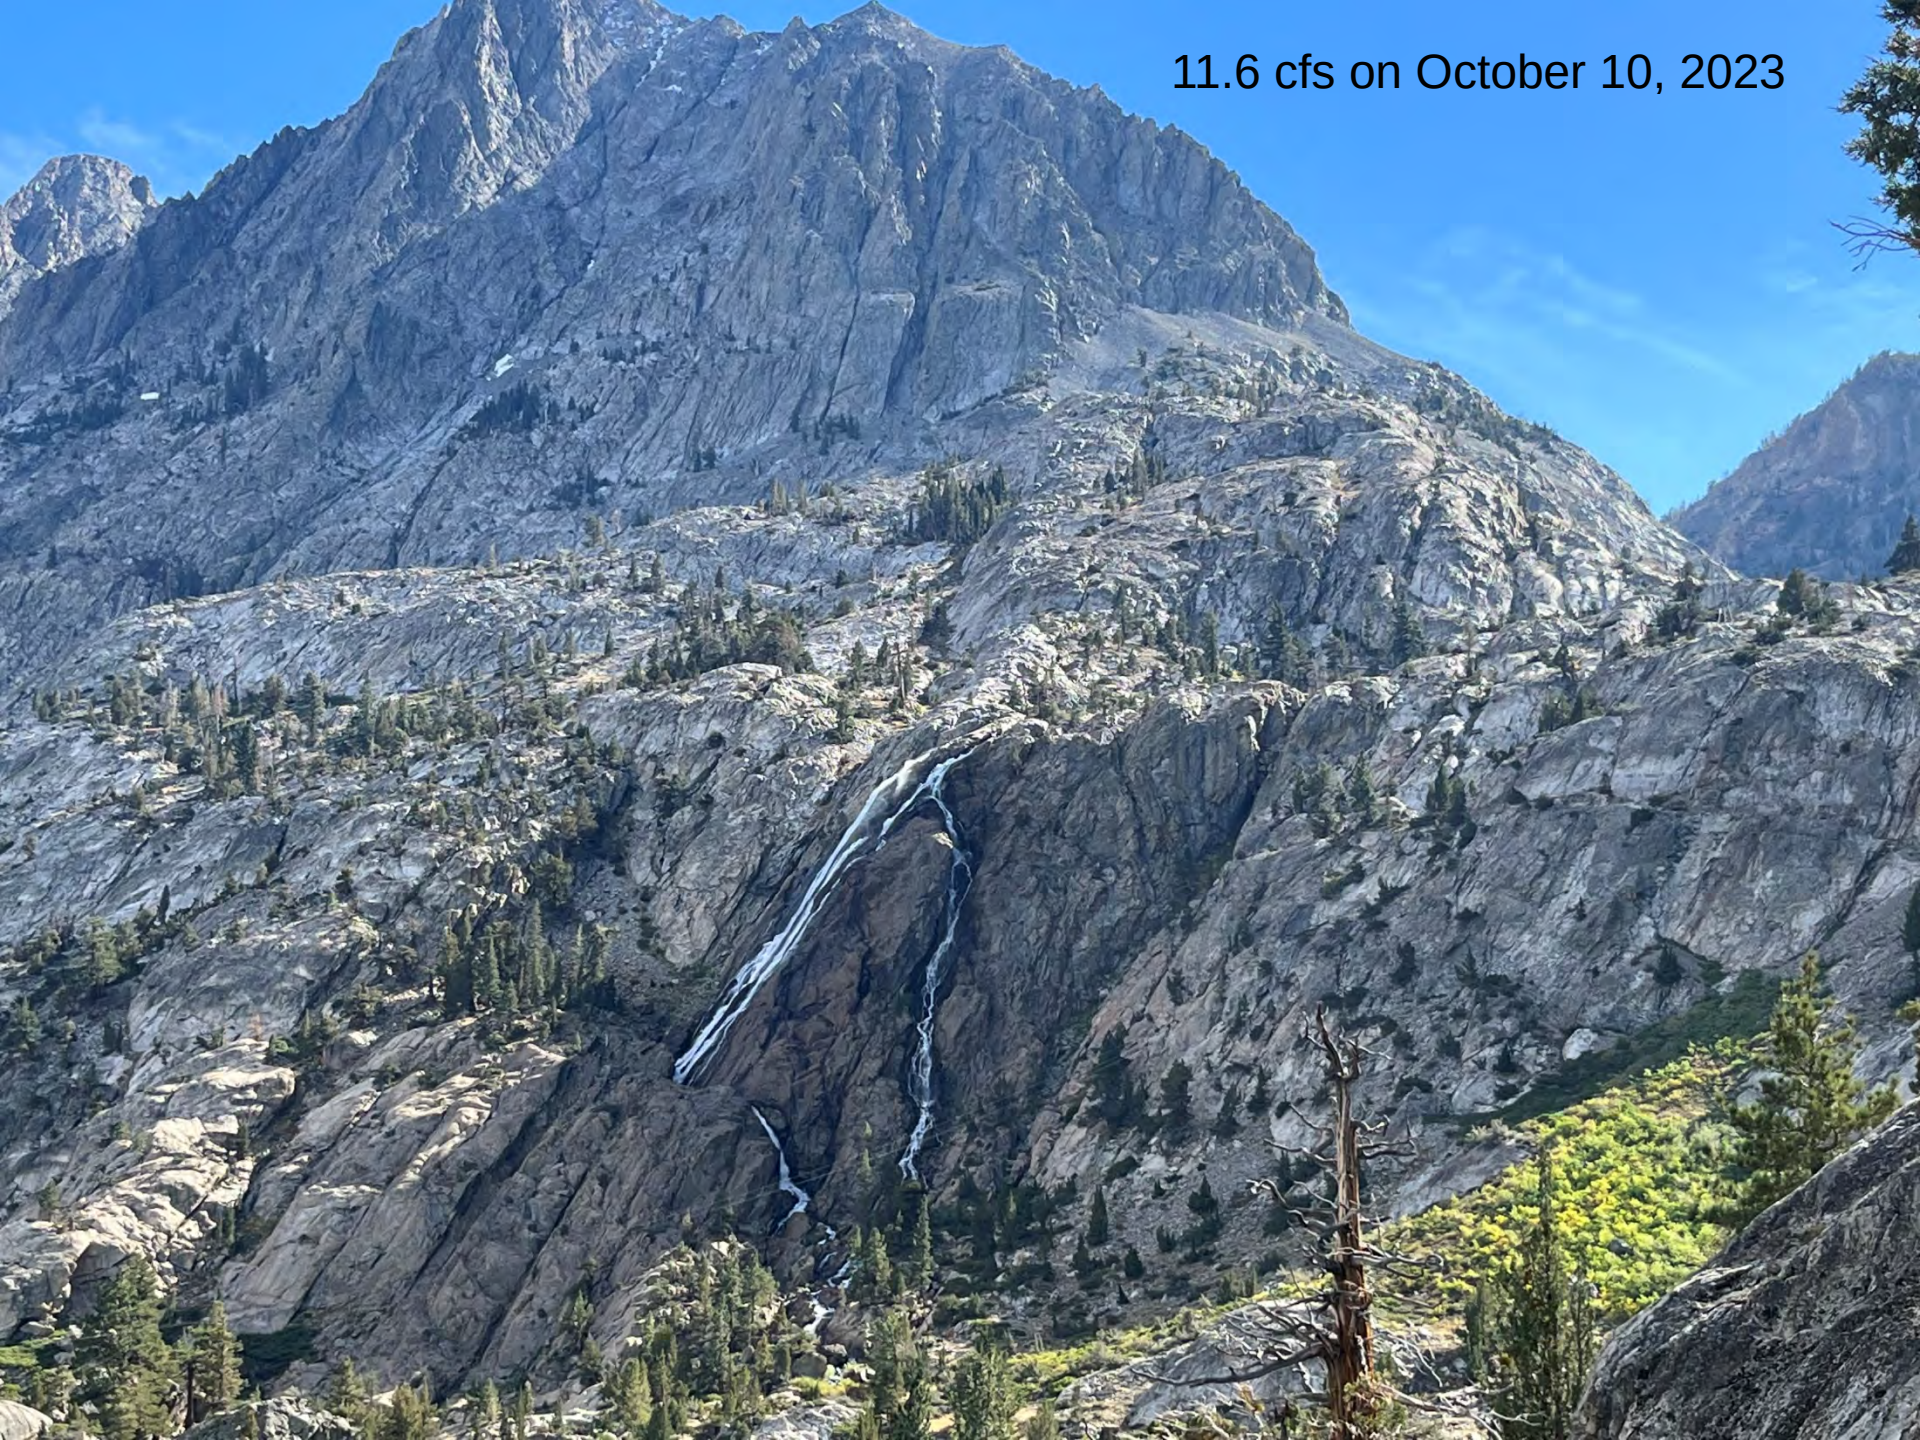
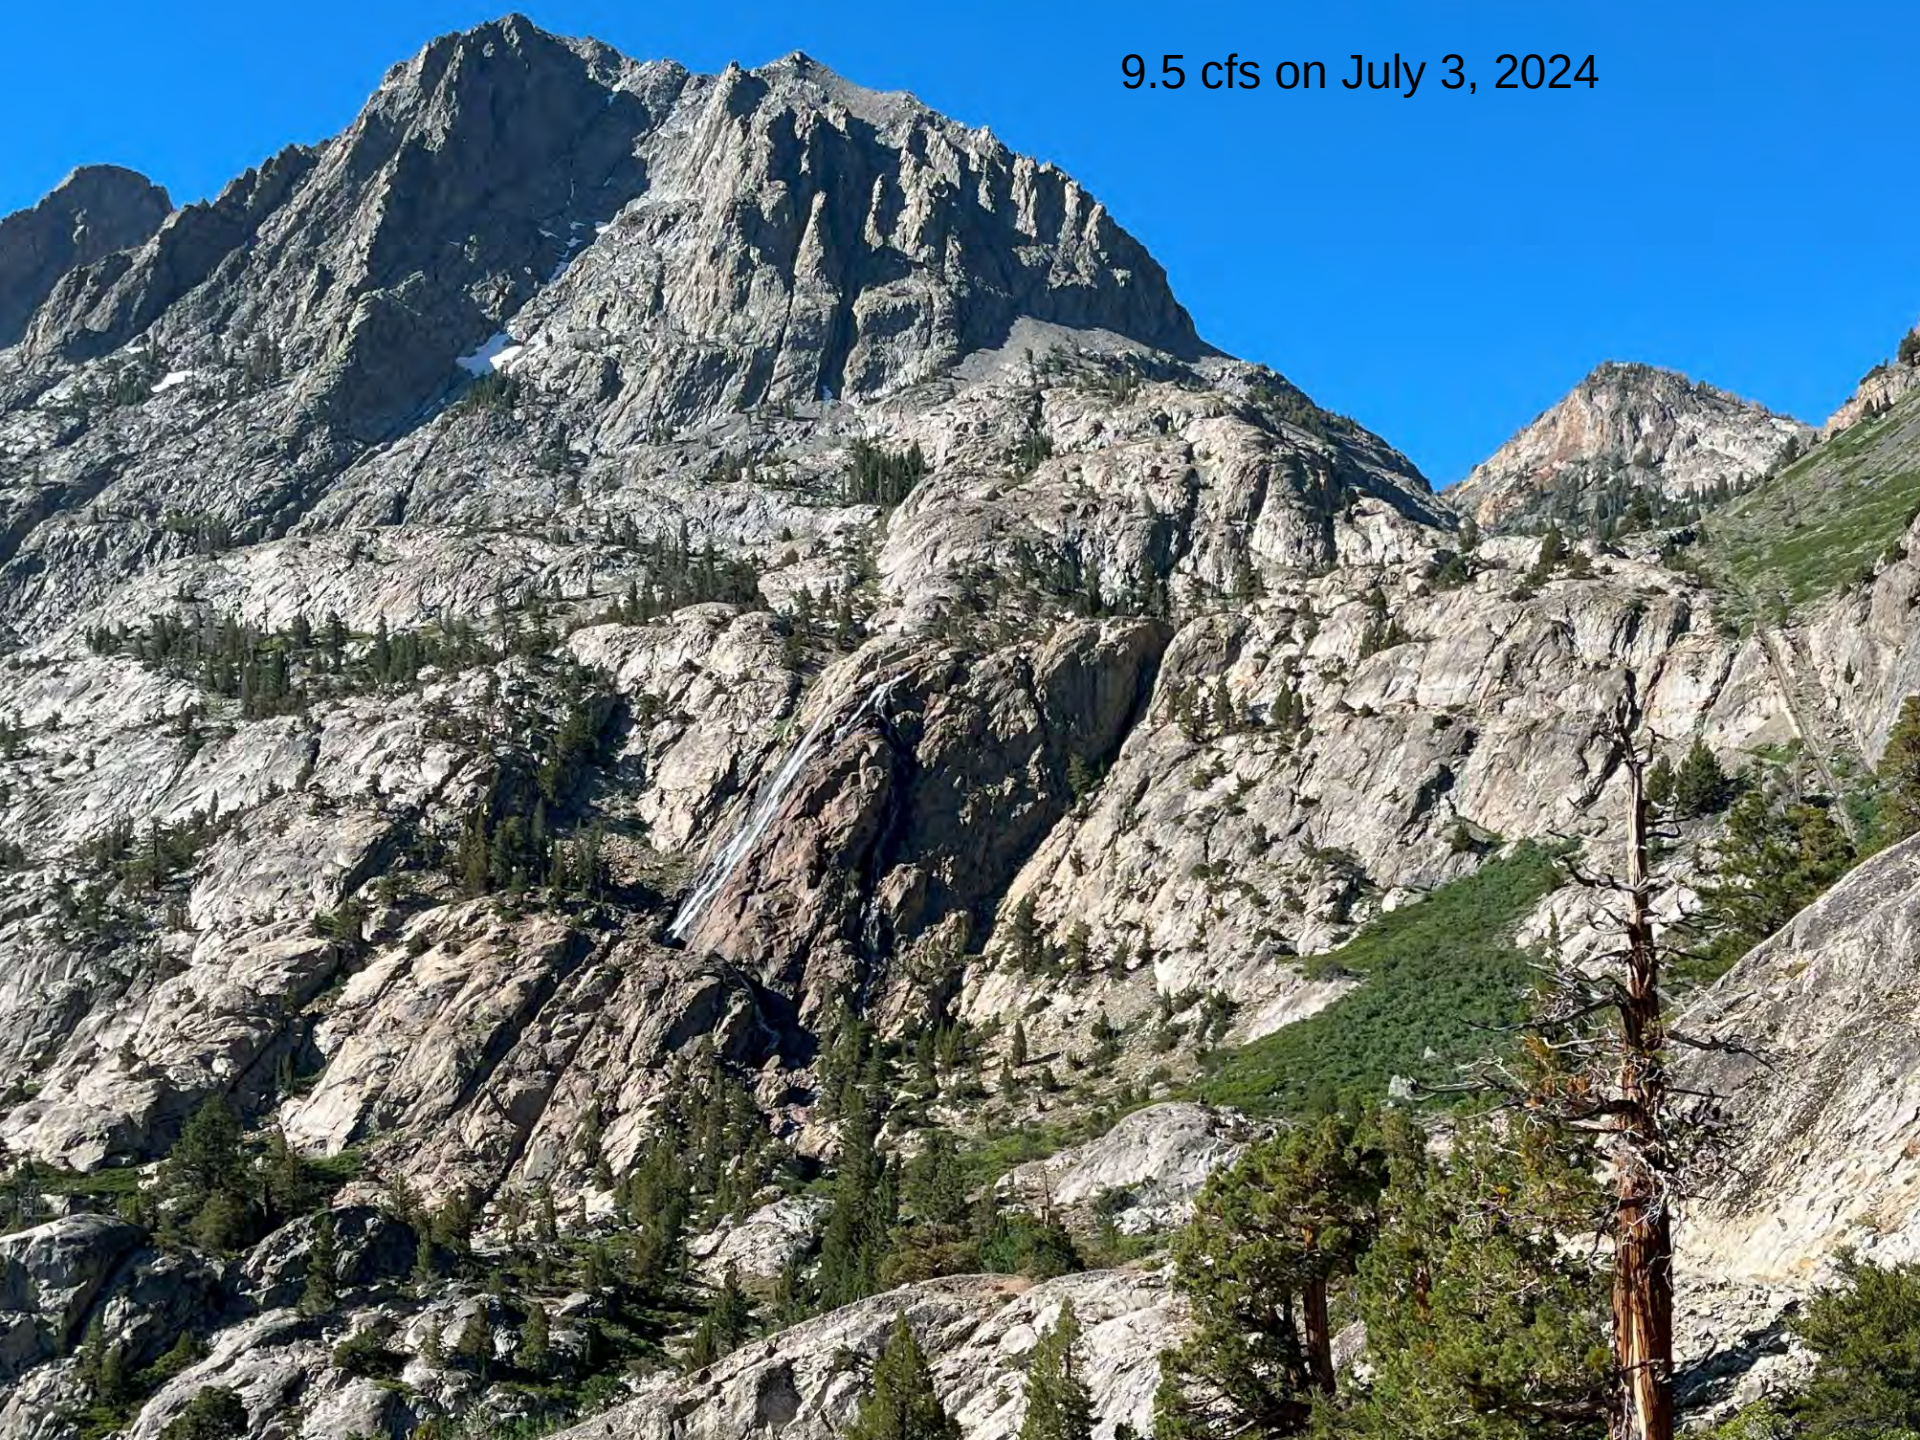
**KEY OBSERVATION POINT 2**

327 cfs on June 24, 2023 ("spill event")

284 cfs on July 17, 2023  
("spill event")

76 cfs on October 1, 2024

18 cfs on October 2, 2024

11.6 cfs on October 10, 2023

9.5 cfs on July 3, 2024

2.6 cfs on September 9, 2023

2.1 cfs on September 16, 2023

Horsetail Falls is a water feature along Rush Creek downstream of Agnew Dam where the creek falls and cascades approximately 500 vertical feet. Horsetail Falls is a dramatic and eye-catching component of the middleground view from SR 158 at high flows and an eye-catching, though less dramatic, visual phenomena at lower flows. At lower flows, time-of-day, and weather conditions (e.g., overcast or clear) may reduce or enhance the view of the falls from the highway. From the Rush Creek Trail, the falls are a larger component of the overall viewshed. While spectacular at high flows, they are an outstanding feature of the landscape from the trail even at 2 cfs.

Over the course of the 2023 and 2024 field season field staff visited the KOPs to photo document Horsetail Falls under different flow conditions. In some cases, coordination with SCE operations was necessary to organize releases commensurate with the desired flow condition because the flow condition was otherwise not present or only present for a short time period. For example, flows in the 13-to 20-cfs range occurred on just 2 days during the 2023 field season—October 11 and October 19—while flows in the 70-to 85-cfs range over the falls occurred on just 1 day—August 2, 2023. Because of the short period during which these flows occurred, field staff were not able to mobilize quickly enough to document flows under these two conditions during the 2023 season. Instead, field staff coordinated with SCE operations to arrange for these two flow conditions in October of

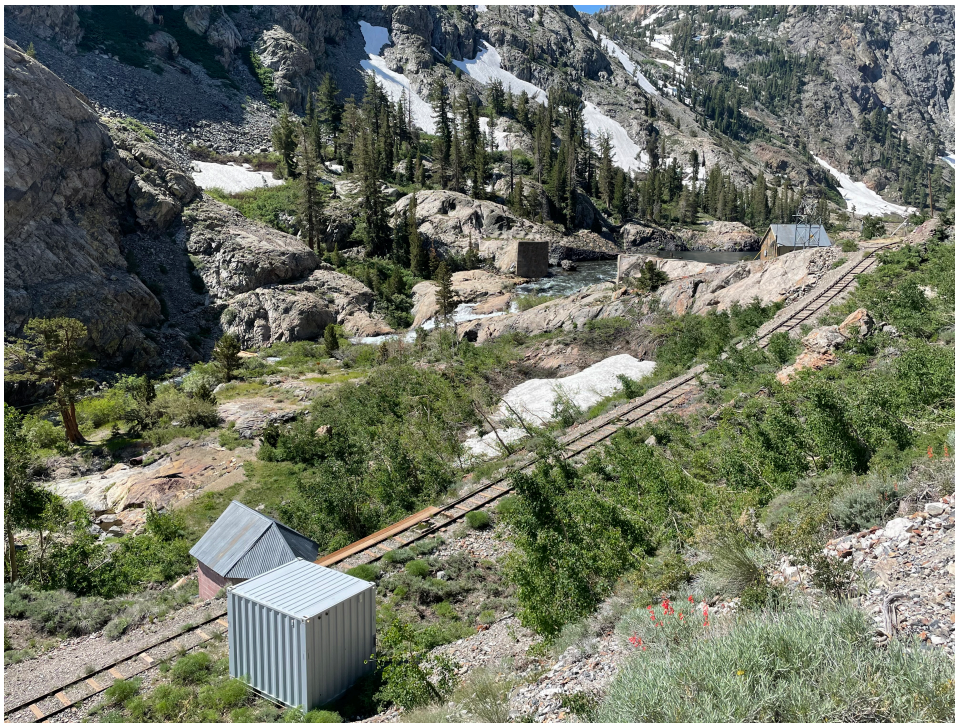
### Simulation – Partial Removal (image updated April 2025)

Specifically, Appendix C of the LAND 1 TSR includes visual renderings for SCE's Proposed Action (partial removal of Rush Meadows and Agnew dams and retrofitting of Gem Dam) and four decommissioning options (full removal of Rush Meadows, Agnew, and Gem dams, and partial removal of Gem Dam). Subsequent to filing the FLA, SCE determined that the visual rendering for partial removal of Agnew Dam (Key Observation Point 3 [KOP 3] on page C-21) is inaccurate. The visual rendering included in the FLA does not depict the remaining abutments. To correct this, SCE is filing a Revised LAND 1 TSR that includes the correct visual renderings for partial removal of Agnew Dam (refer to Appendix C, page C-21). All other visual renderings in Appendix C of the LAND 1 TSR are accurate.

**Visual Rendering – Partial Removal of Agnew Dam, KOP 3 (image filed with the Revised LAND 1 TSR, April 2025)**
