BIO-4 BENTHIC MACROINVERTEBRATE TECHNICAL MEMORANDUM

**KERN RIVER No. 3 HYDROELECTRIC PROJECT
*FERC PROJECT No. 2290***

July 2024

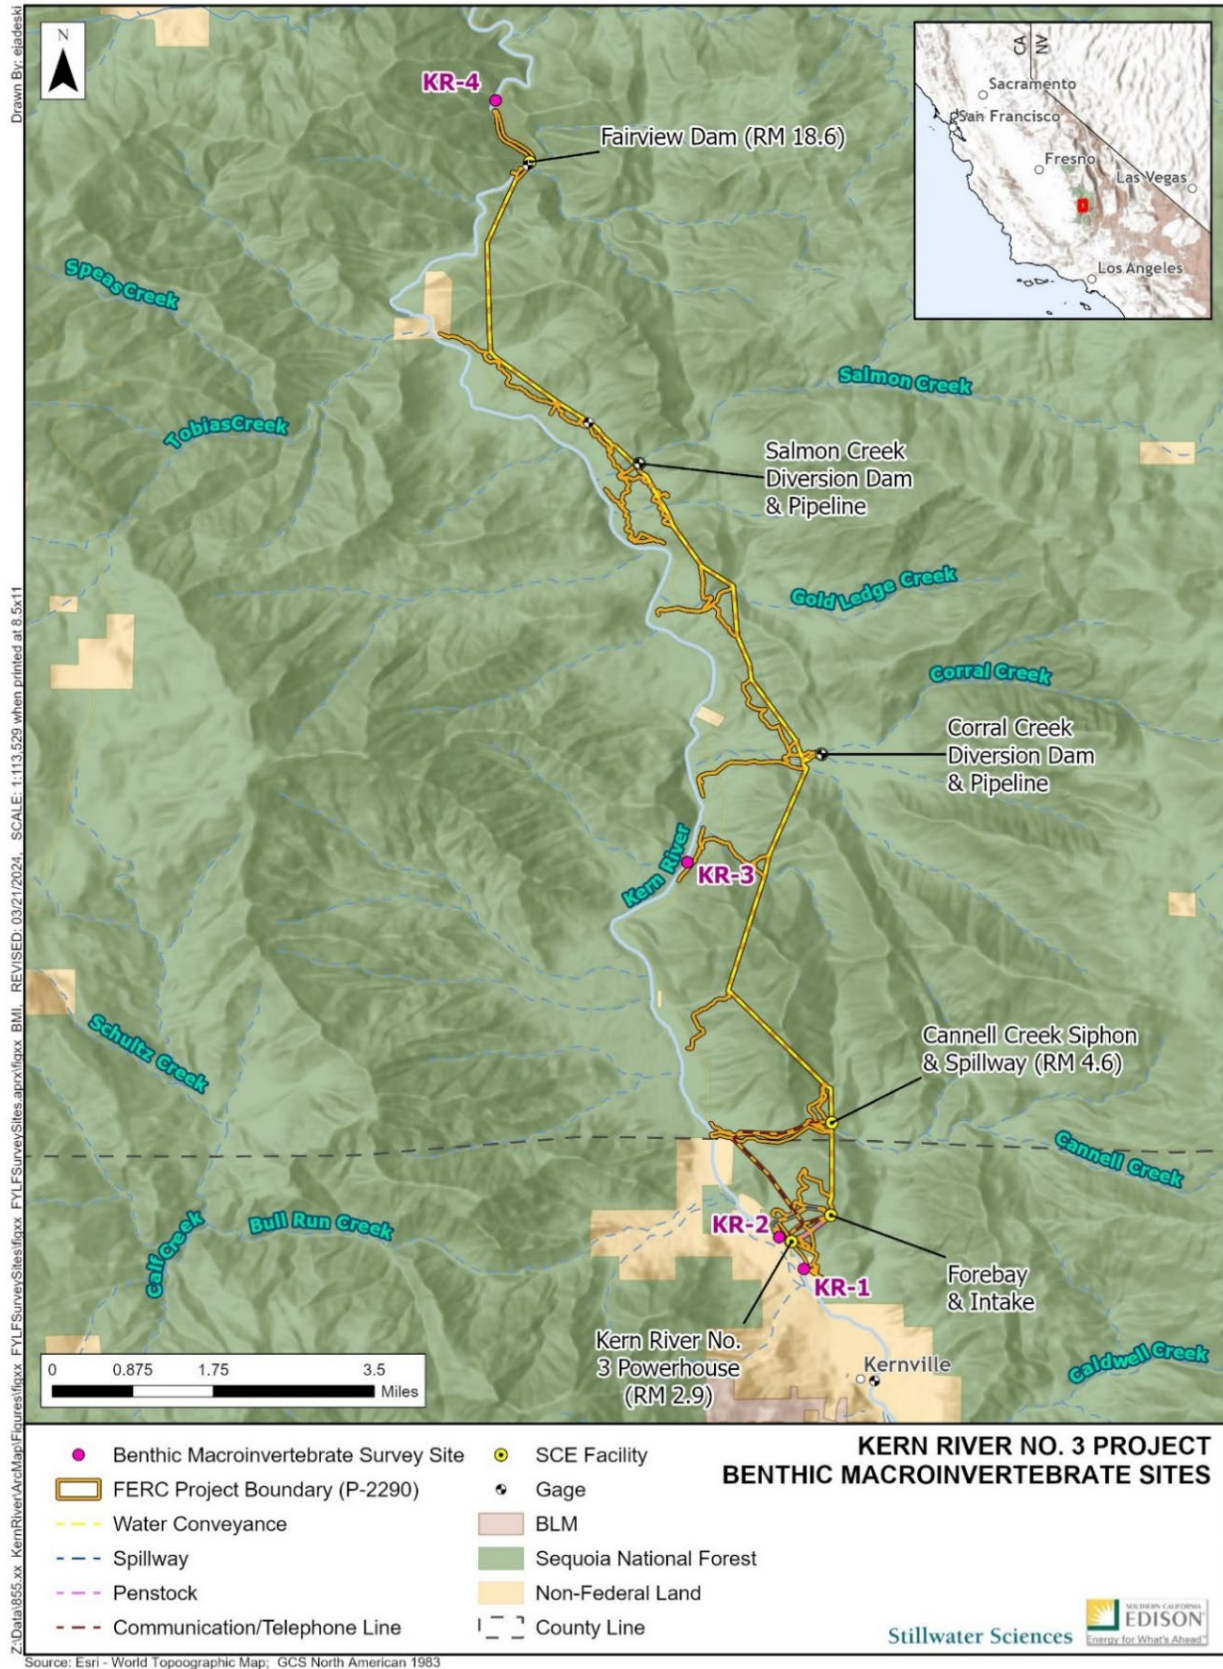
Figure 3-1. Benthic Macroinvertebrate Study Area.

- Downstream of KR3 Powerhouse (Site KR-1)
- Immediately upstream of KR3 Powerhouse (Site KR-2)
- Downstream of Gold Ledge Campground (Site KR-3)
- Upstream of Fairview Dam (control site) (Site KR-4)

Additional detail regarding the BMI study sites is provided in Table 3-1 and locations are shown in Figure 3-1.

A total of four samples were collected from four sites within the NFKR: one control site upstream of Fairview Dam, two within the Fairview Dam Bypass Reach, and one downstream of the Kern 3 Powerhouse (Table 3-1 and Figure 3-1).

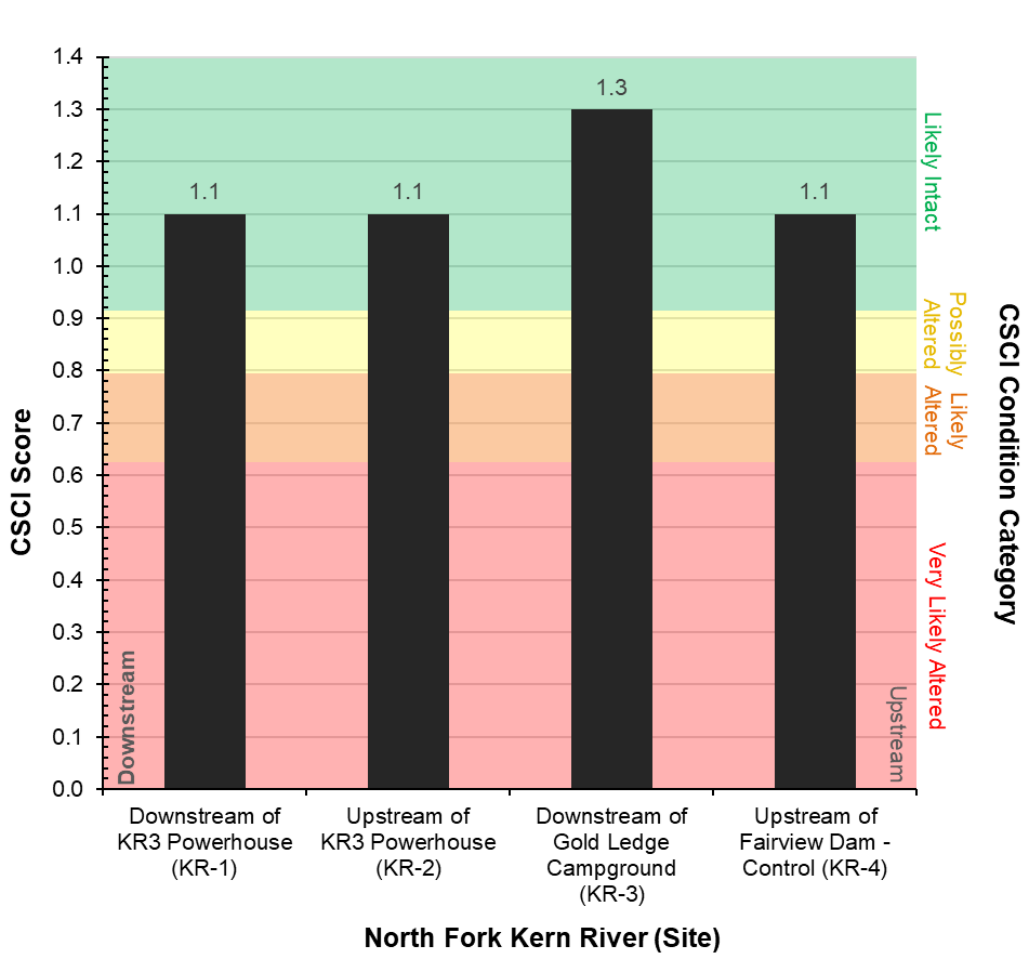
Figure 5.3-1. California Stream Condition Index Scores and Condition Categories for Samples Collected during Benthic Macroinvertebrate Sampling in 2023 for the Kern River No. 3 Hydroelectric Project.

The CSCI scores for the samples collected in the NFKR downstream of the KR3 Powerhouse (Site KR-1), upstream of the KR3 Powerhouse (Site KR-2), downstream of Gold Ledge Campground (Site KR-3), and the control site upstream of Fairview Dam (Site KR-4) were within the condition category described as “likely intact” with a score greater than or equal to 0.92 (Figure 5.3-1). MMI components (as described in Table 4.2-1) of the CSCI and other commonly reported metrics regarding richness, composition (e.g., Shannon-Weaver Diversity Index), and tolerance values for each sample are included in Appendix C.

CSCI calculation integrates O/E taxonomic completeness and MMI results into a single score that typically ranges from 0.1 (great deviation from reference condition) to 1.4 (exceeding quality of reference condition). CSCI scores are further divided into three thresholds, based on the 30th, 10th, and 1st percentiles of CSCI scores at reference sites in the state-wide database. These three thresholds divide the CSCI scoring range into the following four categories of biological condition (Rehn et al., 2015):

- ≥ 0.92 = likely intact condition
- 0.91 to 0.80 = possibly altered condition
- 0.79 to 0.63 = likely altered condition
- ≤ 0.62 = very likely altered condition
